TREE CONSERVATION REPORT V2.0

30 Auriga Drive, Part 10

Tree Conservation Report submitted as Partial
Requirements for a Site Plan Control Application,
July 12, 2023

Tree Conservation Report v2.0

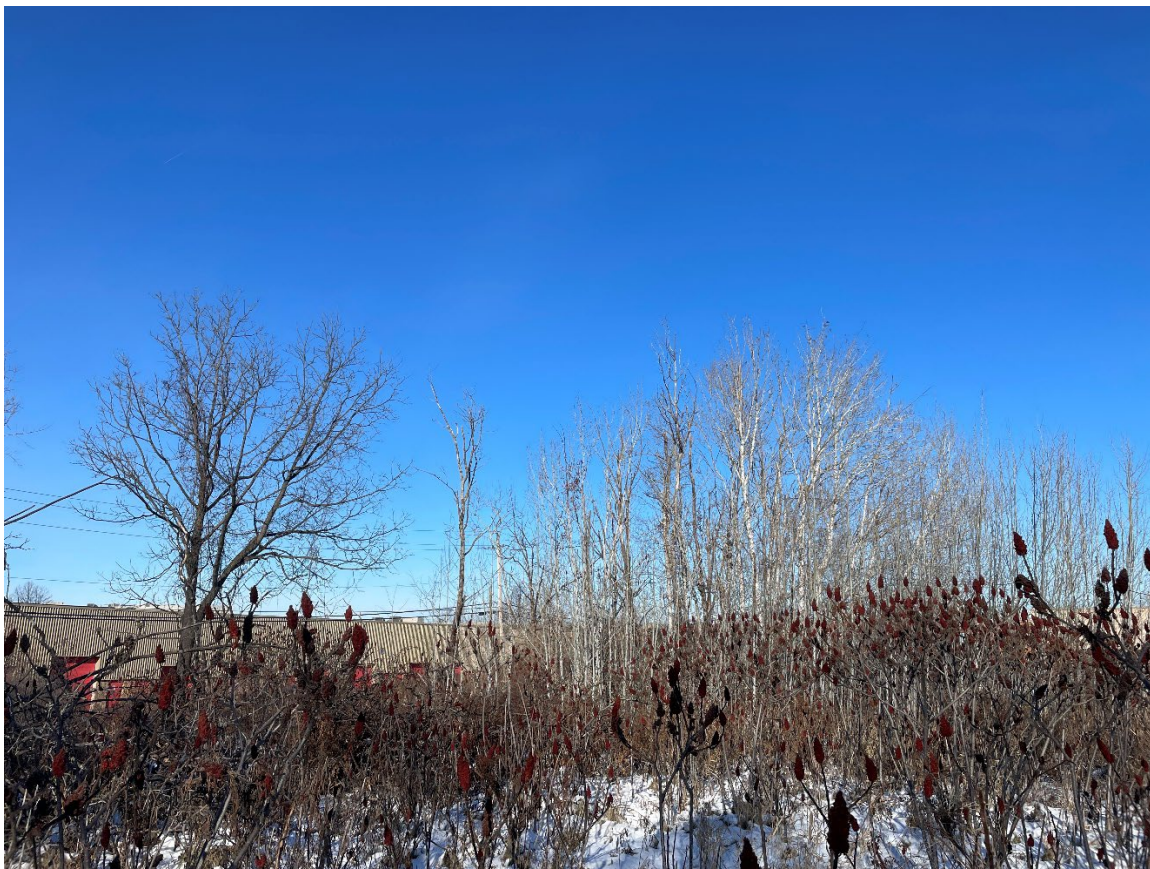
This area has only recently seeded in with trembling aspen (*Populus tremuloides*) which are 1-8 cm in diameter. Although small, this area is dense, and the trees are young and vigorous.

Figure 1: Taken from centre of property looking north. Small poplars in Polygon A on right, and black walnut (tree 7) on left

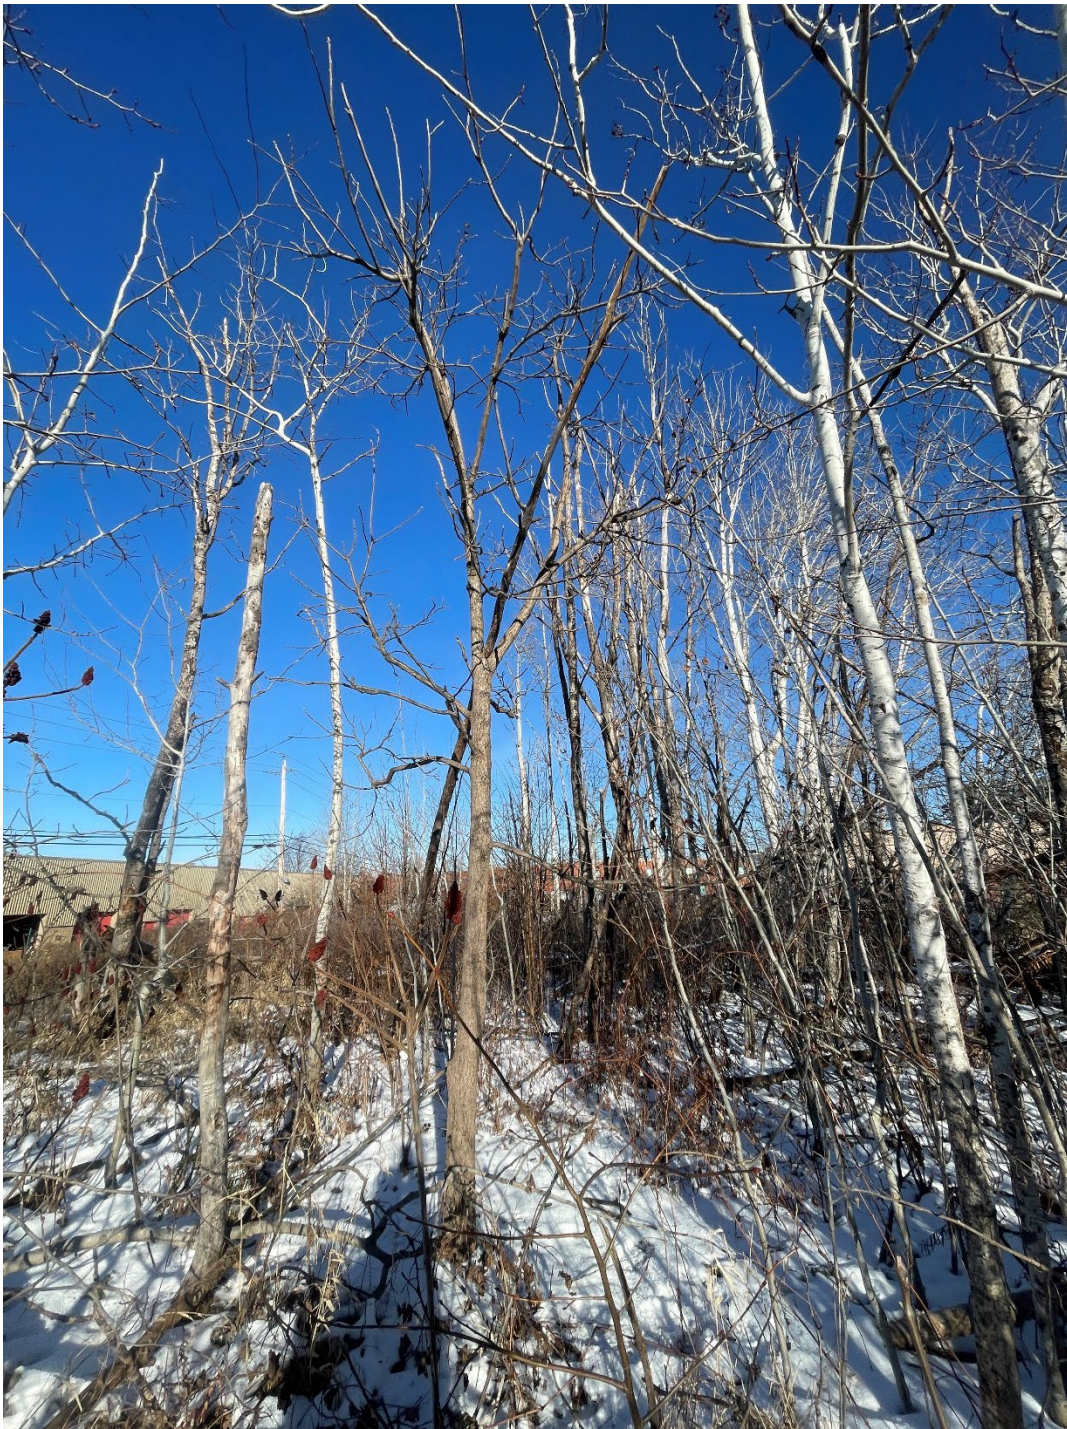
Trees began establishing in this area approximately 30 years ago and consist mainly of *Populus tremuloides* which range from approximately 10 – 30 cm in diameter. There is an abundance of regeneration of *Tilia americana* and *Fraxinus spp.* One 13 cm black walnut (*Juglans nigra*) was also identified in this section.

Figure 2: Polygon B, medium sized poplars in the northern section

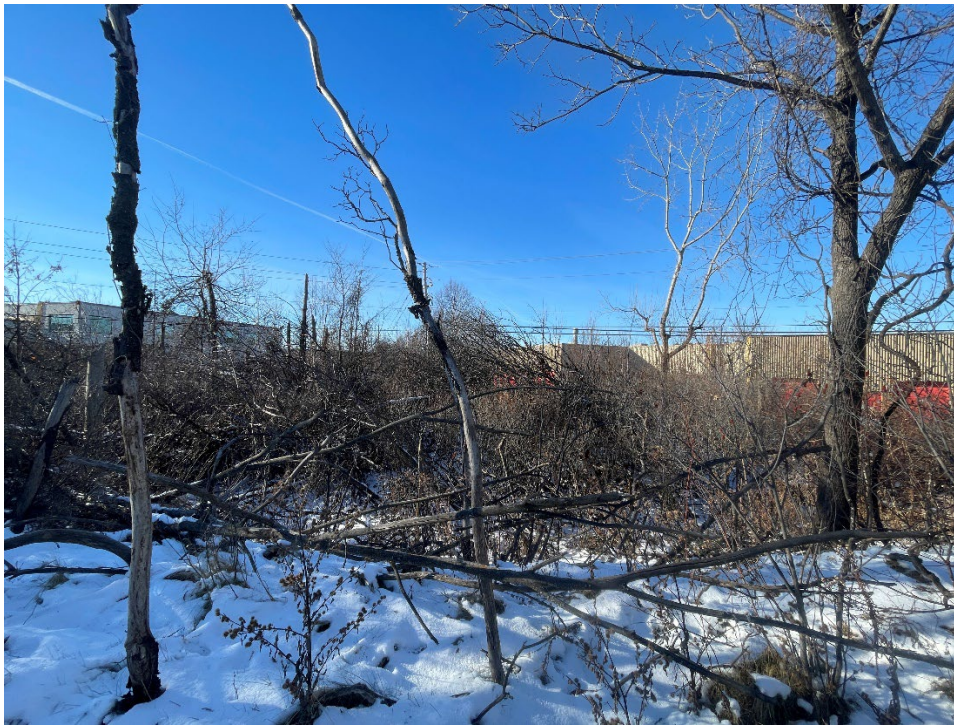
This area in the southwest corner is a depression and was impenetrable due to severe blowdown. Few standing trees exist in this section, and it is likely that part of this blowdown occurred during the Derecho storm that affected this area significantly in May 2022.

Figure 3: Polygon C - depression with blowdown

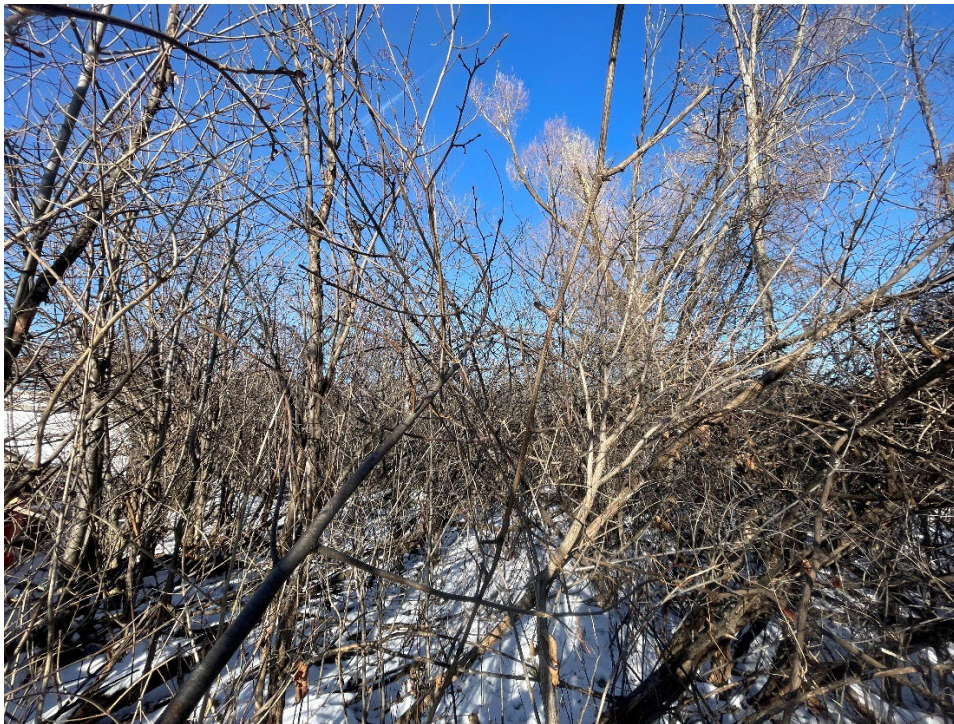
This section is mostly young trees including American elm (*Ulmus americana*), ash (*Fraxinus spp*), serviceberry (*Amelanchier spp*), trembling aspen (*Populus tremuloides*) and hawthorn (*Crataegus spp*). With the loss of the ash canopy due to the emerald ash borer, the area has become a dense thicket, and there is a high abundance of vines (Virginia creeper and wild grape).

Figure 4: Example of dense thicket in Polygon D

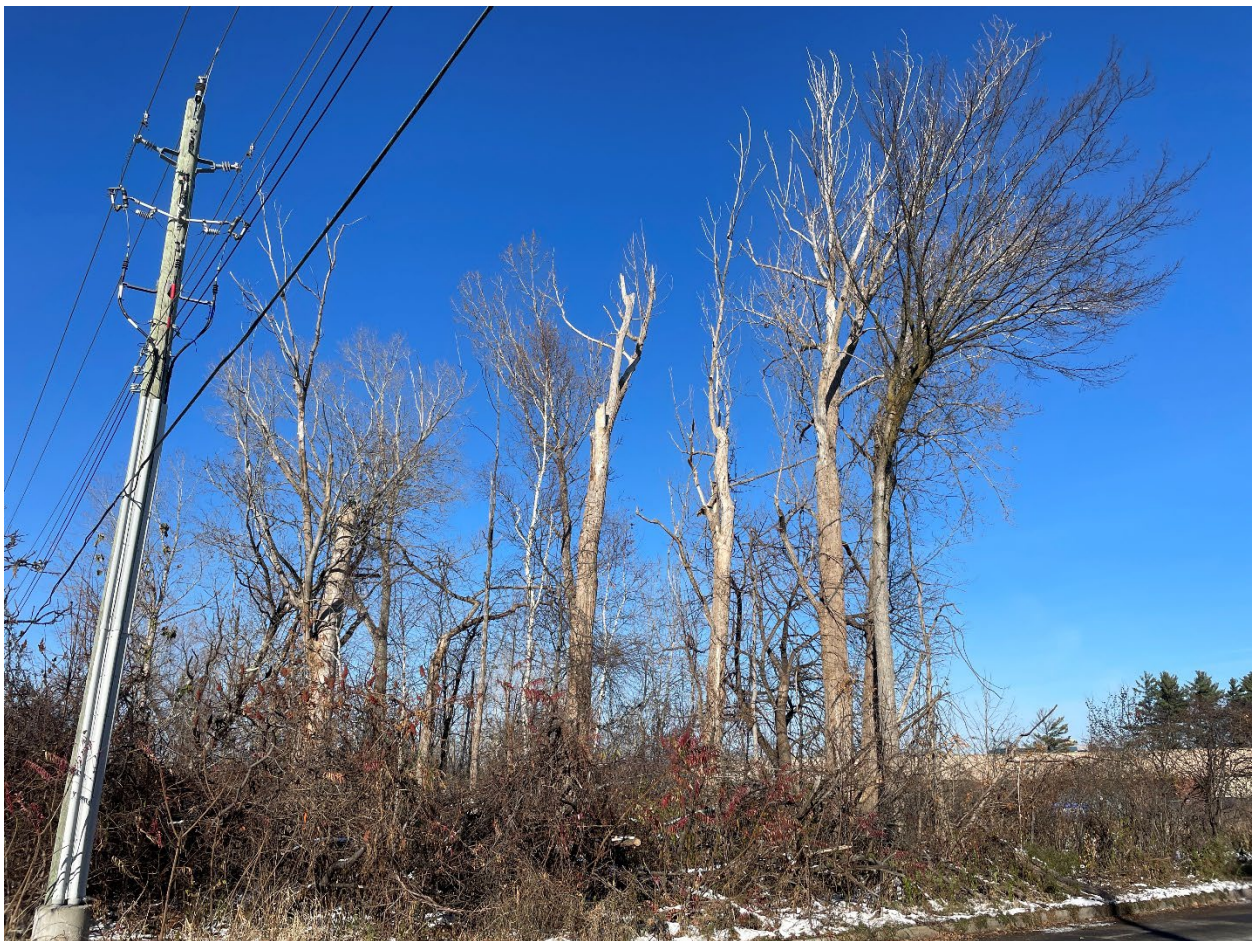
This area is part of the old hedgerow that separated two agriculture fields prior to 1991. Some of the trembling aspen trees are very large and are in decline. Smaller trees (10-30 cm) that are present in this section include white birch (*Betula papyrifera*), black cherry (*Prunus serotina*), basswood, and American elm. All of the trees are in either fair or poor condition. Many have lost larger branches during the recent Derecho storm.

Figure 5: Trees in the southern tip (polygon E) part of the old hedgerow. Elm tree (Tree #1) is on the right

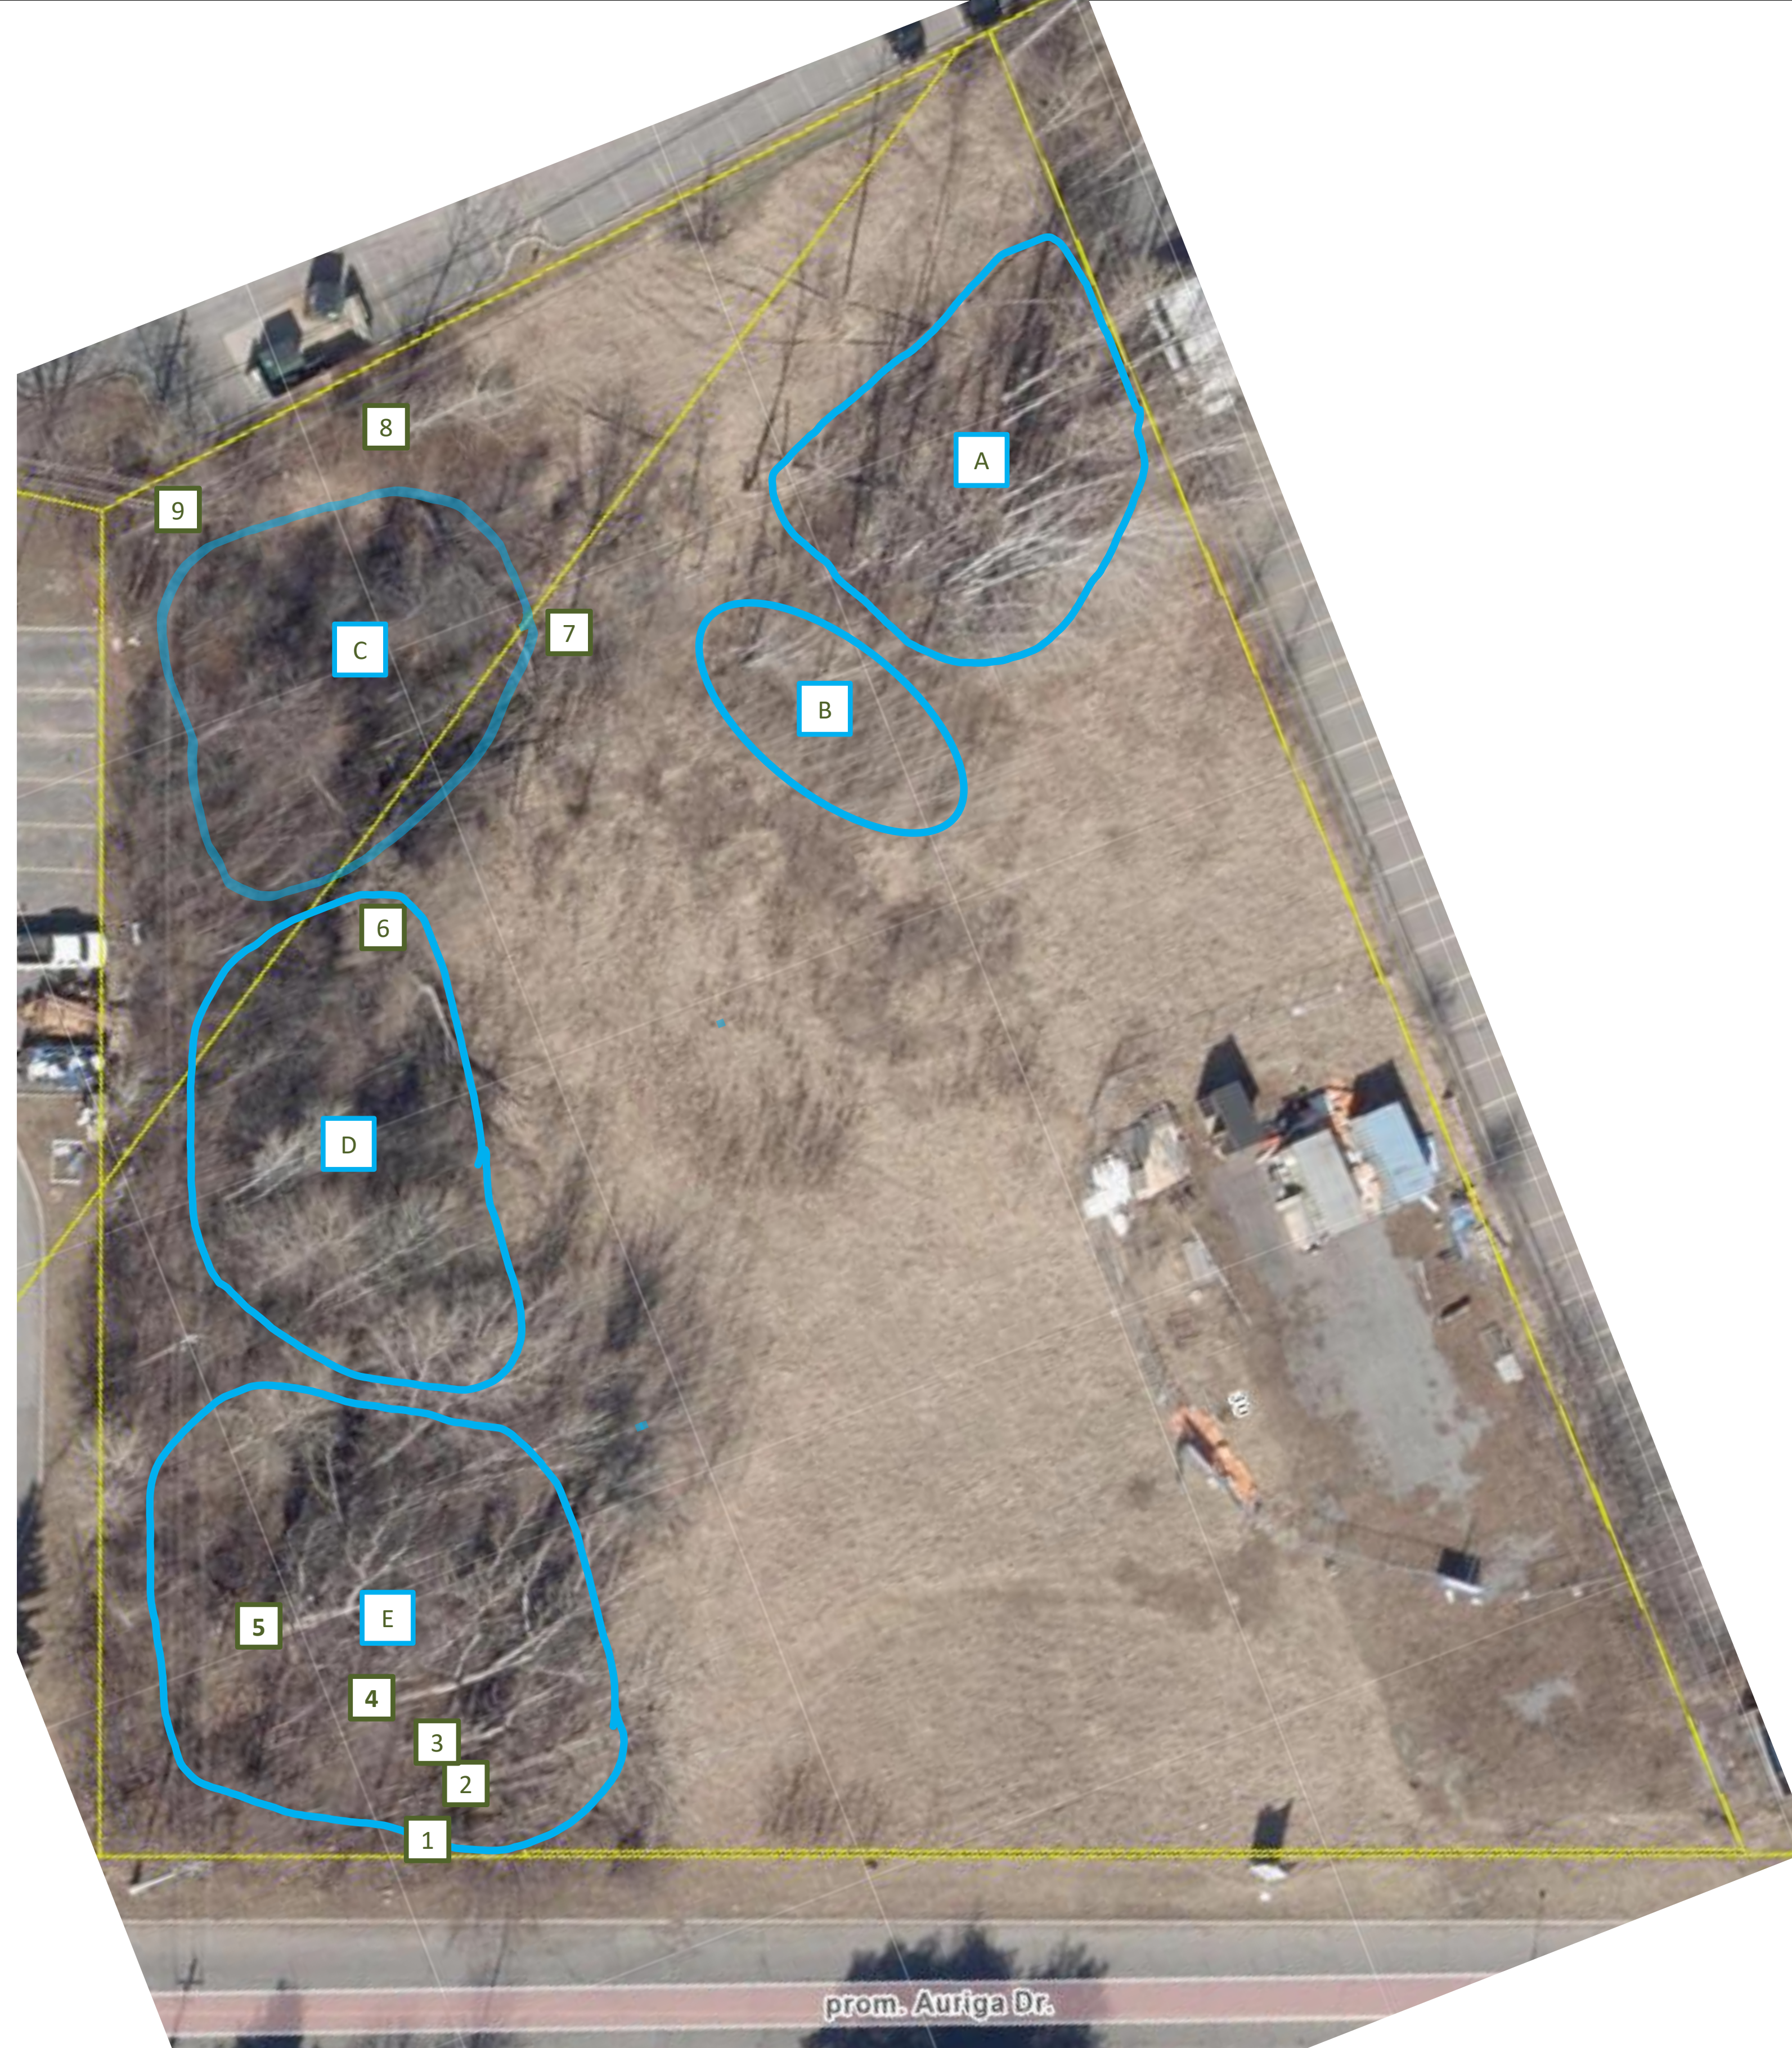
Tree Conservation Report Map #1 – Current Vegetation
 Tree layer prepared by Dendron Forestry Services
 Version 1.0, November 22, 2022
 For more information, please contact info@dendronforestry.ca

Using the 2021 imagery from GeoOttawa, the tree inventory has been parceled into five polygons with similar vegetation types as identified in the *Current Vegetation Map#1*. The boundaries of these polygons are approximate, and the vegetation is described generally as follows:

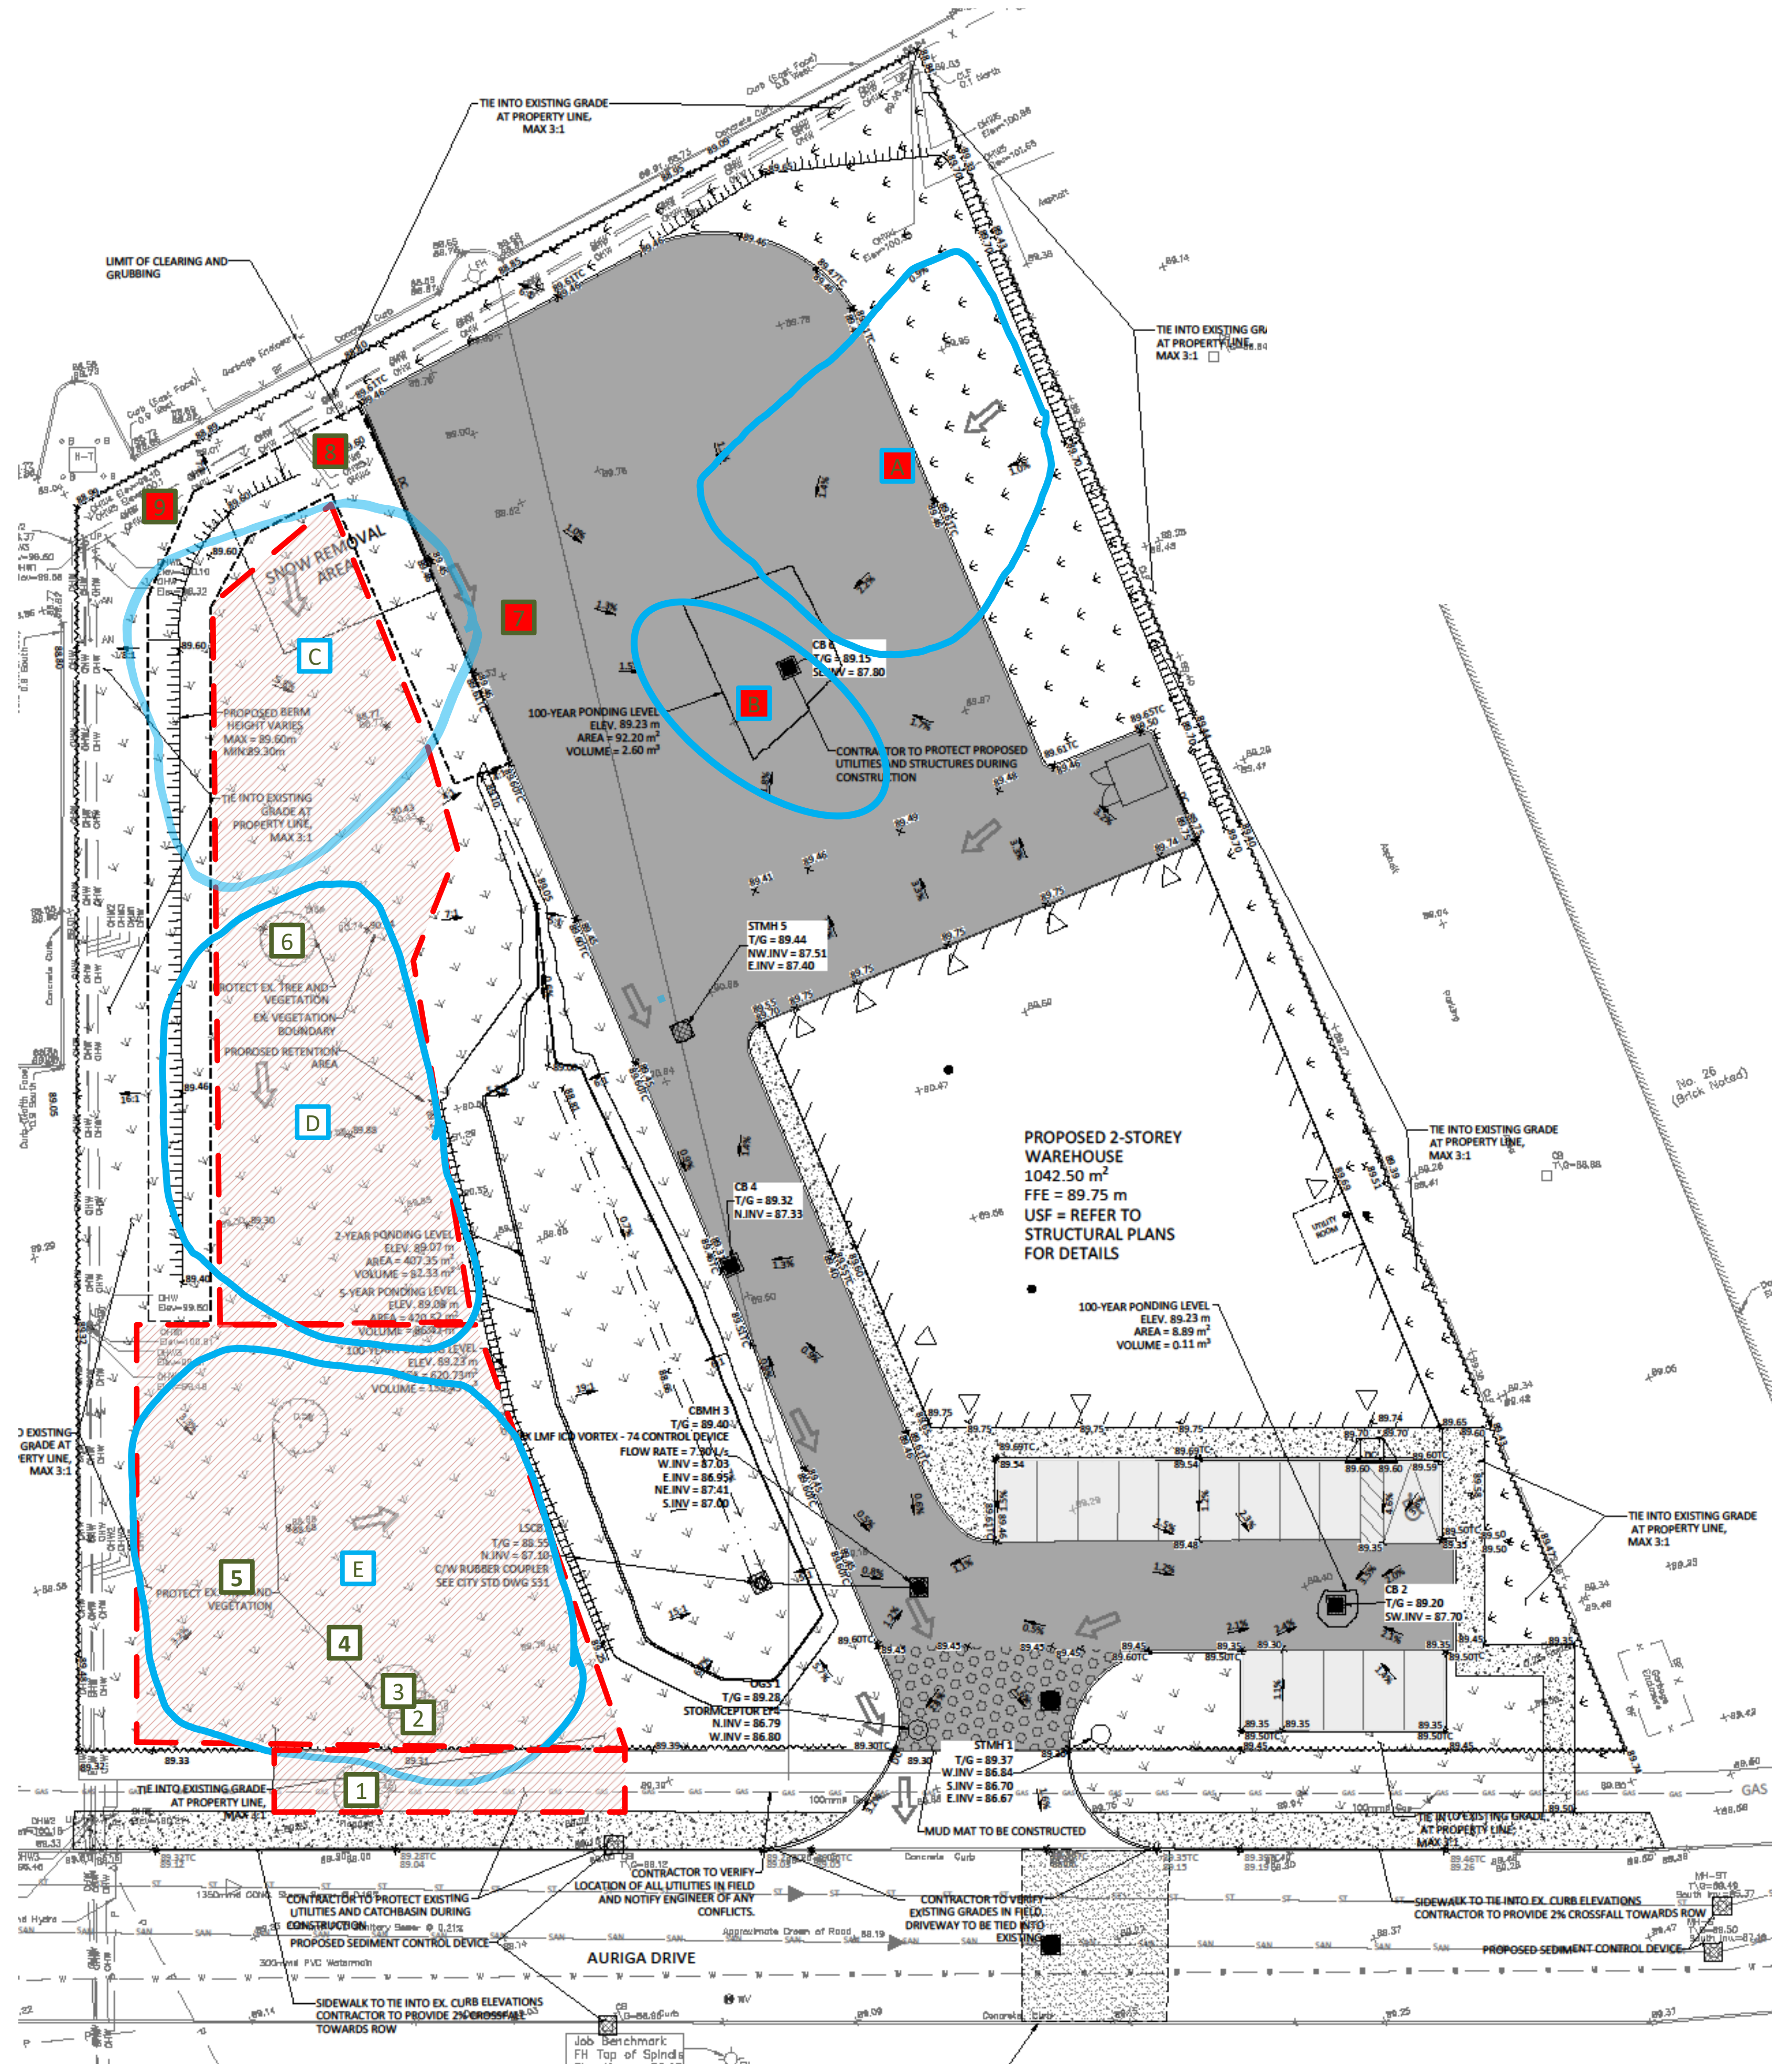
Tree Conservation Report Map #2 – Proposed Development and Conserved Vegetation
 Tree layer prepared by Dendron Forestry Services
 Version 3.0, July 12, 2023
 For more information, please contact info@dendronforestry.ca

The Proposed Development and Conserved Vegetation map (Map #2) shows the area that will be developed as part of Phase 1 with the tree layer from Map #1 transposed on top. The locations are approximate but are sufficient for the purposes of this Tree Conservation Report. The proposed development will involve paving the back section of the upper lot to accommodate the turnaround for trucks. As a result, all the trees in the northern section, including those in Polygons A, B, and tree 7 will require removal.

In an attempt to reduce tree loss, drainage on site has been controlled by use of a berm along the southern property edge, and a drainage pond immediately south of the proposed paved surface. While these measures will necessitate the **removal of Tree 8 and 9**, as well as some trees in **Polygon C and D**, it will allow a large area in the undeveloped southern portion of the property to keep existing grades. This maintaining of grade should allow for the trees in these areas to be retained. Map #2 has been updated to show a Tree Protection Area within which no tree removal should occur:

Prior to any site works, protective fencing should be installed around the Tree Protection Area as indicated in the attached Map #2 and maintained until all construction on site has been completed as per the City of Ottawa Tree Protection Specifications (March 2021). **Failure to install and maintain fencing as indicated in the attached map may result in fines from the city.**

Prior to any site works, protective fencing should be installed around the TPA as indicated in this Map and maintained until all construction on site has been completed as per the City of Ottawa Tree Protection Specifications (March 2021). **Failure to install and maintain fencing as indicated in this report may result in fines from the city.**
