TREE CONSERVATION REPORT

630 Montreal Road, Ottawa, Ontario.

MP Project No.: CCO-21-4432

TREE CONSERVATION REPORT
630 Montreal Road, Ottawa, Ontario

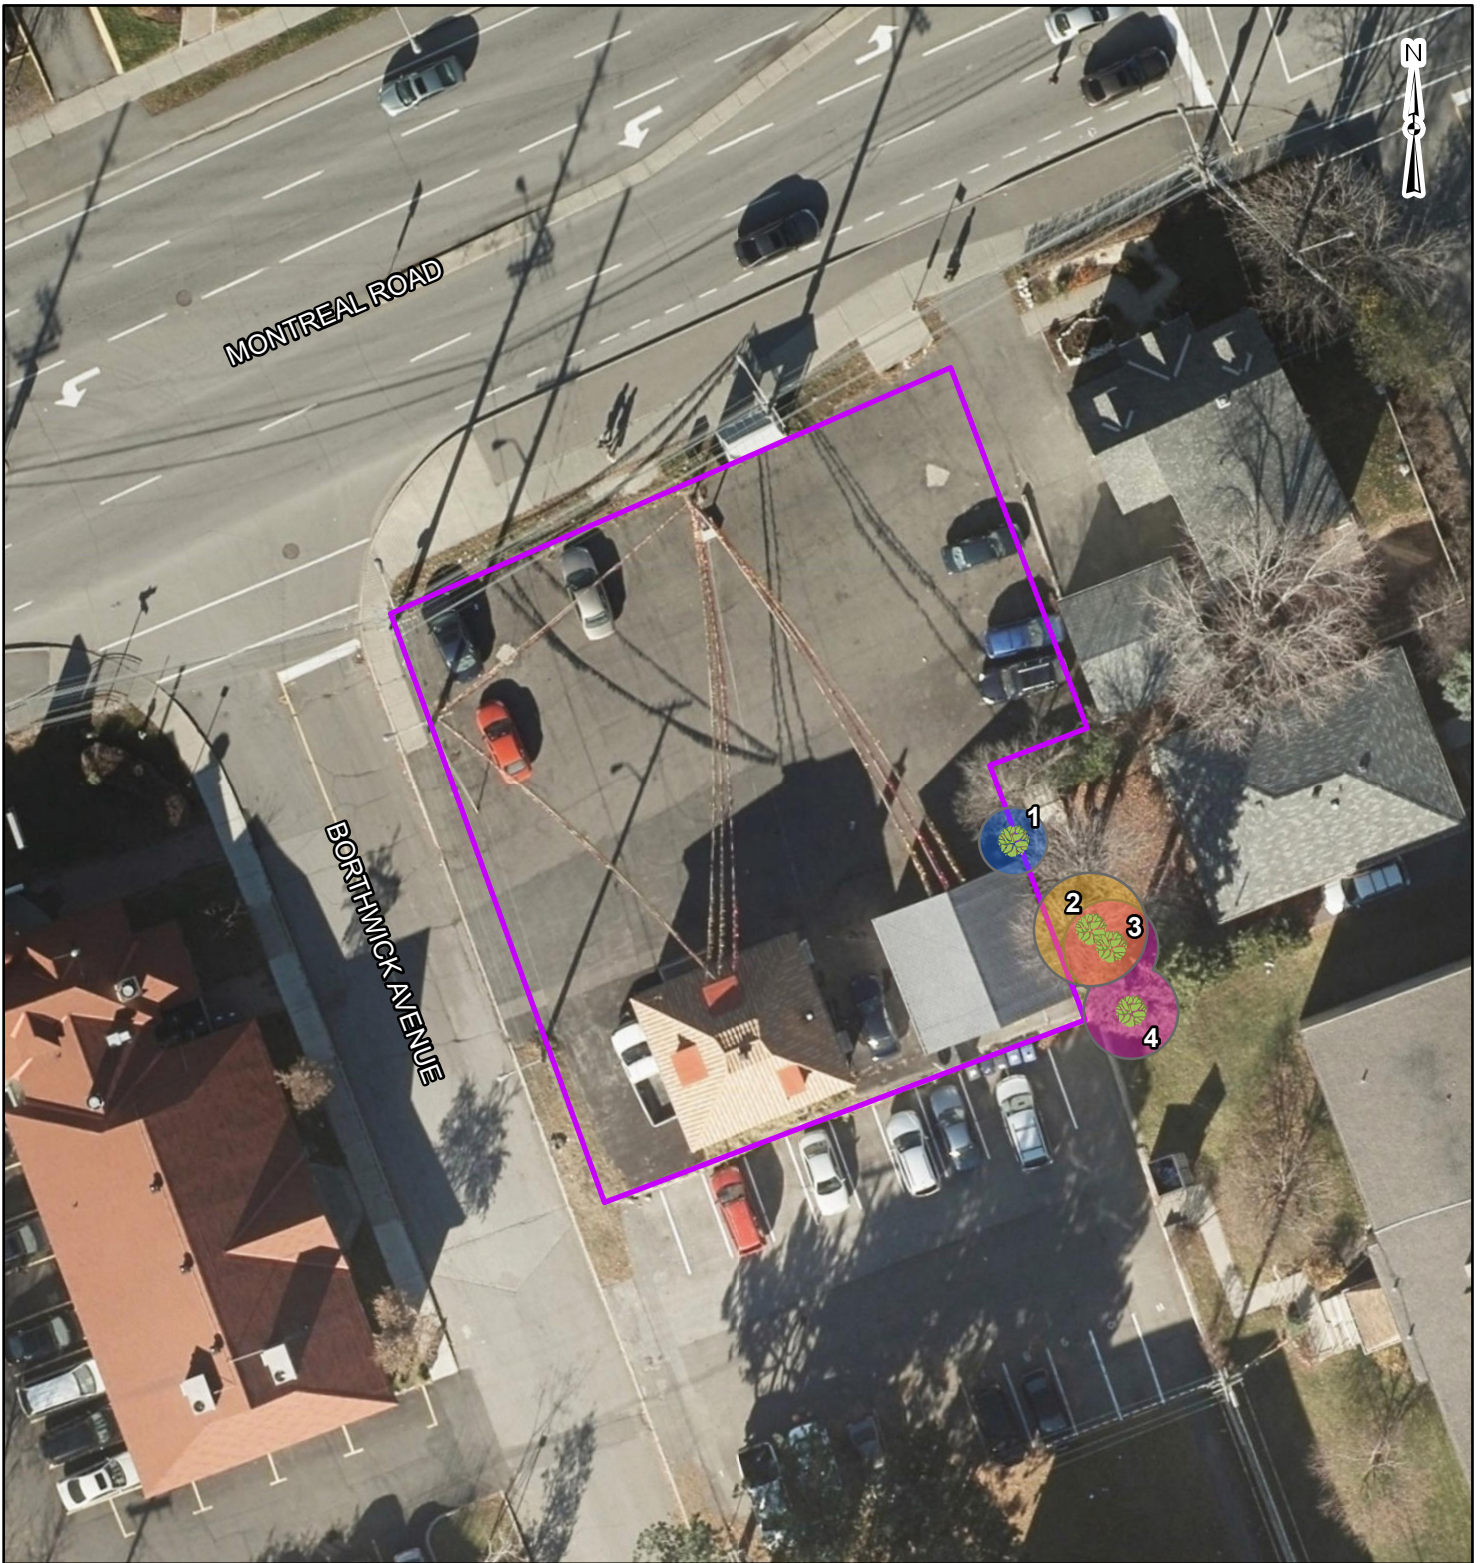
The tree inventory conducted for the subject property resulted in findings that there are no trees located within the property boundary; however, four (4) trees were identified and documented off-site that may be impacted by the proposed development (**Figure 1**). **Table 1** outlines the inventoried trees that are directly adjacent to the subject property.

The health status of the inventoried trees varied slightly, with Fair (2), Good (1), and Poor (1) ratings accounting for the inventoried trees. No dead trees were observed within the study area during the inventory and assessment. The study area is highly developed in nature, with few trees or natural vegetation found throughout the area.

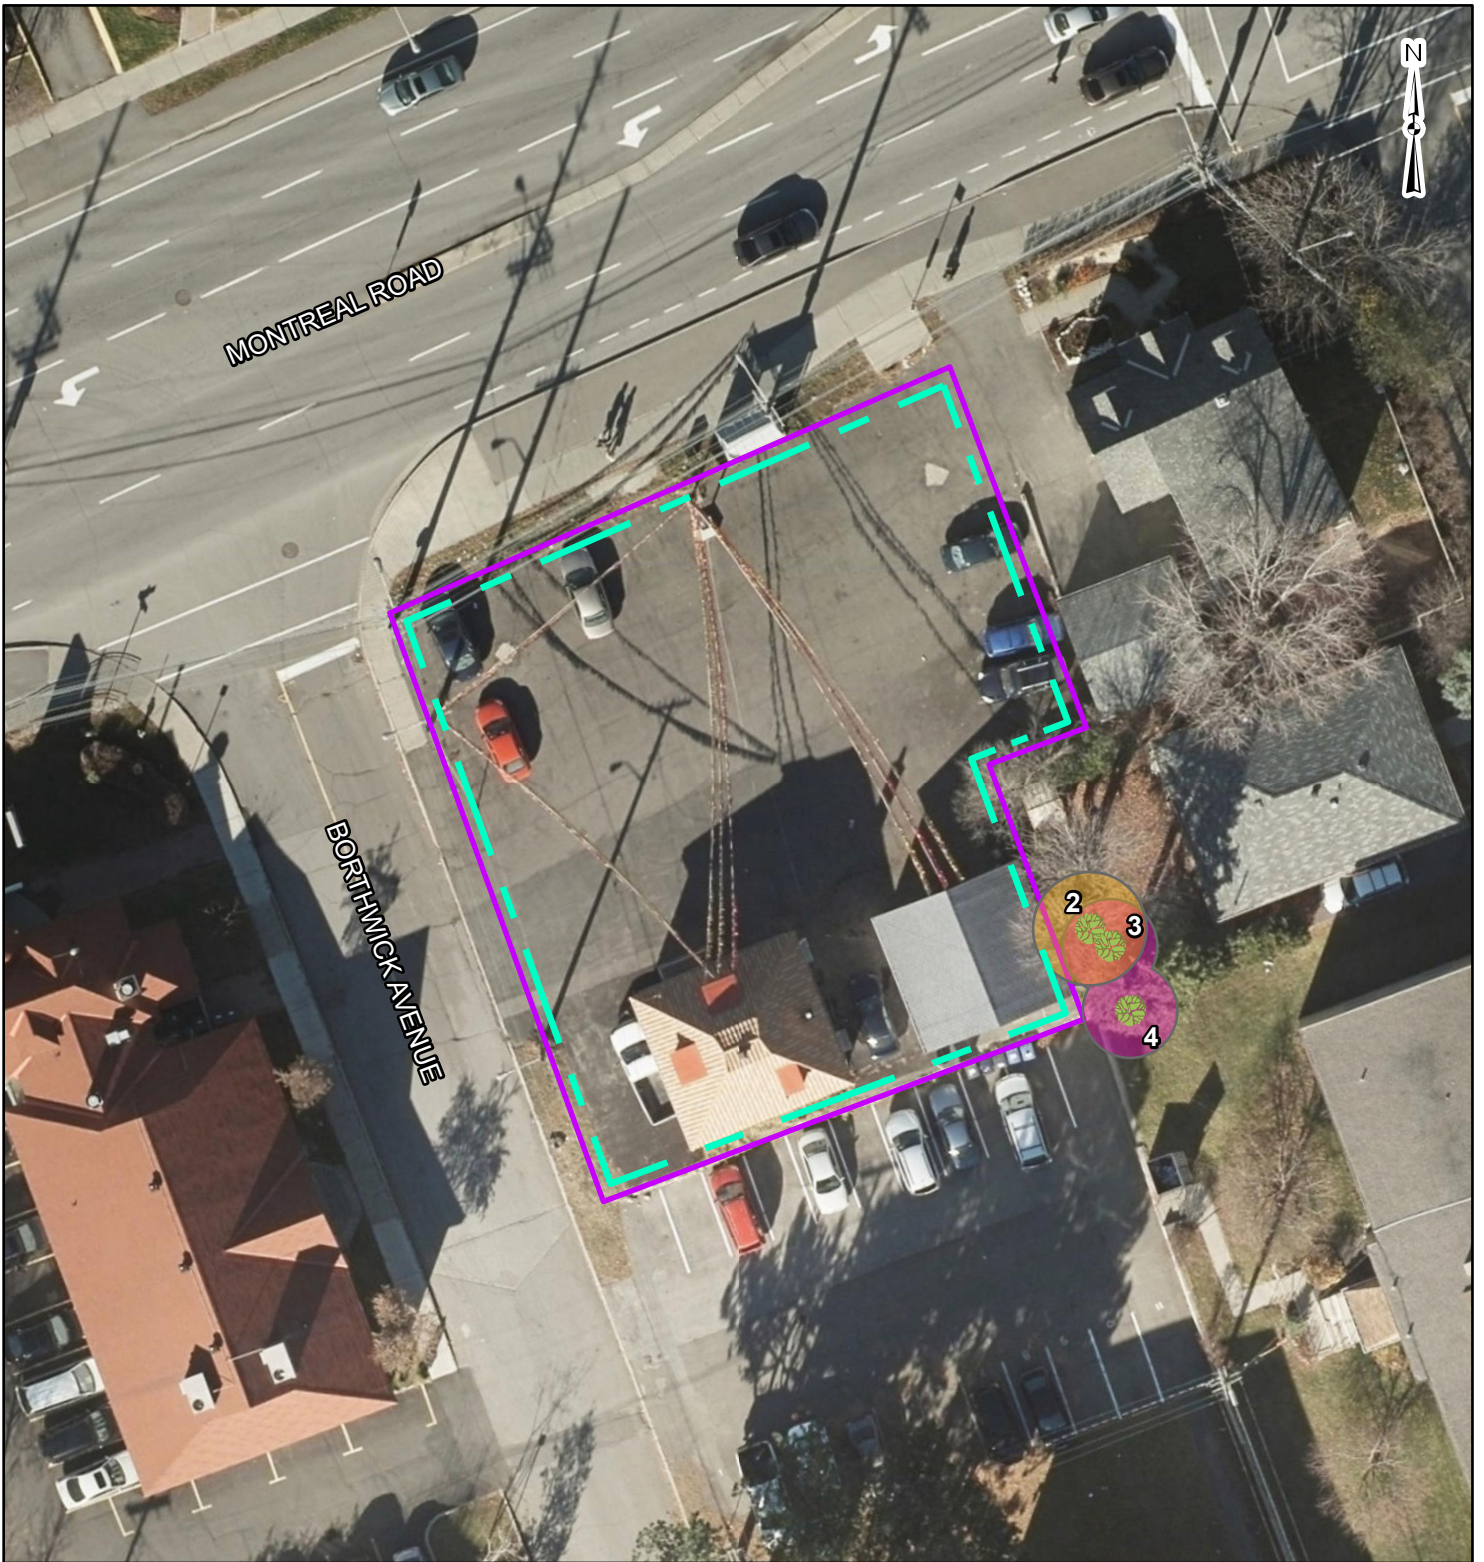
The proposed development will align closely to the original footprint of the subject property, resulting in a low impact to trees within the study area. There are no trees within the subject property; however, a single Siberian Elm, located off-site, directly adjacent to the subject property will be required to be removed (**Figure 2**). Siberian Elm is a non-native, invasive species. As this individual has grown, a portion of the tree has become intertwined with the boundary fence and the tree is in poor condition (see **Appendix A**).

The remaining trees (i.e. trees 2, 3, and 4) should be monitored over time. Care should be taken when removing the asphalt and existing fence and buildings on-site to avoid impacting these individual's critical root zones.

To ensure protection of the root system of trees to be retained, temporary tree protection fencing should be erected at the critical root zone of trees located inside or adjacent to the construction area. Temporary fencing is proposed surrounding the perimeter of the subject property (**Figure 2**) and will sufficiently protect the retained trees that are adjacent to the subject property.

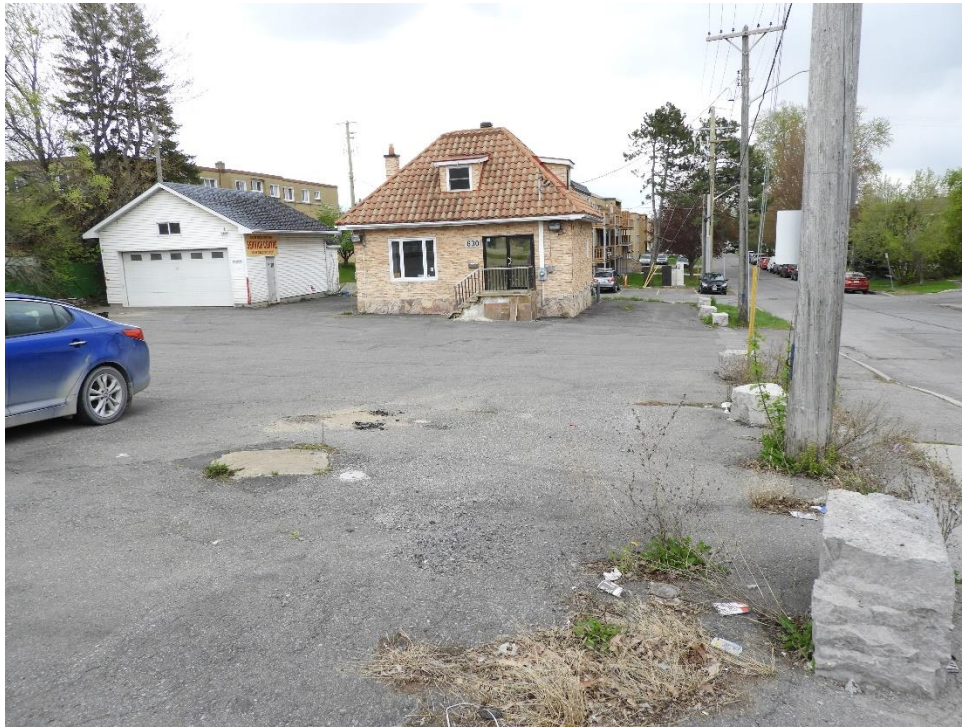
Photo 1: View of the subject property from the northwest corner facing south. May 7, 2021.

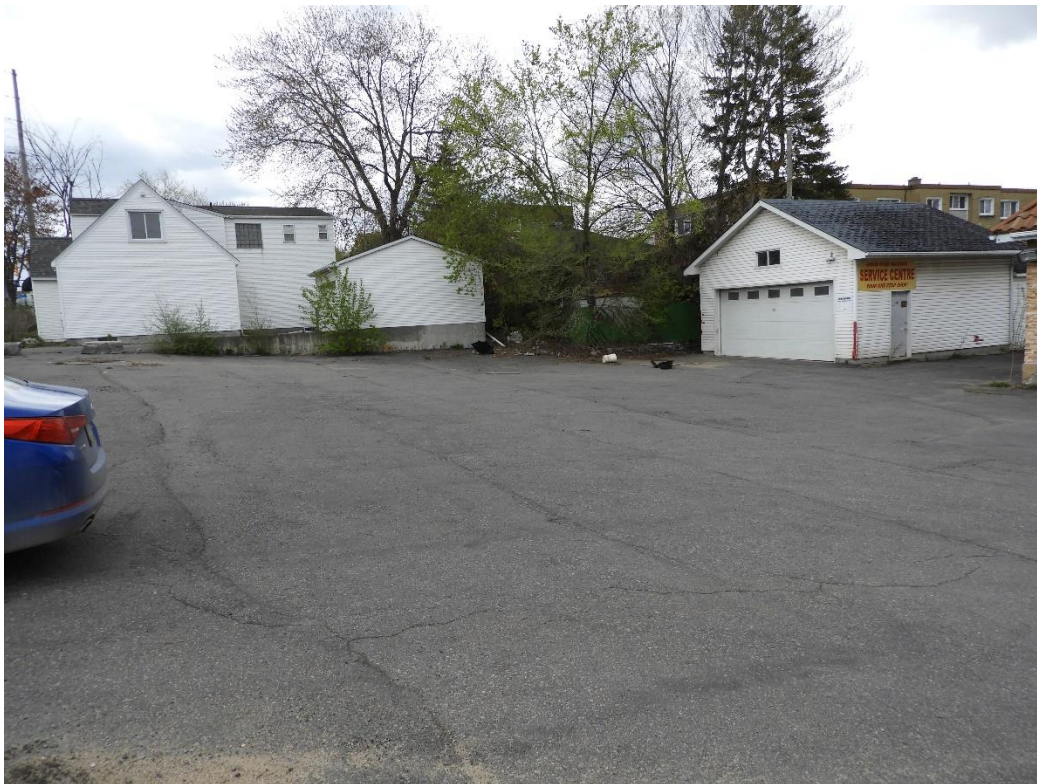
Photo 2: View of the subject property from the northwest corner facing southeast. May 7, 2021.

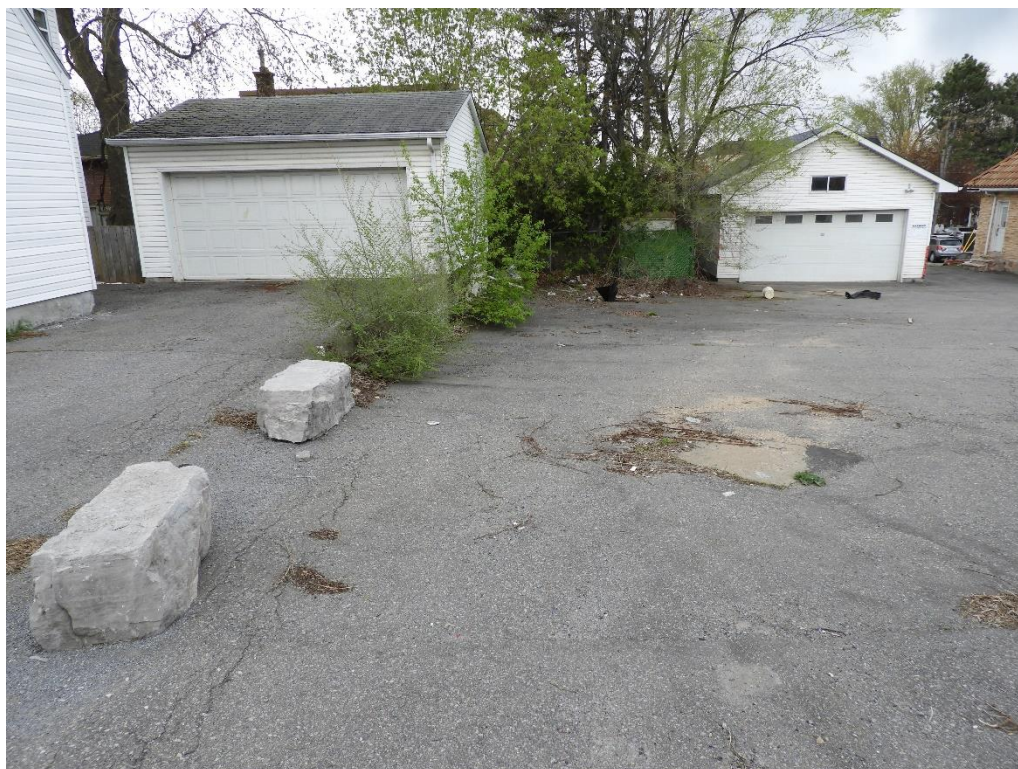
Photo 3: View of the subject property from the northeast corner facing south. May 7, 2021.

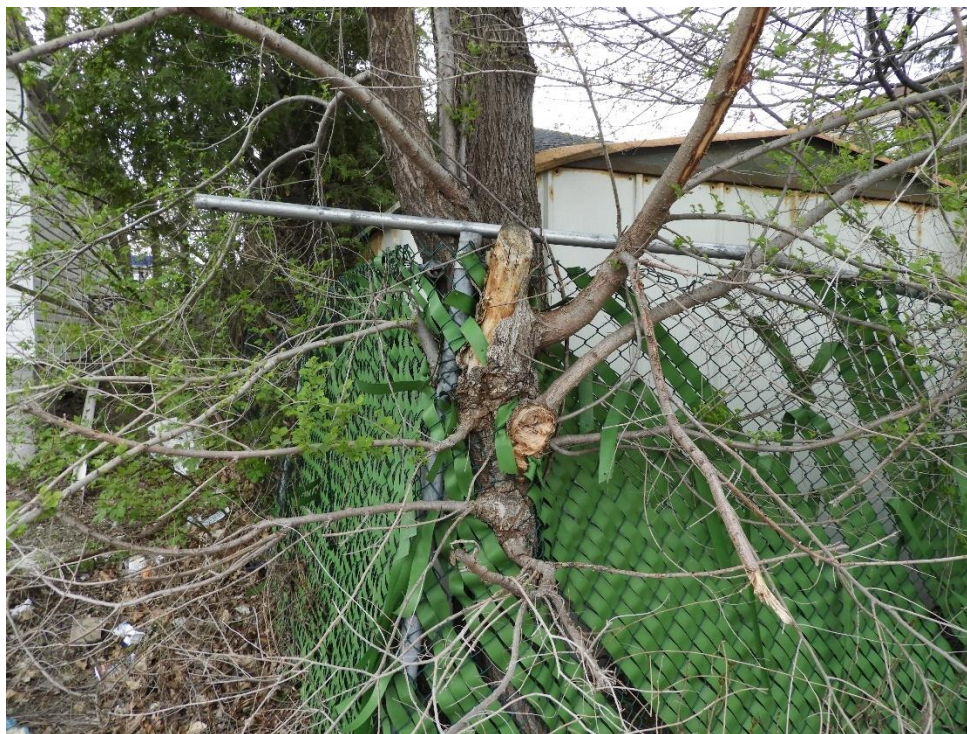
Photo 4: View of the Siberian Elm proposed for removal. May 7, 2021.

A single Siberian Elm (tree No. 1) is proposed for removal and is <30cm DBH; as such no compensation plantings or cash-in-lieu is proposed or required as per the City of Ottawa's Tree By-law (2020-340).

This individual tree is located off-site, directly adjacent to the subject property. In accordance with the City of Ottawa's Tree By-law (2020-340) written permission will be required from the landowner prior to approval for removal.
