THOMSON WATSON CONSULTING ARBORISTS Inc

October 20, 2023

Re: Tree Conservation Report for Canadian Tire Centre at 2501 Greenbank Road, Nepean

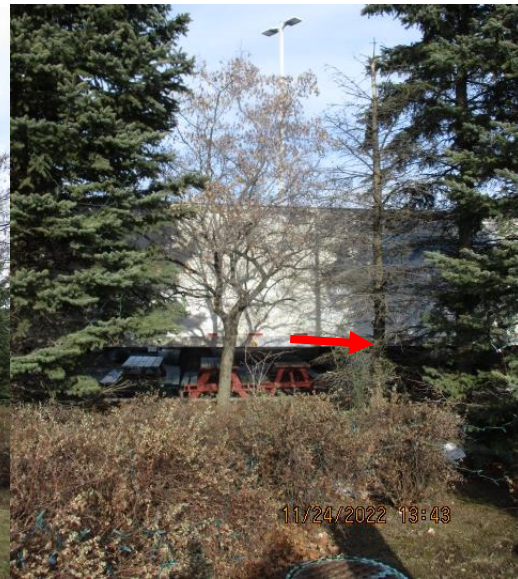
Tree 50 – dead Spruce

| Tree No. | Tree Species | Latin Name | Diameter (cm) | Canopy Radius (m) | Condition | Health and Structural Notes |
|---|---|---|---|---|---|---|
| 50 | Spruce | <i>Picea pungens</i> | 13 | 3.0 | dead | no needles on tree |

Trees 42, 50, 54, 62, 63, 66, 67 and 68 (8 trees). Tree 50 is dead and should not require a permit to allow its removal.

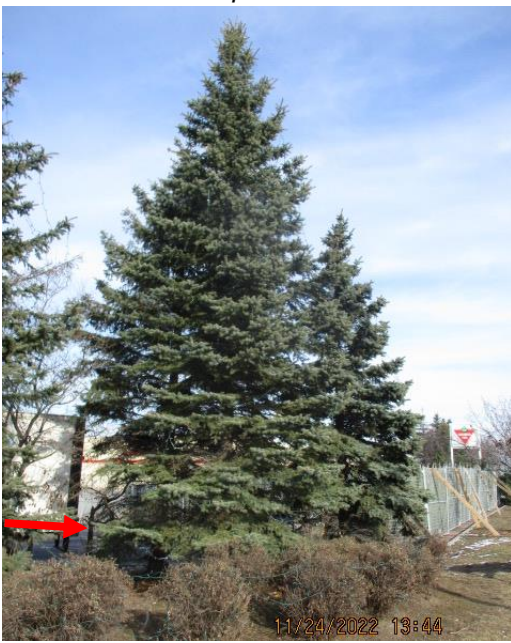
Tree 54 – Amur Maple

| Tree No. | Tree Species | Latin Name | Diameter (cm) | Canopy Radius (m) | Condition | Health and Structural Notes |
|---|---|---|---|---|---|---|
| 54 | Amur Maple | <i>Acer ginnala</i> | 9.5 | 2.5 | poor | lost leader at 1.4 m, decay in stem |

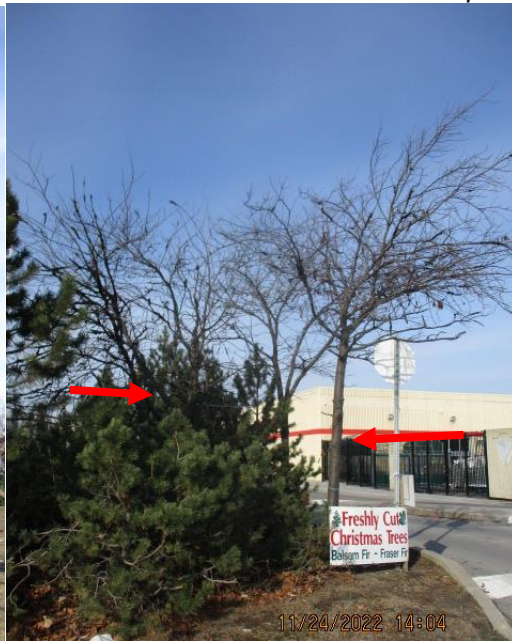
There are four Schubert Cherries (*Prunus virginiana* 'Schubert') growing on site. The trees are infected with Black Knot fungus (*Dibotryon morbosum* or *Apiosporina morbosa*) which affects branches and stems. The symptoms of the disease create a poor appearance and results in dead branches and stems. I have recommended the removal of all four trees.

Trees 62(left) and 63 (right) – Schubert Cherry

| Tree No. | Tree Species | Latin Name | Diameter (cm) | Canopy Radius (m) | Condition | Health and Structural Notes |
|---|---|---|---|---|---|---|
| 62 | Schubert Cherry | <i>Prunus virginiana</i> | 13 | 4.0 | poor | sprouts at base, Black Knot infection, canker in trunk at 1.5 to 2.5 m |
| 63 | Schubert Cherry | <i>Prunus virginiana</i> | 14 | 3.0 | fair | Black Knot infection, growing fine |

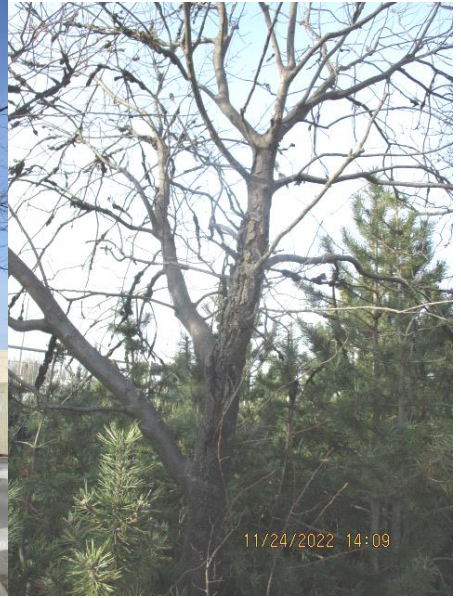
Tree 62 – Canker on trunk

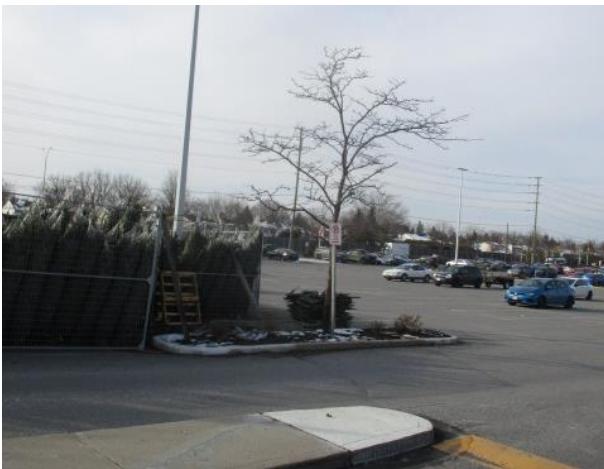
Tree 65 – Honeylocust

| Tree No. | Tree Species | Latin Name | Diameter (cm) | Canopy Radius (m) | Condition | Health and Structural Notes |
|---|---|---|---|---|---|---|
| 65 | Honeylocust | <i>Gleditsia triacanthos</i> | 13 | 3.0 | poor-fair | trunk guard, very slow growth |

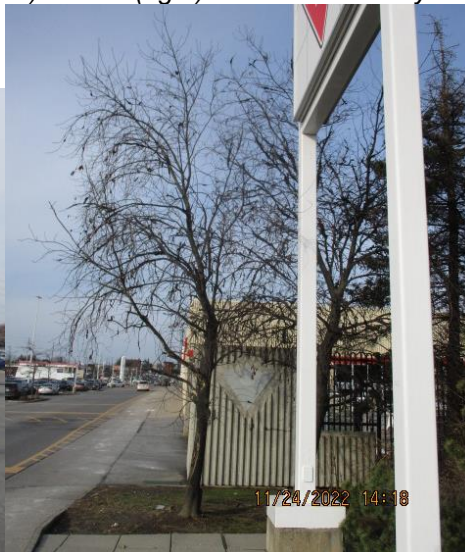
Along this side of the proposed building, it is proposed to remove Trees 66, 67 and 68 due to their health condition, Trees 70, 72, 74, 76, 77 and 78 for their location adjacent to the swale and Trees 82 to 90 due to excavation, construction access and proposed grade changes required to allow construction access. Trees 82 to 86 are growing on a sloped area. The grade will have to be dropped to the building side of the trees. Trees 87 to 90 will have excavation close to the base of the trees, removing 25 to 50% of their root systems. The canopies of these trees also extend up to and into the vertical footprint of the addition.

Trees 66 (left) to 68 (right)

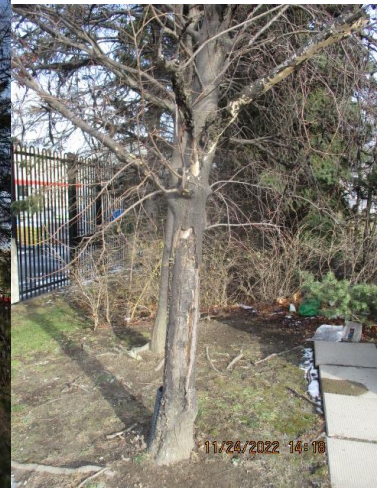
Dieback in trunk – Tree 66

| Tree No. | Tree Species | Latin Name | Diameter (cm) | Canopy Radius (m) | Condition | Health and Structural Notes |
|---|---|---|---|---|---|---|
| 66 | Schubert Cherry | <i>Prunus virginiana</i> | 18 | 3.0 | poor | trunk guard, surface roots, column of decayed wood up south side of trunk, Black Knot Infection |

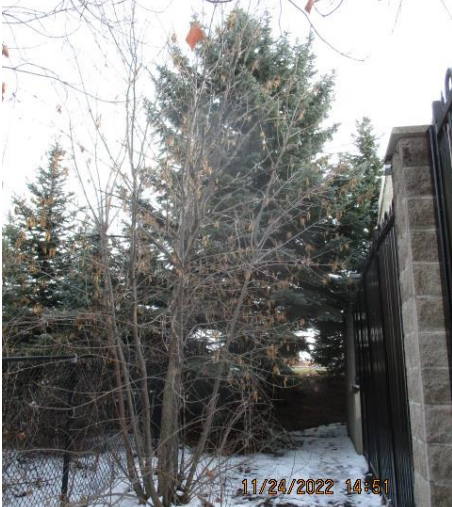
Tree 88 is a Green Ash which has been affected by Emerald Ash Borer, leaving stems with a maximum diameter of 7 cm. A permit should not be required for this tree.

Tree 88 – Green Ash with 87 to south

| Tree No. | Tree Species | Latin Name | Diameter (cm) | Canopy Radius (m) | Condition | Health and Structural Notes |
|---|---|---|---|---|---|--|
| 88 | Green Ash | <i>Fraxinus pennsylvanica</i> | 7 max | | poor | main stem dead due to Emerald Ash Borer, 7 sprouts at base |

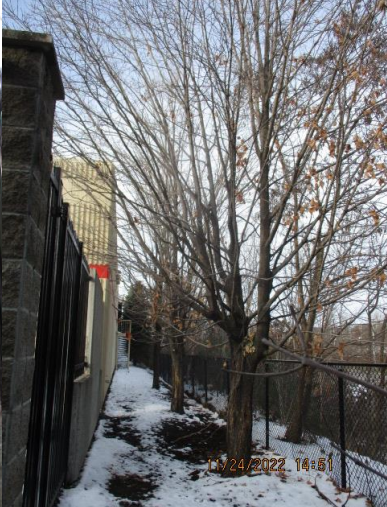
Trees 89, 90 and 91 – Sugar Maple

A Tree Protection Fence will need to be installed a minimum 2.5 metres east of Tree 91, from existing building to property line fence, to keep construction activities from the north side of the existing building.

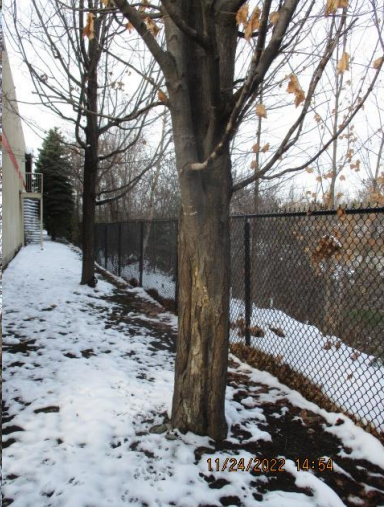
Tree 90 – trunk wound

| Tree No. | Tree Species | Latin Name | Diameter (cm) | Canopy Radius (m) | Condition | Health and Structural Notes |
|---|---|---|---|---|---|--|
| 90 | Sugar Maple | <i>Acer saccharum</i> | 33.5 | 3.5 | poor-fair | wound up trunk from 0 to 1.3 m, tight unions at 1.6 and 2.25 m, deadwood in canopy from stems squeezing others out |

Trees 70, 72, 74, 76, 77, 78, 82, 83, 84, 85, 86, 87, 88, 89 and 90 (15 trees).
