TREE CONSERVATION REPORT

2506 Innes Road

Tree Conservation Report v2.0

Address: 2506 Innes Road
Date of Report: May 2, 2024
Date of Site Visit: November 10, 2023
Prepared by: Kevin Myers, ISA Certified Arborist; kevin.myers@dendronforestry.ca
Client: Concorde Properties c/o Jordan Tannis; jt@concorde-properties.ca

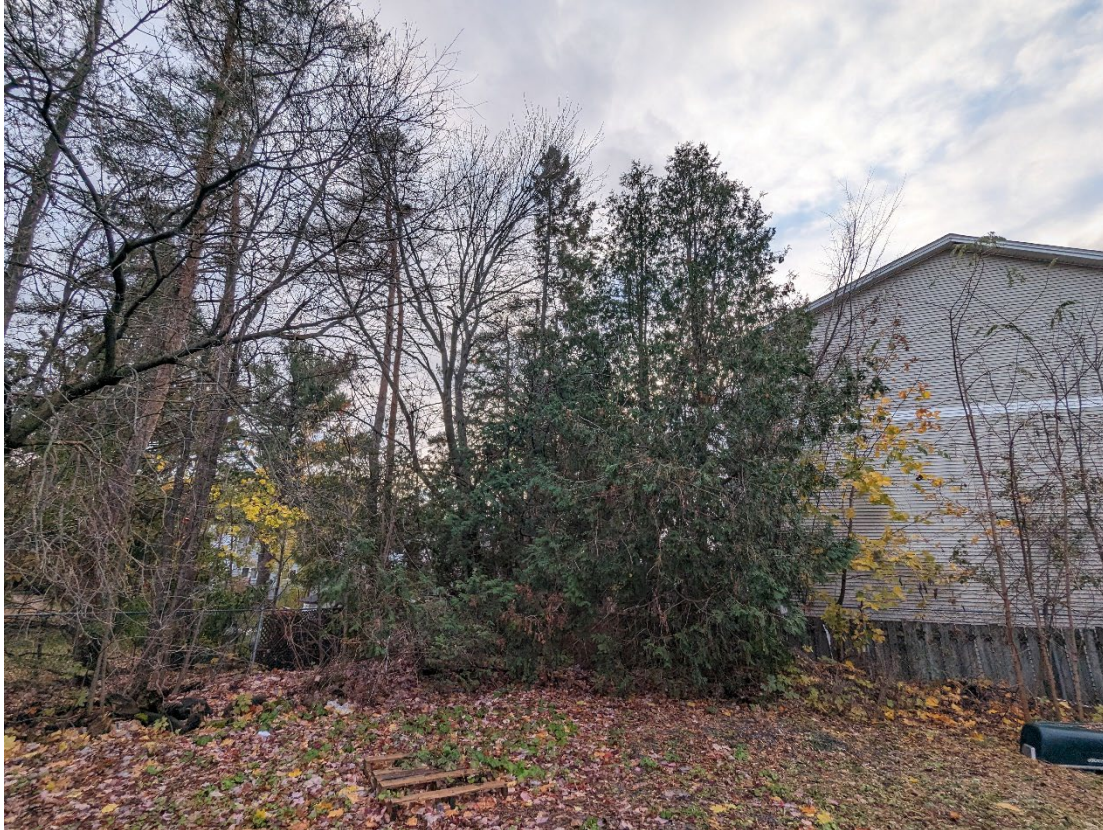
The southwest corner (**Trees 25-32**) has a high percent canopy cover due to large trees on the adjacent properties. These trees are at a lower grade from most of the subject property (approximately 10-30cm). Fencing should be erected at the edge of the proposed retaining wall, and any roots that are encountered during excavation are to be cleanly severed by hand to promote faster sealing after construction. **Tree 25** is a young Manitoba maple approximately 80cm from the proposed retaining wall. This is 4.9x its DBH, which is within best management practices for maintaining stability. What is more, Manitoba maples are known to be able to withstand construction. This tree is recommended for retention, as it could grow into a large-canopy tree in the future. **Tree 31** is a large Freeman maple on the adjacent property. The retaining wall is proposed to come approximately 4.75m from the base of the tree and remove approximately 4% of its CRZ.

Below: southwest corner of the property, including Trees 23-33

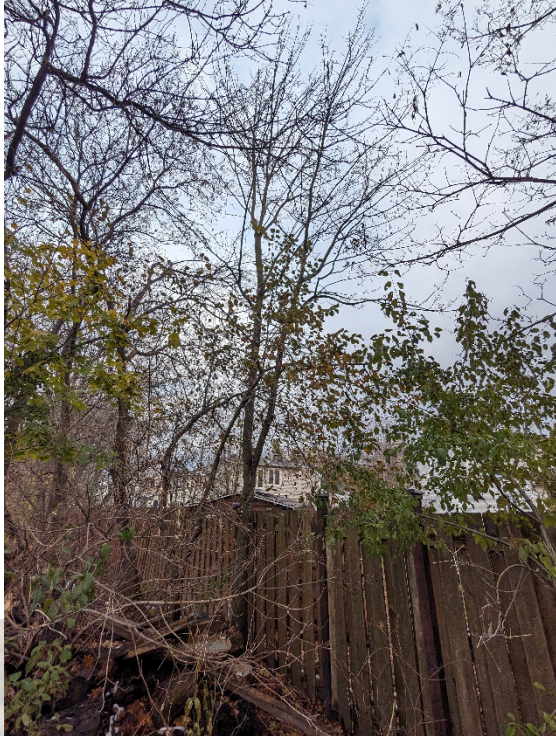
Left: Tree 22 – private maple to be removed.

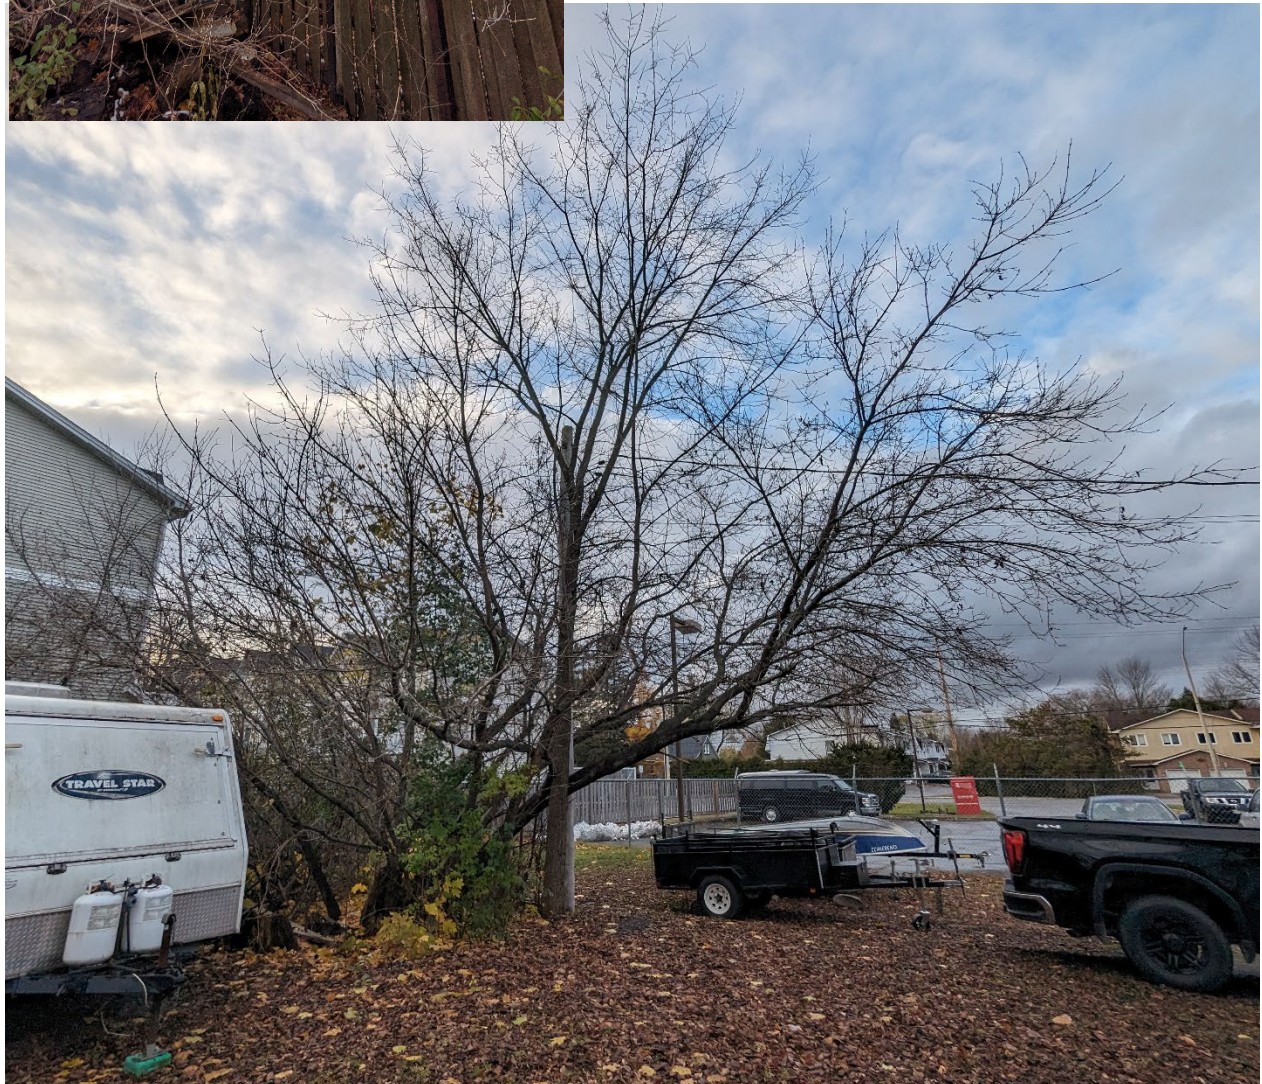
Below: Trees 34-36 - to be removed

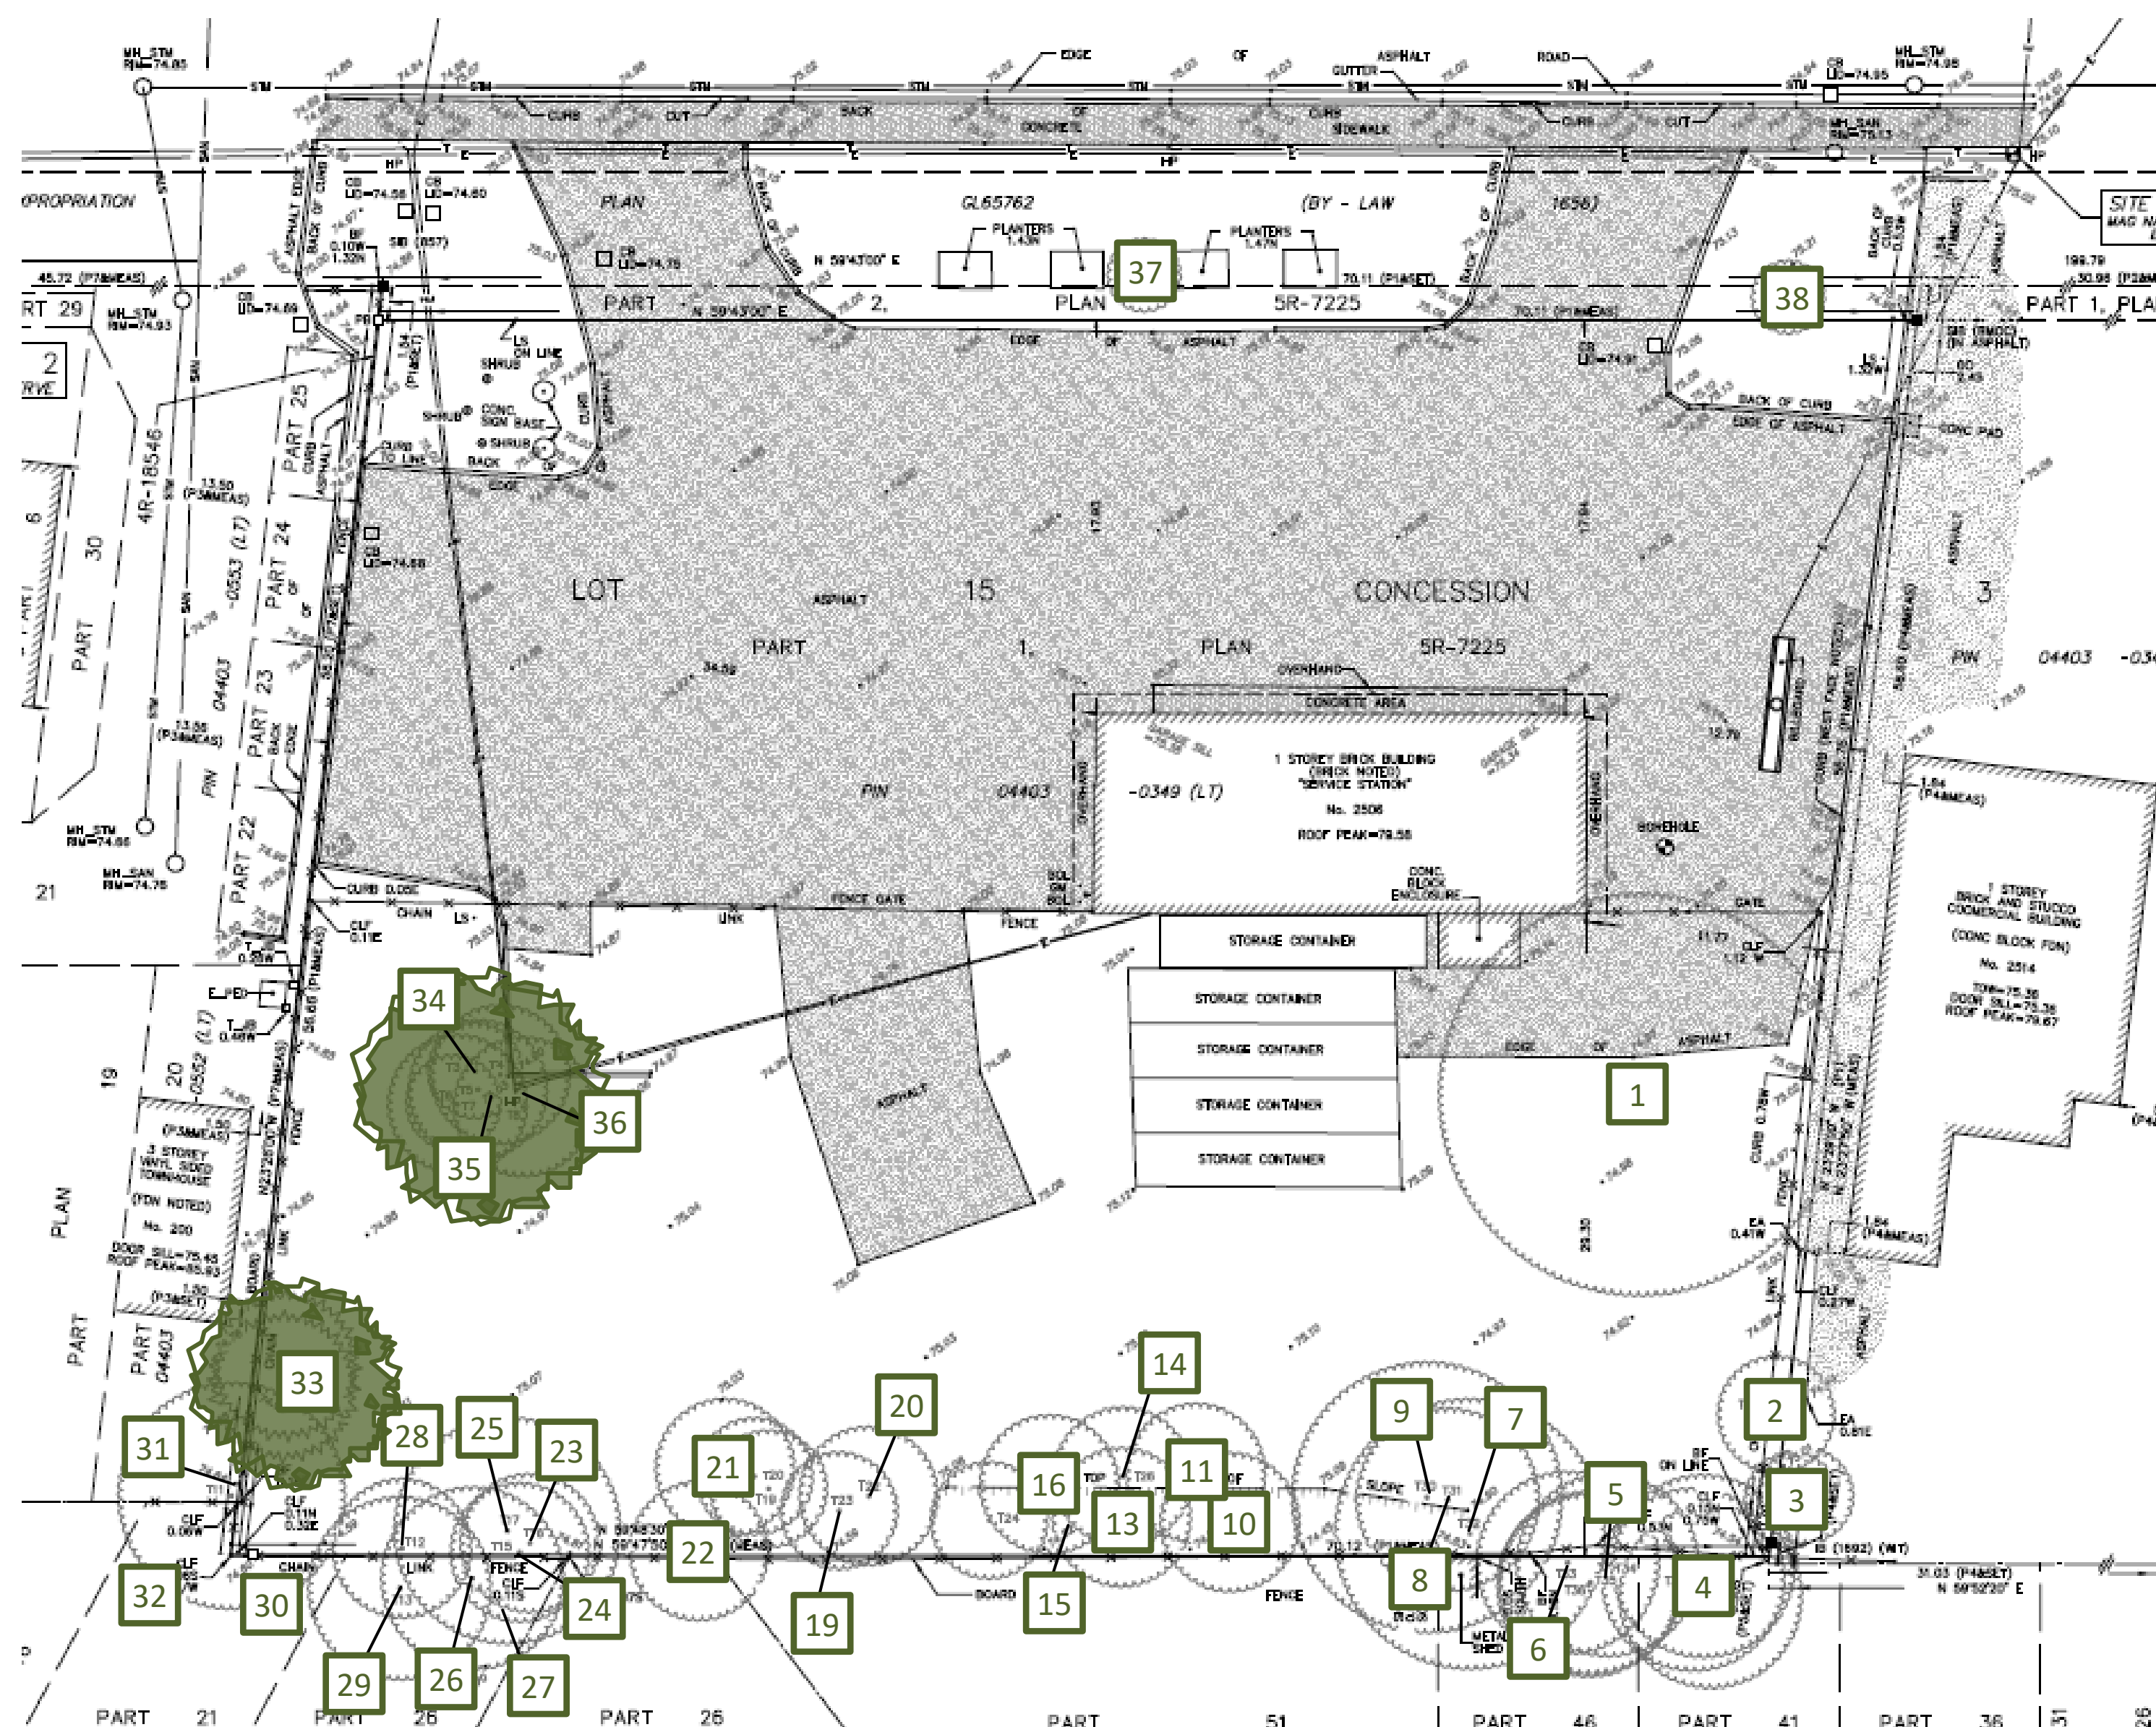
TCR Map – 2506 Innes Road
 Tree layer prepared by
 Dendron Forestry Services
 Existing Vegetation, November 16, 2023
 For more information, please contact: info@dendronforestry.ca

Tree ¹	Species	DBH (cm)	Ownership ²	Tree Condition
1	Manitoba maple (<i>Acer negundo</i>)	56	Subject property	Fair: wound on scaffold branch; pruning wounds sealing; cavities at base
2	Manitoba maple (<i>Acer negundo</i>)	27	Subject property	Poor
3	Red maple (<i>Acer rubrum</i>)	20, 15	Adjacent – 2514 Innes	Fair/Poor
4	Freeman maple (<i>Acer freemanii</i>)	20, 20, 30, 35, 25 (estimated)	Adjacent – 17 Beddoe	Fair/Poor
5	Freeman maple (<i>Acer freemanii</i>)	20	Adjacent – 15 Beddoe	Fair
6	Freeman maple (<i>Acer freemanii</i>)	15, 20, 25, 30 (estimated)	Adjacent – 15 Beddoe	Good/Fair
7	Manitoba maple (<i>Acer negundo</i>)	38, 11	Subject property	Fair/Poor: significant lean; asymmetrical crown
8	Manitoba maple (<i>Acer negundo</i>)	22	Subject property	Fair/Poor: 90 degree bend @ 3.5m
9	Manitoba maple (<i>Acer negundo</i>)	42	Subject property	Good/Fair: significant lean
10	American elm (<i>Ulmus americana</i>)	50	Subject property	Good

11	Manitoba maple (<i>Acer negundo</i>)	25	Subject property	Fair: several wounds on trunk; dead branches
12	Manitoba maple (<i>Acer negundo</i>)	28, 10	Subject property	Fair/Good: large pruning wound at base
13	American elm (<i>Ulmus americana</i>)	32	Subject property	Good
14	Manitoba maple (<i>Acer negundo</i>)	10	Subject property	Good/Fair
15	Manitoba maple (<i>Acer negundo</i>)	16, 8	Subject property	Fair: spreading form; sprouts at base
16	Manitoba maple (<i>Acer negundo</i>)	33	Subject property	Fair: significant lean; wound on trunk
17	Manitoba maple (<i>Acer negundo</i>)	29, 14	Subject property	Fair: wounds with decay; poor form
18	Manitoba maple (<i>Acer negundo</i>)	20	Subject property	Good
19	Manitoba maple (<i>Acer negundo</i>)	20	Subject property	Fair
20	Manitoba maple (<i>Acer negundo</i>)	16	Subject property	Fair: suppressed
21	Manitoba maple (<i>Acer negundo</i>)	33	Subject property	Fair: significant lean

22	Freeman maple (<i>Acer freemanii</i>)	17	Subject property	Good
23	Black cherry (<i>Prunus serotina</i>)	12	Subject property	Fair: lean corrected through growth
24	Black cherry (<i>Prunus serotina</i>)	15	Subject property	Fair/Poor: growing on fence; significant lean
25	Manitoba maple (<i>Acer negundo</i>)	17	Subject property	Fair
26	Scot's pine (<i>Pinus sylvestris</i>)	33	Adjacent – 45 Glen Park	Fair
27	Hackberry (<i>Celtis occidentalis</i>)	16, 4 (estimated)	Adjacent – 45 Glen Park	Fair: suppressed
28	Black cherry (<i>Prunus serotina</i>)	15, 12	Subject property	Fair: codominant stems @ 1.3m
29	Scot's pine (<i>Pinus sylvestris</i>)	28 (estimated)	Adjacent – 45 Glen Park	Fair: thin crown
30	Scot's pine (<i>Pinus sylvestris</i>)	30 (estimated)	Adjacent – 45 Glen Park	Fair: asymmetrical crown
31	Freeman maple (<i>Acer freemanii</i>)	50 (estimated)	Adjacent – 200 Scotland	Fair: large branch attachment wound; small cavity with decay possible; slight lean to the west

32	Scot's pine (<i>Pinus sylvestris</i>)	30 (estimated)	Adjacent – 43 Glen Park	Fair/Poor: very thin crown
33	Eastern white cedar (<i>Thuja occidentalis</i>)	12 stems 5-30	Subject property	Good/Fair
34	Norway maple (<i>Acer platanoides</i>)	13	Subject property	Good
35	Manitoba maple (<i>Acer negundo</i>)	7 stems 11-25	Subject property	Fair/Poor: spreading form
36	American elm (<i>Ulmus americana</i>)	24	Subject property	Good
37	Tree lilac (<i>Syringa reticulata</i>)	8	City	Fair
38	Serviceberry (<i>Amelanchier spp.</i>)	6	City	Fair

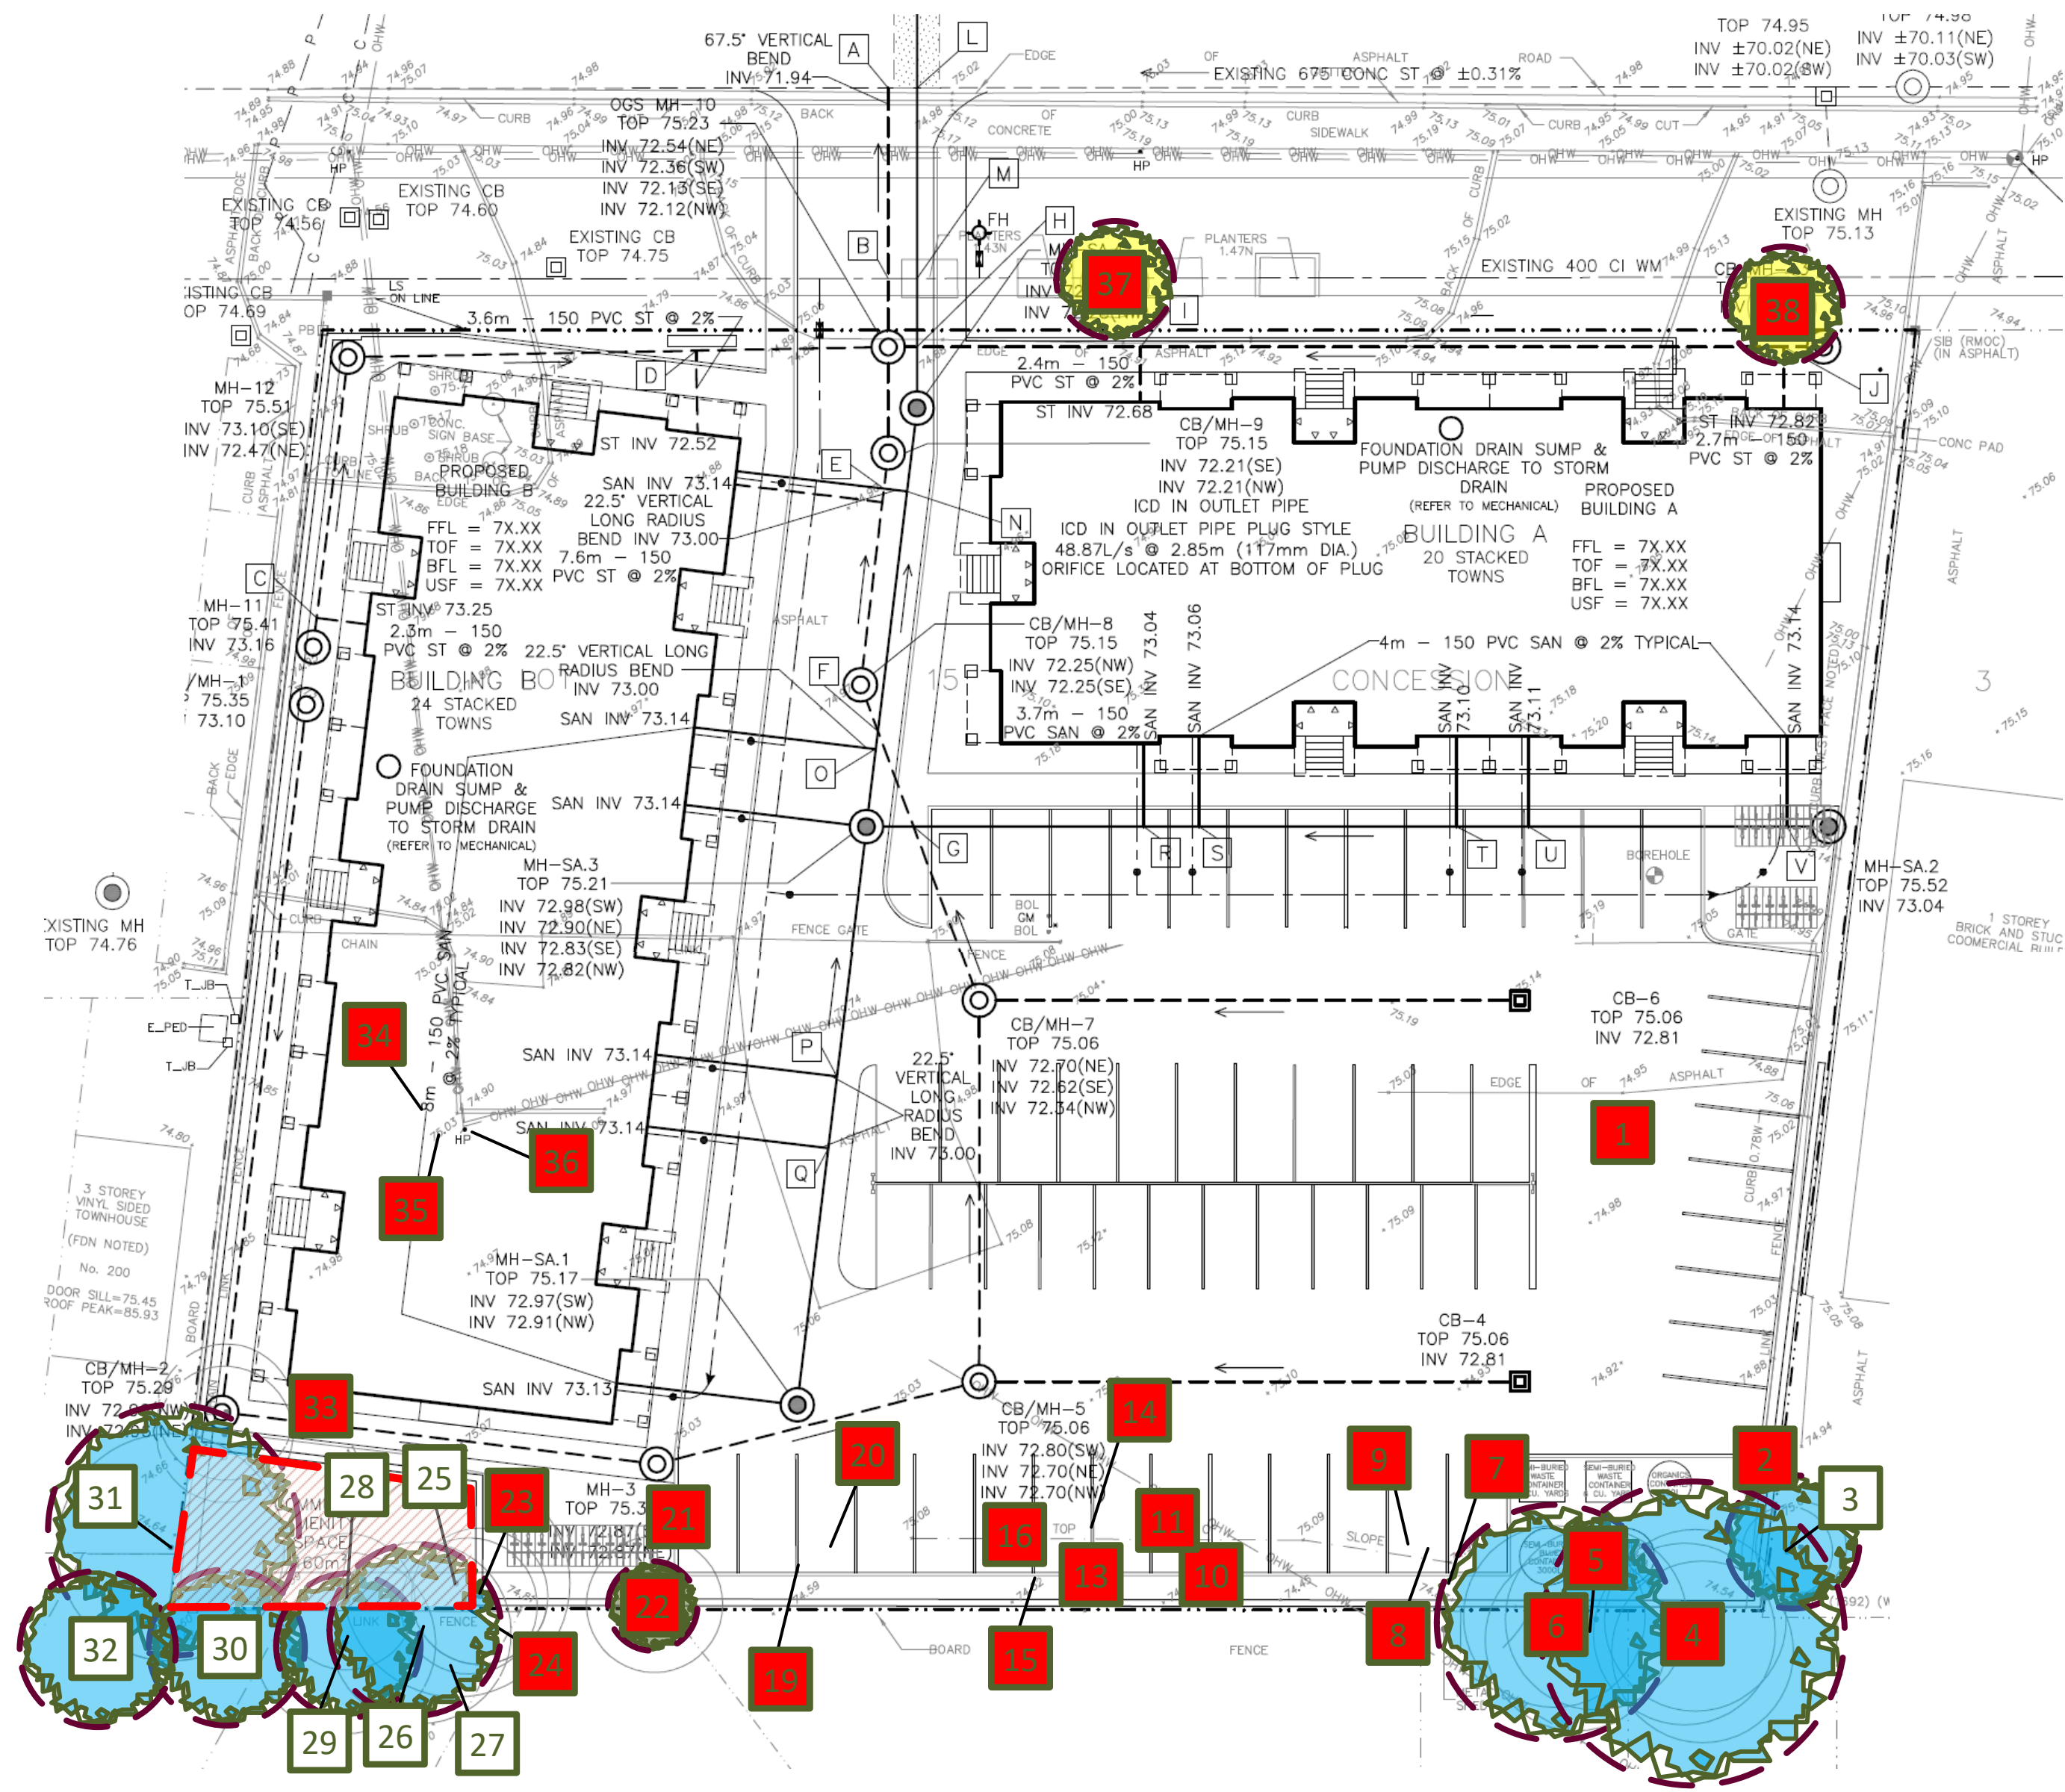
TCR Map – 2506 Innes Road
 Tree layer prepared by
 Dendron Forestry Services
 Proposed Development v2.0, May 2, 2024
 For more information, please contact: info@dendronforestry.ca

Tree#	Species	DBH (cm)	Tree Condition	Forester recommendation
1	Manitoba maple (<i>Acer negundo</i>)	56	Fair: wound on scaffold branch; pruning wounds sealing; cavities at base	Remove
2	Manitoba maple (<i>Acer negundo</i>)	27	Poor	Remove
3	Red maple (<i>Acer rubrum</i>)	20, 15	Fair/Poor	Retain and protect as per the City of Ottawa Tree Protection Specifications (March 2021). Roots are to be revealed along the line of excavation and cleanly severed by hand.
4	Freeman maple (<i>Acer freemanii</i>)	20, 20, 30, 35, 25 (estimated)	Fair/Poor	Remove due to proximity of retaining wall and grade changes. Opportunity may exist to retain individual stems from groupings.
5	Freeman maple (<i>Acer freemanii</i>)	20	Fair	Remove due to proximity of retaining wall and grade changes. Opportunity may exist to retain individual stems from groupings.
6	Freeman maple (<i>Acer freemanii</i>)	15, 20, 25, 30 (estimated)	Good/Fair	Remove due to proximity of retaining wall and grade changes. Opportunity may exist to retain individual stems from groupings.

7	Manitoba maple (<i>Acer negundo</i>)	38, 11	Fair/Poor: significant lean; asymmetrical crown	Remove
8	Manitoba maple (<i>Acer negundo</i>)	22	Fair/Poor: 90 degree bend @ 3.5m	Remove
9	Manitoba maple (<i>Acer negundo</i>)	42	Good/Fair: significant lean	Remove
10	American elm (<i>Ulmus americana</i>)	50	Good	Remove
11	Manitoba maple (<i>Acer negundo</i>)	25	Fair: several wounds on trunk; dead branches	Remove
12	Manitoba maple (<i>Acer negundo</i>)	28, 10	Fair/Good: large pruning wound at base	Remove
13	American elm (<i>Ulmus americana</i>)	32	Good	Remove
14	Manitoba maple (<i>Acer negundo</i>)	10	Good/Fair	Remove
15 ^a	Manitoba maple (<i>Acer negundo</i>)	16, 8	Fair: spreading form; sprouts at base	Remove
16	Manitoba maple (<i>Acer negundo</i>)	33	Fair: significant lean; wound on trunk	Remove
17	Manitoba maple (<i>Acer negundo</i>)	29, 14	Fair: wounds with decay; poor form	Remove
18	Manitoba maple (<i>Acer negundo</i>)	20	Good	Remove

19	Manitoba maple (<i>Acer negundo</i>)	20	Fair	Remove
20	Manitoba maple (<i>Acer negundo</i>)	16	Fair: suppressed	Remove

21	Manitoba maple (<i>Acer negundo</i>)	33	Fair: significant lean	Remove
22	Freeman maple (<i>Acer freemanii</i>)	17	Good	Remove
23	Black cherry (<i>Prunus serotina</i>)	12	Fair: lean corrected through growth	Remove
24	Black cherry (<i>Prunus serotina</i>)	15	Fair/Poor: growing on fence; significant lean	Remove
25	Manitoba maple (<i>Acer negundo</i>)	17	Fair	Retain. Approximately 80cm from wall. Roots are to be revealed and cleanly severed by hand prior to excavation. If tree becomes hazardous it is to be removed.
26	Scot's pine (<i>Pinus sylvestris</i>)	33	Fair	Retain. Any roots encountered during excavation are to be cleanly severed by hand
27 ^a	Hackberry (<i>Celtis occidentalis</i>)	16, 4 (estimated)	Fair: suppressed	Retain. Any roots encountered during excavation are to be cleanly severed by hand
28	Black cherry (<i>Prunus serotina</i>)	15, 12	Fair: codominant stems @ 1.3m	Retain. Any roots encountered during excavation are to be cleanly severed by hand

29	Scot's pine (<i>Pinus sylvestris</i>)	28 (estimated)	Fair: thin crown	Retain and protect as per the City of Ottawa Tree Protection Specifications (March 2021). Roots are to be revealed along the line of excavation and cleanly severed by hand.
30	Scot's pine (<i>Pinus sylvestris</i>)	30 (estimated)	Fair: asymmetrical crown	Retain and protect as per the City of Ottawa Tree Protection Specifications (March 2021). Any roots encountered during excavation to be cleanly severed by hand.
31	Freeman maple (<i>Acer freemanii</i>)	50 (estimated)	Fair: large branch attachment wound; small cavity with decay possible; slight lean to the west	Retain and protect as per the City of Ottawa Tree Protection Specifications (March 2021). Any roots encountered during excavation to be cleanly severed by hand.
32 ^a	Scot's pine (<i>Pinus sylvestris</i>)	30 (estimated)	Fair/Poor: very thin crown	Retain – no action required

33	Eastern white cedar (<i>Thuja occidentalis</i>)	12 stems 5-30	Good/Fair	Remove – in line with proposed building and retaining wall.
34	Norway maple (<i>Acer platanoides</i>)	13	Good	Remove
35	Manitoba maple (<i>Acer negundo</i>)	7 stems 11-25	Fair/Poor: spreading form	Remove
36	American elm (<i>Ulmus americana</i>)	24	Good	Remove
37	Tree lilac (<i>Syringa reticulata</i>)	8	Fair	Remove
38	Serviceberry (<i>Amelanchier spp.</i>)	6	Fair	Remove
