April 4, 2022

**RE: TREE CONSERVATION INVENTORY FOR 5254 BANK STREET, OTTAWA**

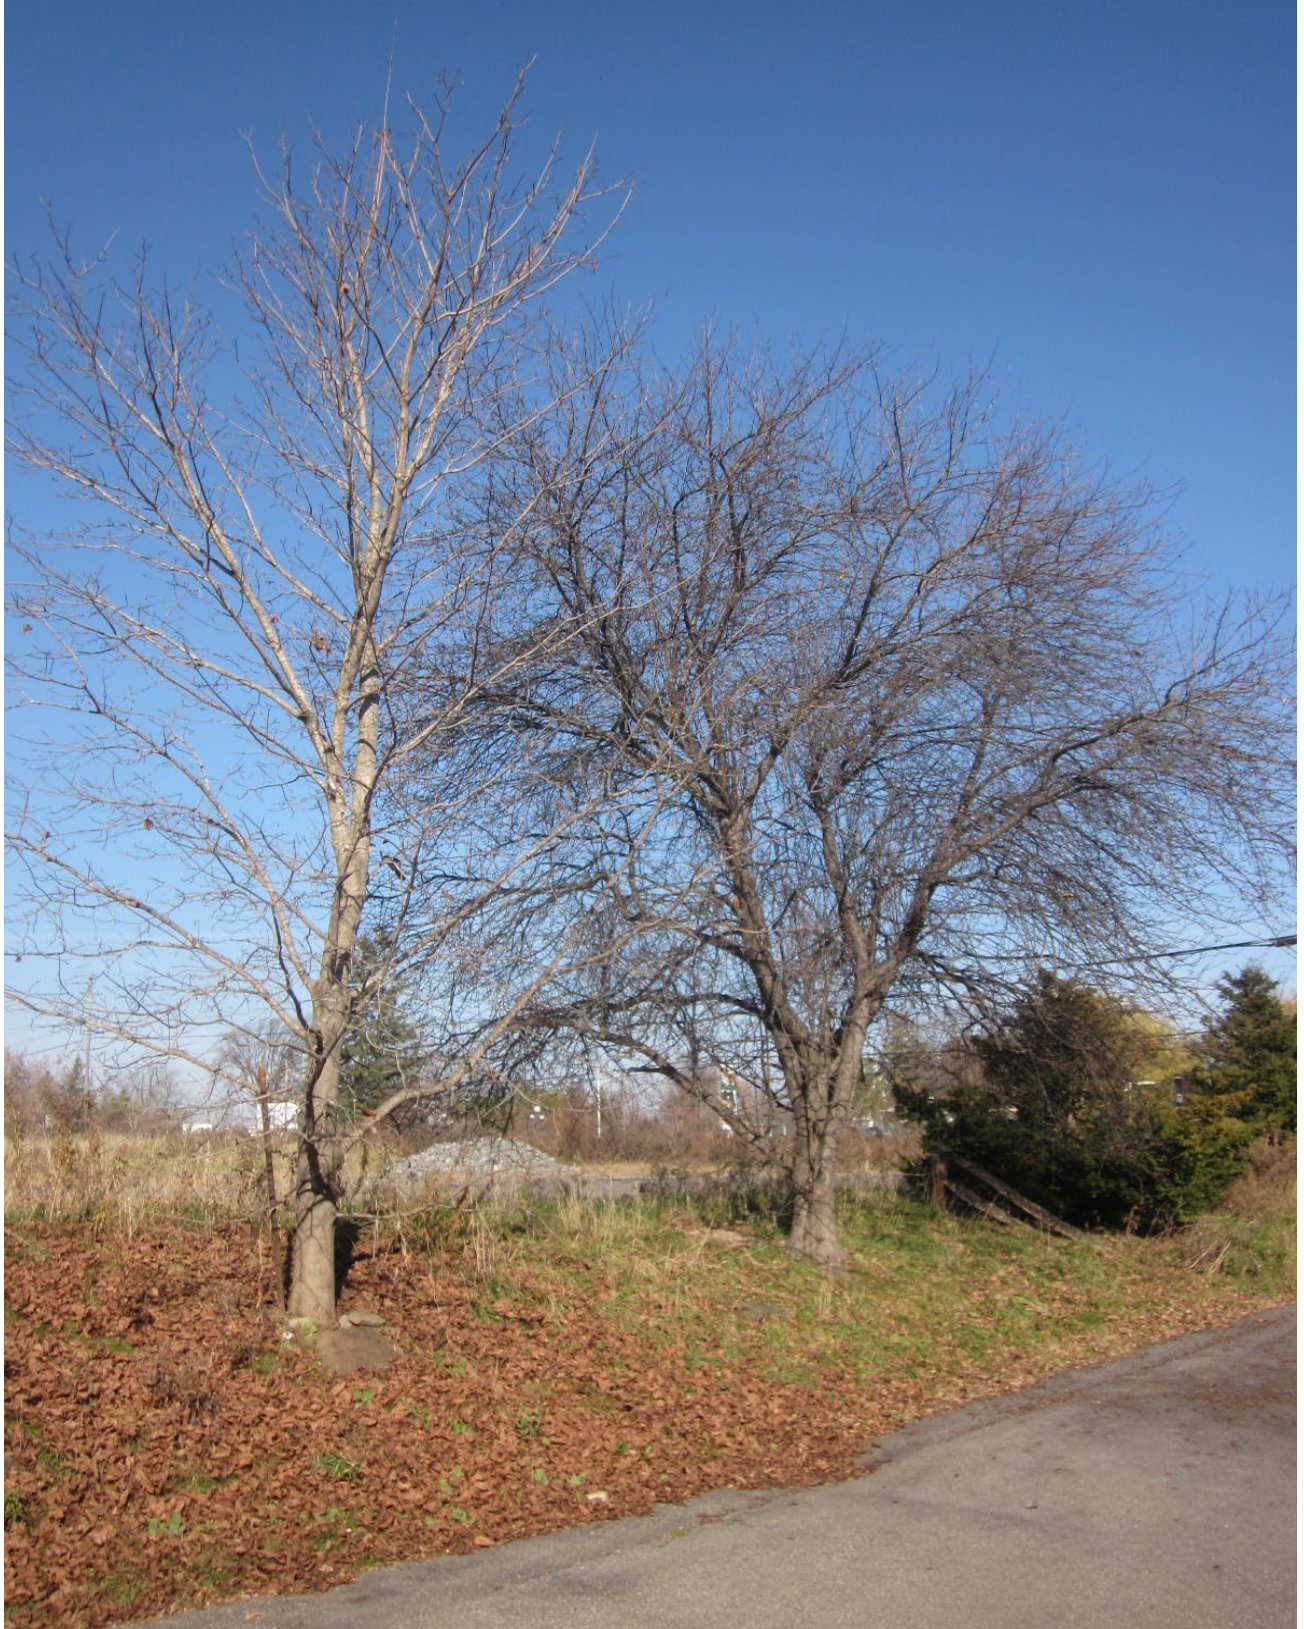
Picture 1. Trees #1 and 2 (right to left), shared crab apple and Norway maple located at 5254 Bank Street

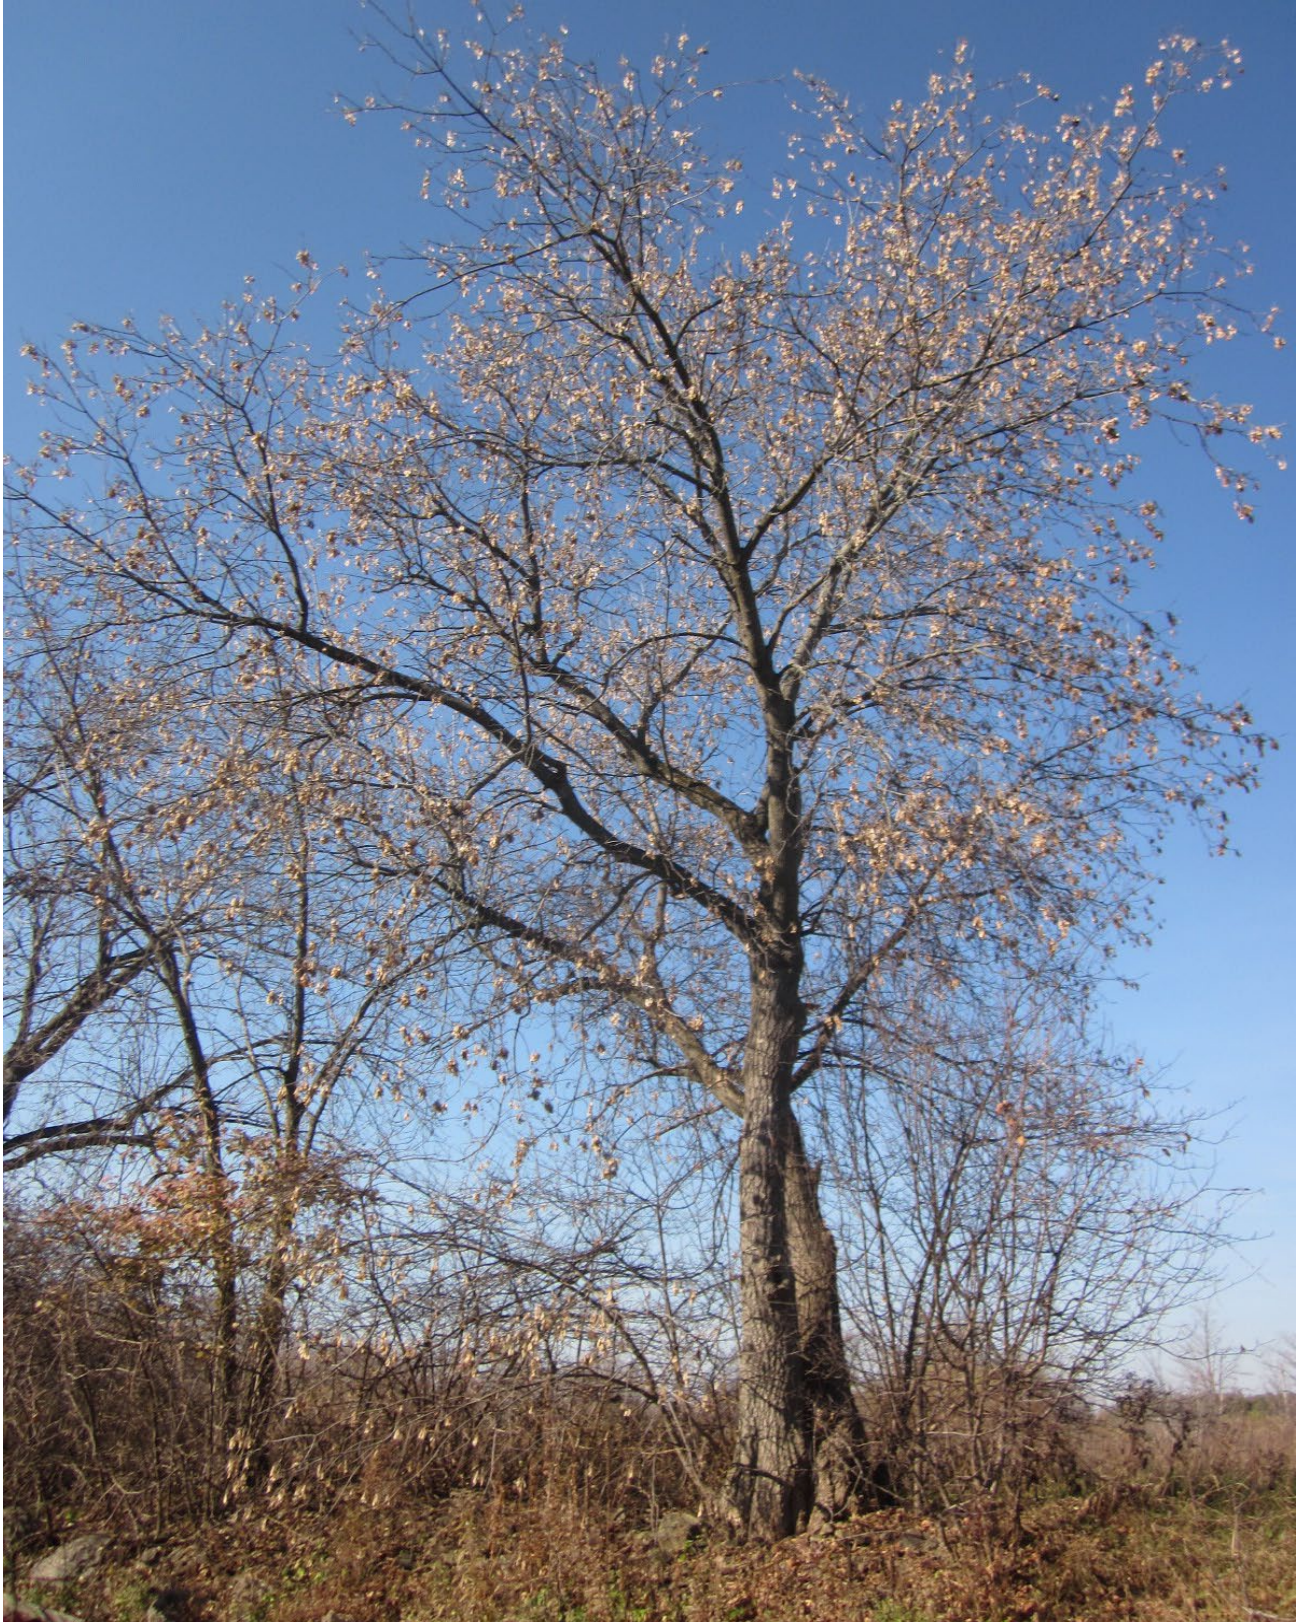
Picture 2. Tree #3, Manitoba maple adjacent to 5254 Bank Street

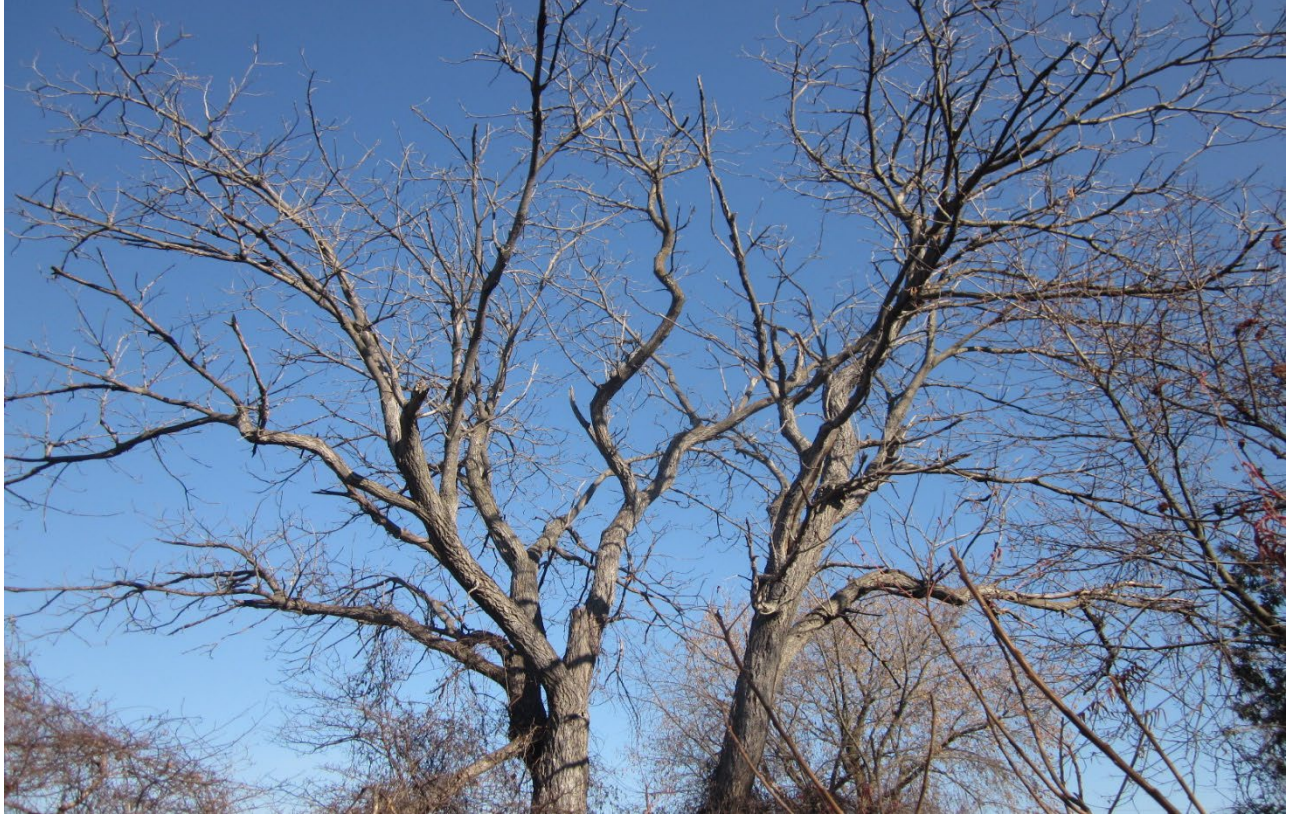
- 1) Endangered Species Act (2007): A mature butternut (*Juglans cinerea*) tree was identified on adjacent private property. This species of tree is listed as threatened under the Province of Ontario's Endangered Species Act (ESA, 2007) and so is protected from harm. This tree will be assessed following ESA protocol in spring 2024.
- 2) Migratory Bird Convention Act (1994): In the period between April and August of each year nest surveys are required to be performed by a suitably trained person no more than five (5) days before trees or other similar nesting habitat are to be removed.

Picture 3. Crown of butternut tree #4 adjacent to 5254 Bank Street

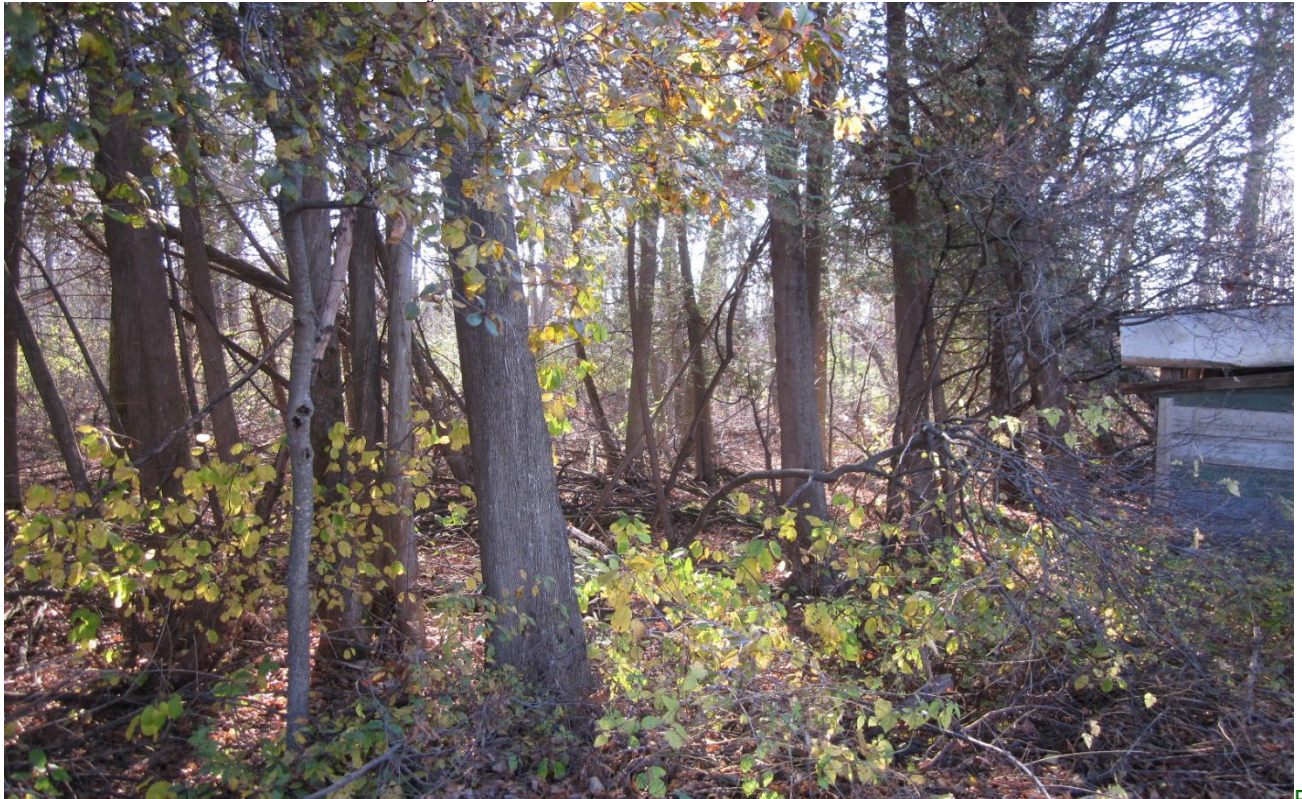
Picture 4. Stand #8, poplar and cedar trees adjacent to 5254 Bank Street

As excavation occurs within the CRZs of tree #6 and those within stand #8, the following measures will be taken:

1. Hydro excavation along the edge of excavation in proximity to the tree(s) to carefully expose roots. Exposed roots will then be cleanly cut and sealed before being reburied. Excavation can then resume using traditional mechanical means. Sealing the cleanly cut root ends with a beeswax product will help prevent the loss of moisture and facilitate healing.
2. If the excavation is to be left open for any time a covering of at least three layers of moistened burlap is to be draped over the exposed face of excavation closet to the tree. This will help reduce the loss of soil moisture.

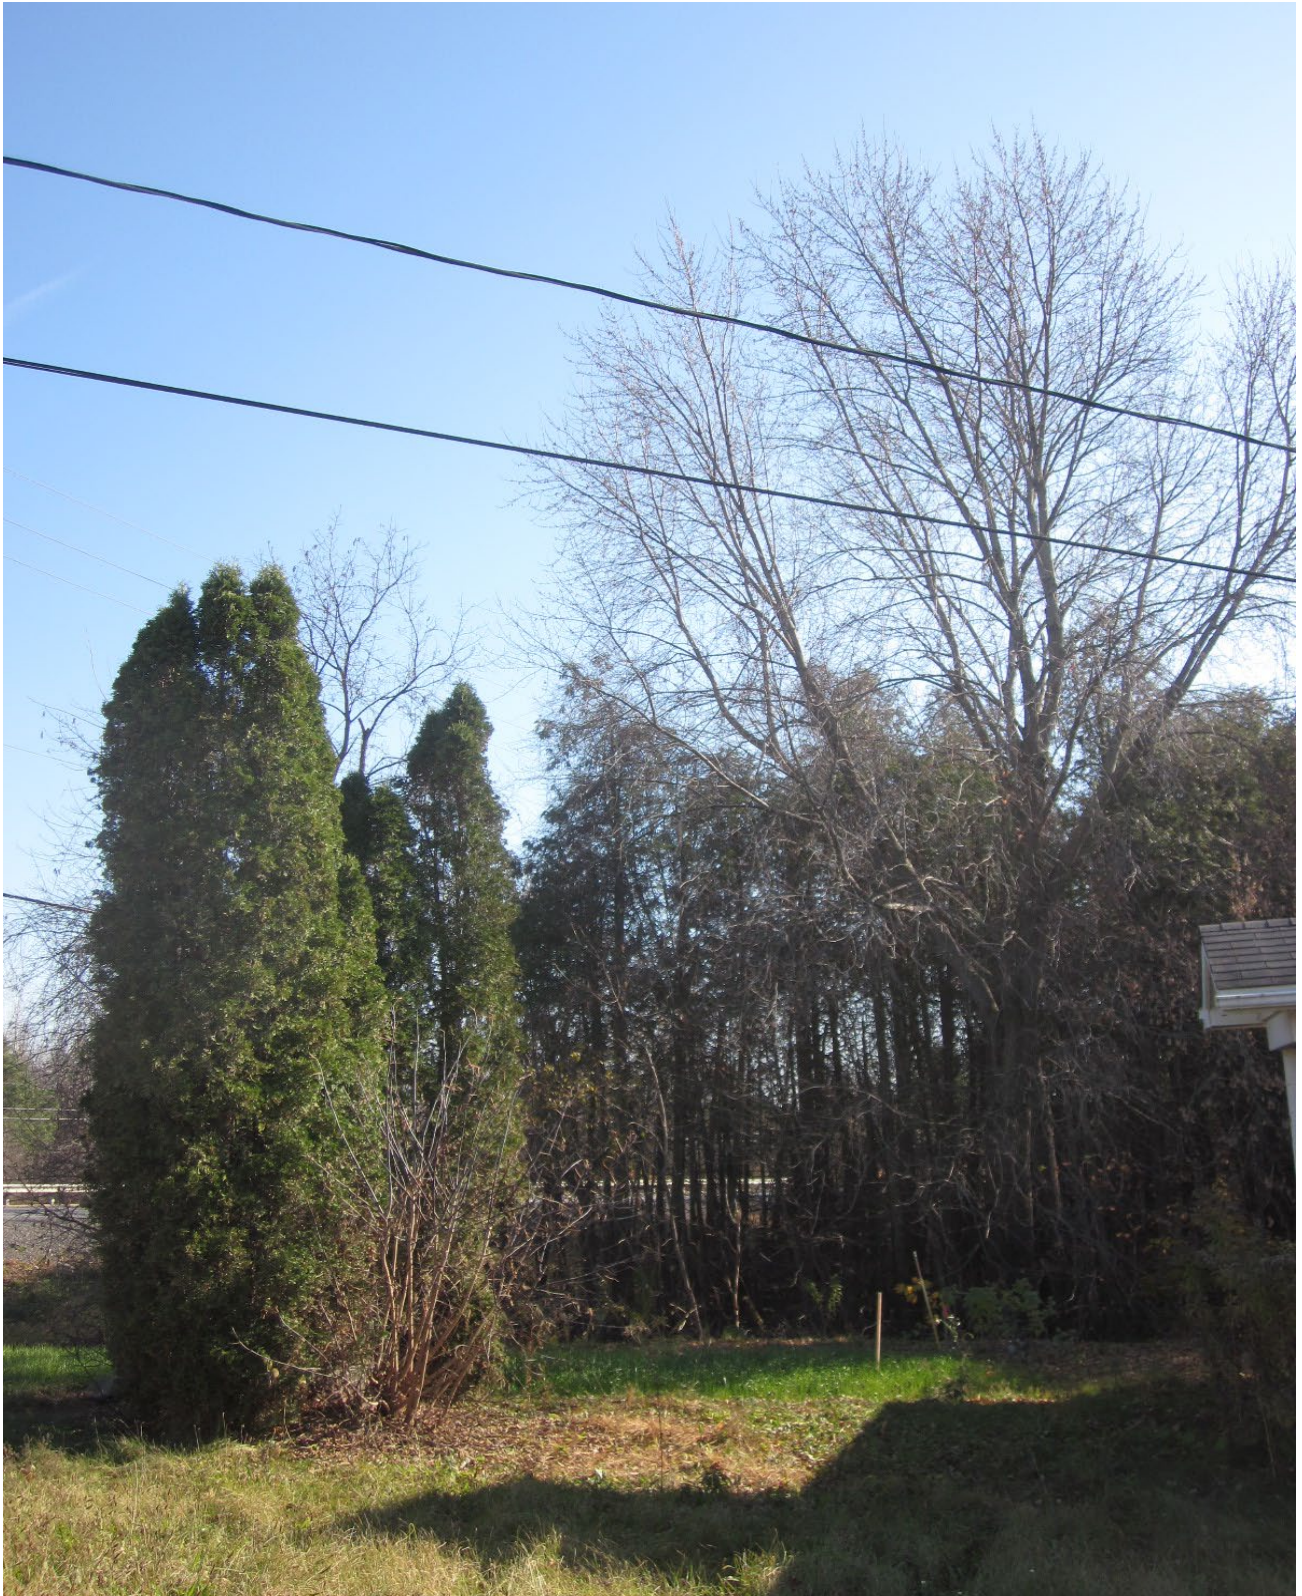
Picture 5. Tree #9 and 10 (right to left), maple and emerald cedar trees on City of Ottawa property adjacent to 5254 Bank Street
