# TREE CONSERVATION REPORT

1047 Richmond Road

August 23, 2024

Submitted as part of Site Plan Control Application

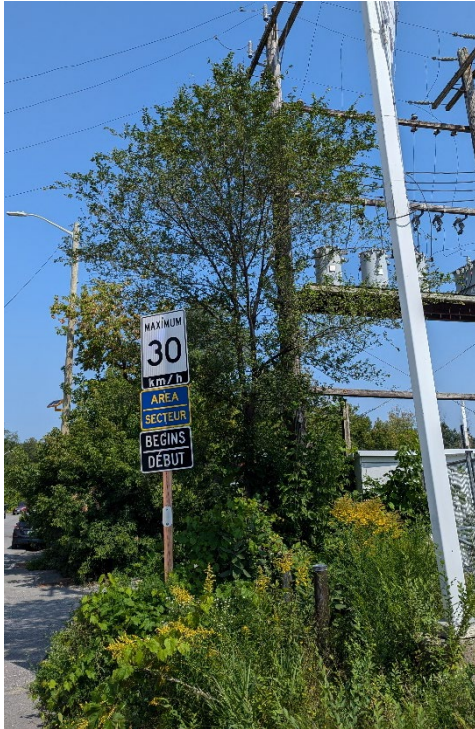
Above left: Tree 1 - City elm to be removed.

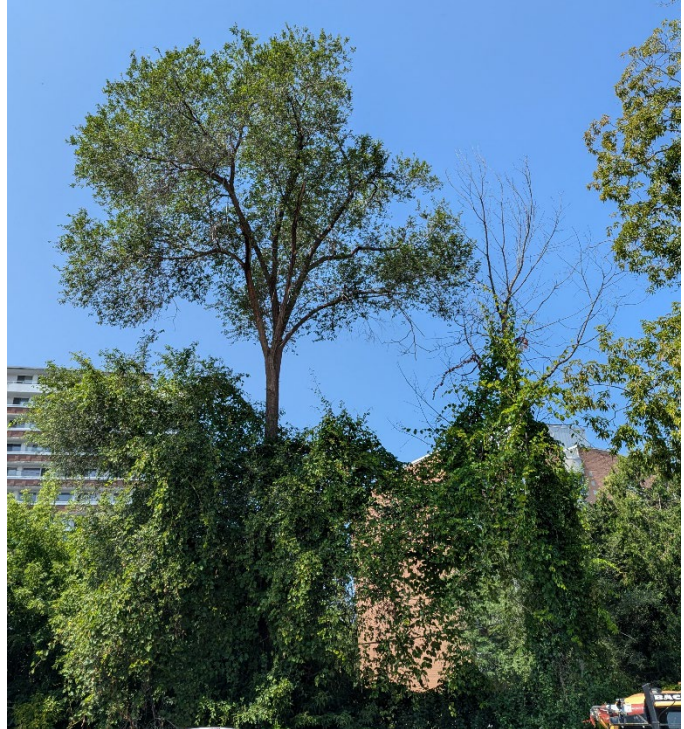
Above right: Tree 3 - boundary elm to be removed - and Tree 4 - dead elm to be removed.

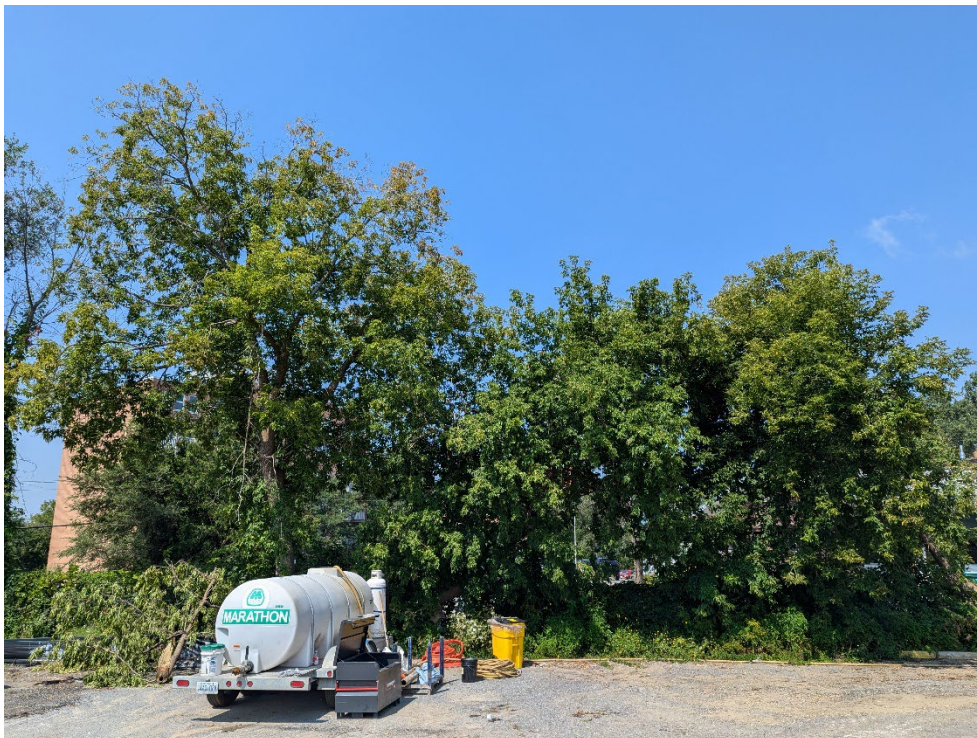
Below: Trees 5-7 – adjacent trees to be removed.

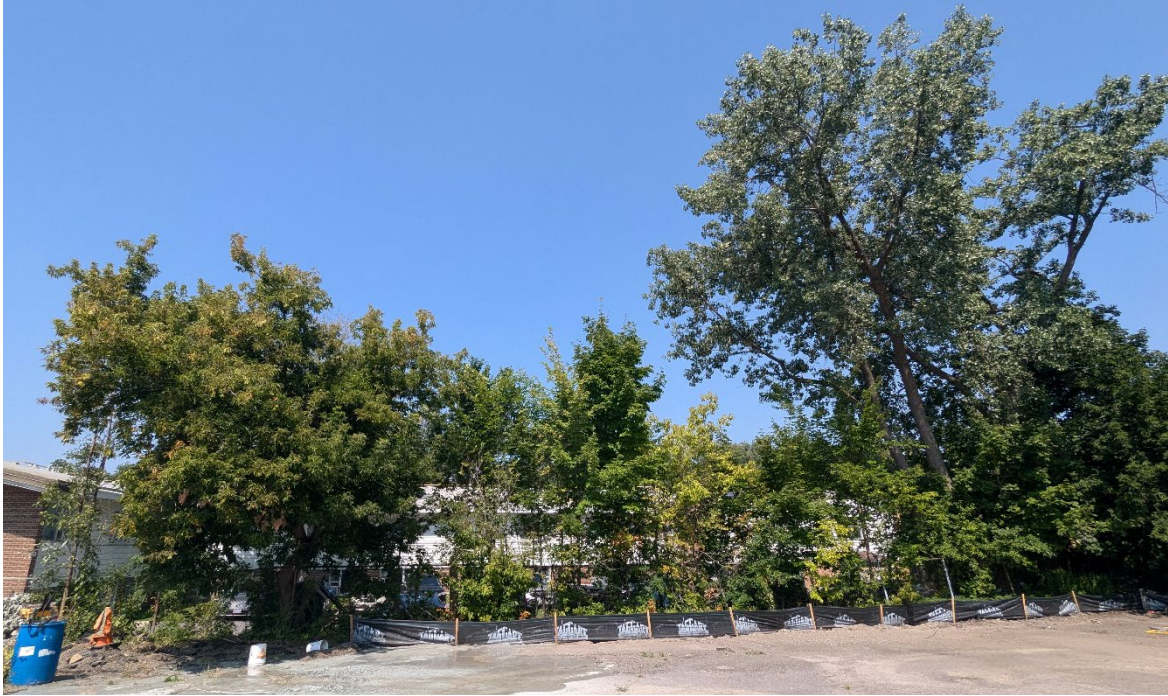
Above: Trees 8-15 and G1.

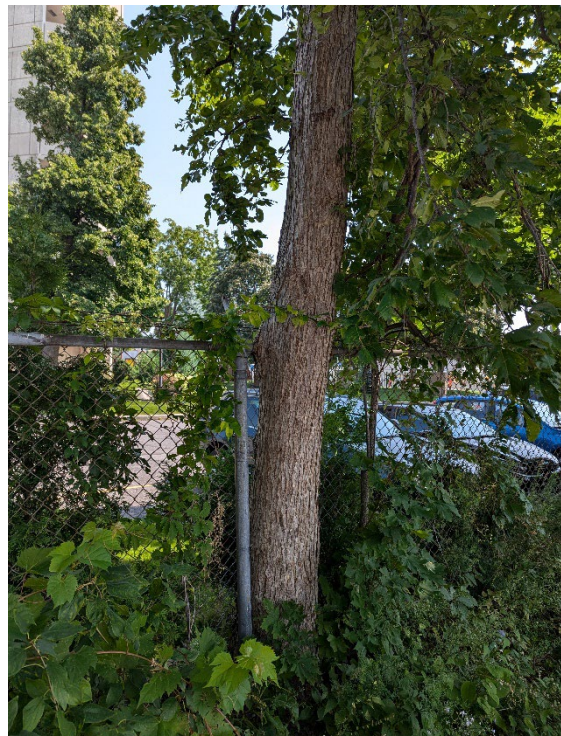
Above right: Tree 25 - boundary Manitoba maple to be removed.
