Landslide Hazard Assessment

Proposed Self-Storage Facility

1015 & 1045 Dairy Drive
Ottawa, Ontario

Report PG6498-2 dated June 10, 2024

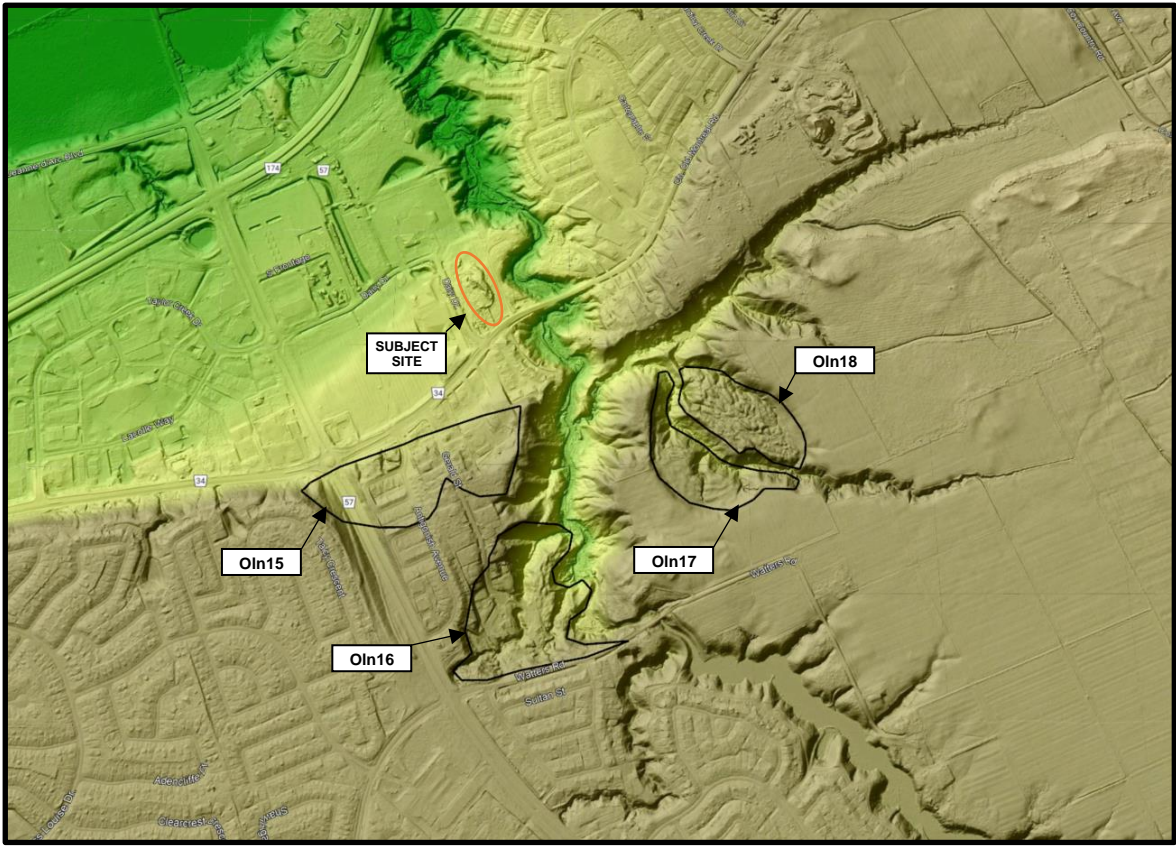
Figure 2 – LiDAR Image of Subject Site and closest landslide and slope failure.

It is understood up to potentially four landslides have been documented within 2 km of the subject site and are depicted on Figure 2 for reference. Two of these landslides, Oln17 and Oln18, reported by GSC to have retrogressed into their respective sides of the incised valley of a tributary of Cardinal Creek (GSC OF8600, 2019) and located within 500 m to the southeast of the subject site.

Oln15 and Oln16 are located within 500 m southwest of the subject site. Oln15 is considered a “probable landslide” which may have retrogressed into the scarp slope above a terrace surface of the proto-Ottawa River (OF8600, 2019). The area corresponding to Oln15 experienced approximately 19 m of topographic relief and a relatively steep (i.e., over 20 degrees) slope along their flank. The areas adjacent to Oln17 and Oln18 were measured to experience up to approximately 11 degrees of slope steepness and up to 9 m of relief along their footprints.

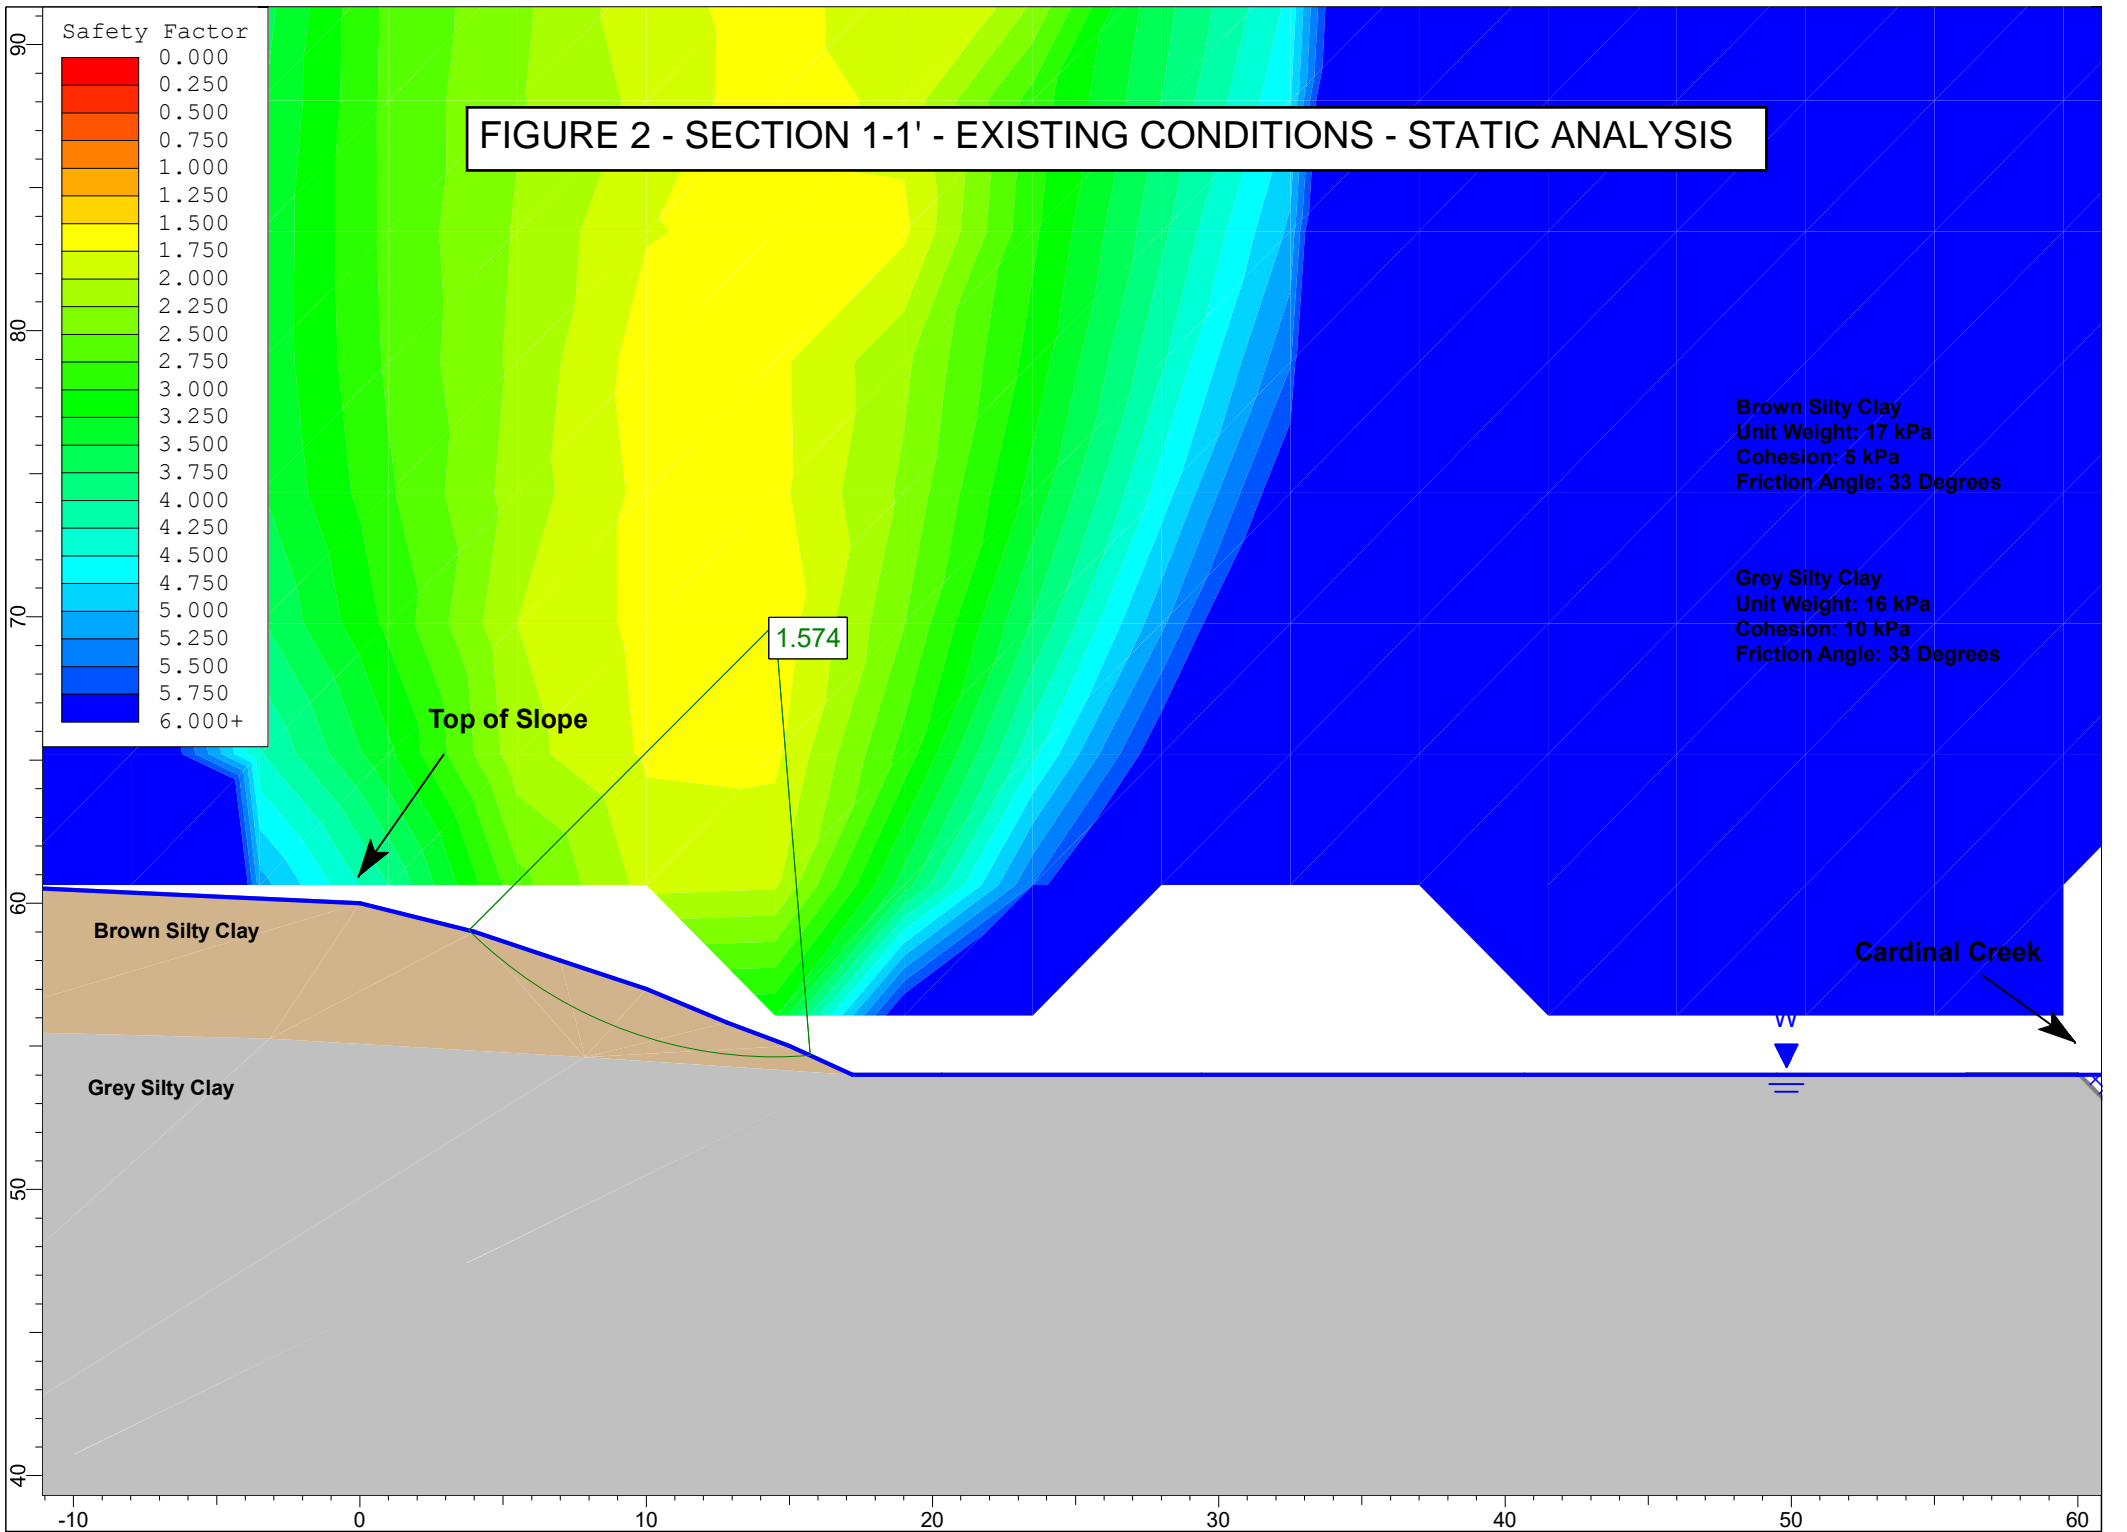
FIGURE 2 - SECTION 1-1' - EXISTING CONDITIONS - STATIC ANALYSIS

The results for the existing slope conditions at Section 1-1' and Section 2-2' are shown in Figure 2 and Figure 4 in Appendix 2. The factor of safety for Section 1-1' was found to be greater than 1.5, and therefore the section is considered stable under static conditions. A factor of safety less than 1.5 was noted for Section 2-2', which requires a **stable slope allowance of 5 m** from top of slope to obtain a factor of safety greater than 1.5.

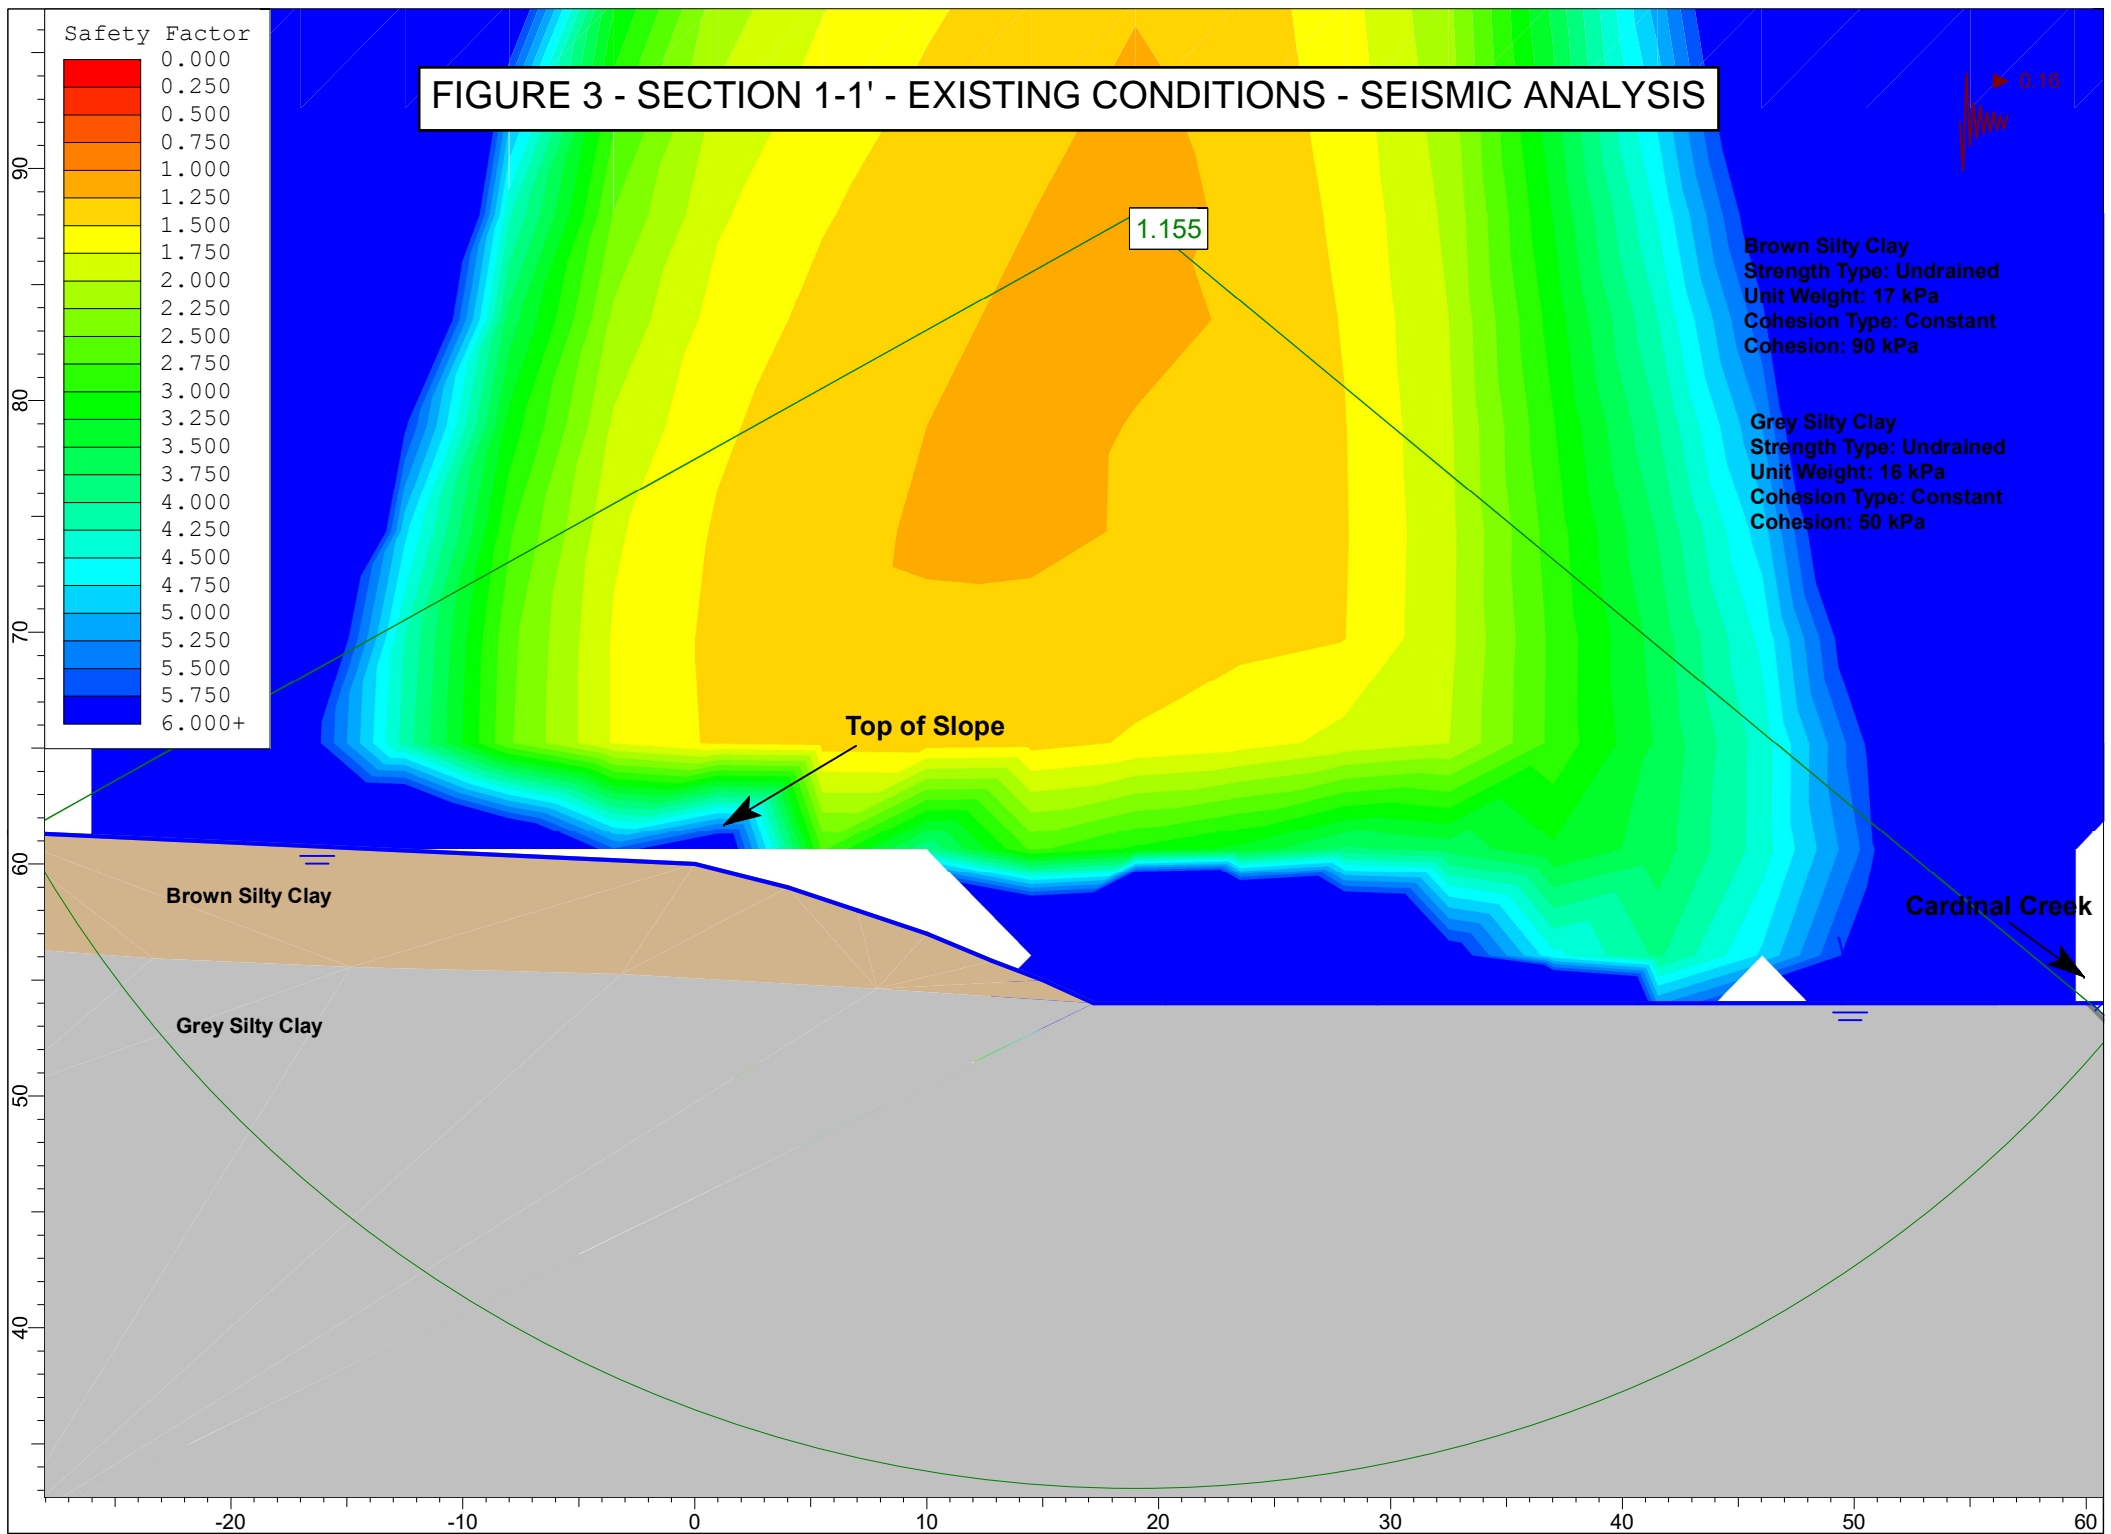
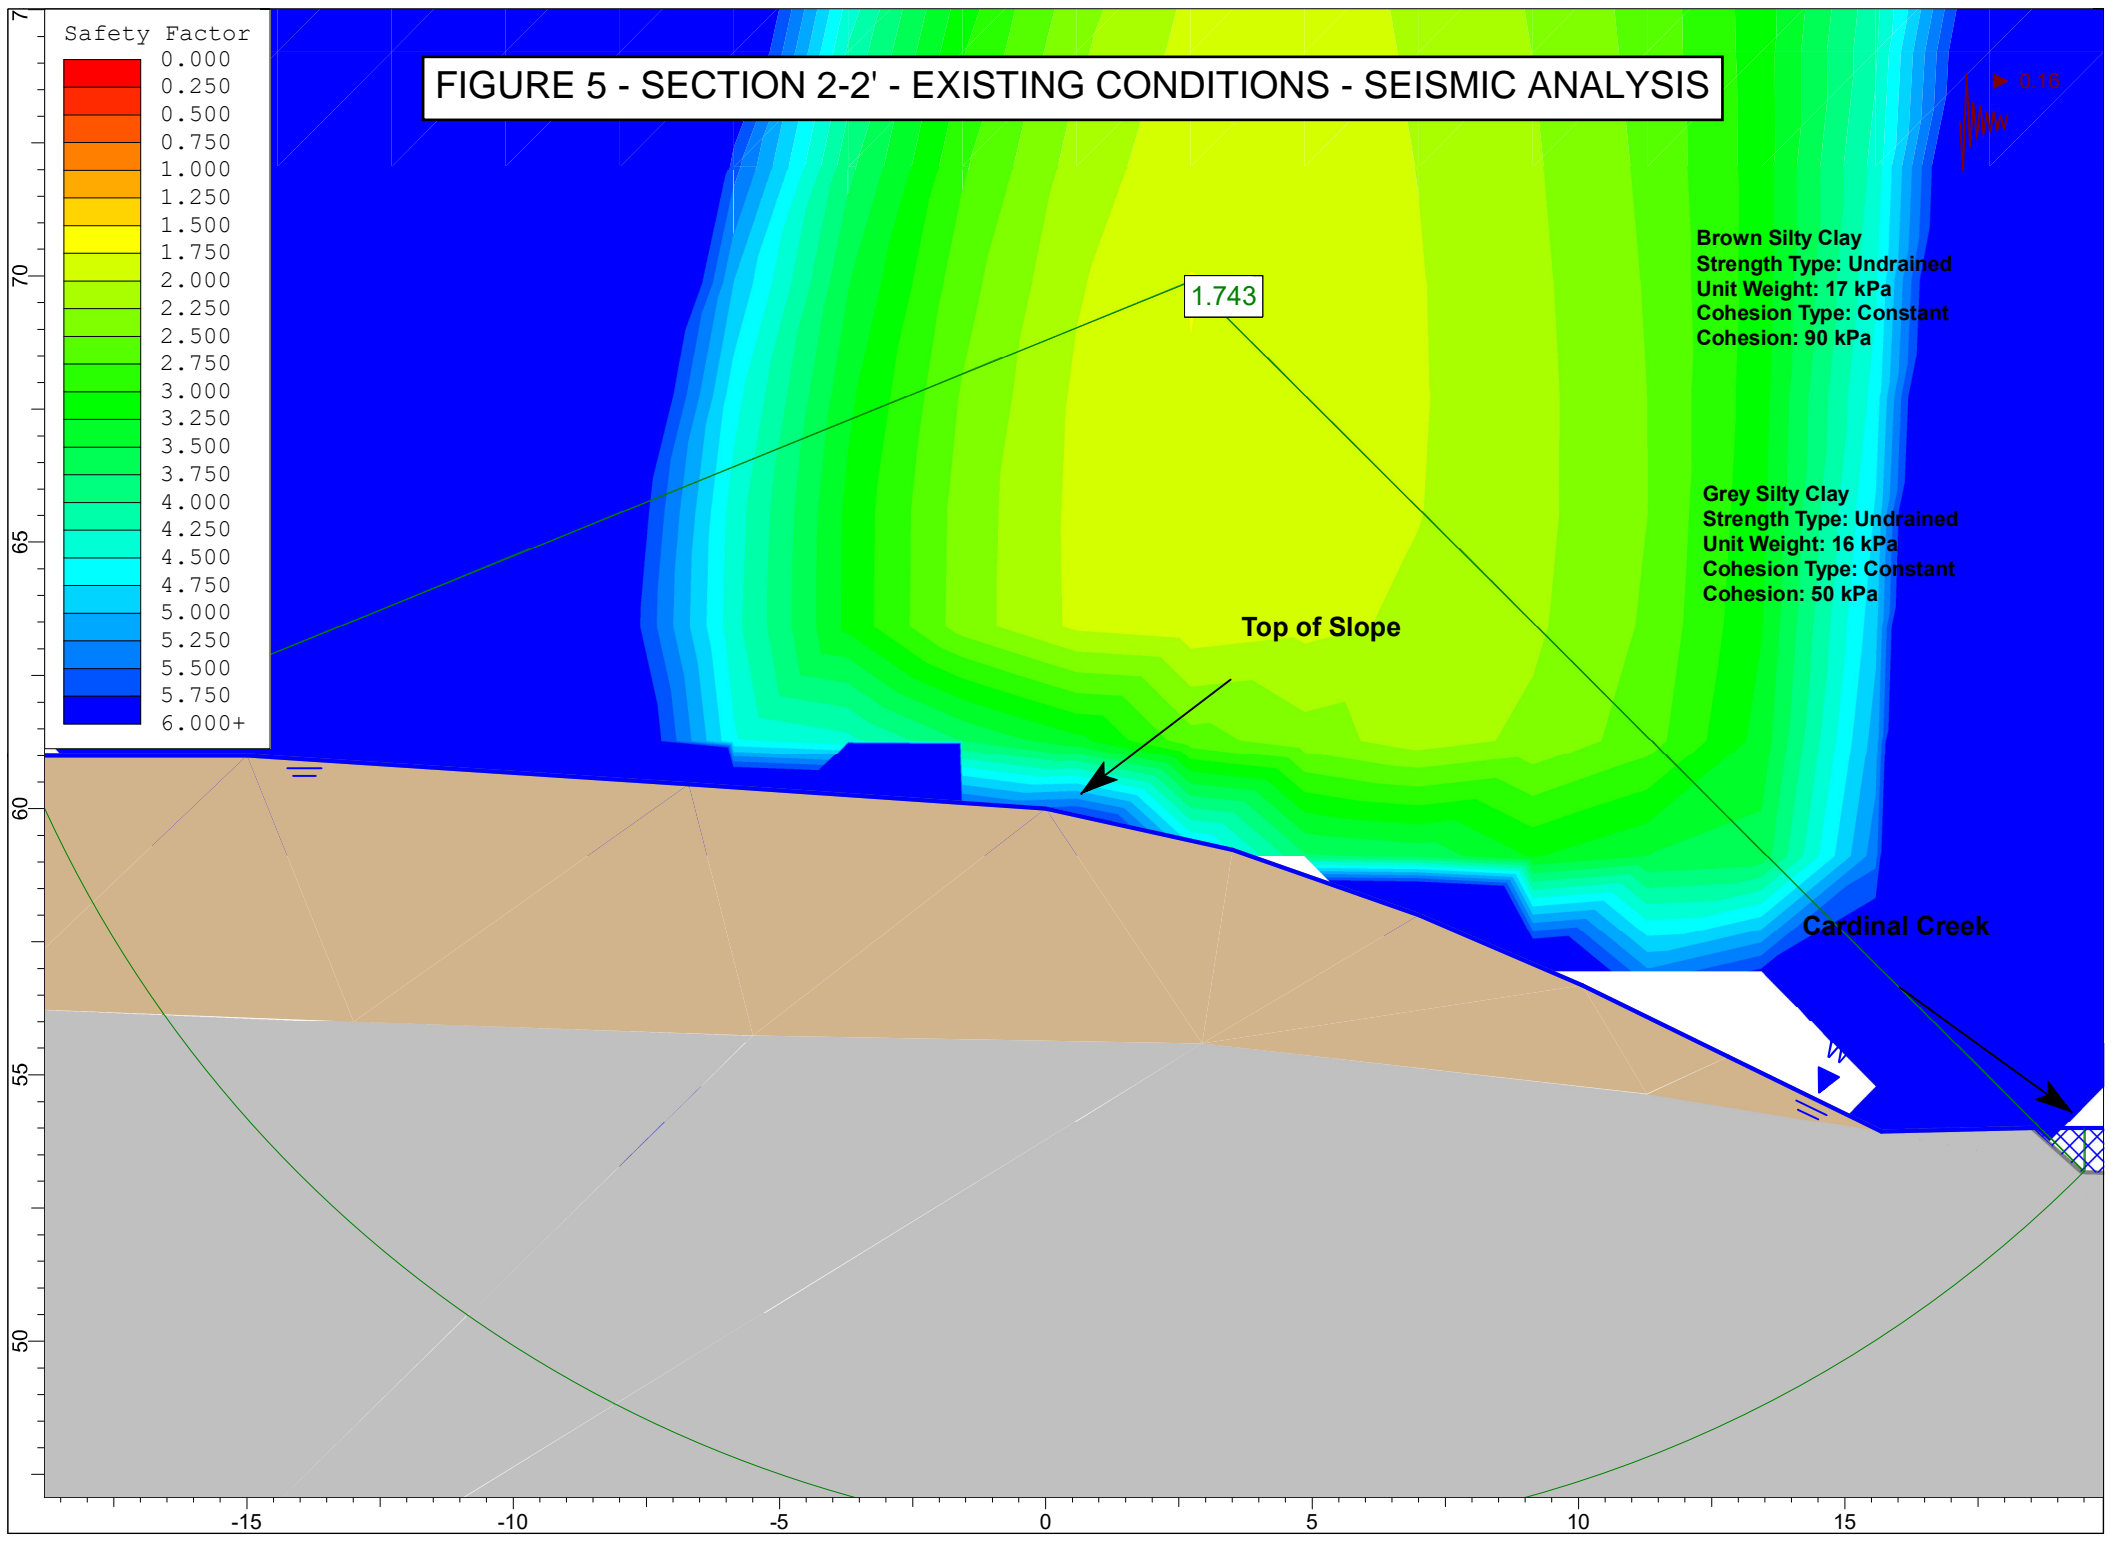
The overall slope stability factor of safety at the two slope cross-sections when considering seismic loading was found to be greater than 1.1, which is considered stable under seismic loading. Therefore, setbacks due to slope stability under seismic conditions are not required from a geotechnical perspective at the subject site.

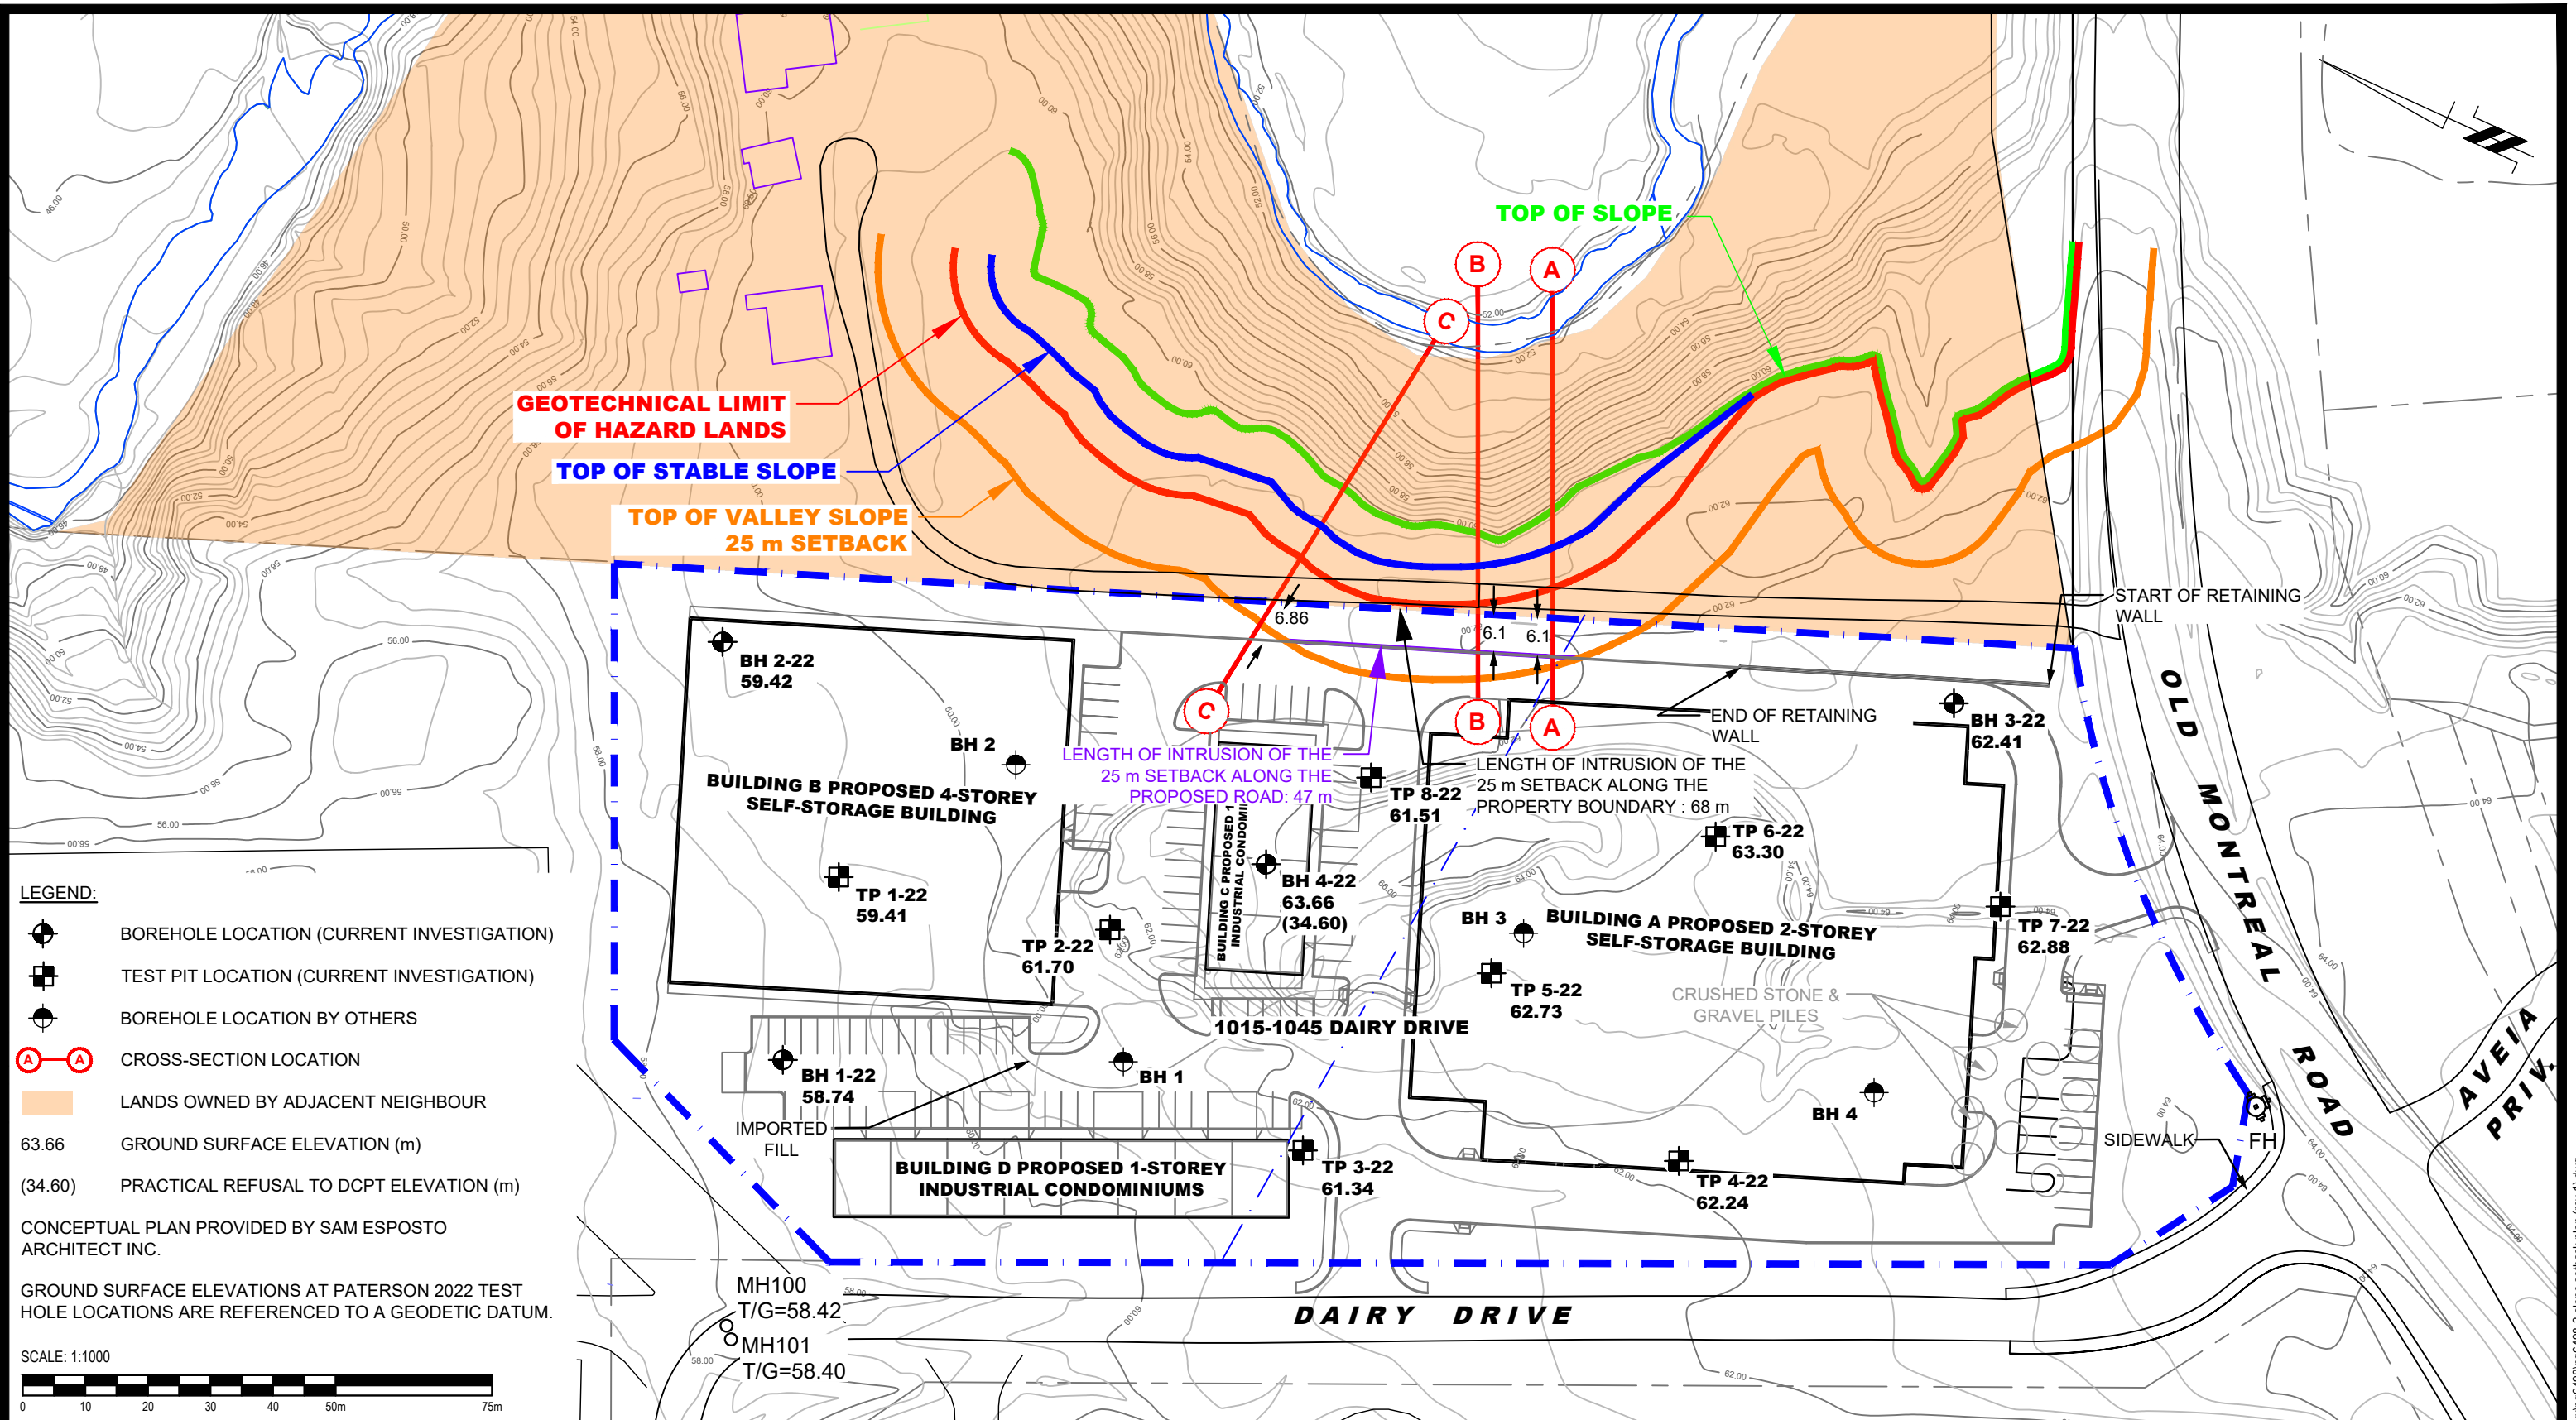
Title: SLOPE SETBACK PLAN

Considering the above, the Limit of Hazard Lands setback provided for the subject site is summarized in Drawing PG6498-3 - Slope Setback Plan, attached in Appendix 2. The setbacks are also shown in cross-section A-A', B-B' and C-C' depicted on Drawings PG6498-4, PG6498-5, and PG6498-6, respectively.

It should be noted that the subject site boundary and proposed self-storage facility are located approximately 13.5 m from the top of slope, at its nearest point, the Limit of Hazard Lands does not extend onto the subject site and does not impact the proposed development.

It is recommended that the existing vegetation on the slope faces is not removed as it contributes to the stability of the slope and reduces erosion.
