TREE CONSERVATION REPORT

2506 Innes Road

Dendron Forestry Services

September 16, 2024

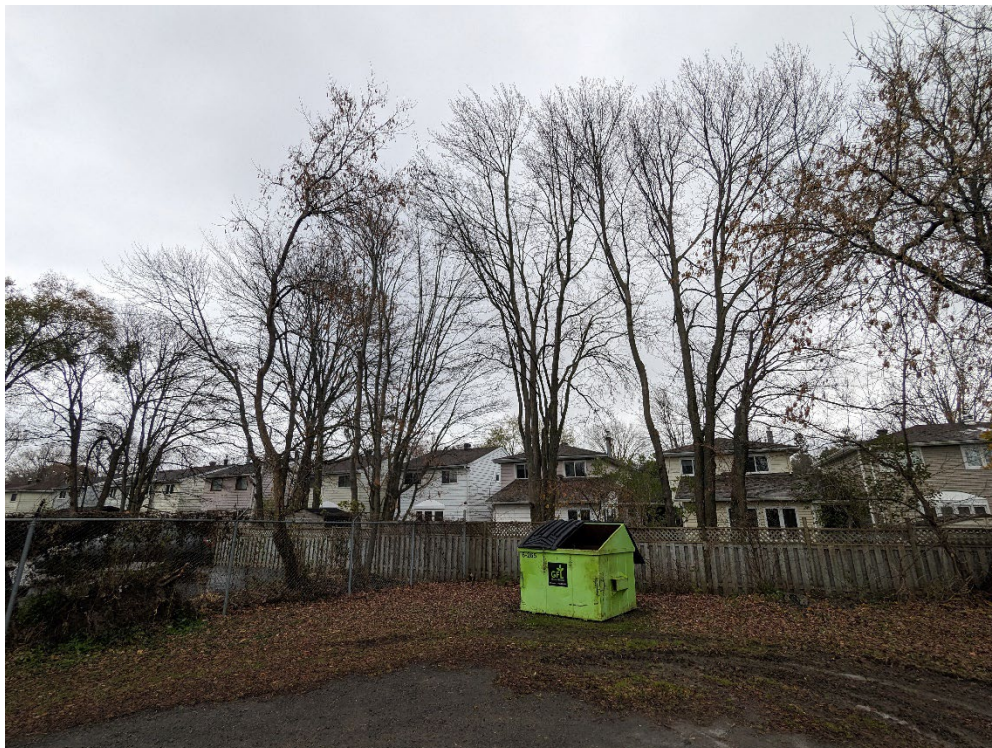
Below: East corner of the property, including Trees 2-6

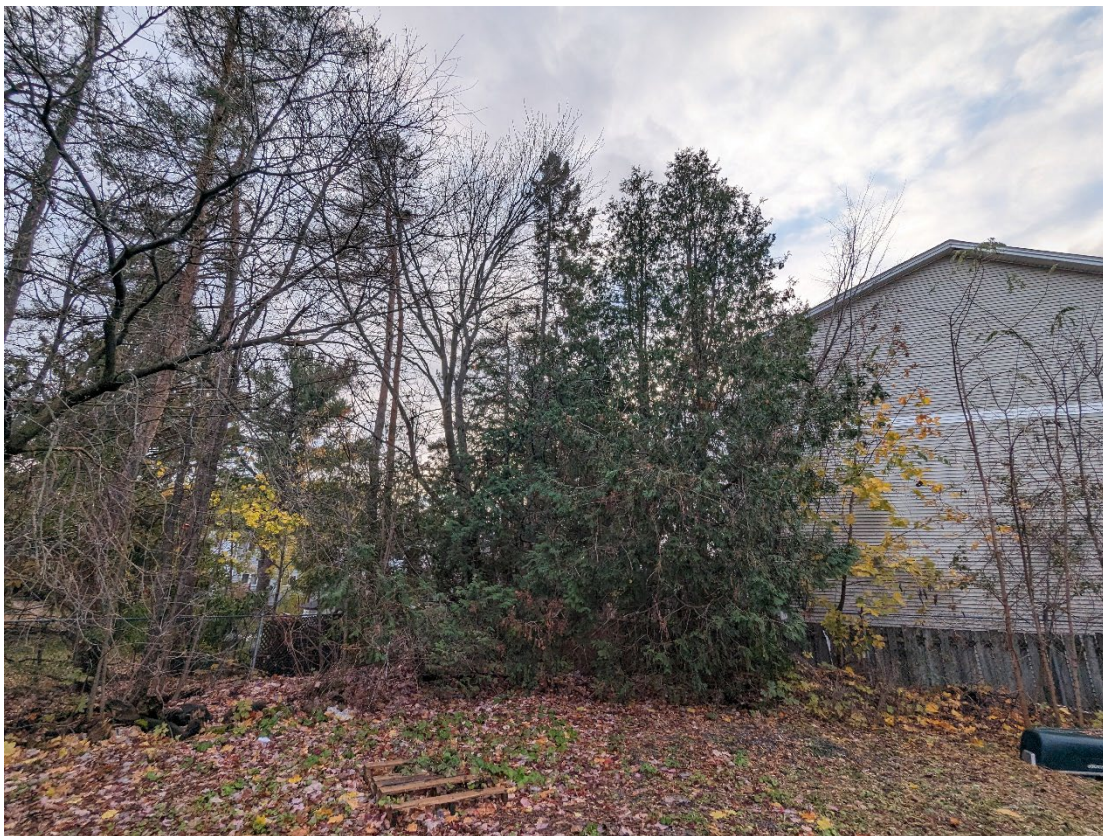
Below: southwest corner of the property, including Trees 23-33
