TREE CONSERVATION REPORT

1058-1066 Silver Street
and 1291-1305 Summerville Avenue

Dendron Forestry Services

December 23, 2024

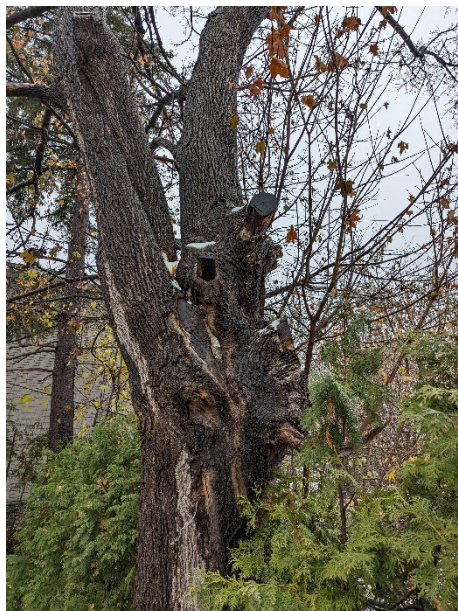
Above: Tree 1 (right) - Private maple to be removed and Tree 2 (left) - private spruce to be removed. Below: main union of Tree 1

Due to the significant grade changes at 1058-1066 Silver, **Trees 1-12** will need to be removed. Refer to the listed grading plan for details.

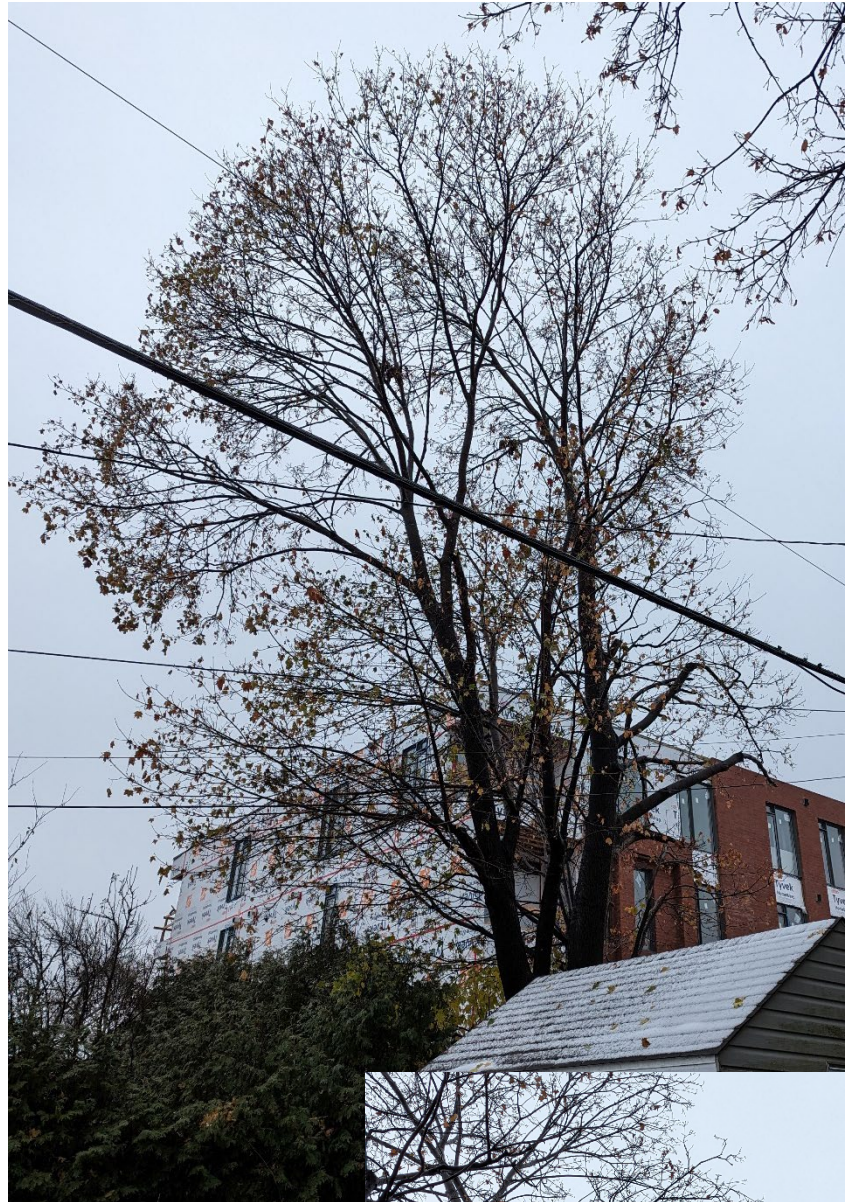
Above right: Canopies of Trees 3-5 - private maples to be removed.

Prior to the final site visit, all of the boundary trees abutting the parking area behind the Summerville properties had been removed by Hydro. **Trees 3-5 and 21-25 have been removed.**

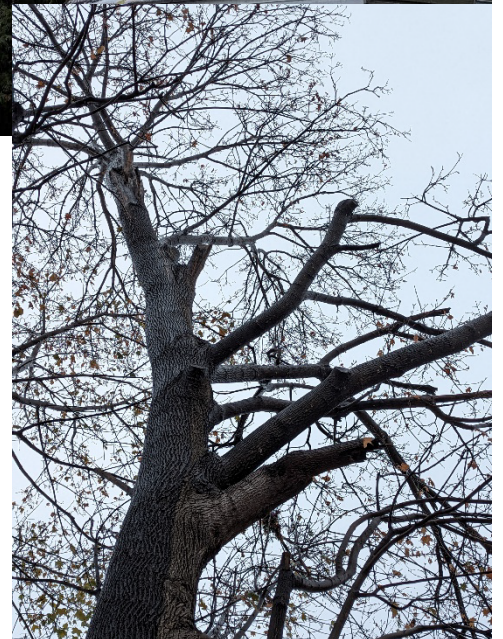
Below right: trunk and pruned branches of Tree 4

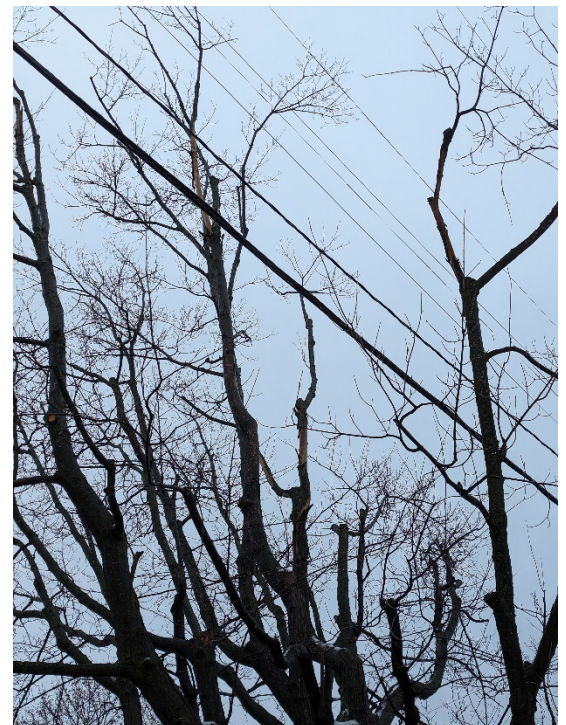
Right: Canopy of Tree 8 pruned around wires with some dead central branches.

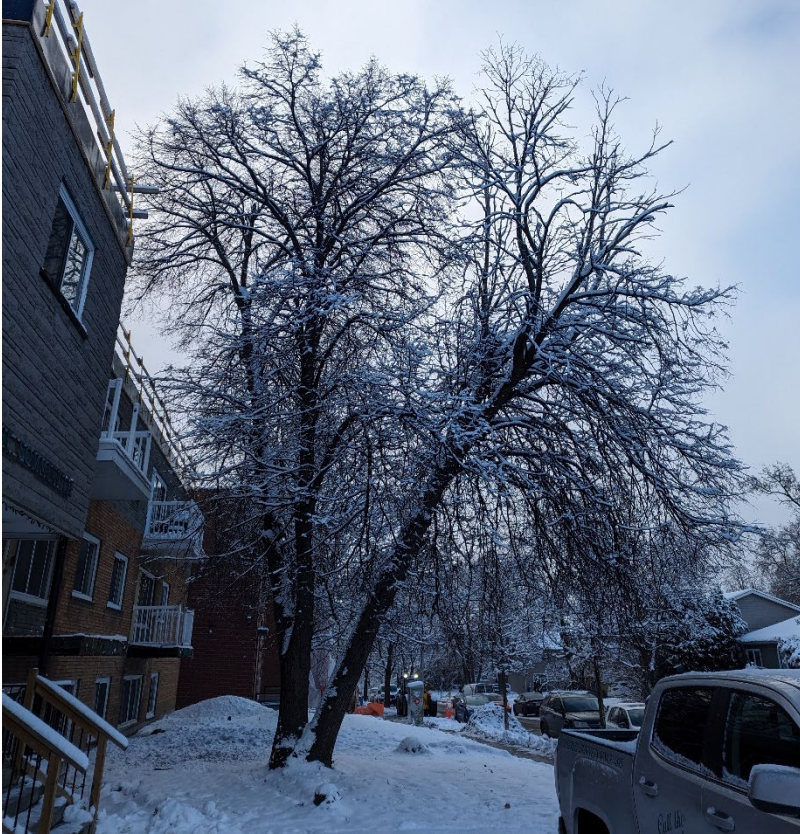
Above: Tree 20 - Private linden to be retained. Recommend removing the leaning stem.

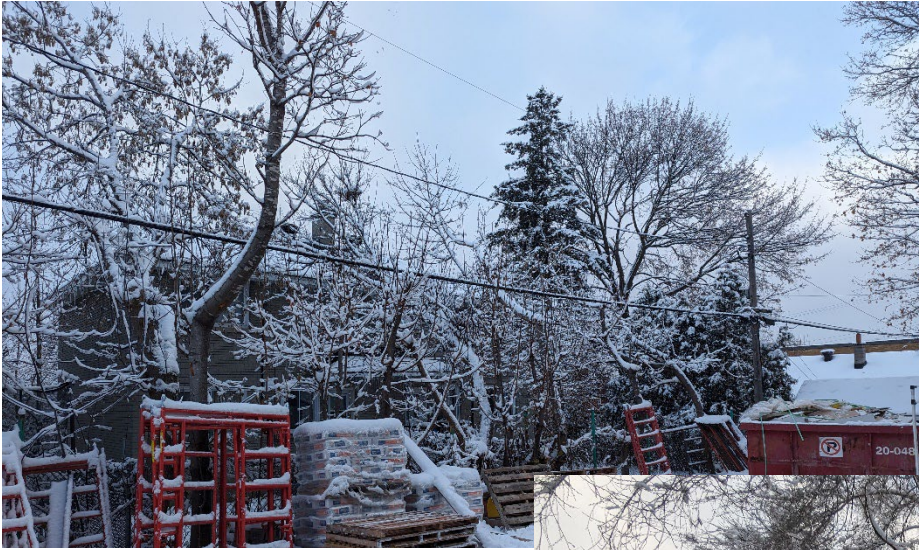
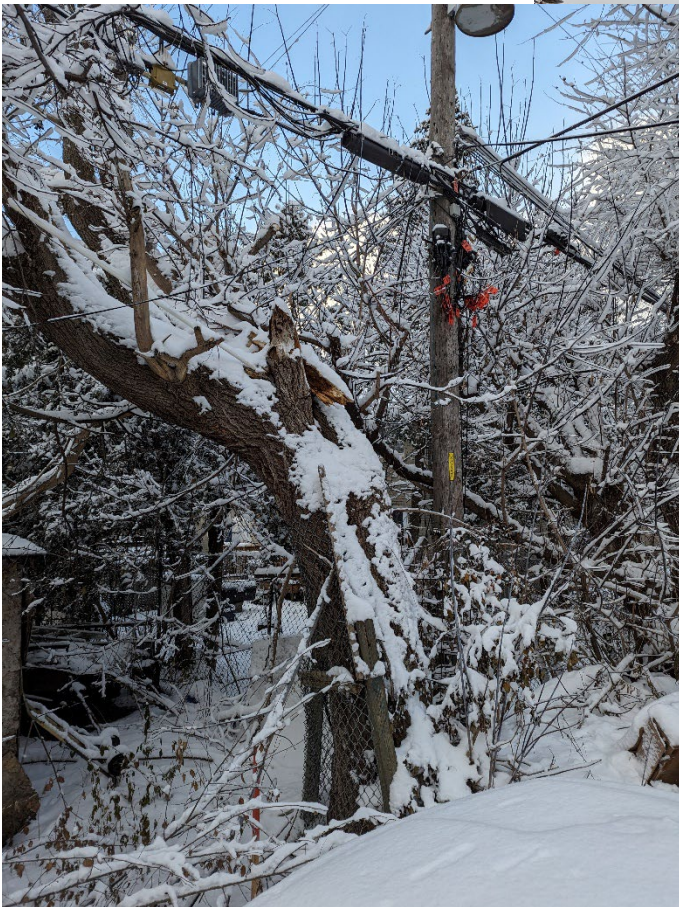
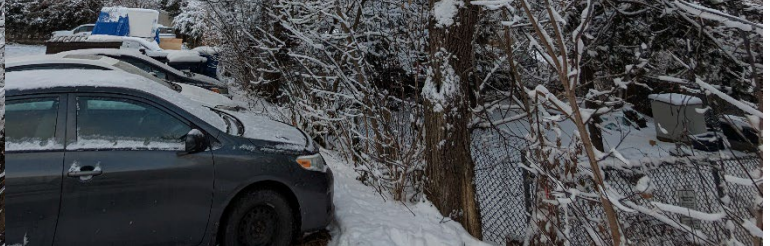
Clockwise from upper left: Tree group 21 – heavily pruned Manitoba maples to be removed (crowns of Tree 1 and 2 in background).

Tree 22 – Boundary Siberian elm to be removed.

Tree 25 – Boundary Siberian elm to be removed.

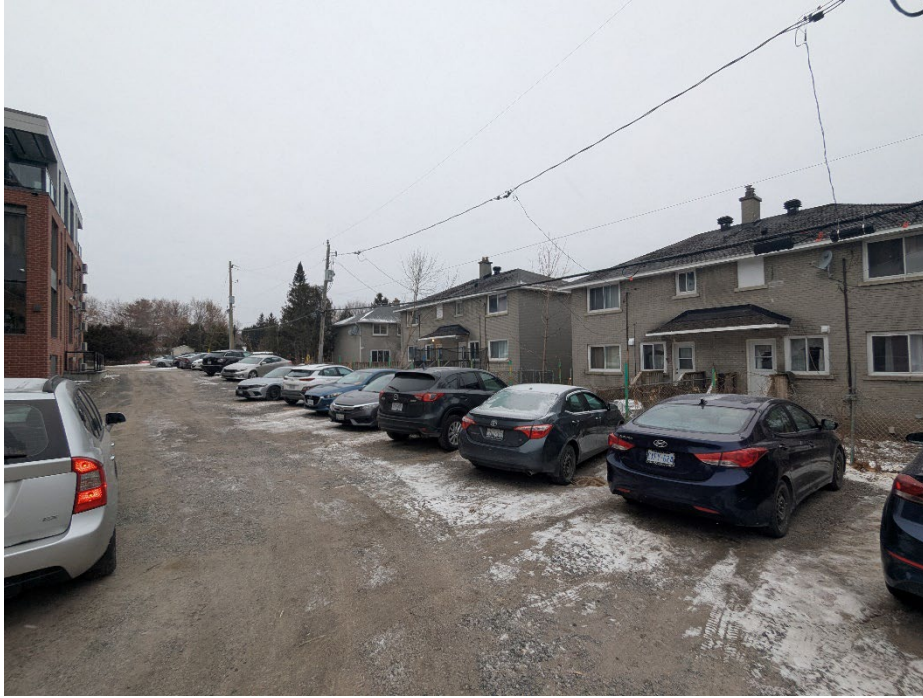
Above: Rear parking area behind the Summerville properties – all trees removed (photo December 23, 2024).

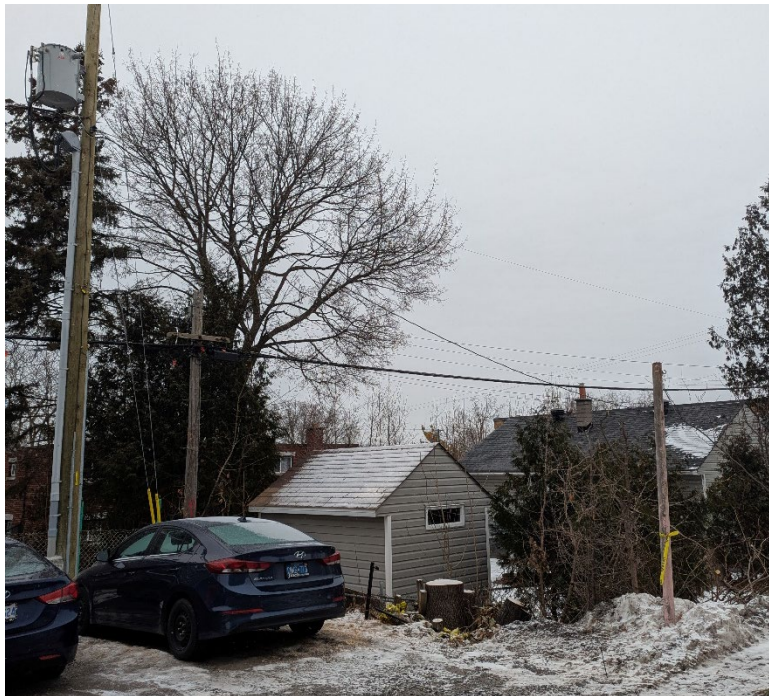
Below: stumps of Trees 3-5 (photo December 23, 2024)
