# **TREE CONSERVATION REPORT**

The Ottawa Hospital – Riverside Campus Staff Parking Lot

Revision 02

March 2025

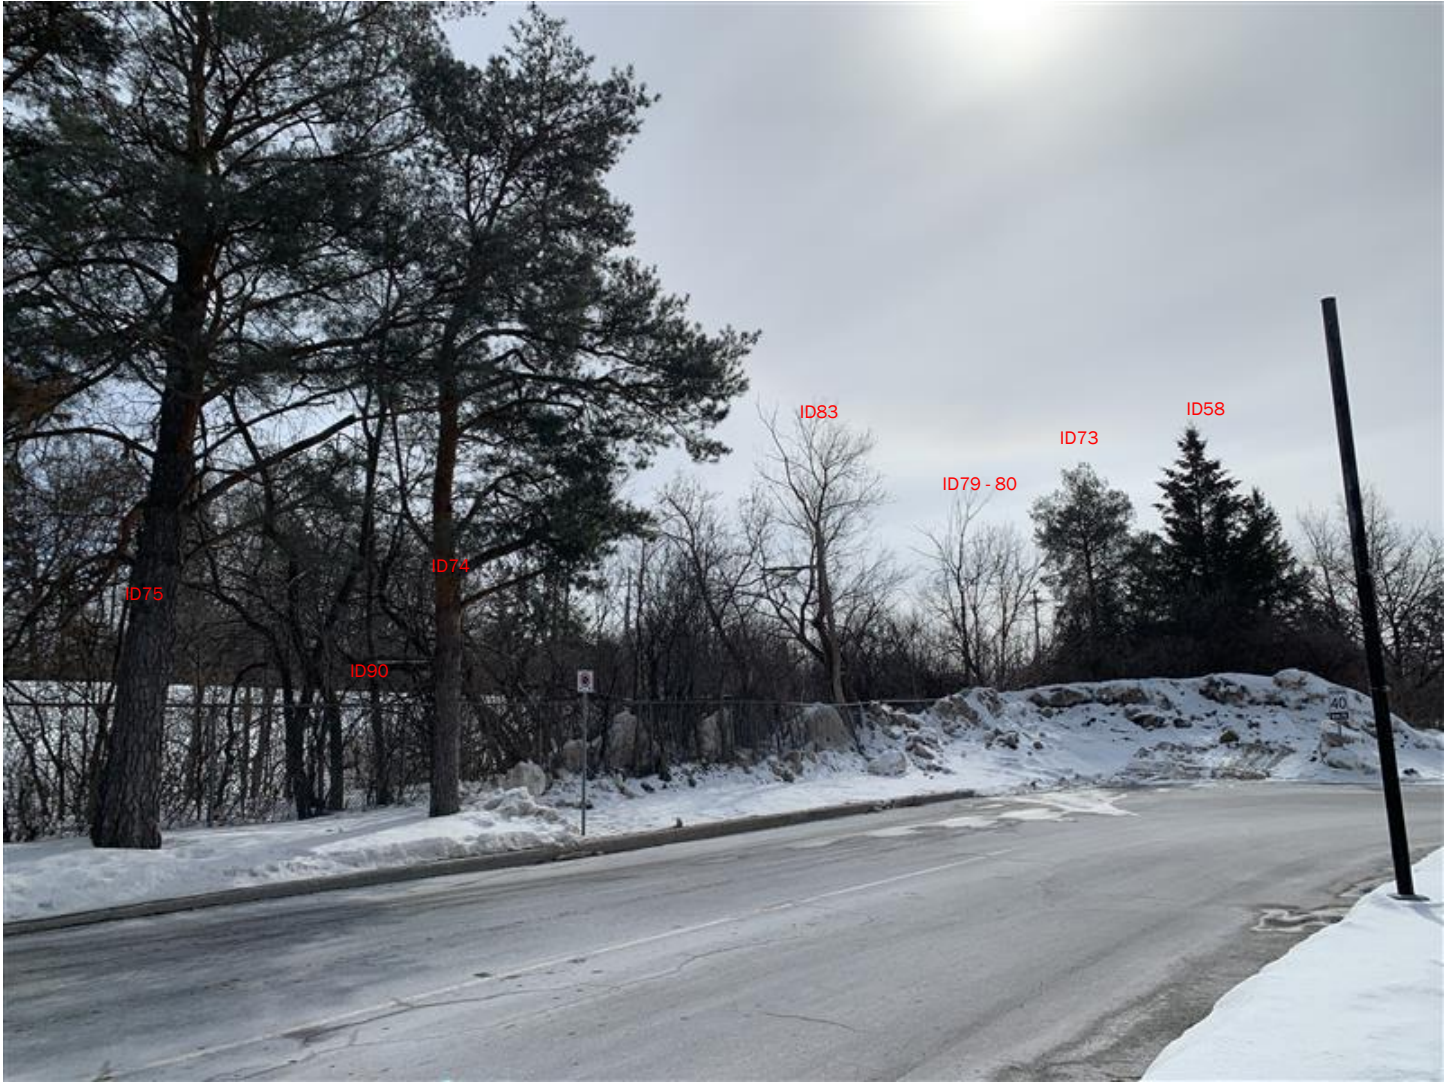
Photo 1: View of trees near the existing fence line at Parking Lot C with Tree ID numbers.

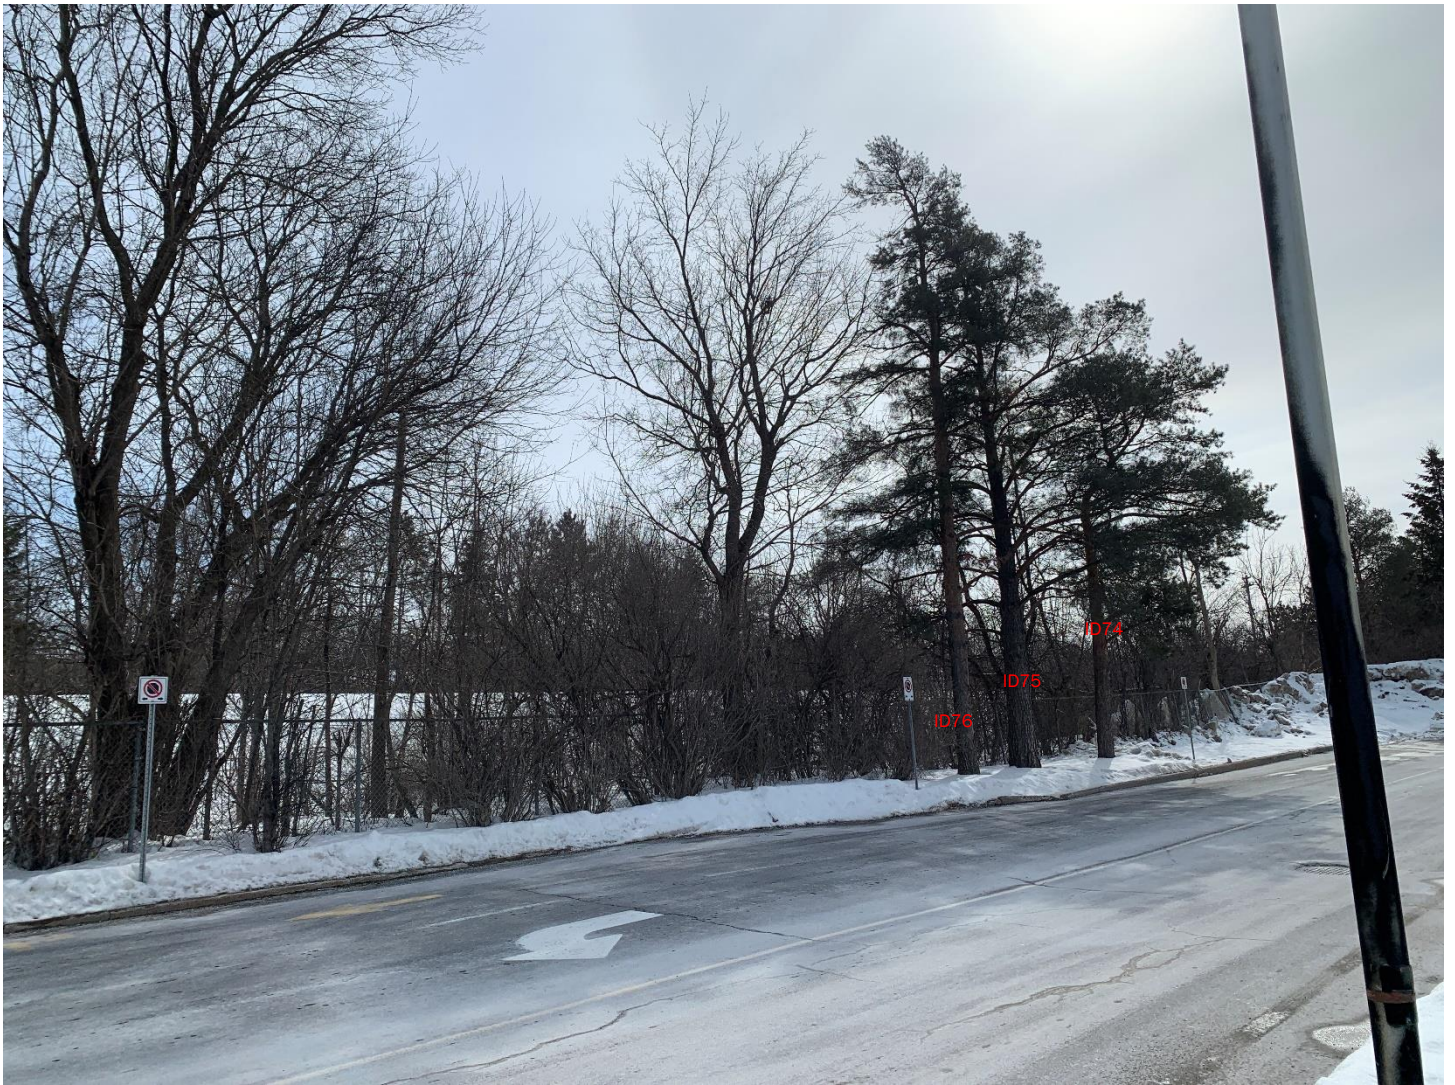
Photo 2: Extended view of trees near the existing fence line at Parking Lot C with Tree ID numbers.

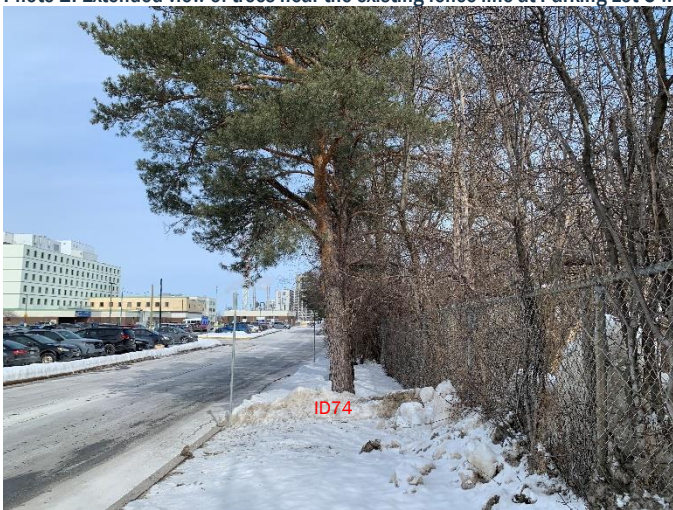
Photo 3: View of the space between the existing fence line and trees at Parking Lot C.

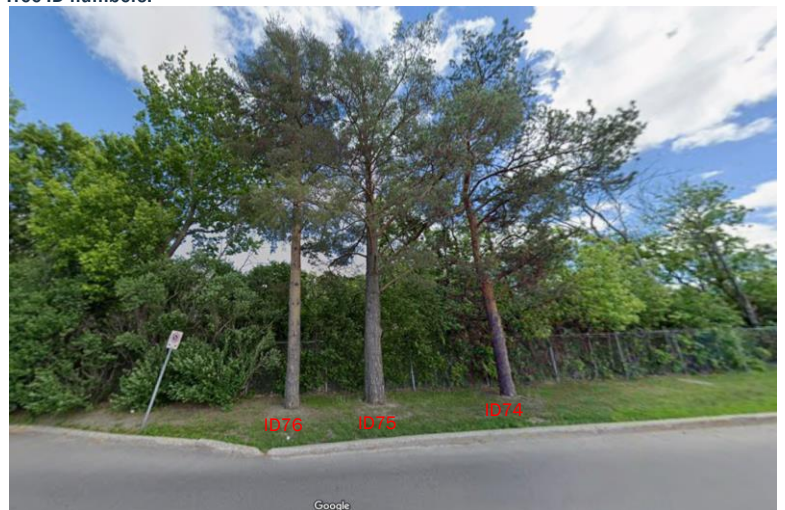
Photo 4: View of three coniferous trees in front of the fence line at Parking Lot C.

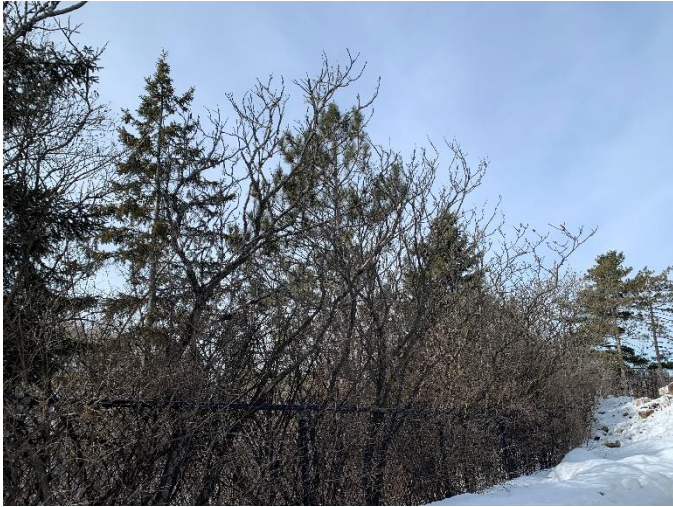
Photo 5: View existing fence line along the transitway and the mix of trees and shrubs beyond the fence line.

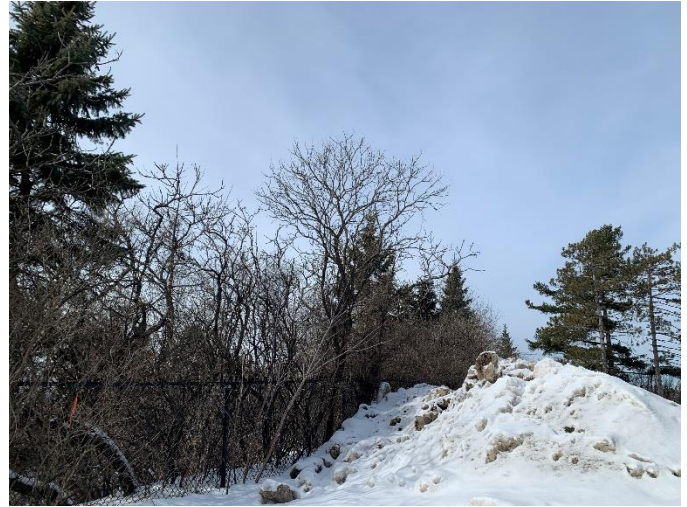
Photo 6: Extended view of existing fence line along the transitway, showing mix of trees and shrubs beyond the fence line.

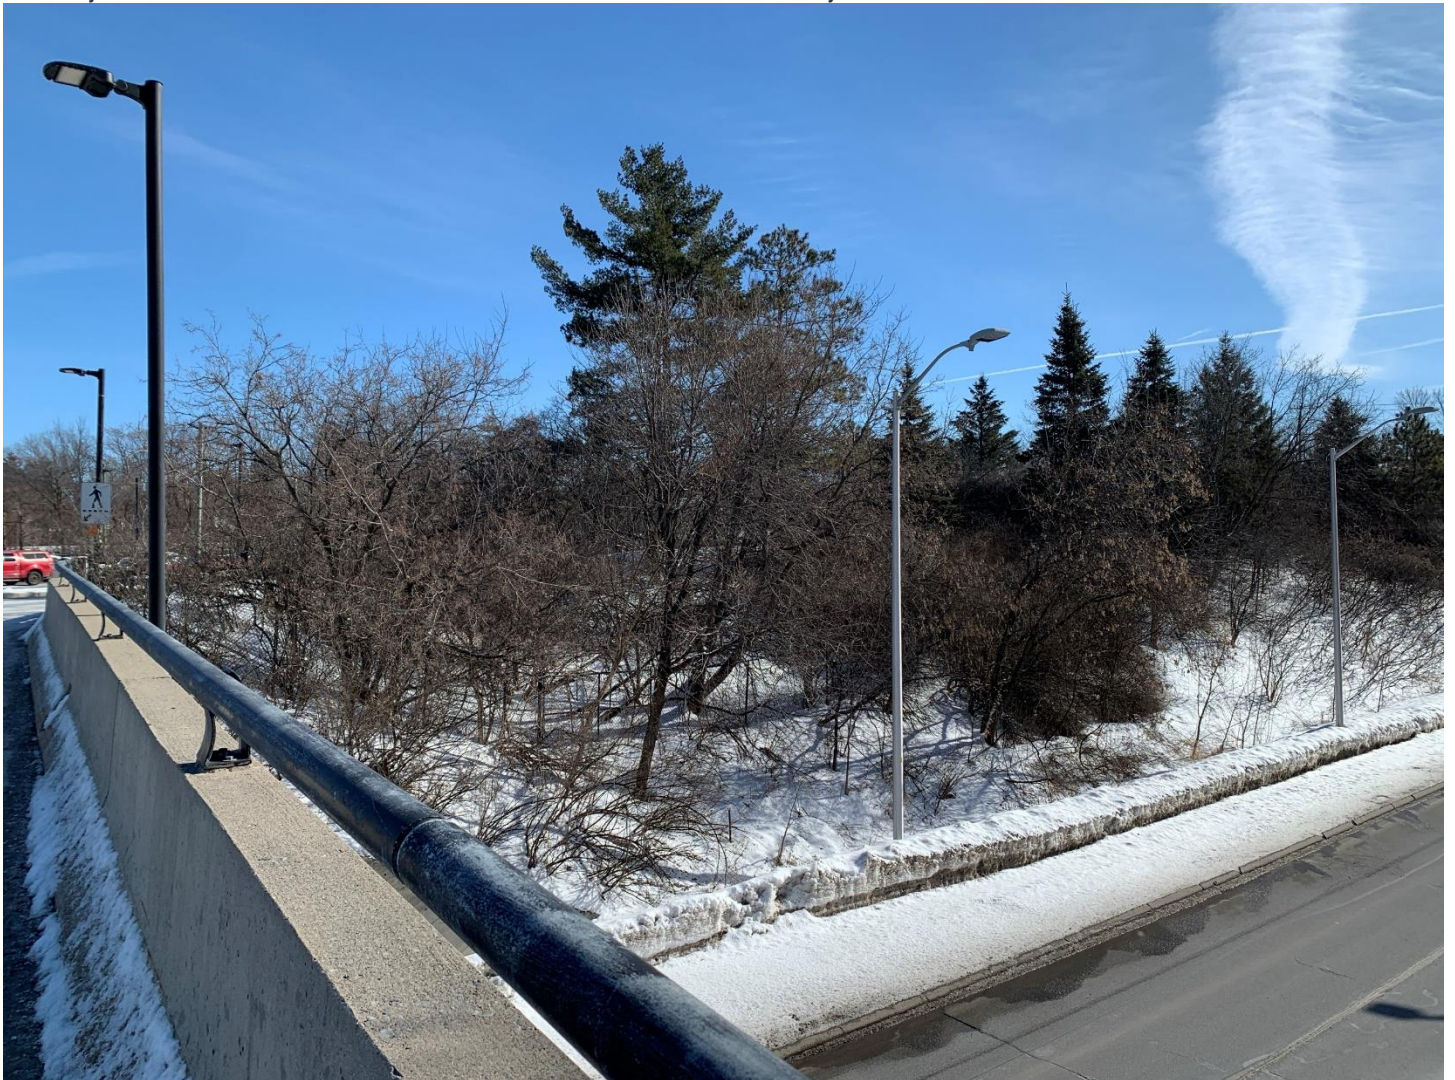
Photo 7: View of existing fence line and surrounding trees on City of Ottawa property along the transitway.

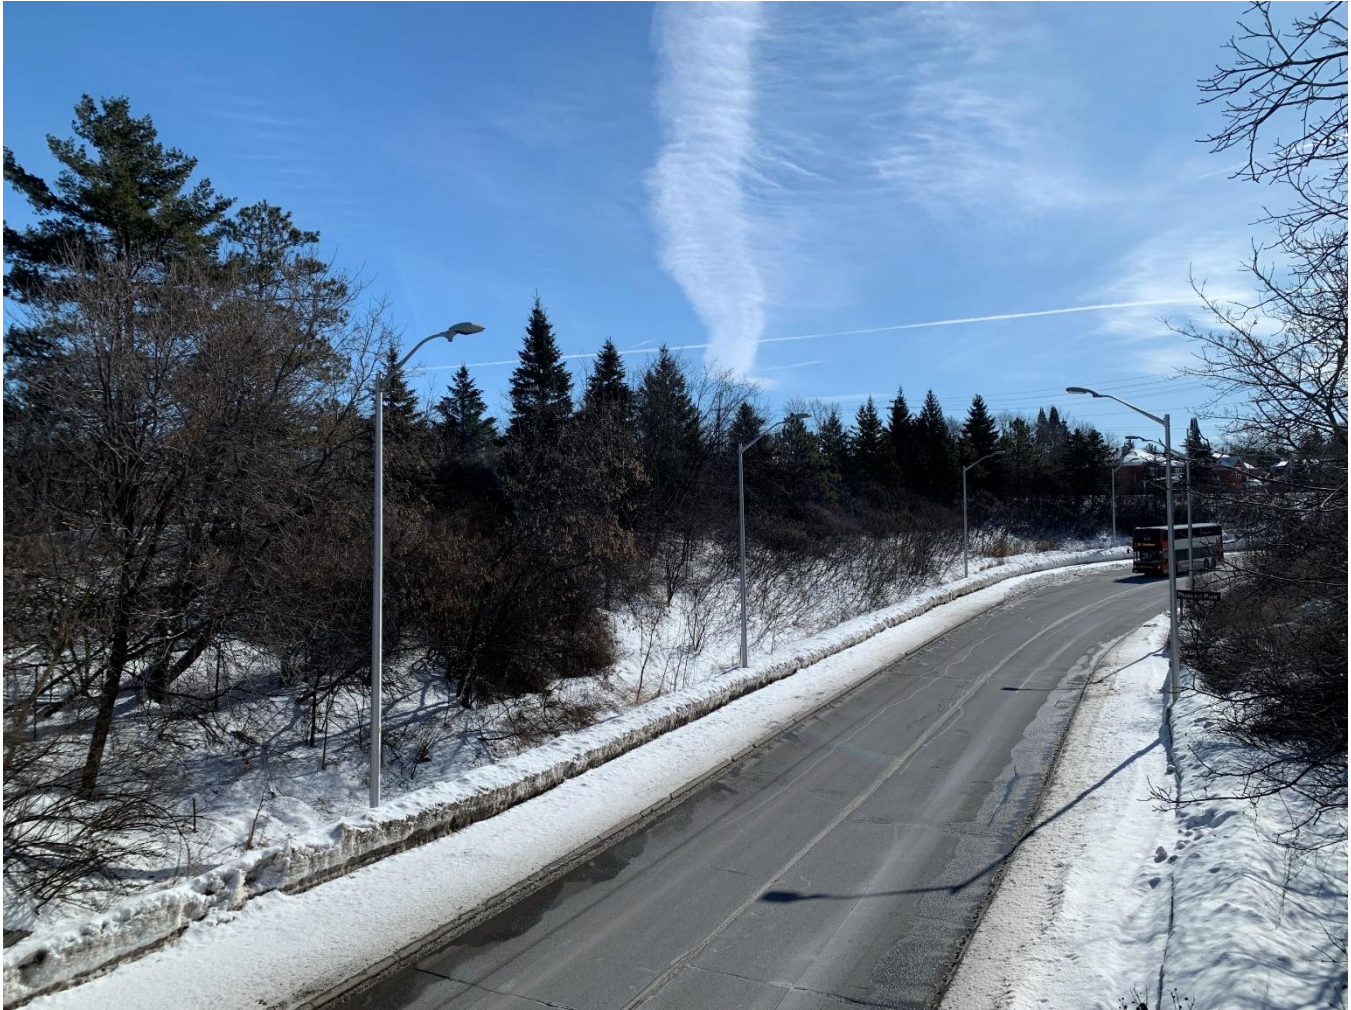
Photo 8: Extended view of vegetated areas along the transitway on City of Ottawa property.
