THOMSON WATSON CONSULTING ARBORISTS Inc

October 20, 2023 (revised March 14, 2025)

Re: Tree Conservation Report for Canadian Tire Centre at 2501 Greenbank Road, Nepean

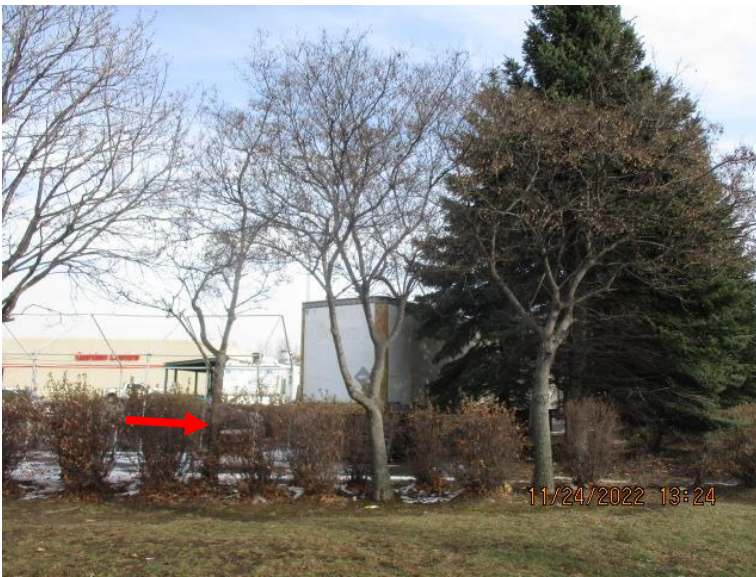
Tree 42 – Amur Maple

Trees 42, 50, 54, 62, 63, 66, 67 and 68 (8 trees). Tree 50 is dead and should not require a permit to allow its removal.

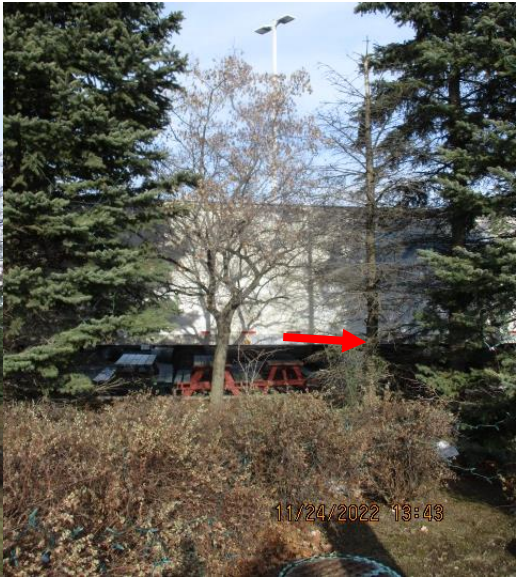
Tree 50 – dead Spruce

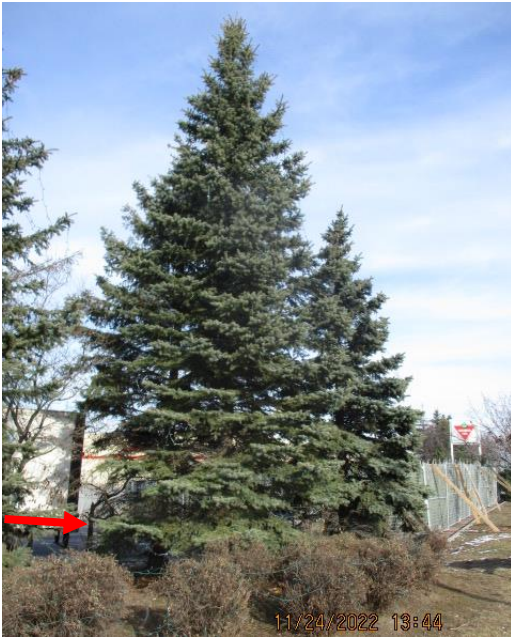
Tree 54 – Amur Maple

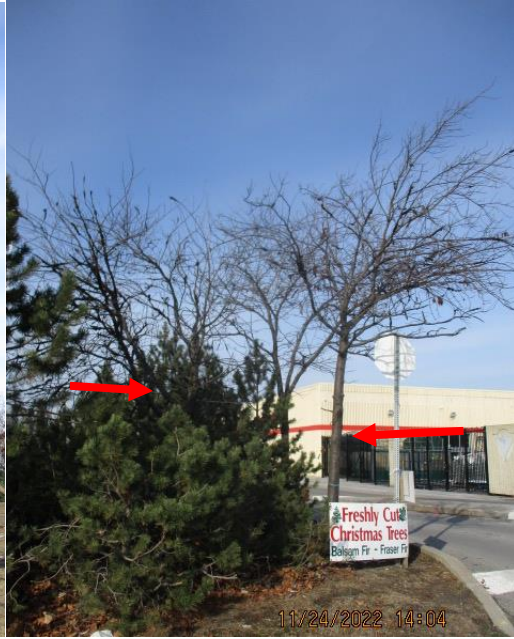
There are four Schubert Cherries (*Prunus virginiana* 'Schubert') growing on site. The trees are infected with Black Knot fungus (*Dibotryon morbosum* or *Apiosporina morbosa*) which affects branches and stems. The symptoms of the disease create a poor appearance and results in dead branches and stems. I have recommended the removal of all four trees.

Trees 62(left) and 63 (right) – Schubert Cherry

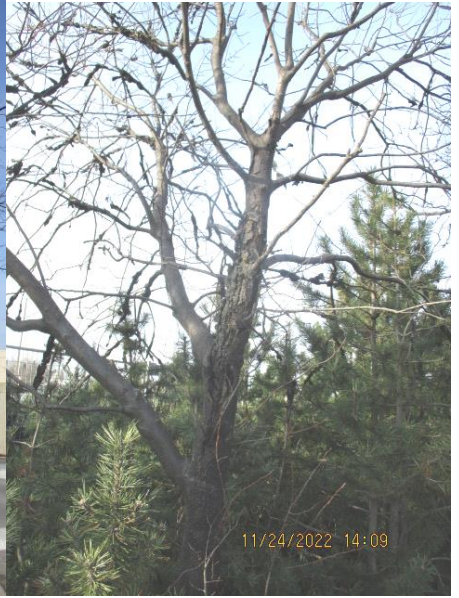
Tree 62 – Canker on trunk

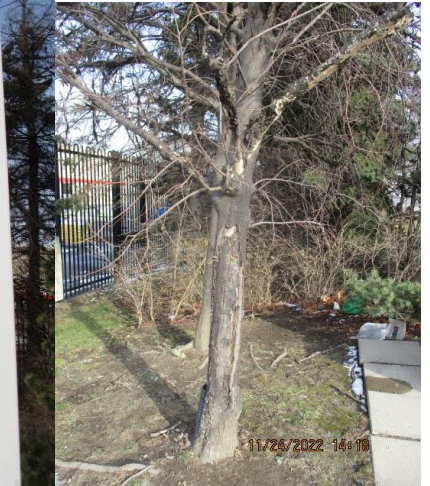
Dieback in trunk – Tree 66

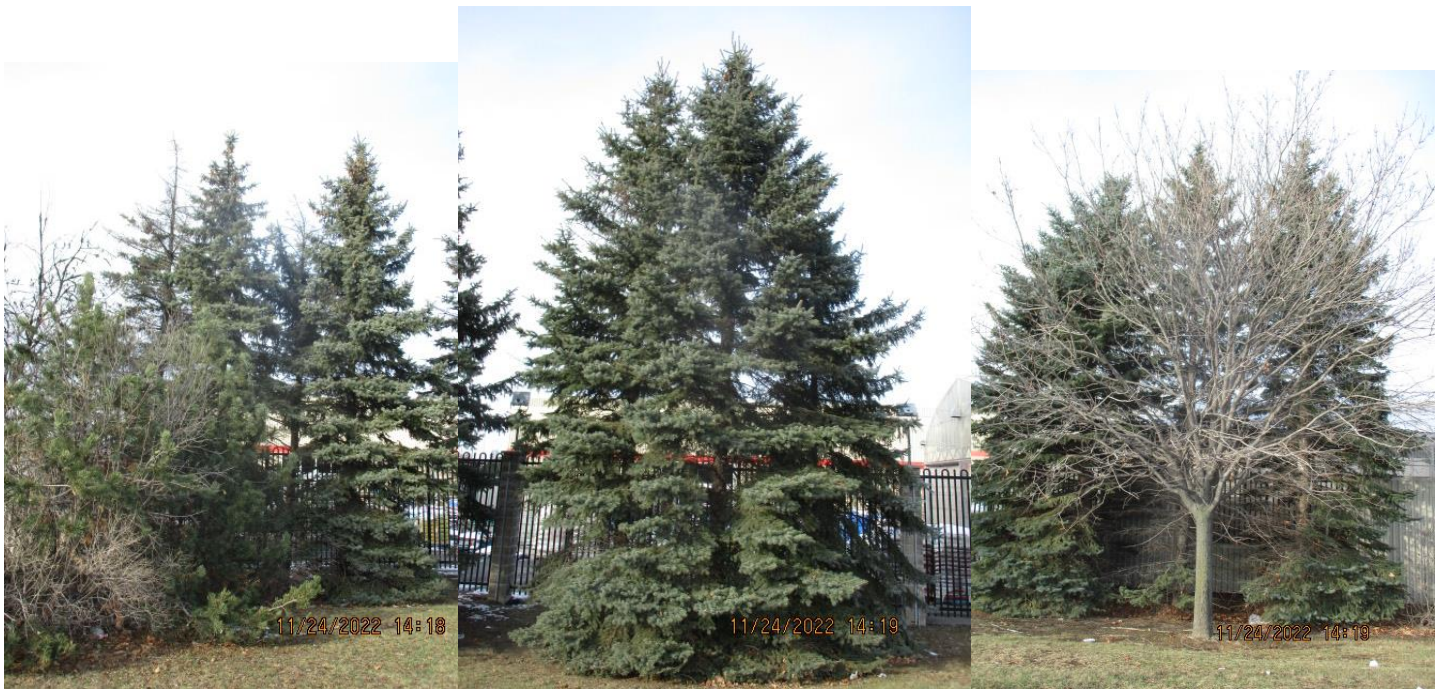
Trees 68 to 71 – Colorado Spruce

Trees 72 to 74 – Colorado Spruce

Trees 75 to 78 (Spruce) and 79 (Maple)

Trees 70, 72, 74, 76, 77, 78, 82, 83, 84, 85, 86, 87, 88, 89 and 90 (15 trees).

Swale installation injuries - Trees 69, 71, 73, 79, 80 and 81 (6 trees)

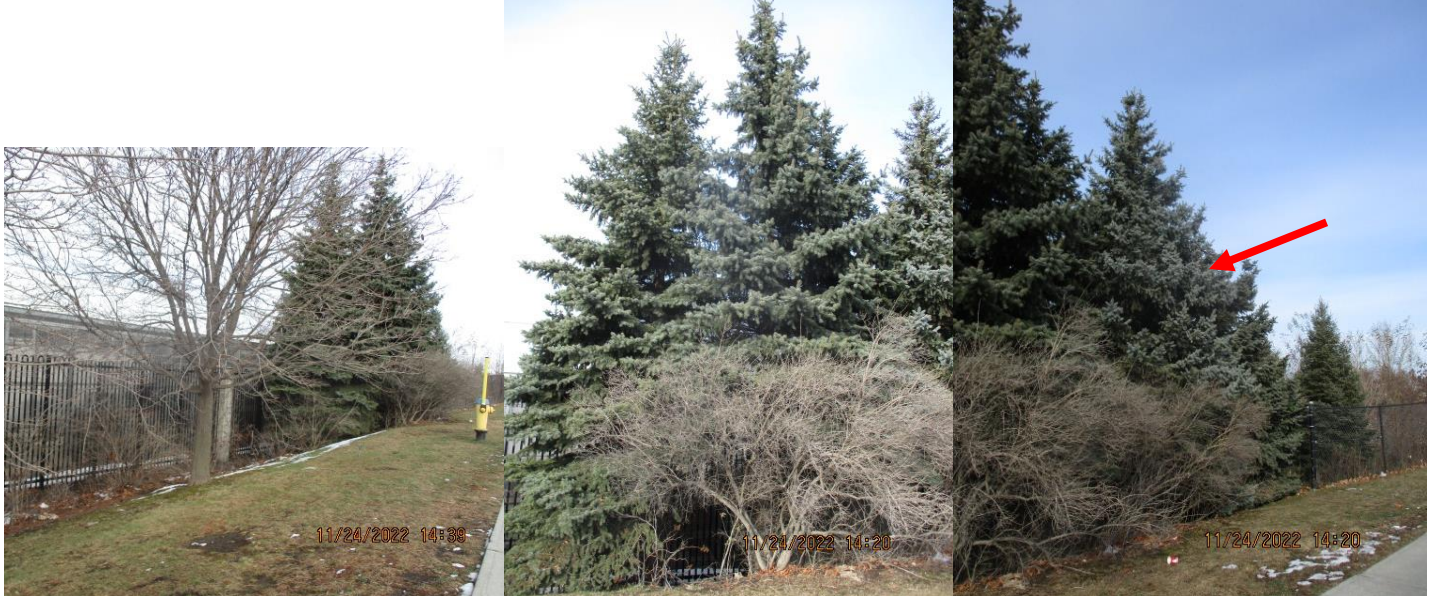
Tree 80 with grade increase in NE corner

Trees 82 to 85 – Colorado Spruce

Tree 86 – Colorado Spruce

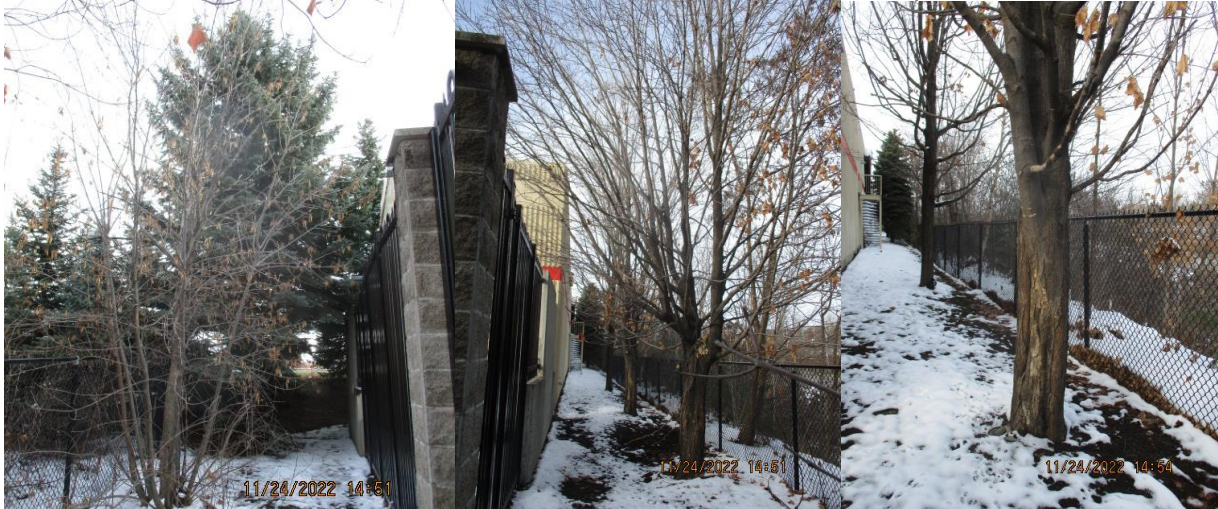
Tree 88 is a Green Ash which has been affected by Emerald Ash Borer, leaving stems with a maximum diameter of 7 cm. A permit should not be required for this tree.

Tree 88 – Green Ash with 87 to south

Trees 89, 90 and 91 – Sugar Maple

Tree 90 – trunk wound
