TREE CONSERVATION REPORT

18 Louisa Street, Ottawa, Ontario

Ironwood Fund Limited Partnership Ottawa, Ontario

May 26, 2021 revised November 10, 2021 revised August 09, 2024 revised March 24, 2025

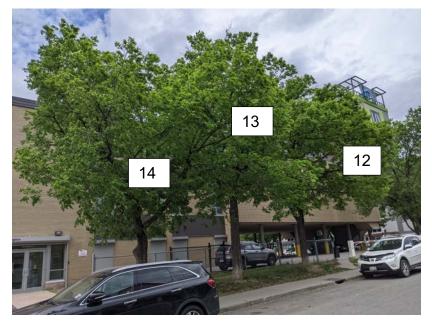
Figure 2 Picture of Ash trees on May 26, 2021.

Trees #12, 13, 14 will be impacted by the proposed development (transformer location and access drive). These are Ash trees and do not appear to have received inoculation against Emerald Ash Borer. As the initial inventory was conducted in the winter, overall canopy condition was impossible to determine. However, as Figure 1 shows, all the Ash trees appear to be in overall good condition as of May 26th, 2021. The roots on all three trees are slightly girdled, but canopies appear to be full and lush.

Update March 25, 2024, All trees are showing signs of the Emerald Ash Borer.

All removals to be done and will require a permit, in accordance with the City of Ottawa tree bylaw 2020-340 and this Tree Conservation Report.

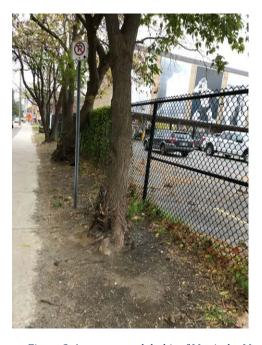
Figure 2-4: poor growth habit of Manitoba Maple and Ash along Bell Street, canopy pruned for overhead hydro

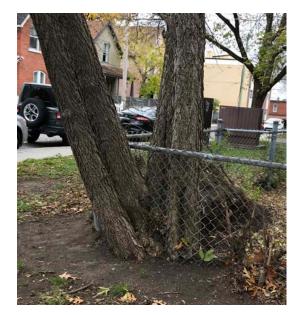
Figure 2-4: poor growth habit of Manitoba Maple and Ash along Bell Street, canopy pruned for overhead hydro
