TREE CONSERVATION REPORT V4.0

6600 Rue Carrière

Tree Conservation Report prepared as Partial
Requirements for a Site Plan Control
Application, May 2, 2025

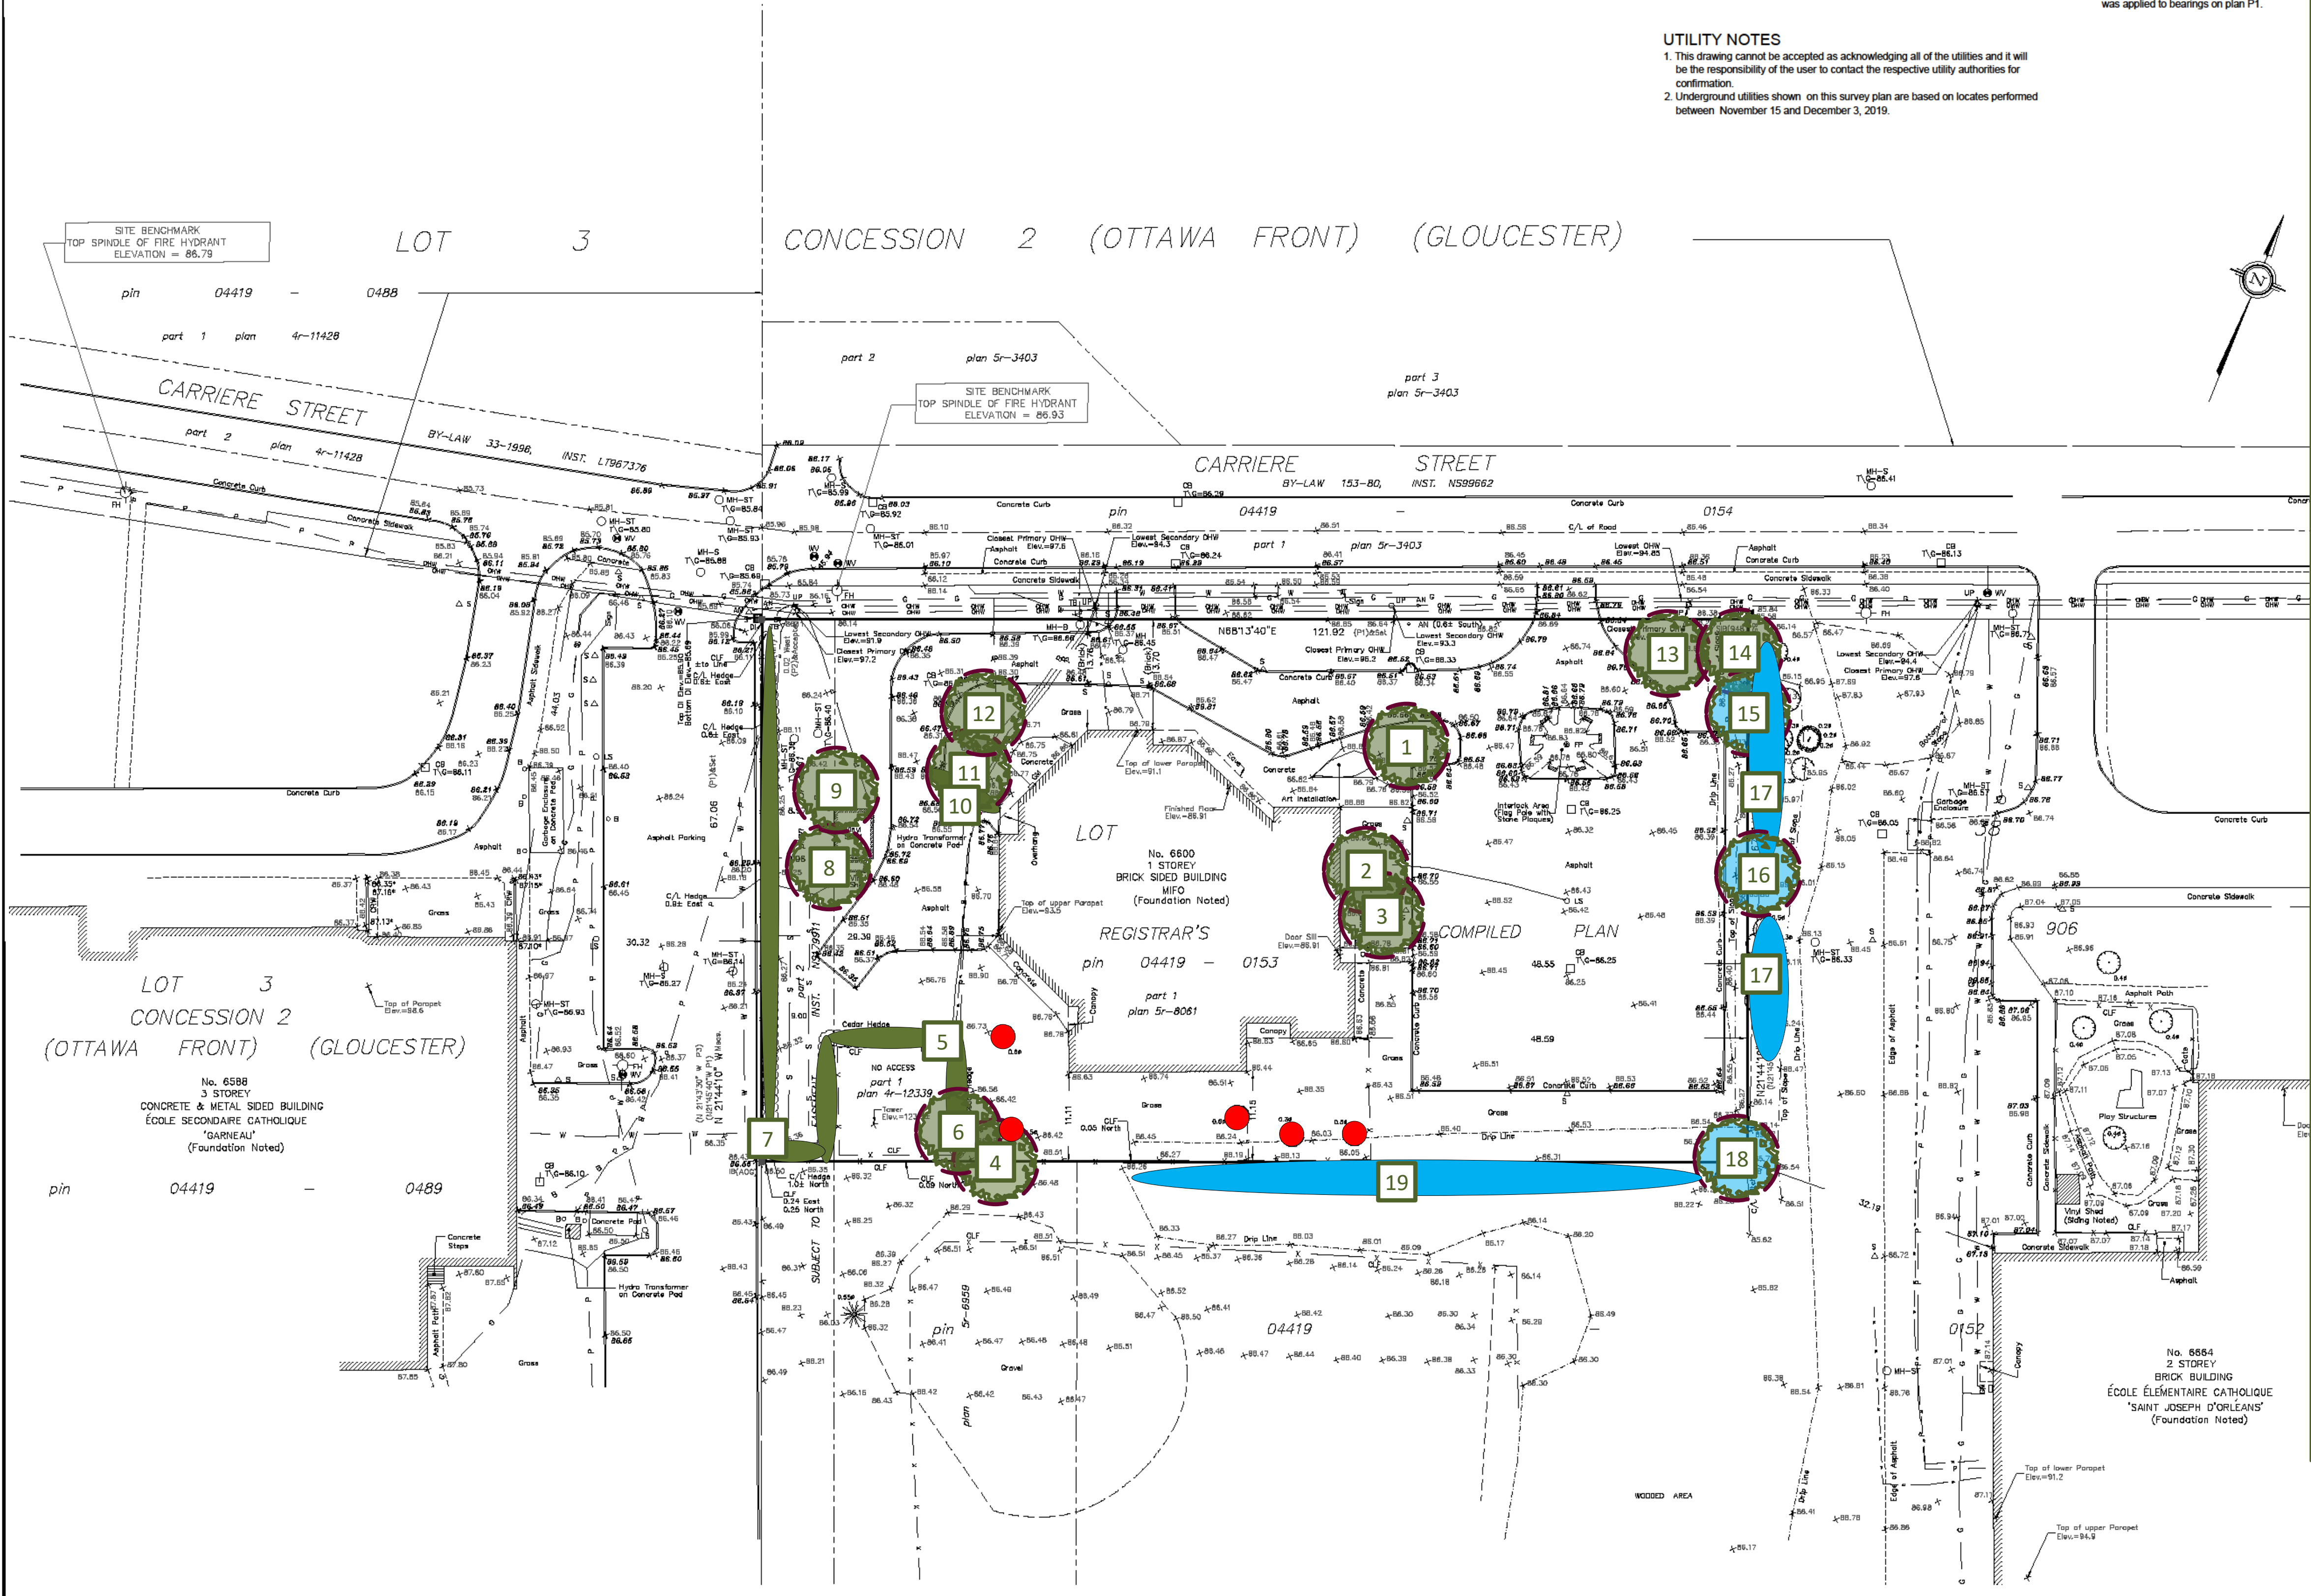
Tree Conservation Report – 6600 Rue Carriere
Current Vegetation
Tree layer prepared by Dendron Forestry Services
Version 1.0, July 28, 2022
For more information, please contact info@dendronforestry.ca

Tree ¹	Species	Diameter at breast height (dbh)
1	Colorado spruce (<i>Picea pungens</i>)	67 cm
2	White pine (<i>Picea glauca</i>)	42, 42 cm
3	Honey locust (<i>Gleditsia triacanthos</i>)	38 cm
4	Manitoba maple (<i>Acer negundo</i>)	10 cm sprouts
5	Cedar hedge (<i>Thuja occidentalis</i>)	5-15 cm
6	Austrian pine (<i>Pinus nigra</i>)	39 cm
7	Cedar hedge (<i>Thuja occidentalis</i>)	5-10 cm
8	Cedar (<i>Thuja occidentalis</i>)	51 cm (measured at 0.5 m)
9	Cedar (<i>Thuja occidentalis</i>)	21, 45, 22 cm
10	Cedar hedge (<i>Thuja occidentalis</i>)	5-15 cm
11	Norway maple (<i>Acer platanoides</i>)	46 cm
12	Red maple (<i>Acer rubrum</i>)	52 cm
13	Crabapple (<i>Malus spp</i>)	7 cm
14	Trembling aspen (<i>Populus tremuloides</i>)	21 cm
15	Eastern Cottonwood (<i>Populus deltoides</i>)	65 cm
16	Eastern Cottonwood (<i>Populus deltoides</i>)	97 cm
17 ⁴	Poplars (<i>Populus spp.</i>)	20-40 cm (20-25 trees in total)
18 ⁴	Eastern Cottonwood (<i>Populus deltoides</i>)	52, 44 cm

19 ⁴	Row of eastern Cottonwood (<i>Populus deltoides</i>) in front and red maples (<i>Acer rubrum</i>) in the back	27-52 cm

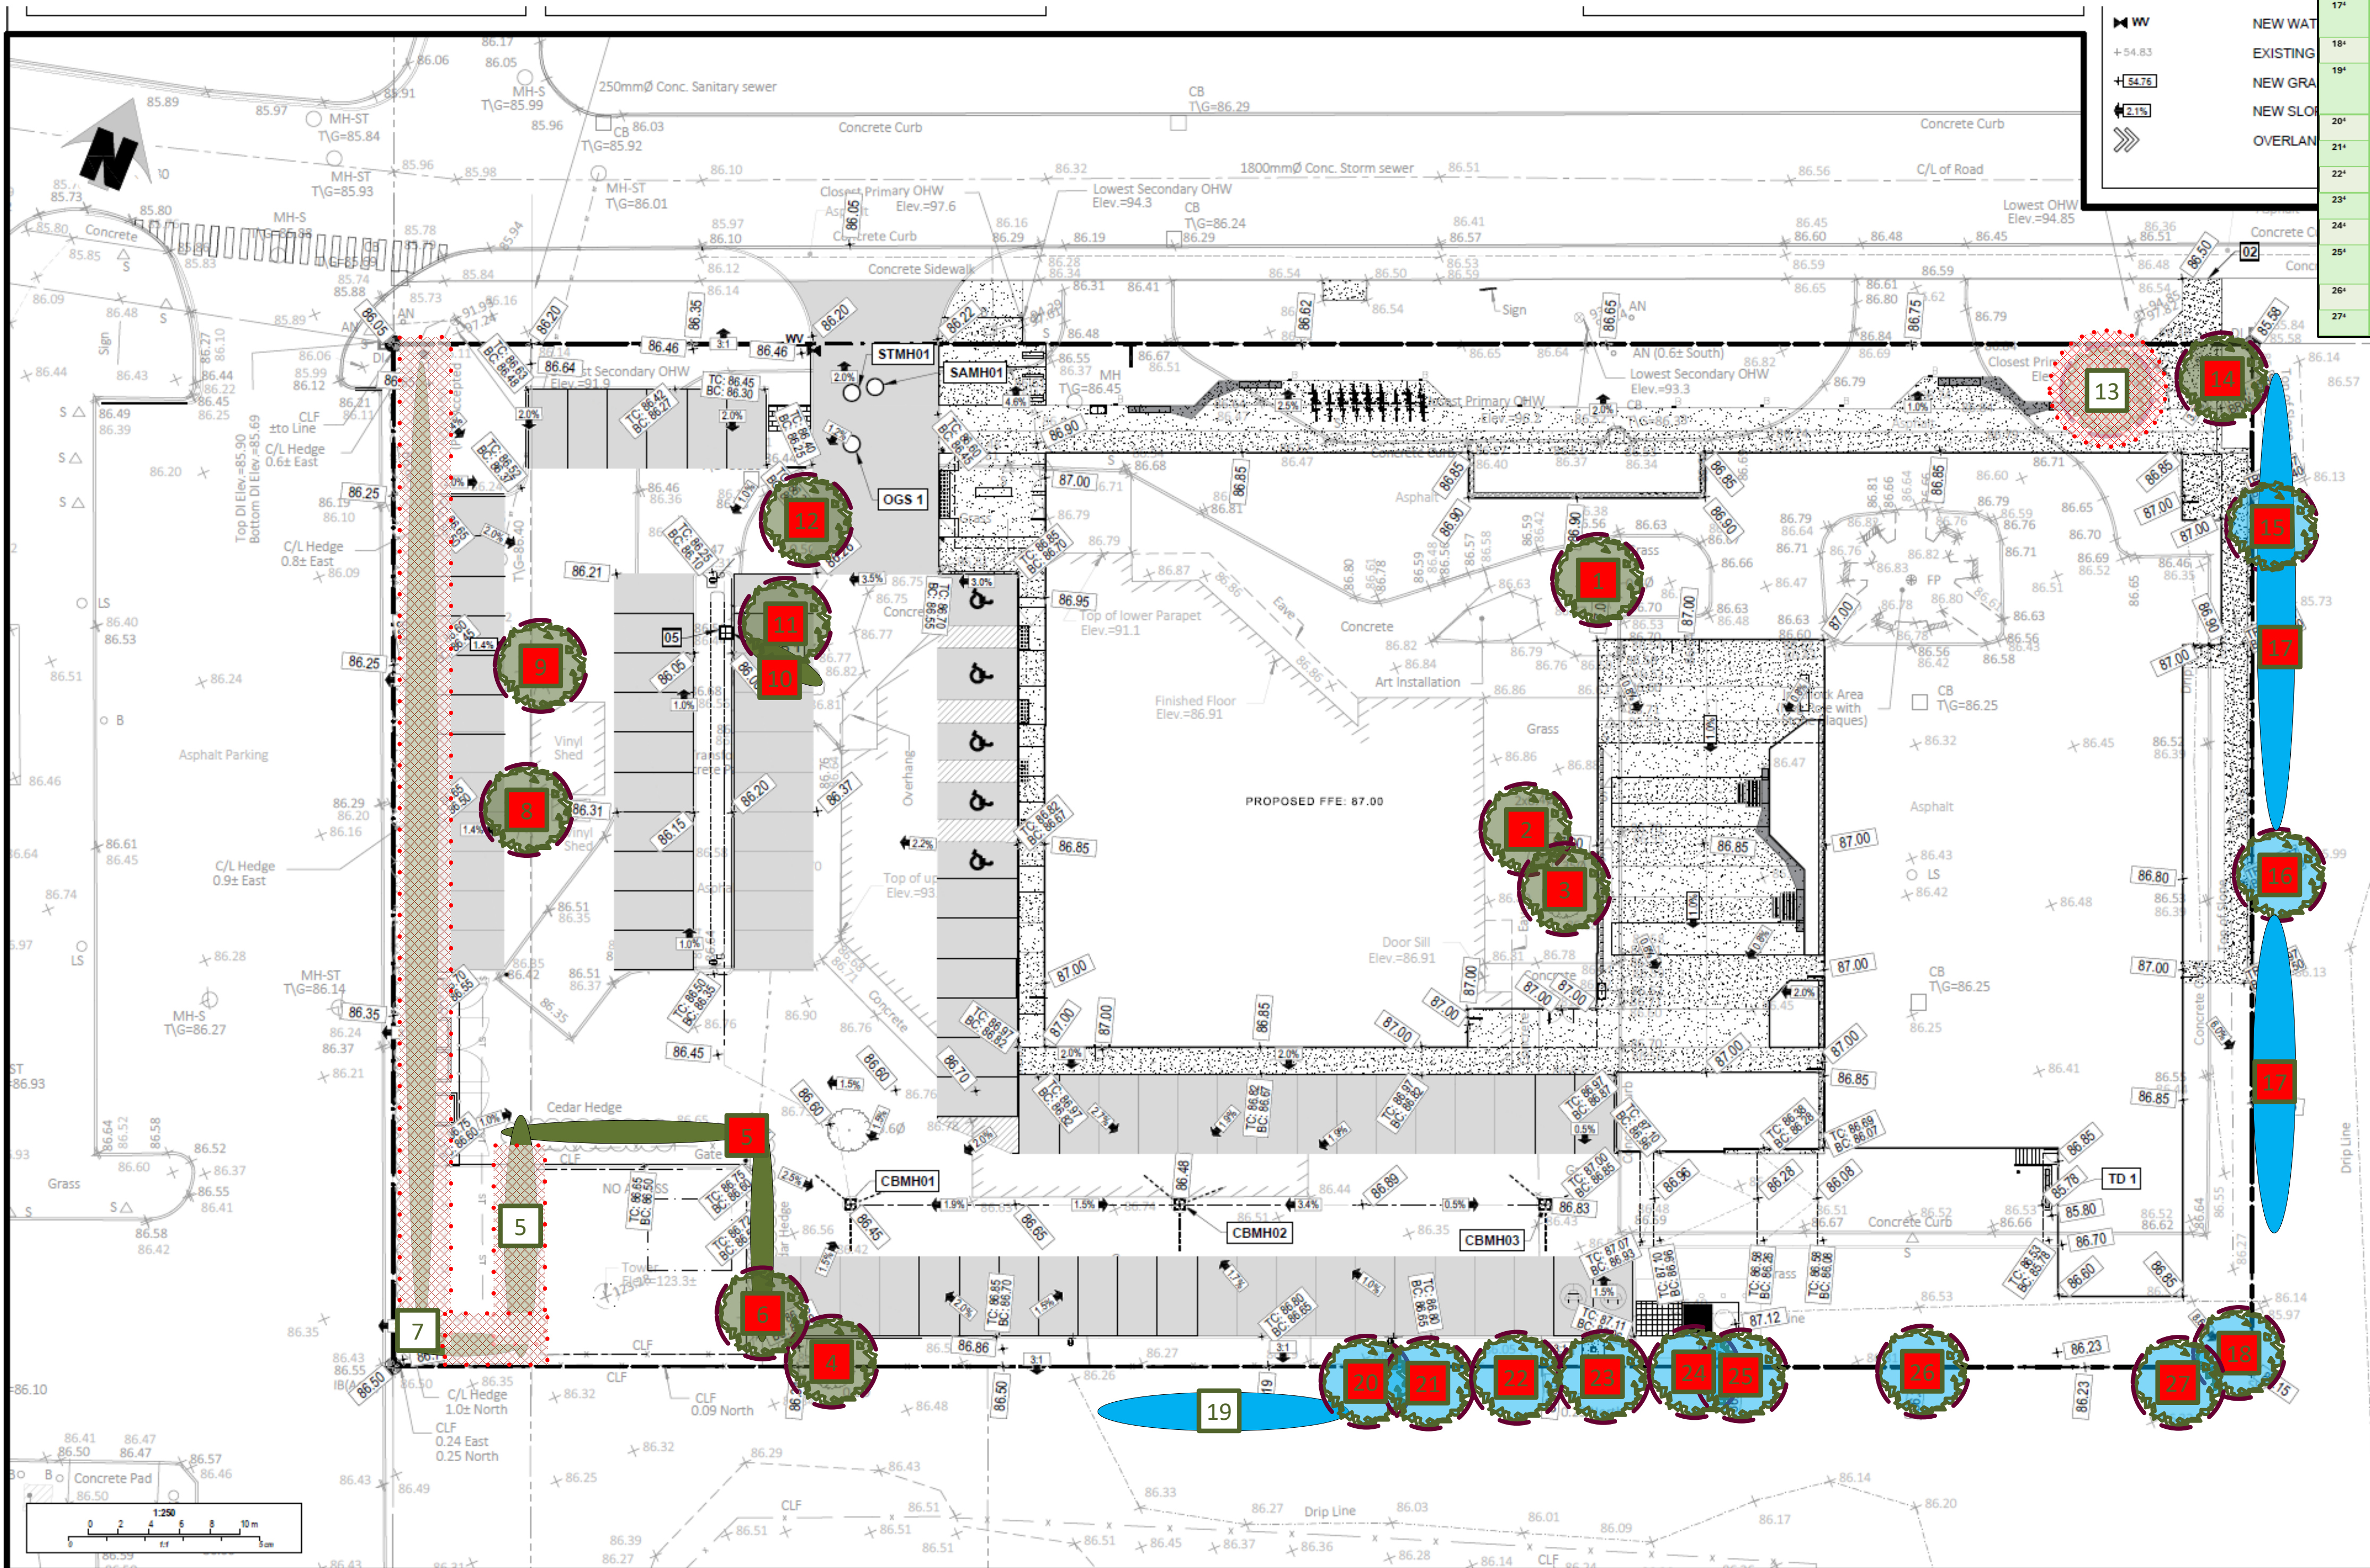
Tree Conservation Report – 6600 Rue Carriere
Proposed Development and Conserved Vegetation
Tree layer prepared by Dendron Forestry Services
Version 4.0, May 2, 2025
For more information, please contact info@dendronforestry.ca

Tree #	Species	Diameter at breast height (cm)	Ownership	Condition	Action and Recommendations
1	Colorado spruce (<i>Picea pungens</i>)	67 cm	Private	Fair; some dieback throughout crown	To be removed; in footprint of proposed building; Tree permit required
2	White pine (<i>Picea glauca</i>)	42, 42 cm	Private	Good; included bark at junction	To be removed; in footprint of proposed building; Tree permit required
3	Honey locust (<i>Gleditsia tricanthos</i>)	38 cm	Private	Good; fair, 10% crown dieback	To be removed; in footprint of proposed building; Tree permit required
4	Manitoba maple (<i>Acer negundo</i>)	10 cm sprouts	Private	Poor; old stump with sprouts	To be removed due to health; Tree permit required
5	Cedar hedge (<i>Thuja occidentalis</i>)	5-15 cm	Private	Good; fair	Partial removal as shown on map, remaining section to be protected with fencing as per City of Ottawa Tree Protection Specifications (March 2021)

6	Austrian pine (<i>Pinus nigra</i>)	39 cm	Private	Fair; boring insect holes, heavy gypoxane presence	Remove based on health and conflict with infrastructure
7	Cedar hedge (<i>Thuja occidentalis</i>)	5-10 cm	Private	Good; fair	Retain and protect with fencing as per City of Ottawa Tree Protection Specifications (March 2021)
8	Cedar (<i>Thuja occidentalis</i>)	51 cm (measured at 0.5 m)	Private	Fair; multiple stems, 5% lean	Remove; in footprint of proposed parking area; Tree permit required
9	Cedar (<i>Thuja occidentalis</i>)	21, 45, 22 cm	Private	Good; fair	Remove; in footprint of proposed parking area; Tree permit required
10	Cedar hedge (<i>Thuja occidentalis</i>)	5-15 cm	Private	Poor; unmaintained and shaded by adjacent tree	Remove; in footprint of proposed parking area; Tree permit required
11	Norway maple (<i>Acer platanoides</i>)	46 cm	Private	Good	Remove; in footprint of proposed parking area; Tree permit required

12	Red maple (<i>Acer rubrum</i>)	52 cm	Private	Good; fair; exposed roots, some root grinding beginning	Remove; in footprint of proposed parking area; Tree permit required
13	Crabapple (<i>Malus spp</i>)	7 cm	Private	Fair; recent loss of secondary stem and branch, split at old branch attachment wound	Retain and protect with fencing as per City of Ottawa Tree Protection Specifications (March 2021); may be relocated but no permit required as under 10 cm
14	Trembling aspen (<i>Populus tremuloides</i>)	21 cm	Private	Good	Remove due to proximity of new building and sensitive marine clay soils (see report for more details)
15	Eastern Cottonwood (<i>Populus deltoides</i>)	65 cm	Adjacent school property	Fair/good	Remove due to proximity of new building and sensitive marine clay soils (see report for more details)
16	Eastern Cottonwood (<i>Populus deltoides</i>)	97 cm	Adjacent school property	Fair/good	Remove due to proximity of new building and sensitive marine clay soils (see report for more details)

17	Poplars (<i>Populus spp.</i>)	20-40 cm (20-25 trees in total)	Adjacent school property	Fair - good	Remove due to proximity of new building and sensitive marine clay soils (see report for more details)
18	Eastern Cottonwood (<i>Populus deltoides</i>)	52, 44 cm	Adjacent school property	Fair - good	Remove due to proximity of new building and sensitive marine clay soils (see report for more details)
19	Row of red maples (<i>Acer rubrum</i>)	10-30 cm	Adjacent school property	Fair - good	Retain; no action needed as far enough from proposed construction
20	Large tooth aspen (<i>Populus grandidentata</i>)	54 cm	Adjacent school property	Good	Remove based on proximity (less than 2 m) to new parking lot which will damage roots increasing risk of failure
21	Large tooth aspen (<i>Populus grandidentata</i>)	46 cm	Adjacent school property	Good	Remove based on proximity (less than 2 m) to new parking lot which will damage roots increasing risk of failure

22	Large tooth aspen (<i>Populus grandidentata</i>)	40 cm	Adjacent school property	Good	Remove based on proximity (less than 2 m) to new parking lot which will damage roots increasing risk of failure
23	Large tooth aspen (<i>Populus grandidentata</i>)	51 cm	Adjacent school property	Good	Remove based on proximity (less than 2 m) to new parking lot which will damage roots increasing risk of failure
24	Large tooth aspen (<i>Populus grandidentata</i>)	42 cm	Jointly owned with school	Good	Remove due to proximity to new building and conflict with the new transfer to be installed within 2 m of the tree
25	Large tooth aspen (<i>Populus grandidentata</i>)	46 cm	Jointly owned with school	Good; fair; large branch hanging over subject property	Remove due to proximity to new building and conflict with the new transfer to be installed within 2 m of the tree
26	Large tooth aspen (<i>Populus grandidentata</i>)	50 cm	Jointly owned with school	Remove	Remove due to proximity of the tree to the new building (approx 9.5 m)

27	Red maple (<i>Acer rubrum</i>)	26.25, 15.23 cm	Adjacent school property	Good	Remove due to proximity of new building and sensitive marine clay soils (see report for more details)

Prior to any site works, protective fencing should be installed around the trees as indicated in Map and maintained until all construction on site has been completed as per the **City of Ottawa Tree Protection Specifications (March 2021)**. Within the fenced area, the following tree protection guidelines should be applied:
