TREE CONSERVATION REPORT

Project No.: CCO-21-4432

630 MONTREAL ROAD, OTTAWA, ONTARIO

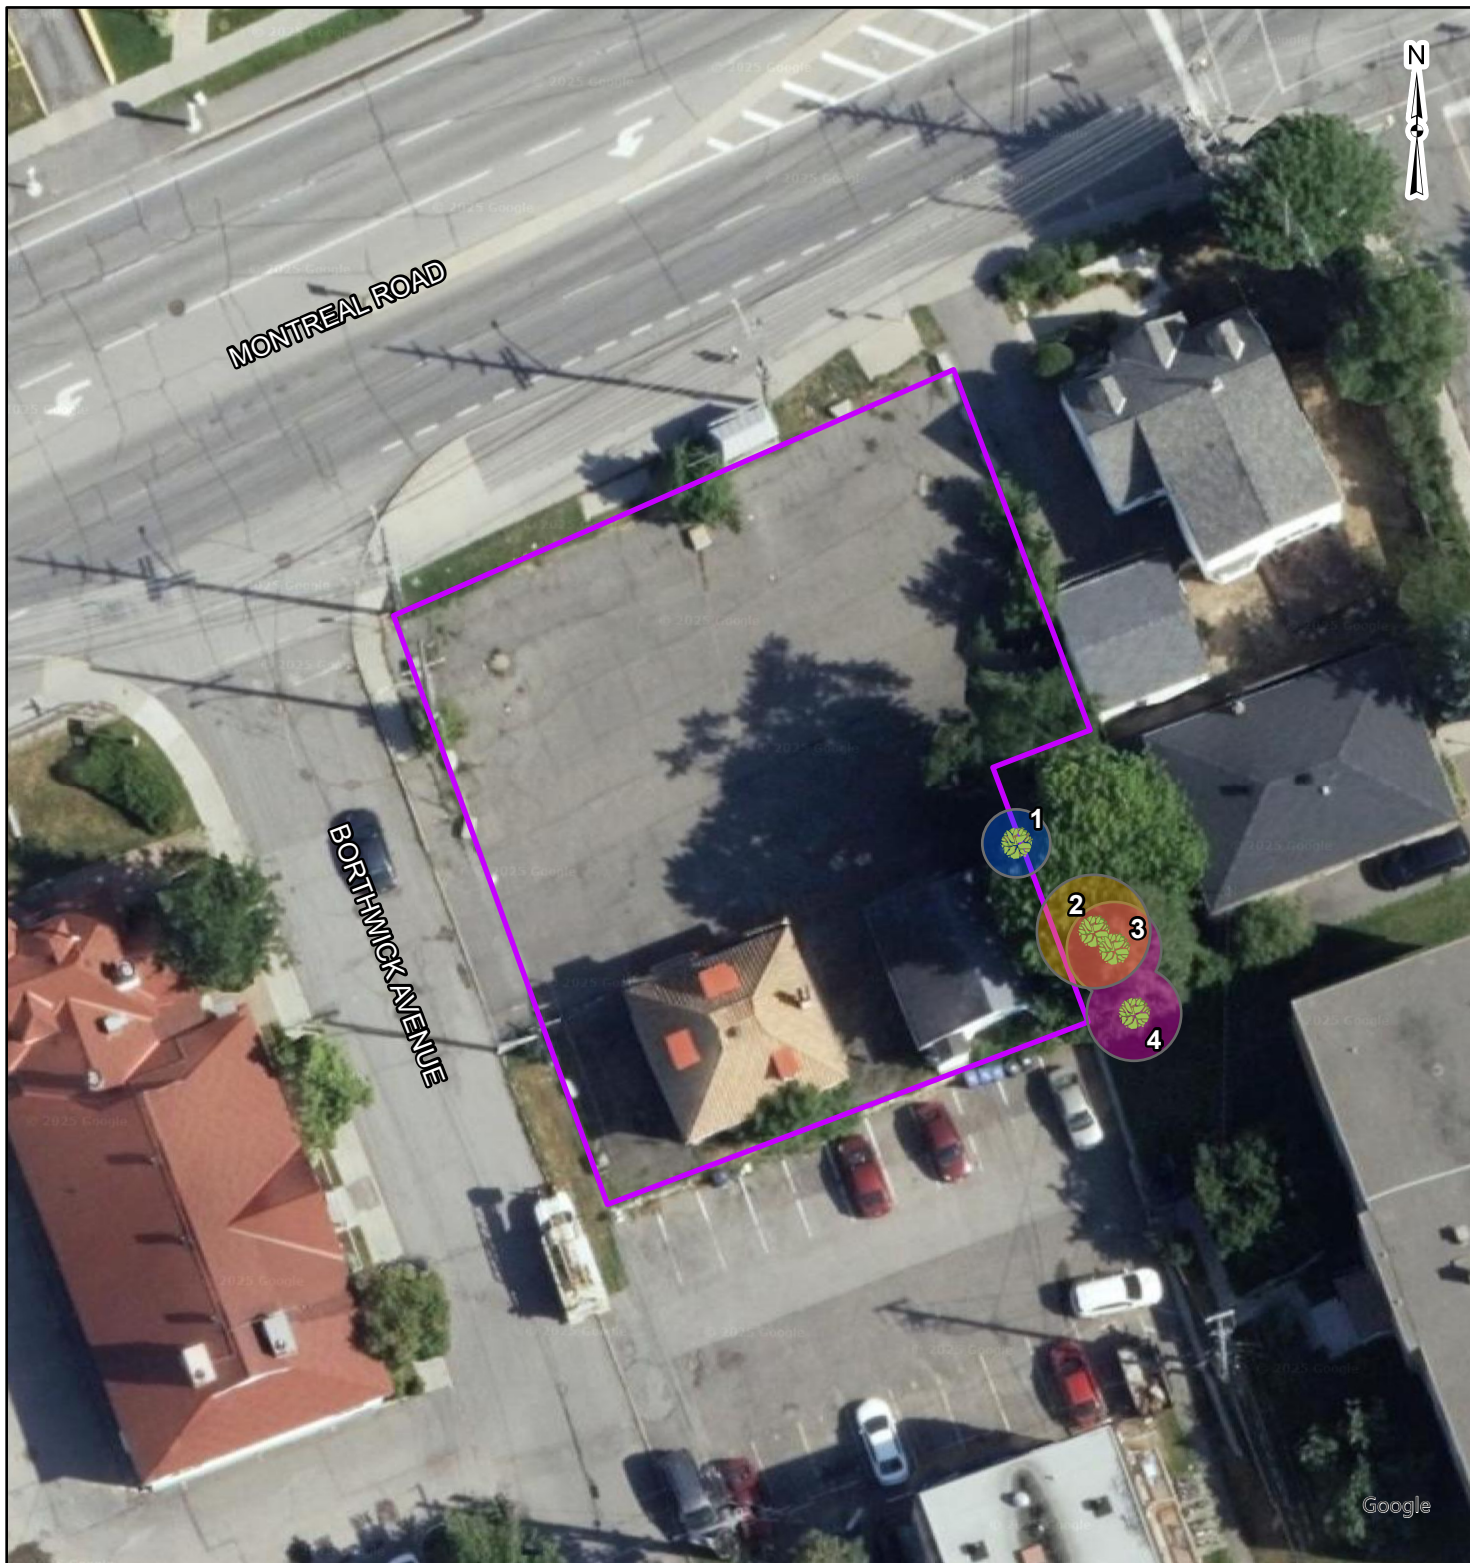
CLIENT:	MB GROUP CANADA		
PROJECT:	TREE CONSERVATION REPORT 630 MONTREAL ROAD, OTTAWA, ON		
TITLE:	CURRENT VEGETATION		
 750 Palladium Dr, Suite 310, Kanata, ON K2V 1C7 Tel: 613-836-2184 Fax: 613-836-3742	PROJECT NO:	CCO-21-4432	FIGURE:
	Date	Mar., 27, 2025	1
	GIS	EU	
	Checked By	KB

The tree inventory conducted for the subject property resulted in findings that there are no trees located within the property boundary; however, four (4) trees were identified and documented off-site that may be impacted by the proposed development (**Figure 1**).

The health status of the inventoried trees varied slightly, with Fair (2), Good (1), and Poor (1) ratings accounting for the inventoried trees. No dead trees were observed within the study area during the inventory and assessment. The study area is highly developed in nature, with few trees or natural vegetation found throughout the area.

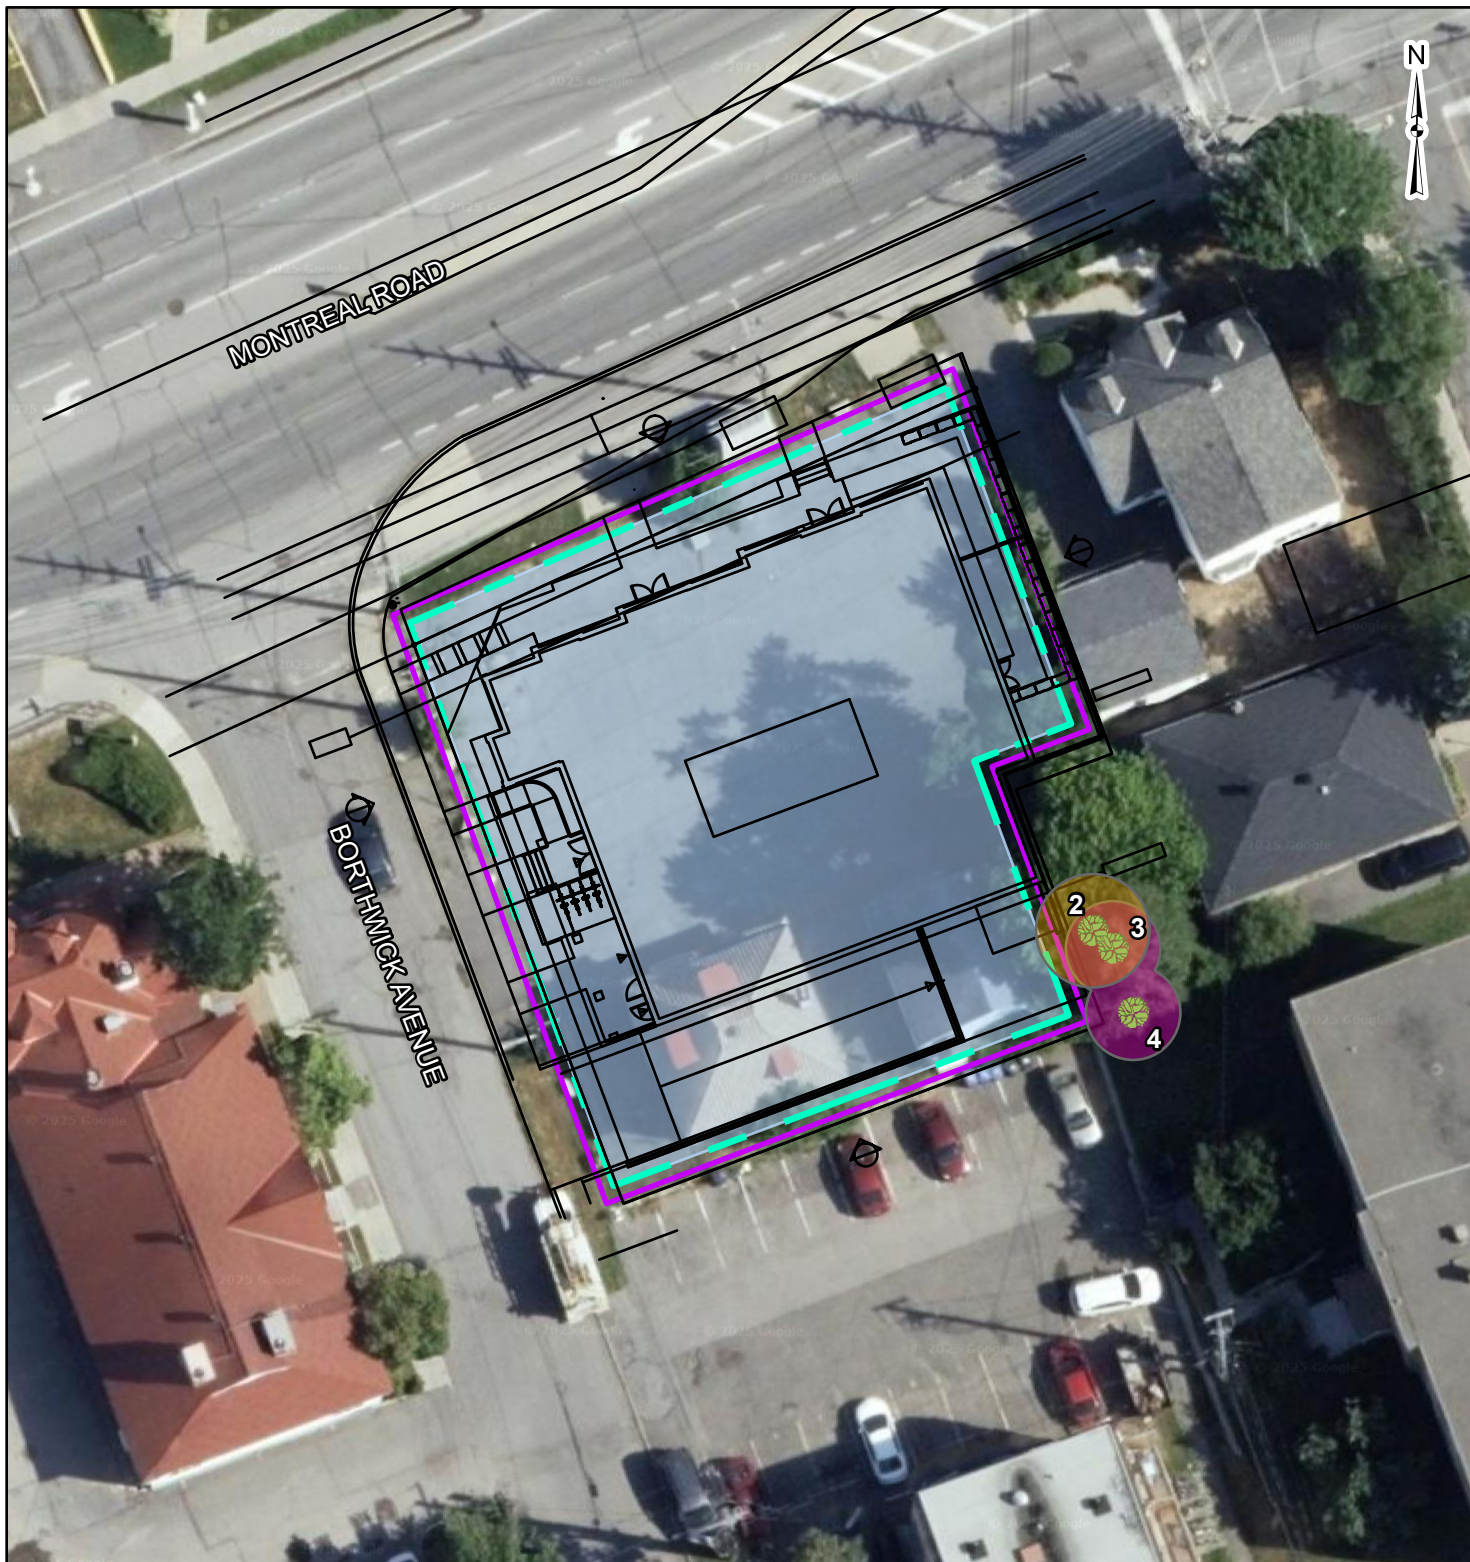
CLIENT: MB GROUP CANADA	
PROJECT: TREE CONSERVATION REPORT 630 MONTREAL ROAD, OTTAWA, ON	
TITLE: PROPOSED DEVELOPMENT AND CONSERVED VEGETATION

The proposed development will align closely to the original footprint of the subject property, resulting in a low impact to trees within the study area. There are no trees within the subject property; however, a single Siberian Elm, located off-site, directly adjacent to the subject property will be required to be removed ([Refer to Figure 2](#)). Siberian Elm is a non-native, invasive species. As this individual has grown, a portion of the tree has become intertwined with the boundary fence and the tree is in poor condition (see **APPENDIX A**).

Care should be taken when removing the asphalt and existing fence and buildings on-site to avoid impacting these individual's critical root zones. Pavement overlapping with the CRZ of tree 2 will be done without the use of machinery.

To ensure protection of the root system of trees to be retained, temporary tree protection fencing should be erected at the critical root zone of trees located inside or adjacent to the construction area. Temporary fencing is proposed surrounding the perimeter of the subject property **Figure 2** and will sufficiently protect the retained trees that are adjacent to the subject property.

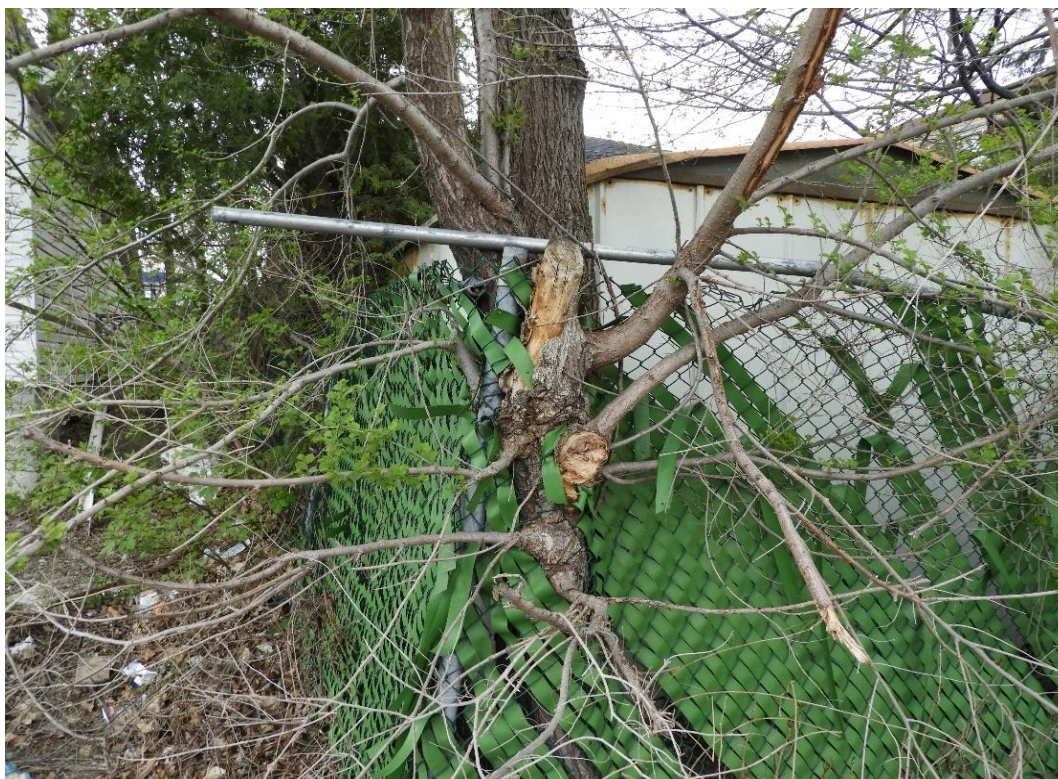
Photo 4: View of the Siberian Elm Proposed for Removal. (May 7, 2021)

A single Siberian Elm (tree No. 1) is proposed for removal and is <30cm DBH; as such no compensation plantings or cash-in-lieu is proposed or required as per the City of Ottawa's Tree By-law (2020-340).

This individual tree is located off-site, directly adjacent to the subject property. In accordance with the City of Ottawa's Tree By-law (2020-340) written permission will be required from the landowner prior to approval for removal.
