TREE CONSERVATION REPORT

18 Louisa Street, Ottawa, Ontario

May 26, 2021 revised November 10, 2021 revised August 09, 2024 revised March 24, 2025

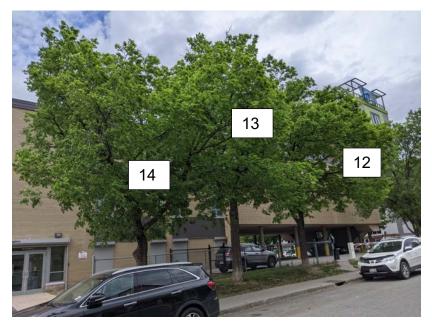
Trees #12, 13, 14 will be impacted by the proposed development (transformer location and access drive). These are Ash trees and do not appear to have received inoculation against Emerald Ash Borer. As the initial inventory was conducted in the winter, overall canopy condition was impossible to determine. However, as Figure 1 shows, all the Ash trees appear to be in overall good condition as of May 26th, 2021. The roots on all three trees are slightly girdled, but canopies appear to be full and lush.

Update March 24, 2025, All trees are showing signs of the Emerald Ash Borer.

Figure 2 Picture of Ash trees on May 26, 2021.

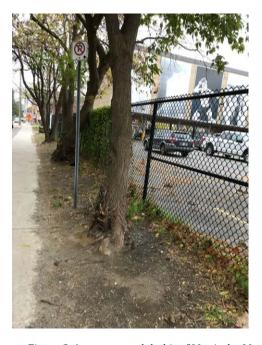
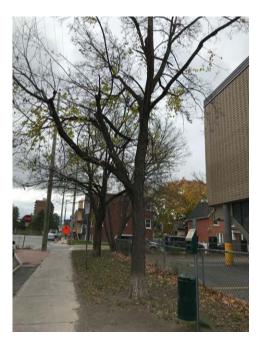
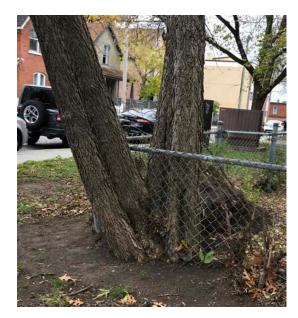
Figure 2-4: poor growth habit of Manitoba Maple and Ash along Bell Street, canopy pruned for overhead hydro
