July 4, 2025
ARBORIST REPORT
1309 Carling Avenue, Ottawa, Ontario

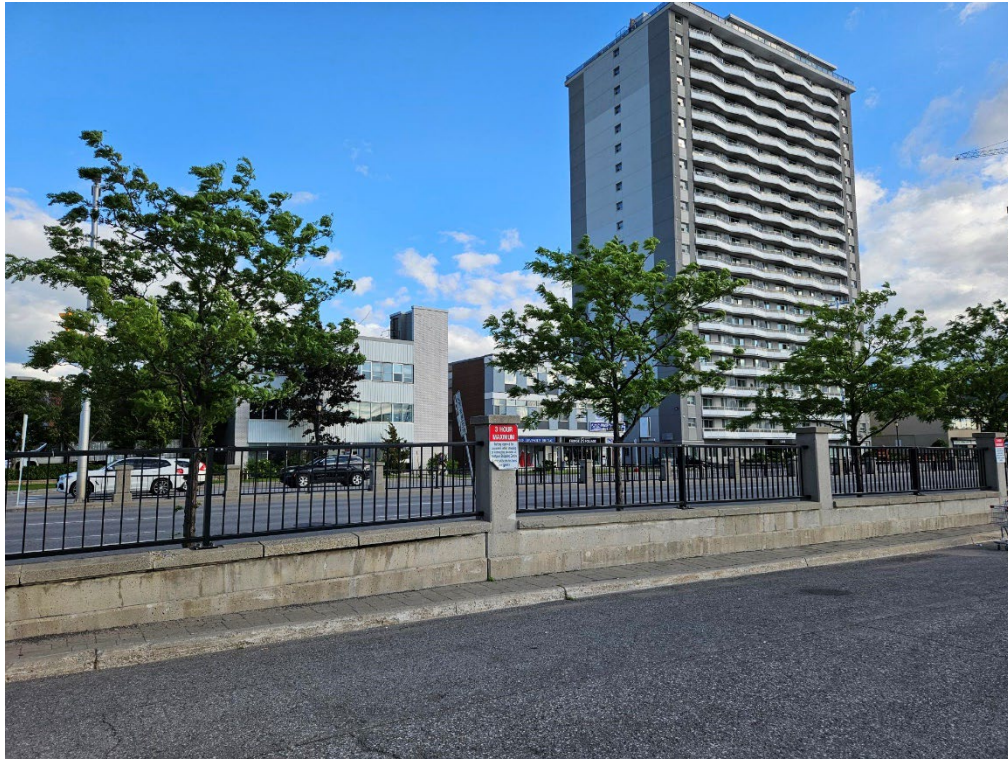
Trees 1 – 3

Tree #	Common Name	Botanical Name	DBH (CM)	Condition	Comments	Recommendation
1	Honey Locust	Gleditsia triacanthos	12	F/G		Retain
2	Honey Locust	Gleditsia triacanthos	12	F/G		Retain
3	Honey Locust	Gleditsia triacanthos	12	F/G		Retain
4	Honey Locust	Gleditsia triacanthos	14	F/G		Retain
5	Honey Locust	Gleditsia triacanthos	14	F/G		Retain
6	Honey Locust	Gleditsia triacanthos	16	F/G		Retain
7	Honey Locust	Gleditsia triacanthos	17	F/G		Remove due to construction
8	Maidenhair Tree	Ginkgo biloba	10	F		Retain
9	Maidenhair Tree	Ginkgo biloba	9	F	Elevated crown, poor form, bow in trunk	Retain
10	Maidenhair Tree	Ginkgo biloba	13	F		Retain
