TREE CONSERVATION REPORT

1058-1066 Silver Street
and 1291-1305 Summerville Avenue

Tree Conservation Report submitted as Partial
Requirements for a Site Plan Control Application.

Dendron Forestry Services

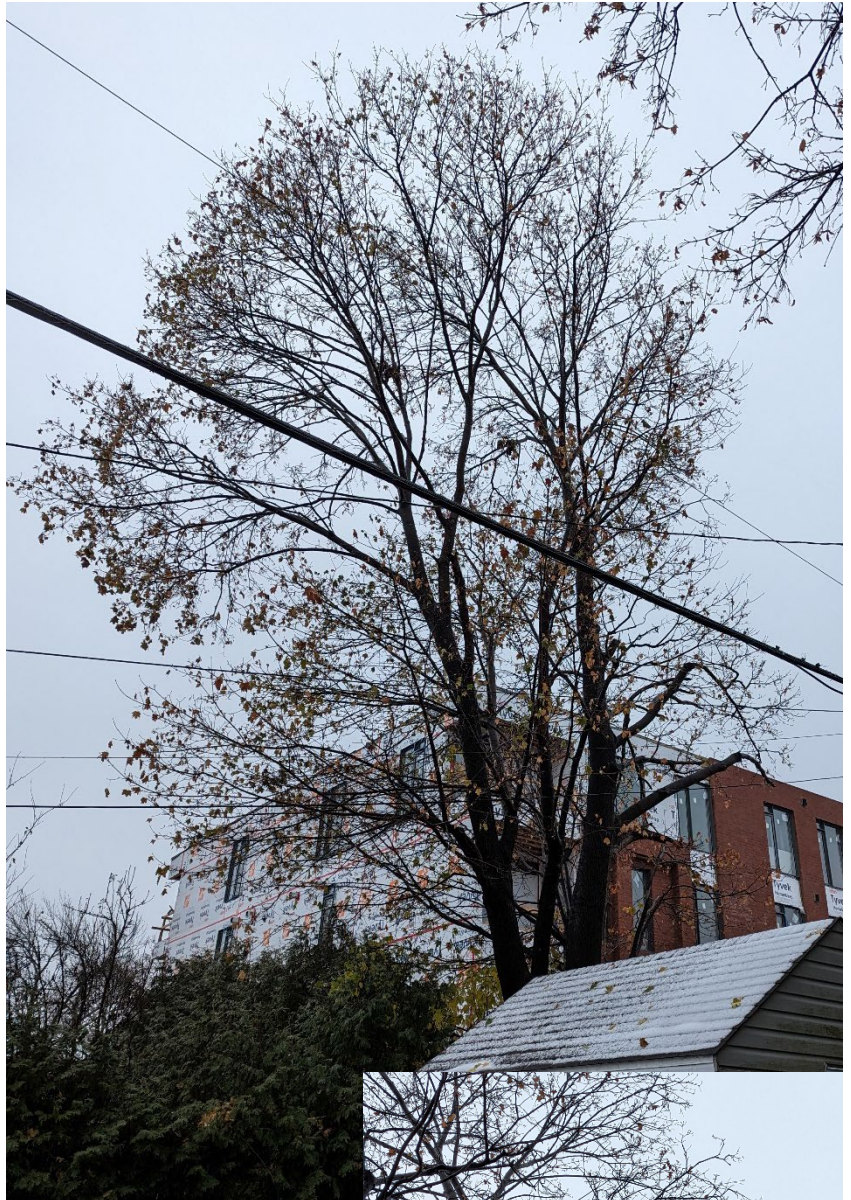
Above right: Canopies of Trees 3-5 - private maples to be removed.

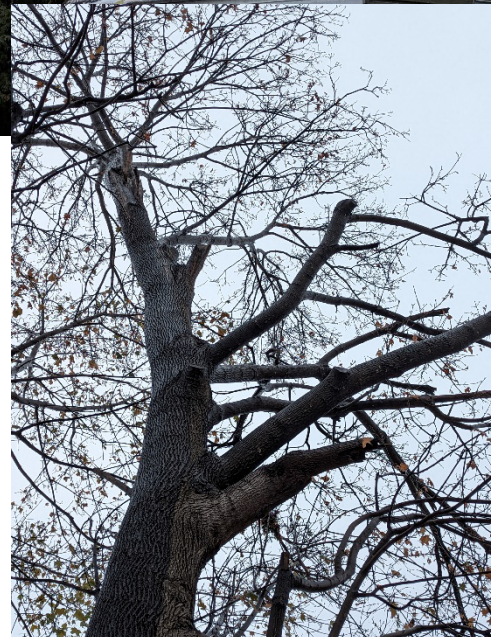
Below right: trunk and pruned branches of Tree 4

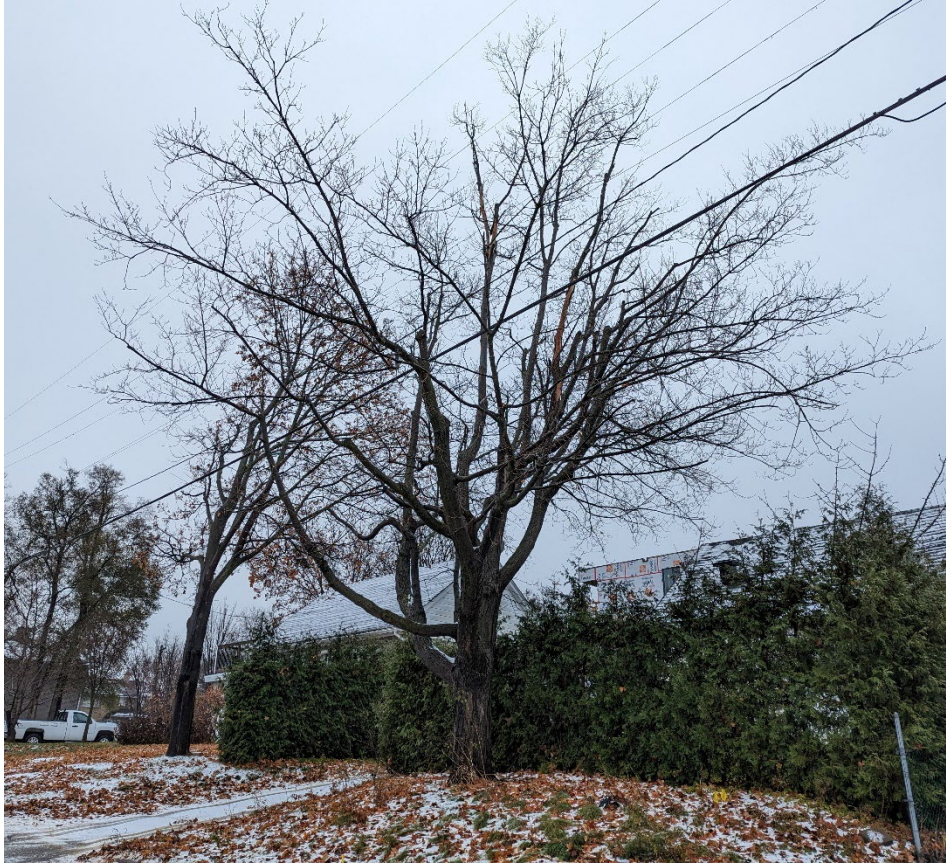
**Above: Tree 9 (left) and Tree 8 (right) -
City maples to be removed.**

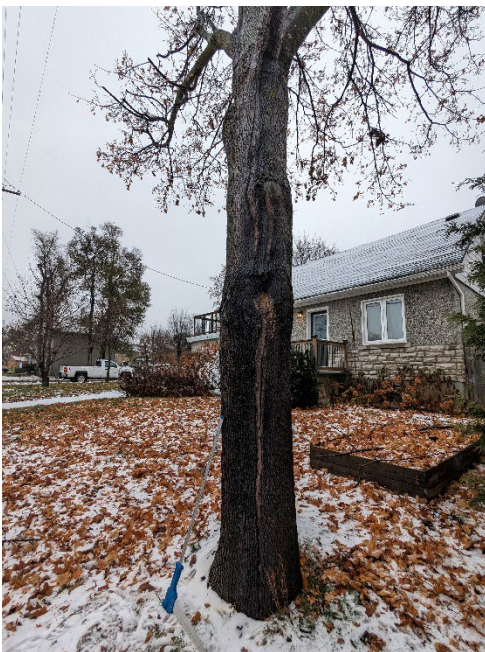
Left: Trunk of Tree 9.

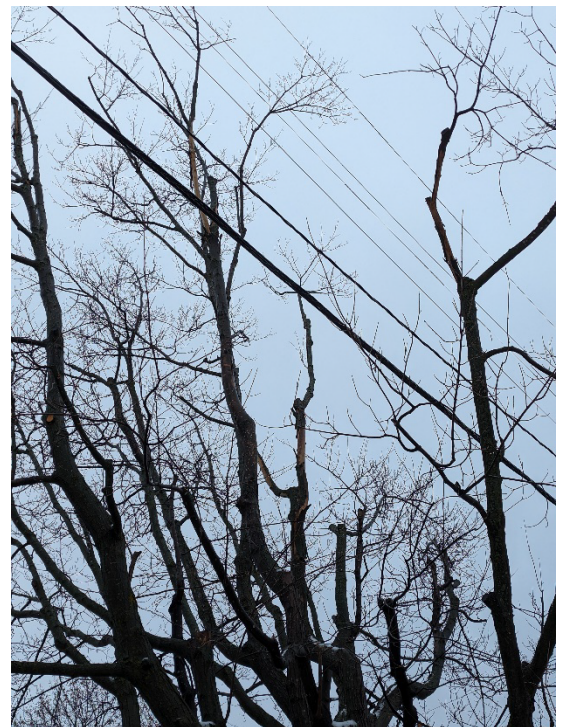
**Right: Canopy of Tree 8 pruned
around wires with some dead central
branches.**

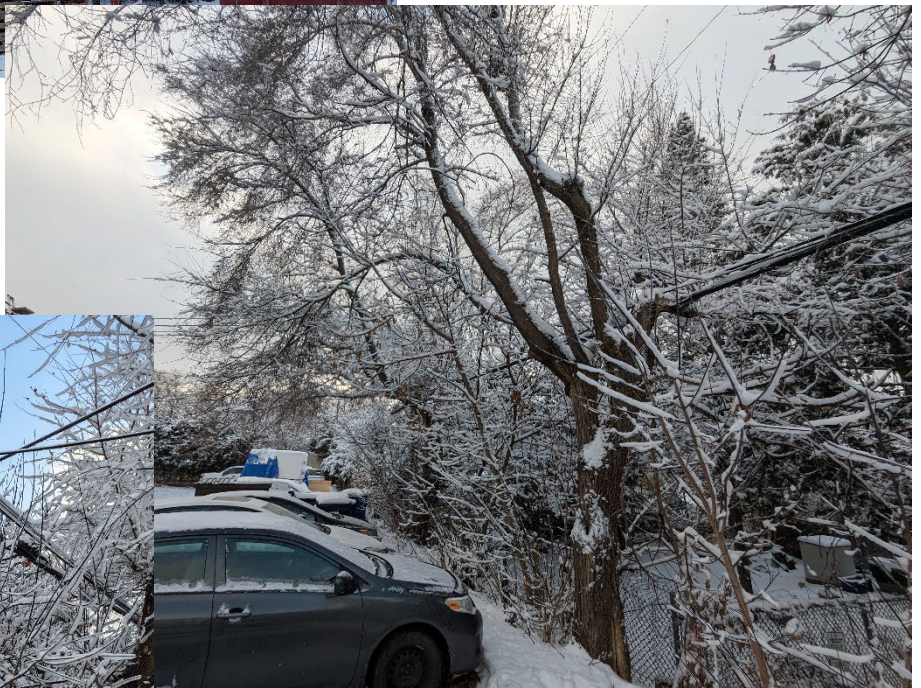
Tree 22 – Boundary Siberian elm to be removed.

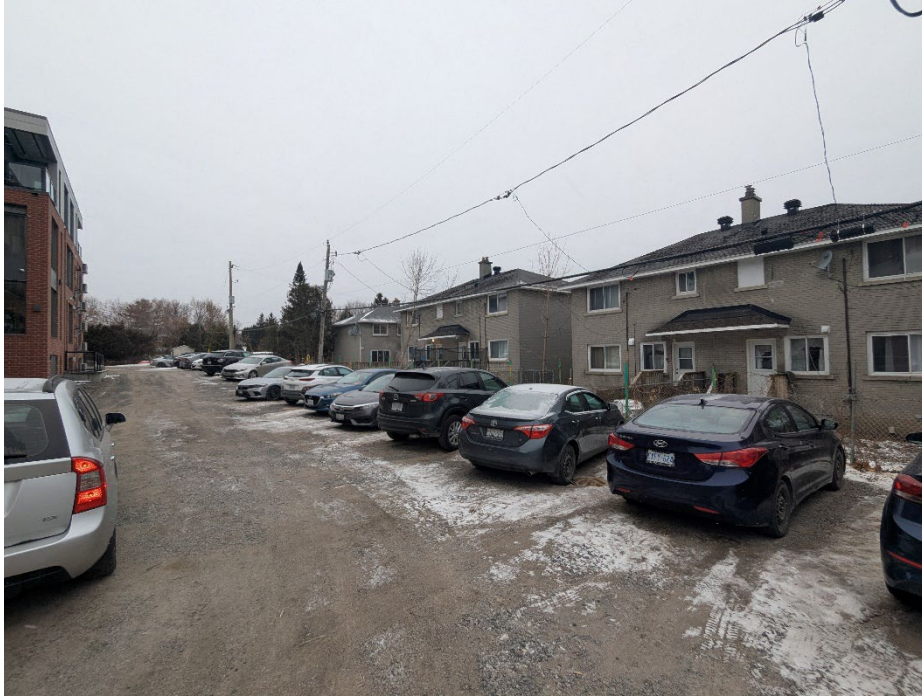
Above: Rear parking area behind the Summerville properties – all trees removed (photo December 23, 2024).
