# TREE CONSERVATION REPORT V5.0

**6600 Rue Carrière**

Tree Conservation Report prepared as Partial  
Requirements for a Site Plan Control  
Application, September 11, 2025

**Date of Report:** September 11, 2025

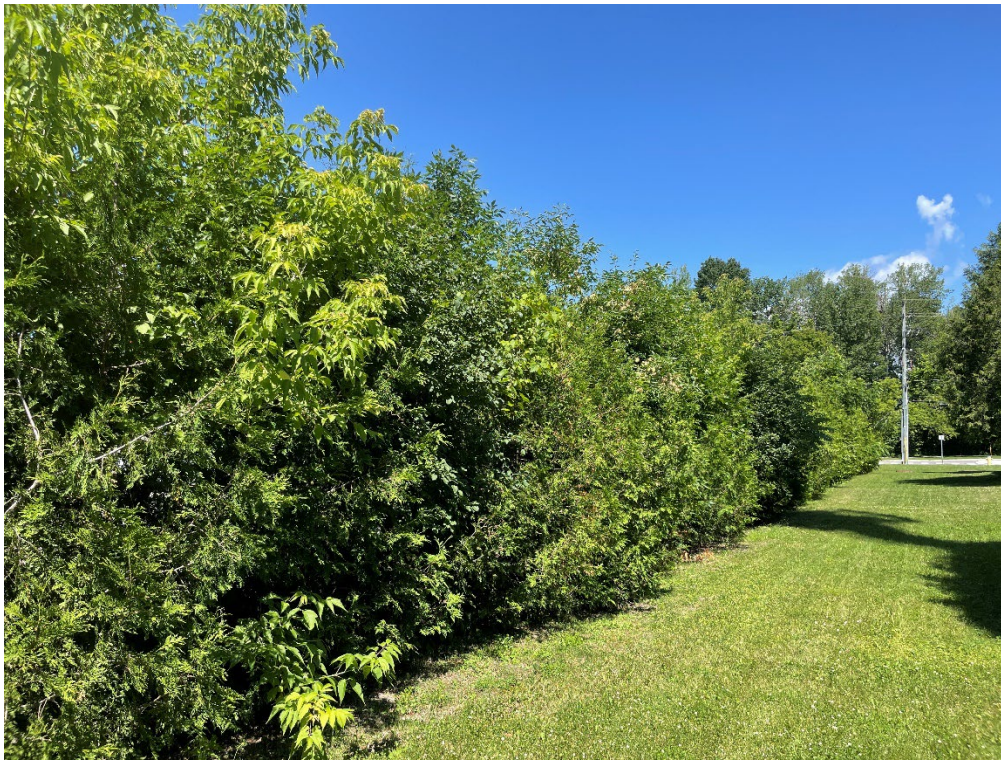
| 5 | Cedar hedge<br>( <i>Thuja occidentalis</i> ) | 5-15 cm | Private | Good/fair | Partial removal as shown on map, remaining section to be protected with fencing as per City of Ottawa Tree Protection Specifications (March 2021) |
| 7 | Cedar hedge<br>( <i>Thuja occidentalis</i> ) | 5-10 cm | Private | Good/fair | Partial removal as shown on map, remaining section to be protected with fencing as per City of Ottawa Tree Protection Specifications (March 2021) |

**Figure 1: Cedar hedge along the western property line**
