Report

Trail Road Battery Energy Storage System (BESS)
Fluvial Geomorphology Assessment

H375035-0000-2B0-066-0001

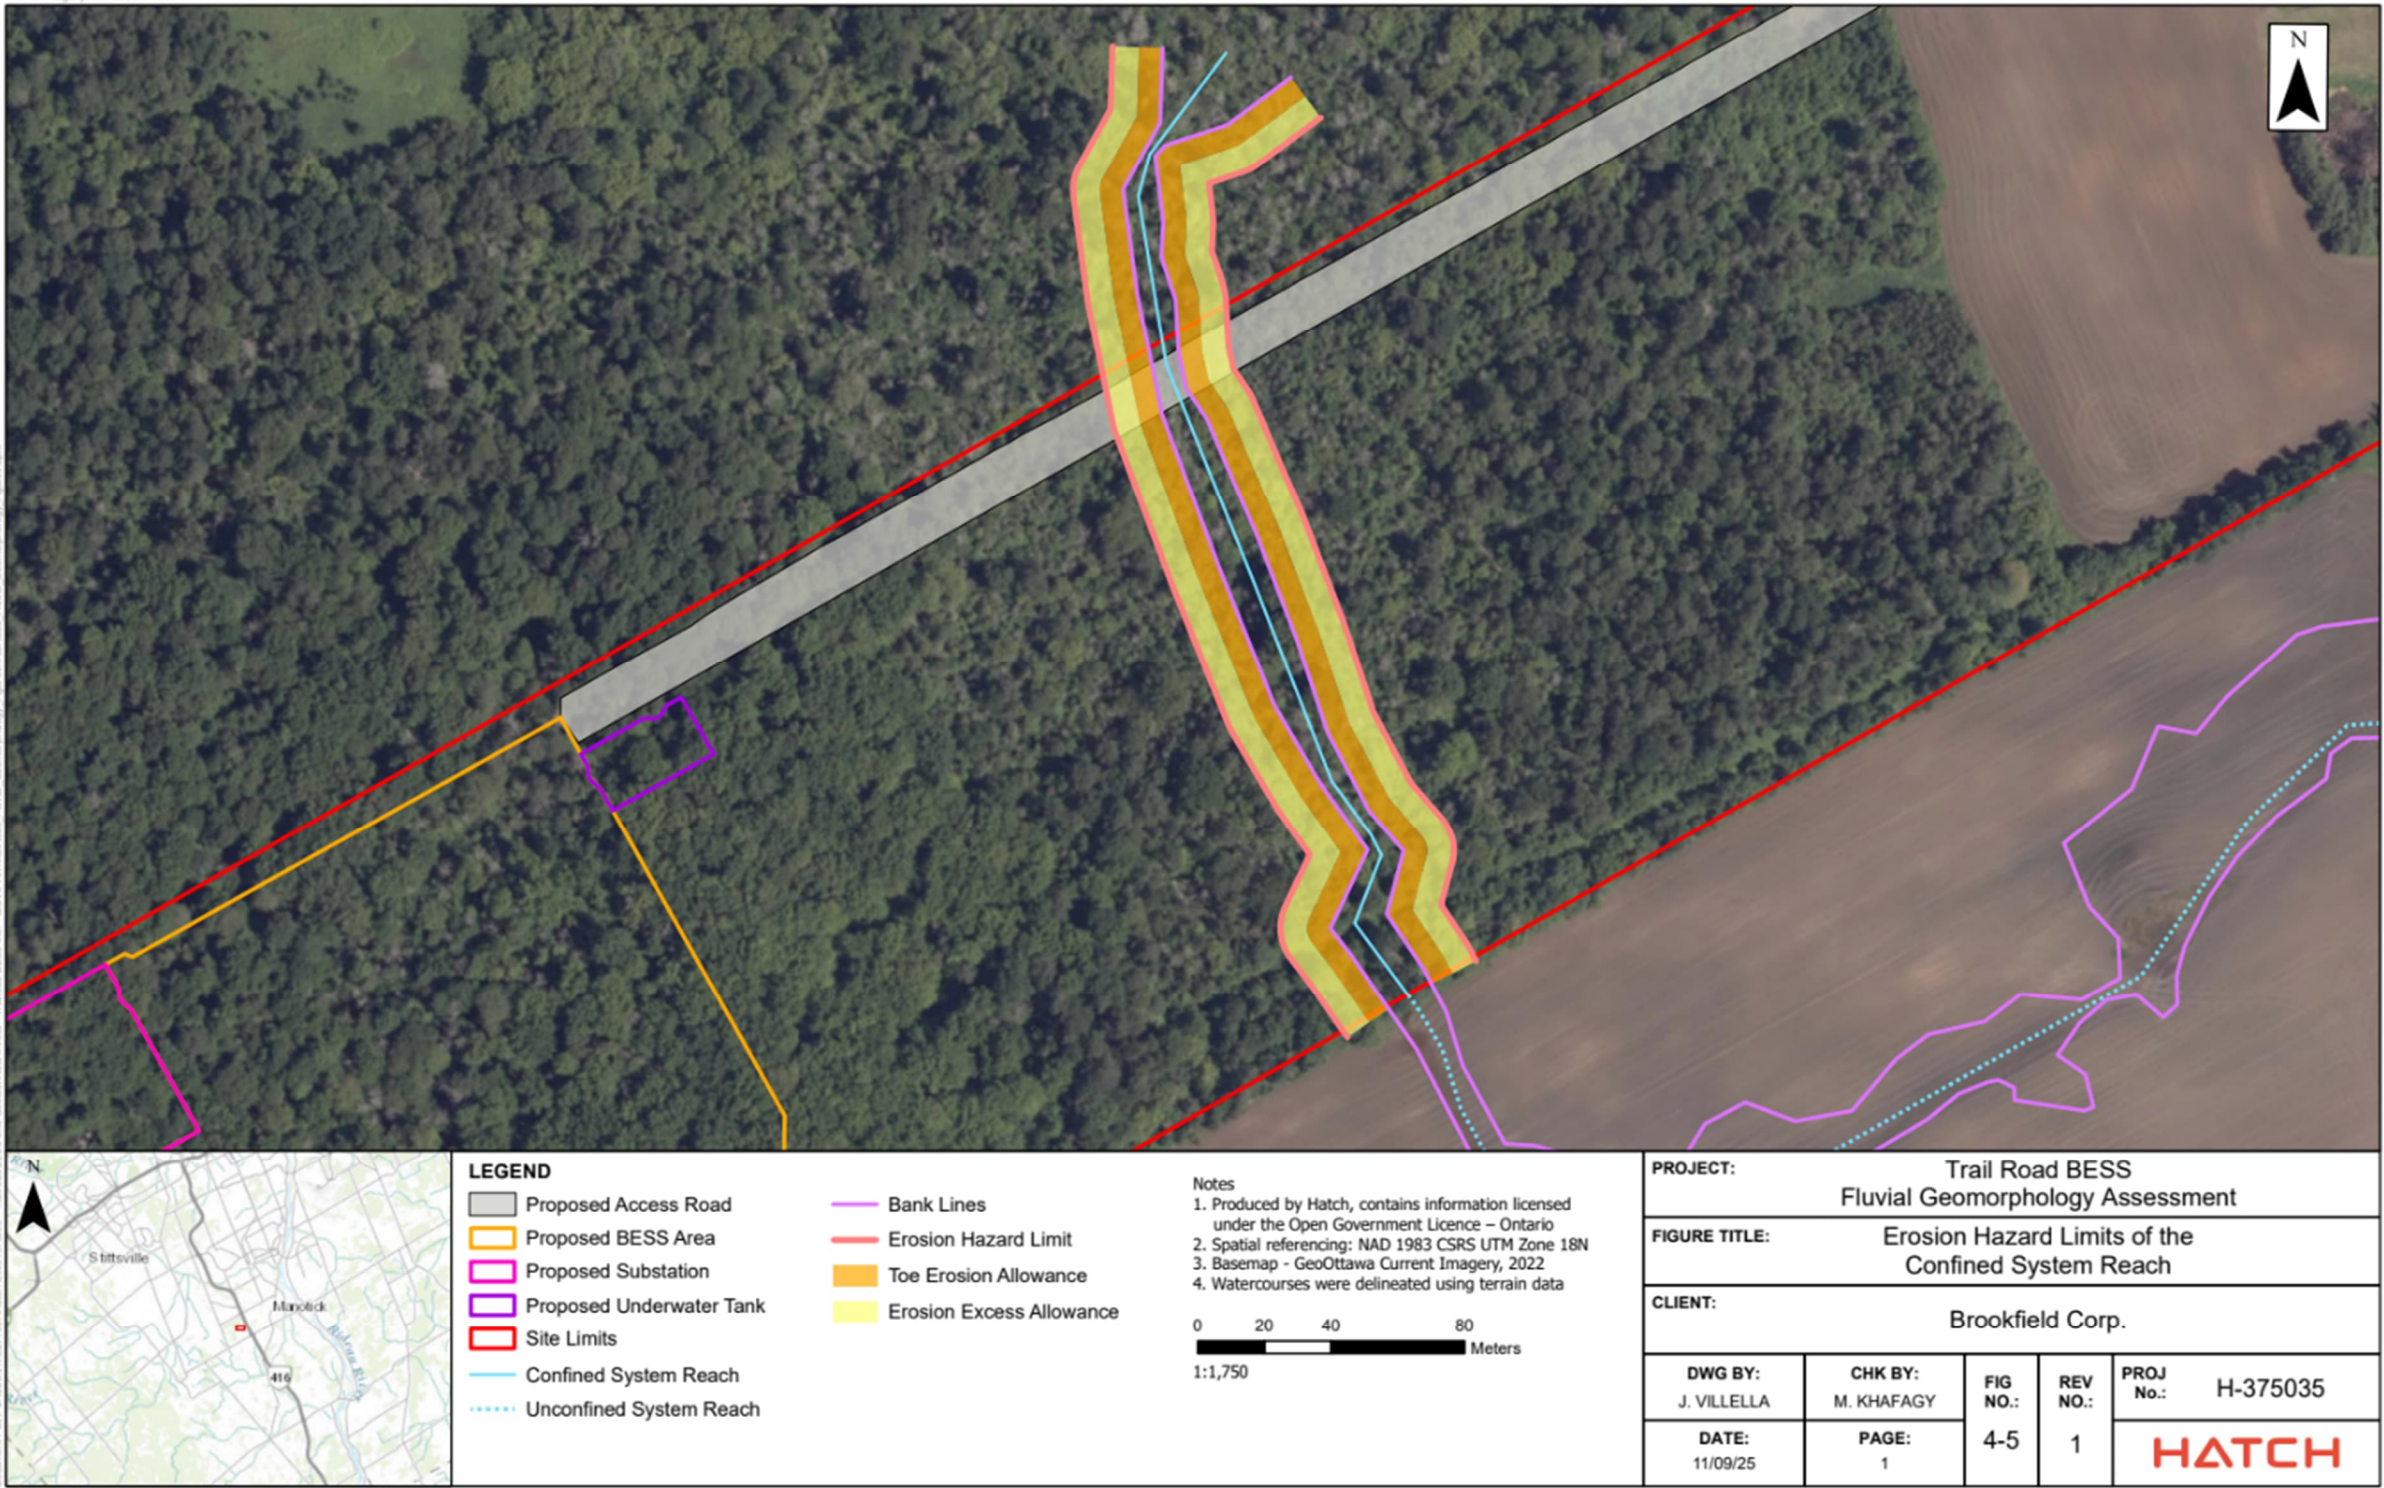
Figure 4-5: Erosion Hazard Limit of the Confined System Reach

An appropriate approach is to delineate the erosion hazard for the confined systems following MNR Erosion Hazard Limit Technical Guide (2002), where the erosion hazard is comprised of three main components: 1) the toe erosion allowance; 2) the stable slope allowance; and 3) the erosion access allowance. The toe Erosion Allowance represents the potential for channel migration at the base of the valley slope. A toe erosion allowance of 7 m was applied following the MNR Technical Guide (2001). Stable Slope Allowance is to address potential long-term slope instability, where the stable slope allowance is determined based on geotechnical criteria. Based on field observations and desktop review, the Creek within the study area exhibits a shallow bankfull depth of approximately 15 cm, and no defined valley slopes or steep embankments were identified adjacent to the channel. In accordance with the CVC Watershed Planning and Regulation Policies (2010), a stable slope allowance is required only where specific conditions apply, including: slope gradients steeper than 3:1, slope heights equal to or greater than 2 m, visible evidence of slope instability, proximity of bankfull flow to the valley toe of slope (within 15 m), or a known history of slope failure. Not all of these conditions were observed at the subject site.

Therefore, a stable slope allowance is not considered necessary for this reach of the watercourse. Erosion Access Allowance is a minimum access distance is typically applied at the top of the valley slope to allow space for maintenance or future stabilization works. Regarding the erosion access allowance, MNR Technical Guide (2002) guidelines note that for stiff/hard cohesive soil (clays, clay silt) and coarse granular (gravels) tills, a 5 to 8 m erosion access is to be applied. Given the evidence of erosion along the Creek, erosion access allowance of 8 m is recommended.

The proposed development area is located entirely outside the delineated erosion hazard limit associated with the confined system reach of the Creek. As shown in Figure 4-5, there is no overlap between the development footprint and the defined erosion hazard components, including the toe erosion allowance and erosion access allowance. Some considerations should be applied for the proposed service road crossing the Creek and discussed in Section 4.6. This confirms that the development, as currently planned, does not encroach upon areas identified as geomorphologically sensitive or at risk of fluvial erosion.

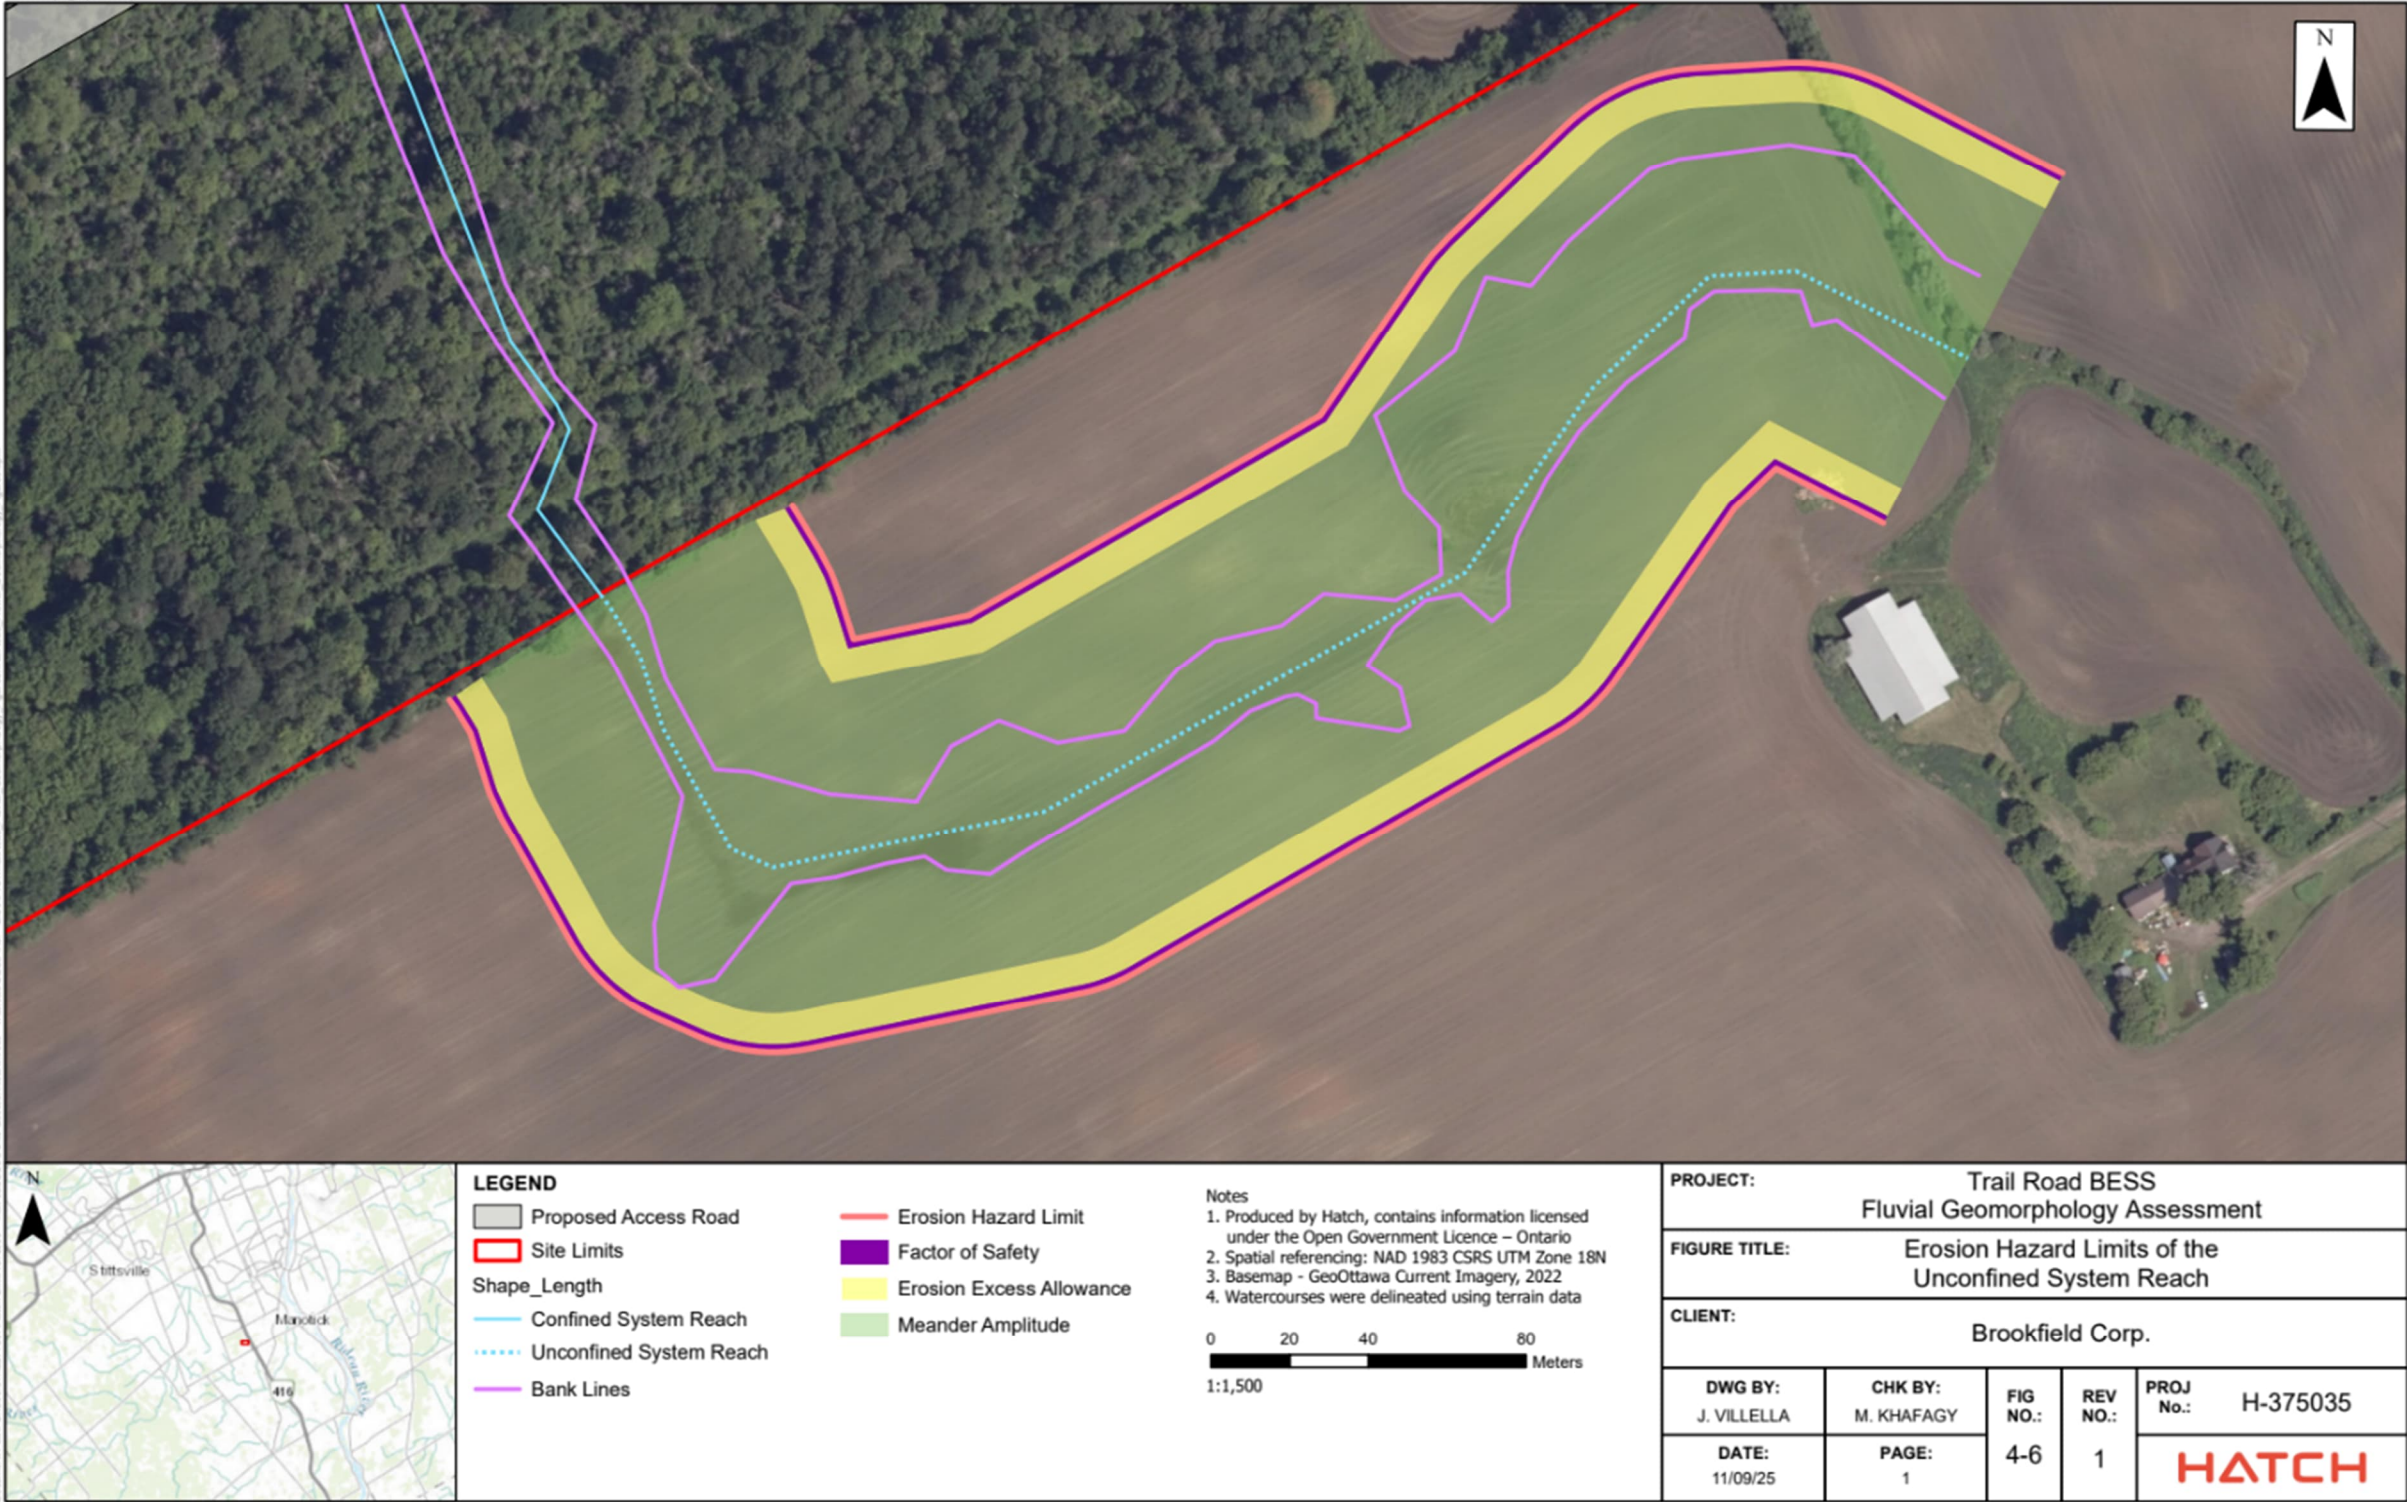
Figure 4-6: Erosion Hazard Limit of the Unconfined System Reach

The downstream reach of the Creek transitions into an unconfined system. In such systems, the erosion hazard is better assessed using a meander belt width approach, which reflects the maximum fixed lateral extent of historical and potential future channel migration. As per MNR Technical Guide (2002), the meander belt width is defined as the summation of meander amplitude and erosion access allowance. In this case, the historical aerial photograph analysis confirms lateral channel migration and expansion of the channel and adjacent wetland features over time. An erosion access allowance of 8 m is recommended for the unconfined system reach. Figure 4-6 shows the erosion hazard limit for both reaches of the Creek (Unconfined System) including the Meander belt Width and erosion access allowance.

An appropriate safety factor can be applied to the Erosion Hazard limit as per guideline recommendations. A 2 m safety factor has been applied to both reaches of the creek (the confined and unconfined systems).

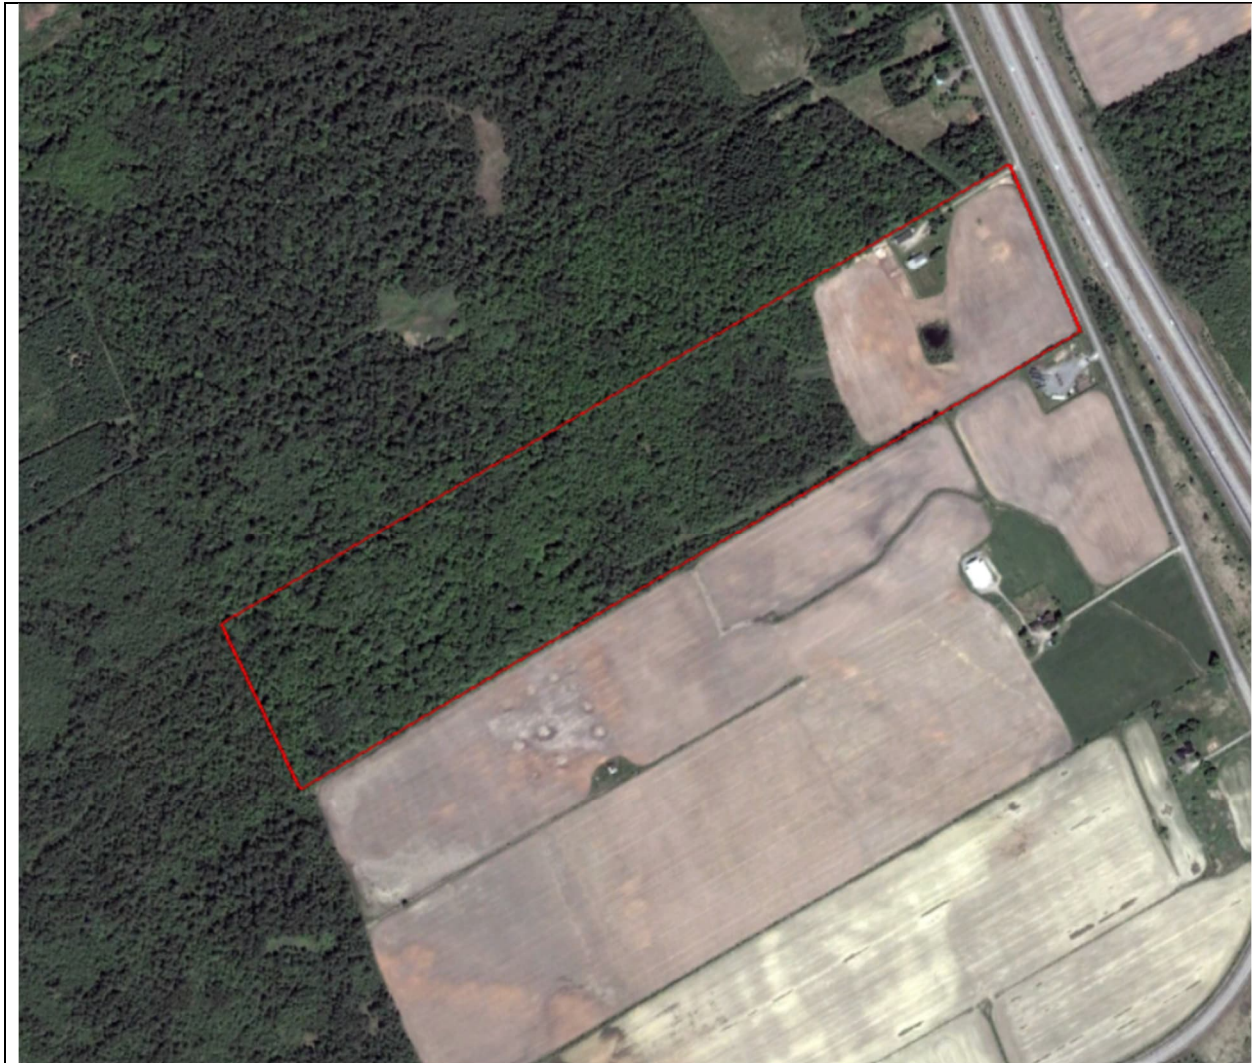
By 2012, a small wetland or pond feature is present along the tributary to the south. The constructed side banks of the Creek are no longer visible, and the channel condition appears to deteriorate. This may have resulted from a flooding event. By 2016, the Creek shows signs of widening, and an additional pond feature emerges along the tributary downstream of the project site. Tree cover within the subject property remains consistent.

Location: Ottawa, ON
Year: 2012
Scale: 1:14,000
Source: Google Earth Pro
Red Boundary: Site Limits

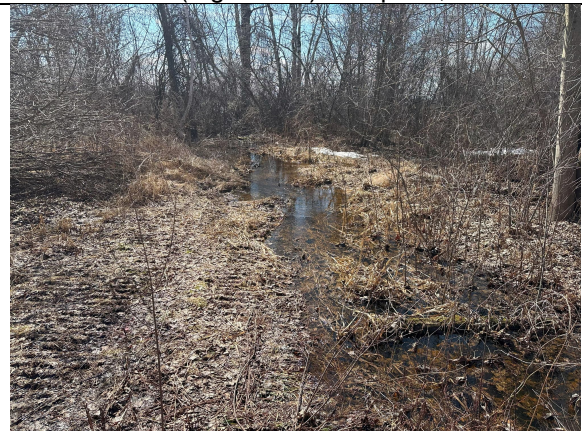
In several locations, including the area shown at location S8 (Photo 16 in Appendix B), evidence of localized channel adjustment and planform variability was observed. The Creek exhibits minor sinuosity, with lateral deflections of the low-flow channel that suggest active, albeit limited, fluvial processes. These deviations in flow alignment are likely the result of small-scale bank erosion and scour occurring along the outer margins of emerging meander features. While the degree of meandering is minimal due to the confined nature of the corridor and limited stream power, these features may represent the early development of a meander belt within the system.

Photo 16: View looking southeast (downstream) at location S8 (Figure 3-1) (minor sinuosity) on April 7, 2025.
