Project:  
**Gladstone and Loretta**

Drawing:  
**TREE CONSERVATION REPORT**

| 1987-01 | TCR 1.0 |

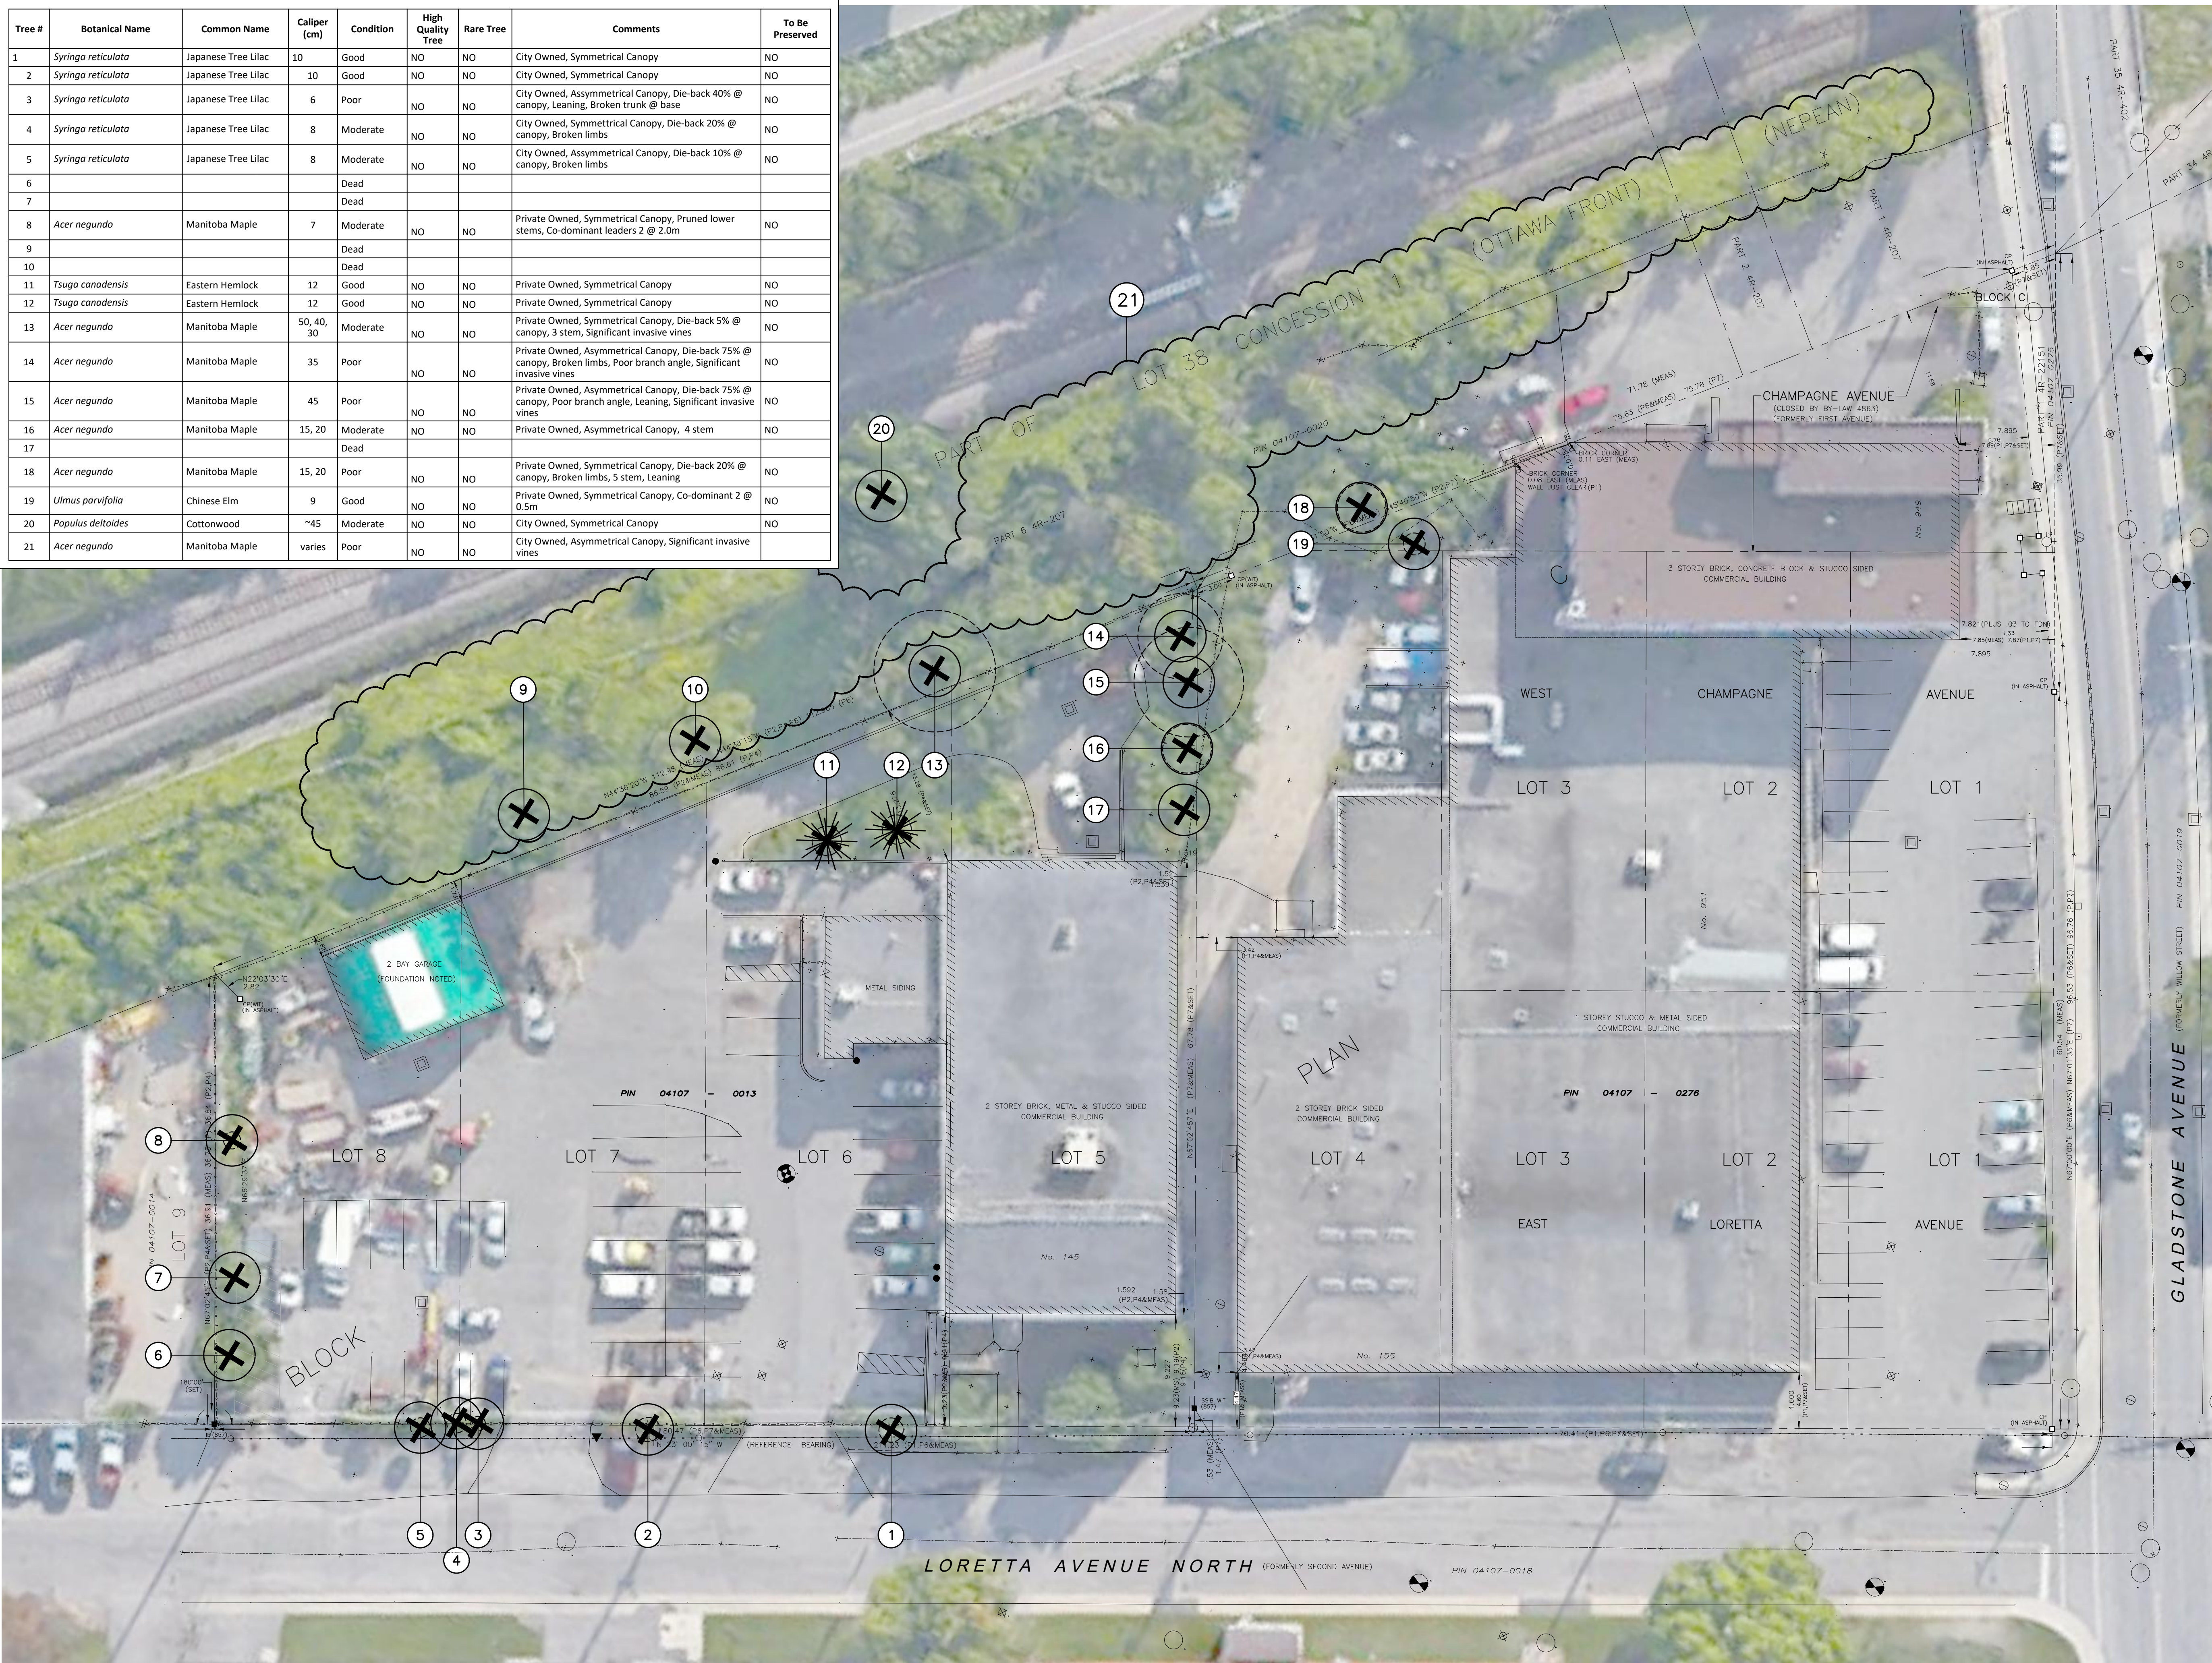
THIS IS AN EXISTING COMMERCIAL SITE USED PRIMARILY AS BUSINESS SPACE FOR MULTIPLE TENANTS. MUCH OF THE SITE IS CURRENTLY OCCUPIED BY ASPHALT PARKING LOT. THE MAJORITY OF TREES ON SITE ARE AT THE PERIMETER EDGES. WITH THE EXCEPTION OF THE STREET TREES ALONG LORETTA AVE, MOST TREES HAVE ESTABLISHED POORLY AND ARE ILL SITUATED ALONG FENCE LINES OR DIRECTLY AT RETAINING WALLS.

THE LINEAR LANDSCAPE AREA NORTHEAST OF THE SITE RUNS ADJACENT TO THE EXISTING O-TRAIN TRACKS. THIS AREA IS SEPARATED FROM THE COMMERCIAL PROPERTIES WITH CHAIN LINK FENCE AT THE TOP OF A SLOPE. THE AREA IS DENSE WITH INVASIVE PLANTS SUCH AS MANITOBA MAPLE, WILD GRAPE VINE AND VIRGINIA CREEPER. THE AREA HAS A GREAT DEAL OF DEAD TREES AND MISCELLANEOUS DEBRIS MAKING THE AREA DIFFICULT TO ACCESS.

THE SITE LACKS SIGNIFICANT TREES OF VALUE. THE PRESENT TREES OFFER LITTLE BENEFIT TO THE SITE IN TERMS OF ECOLOGY, CHARACTER, OR SHADE VALUE. THE GENERAL CONDITION OF THE SITE'S TREES ARE POOR WITH A DECLINING STATE OF HEALTH.
