Tree Conservation Report

**Carlingwood Shopping Centre Parking Renovation –
2085 Carling Avenue**

December 2025

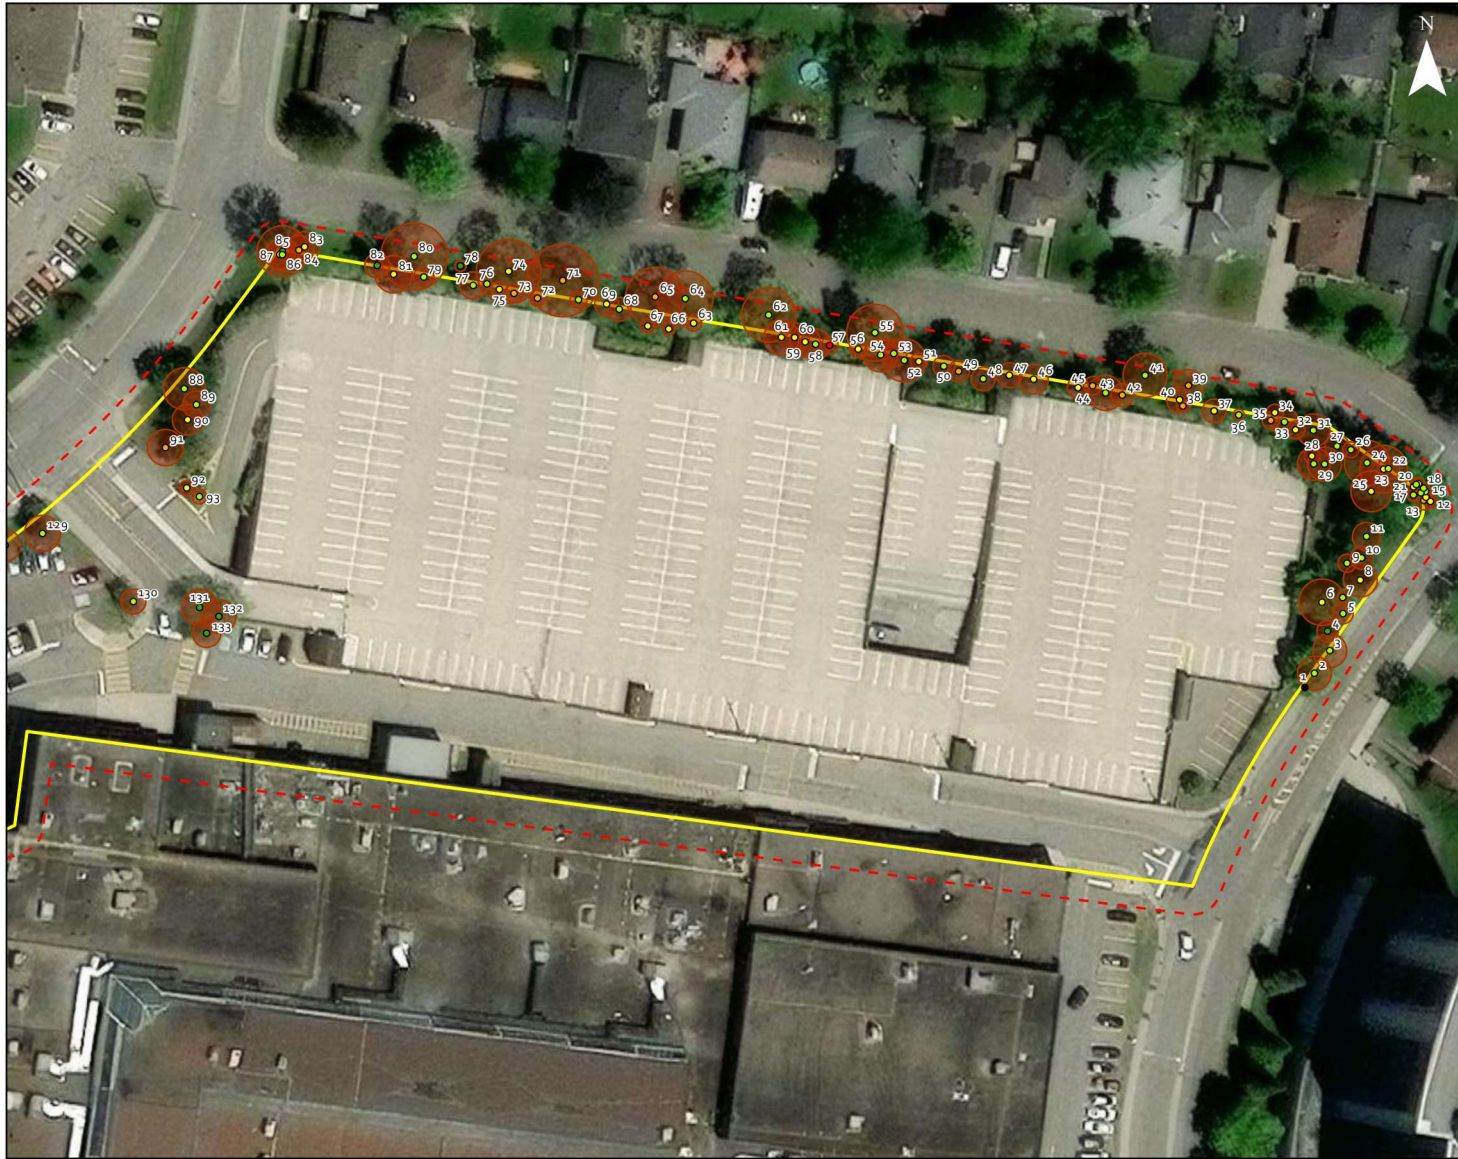
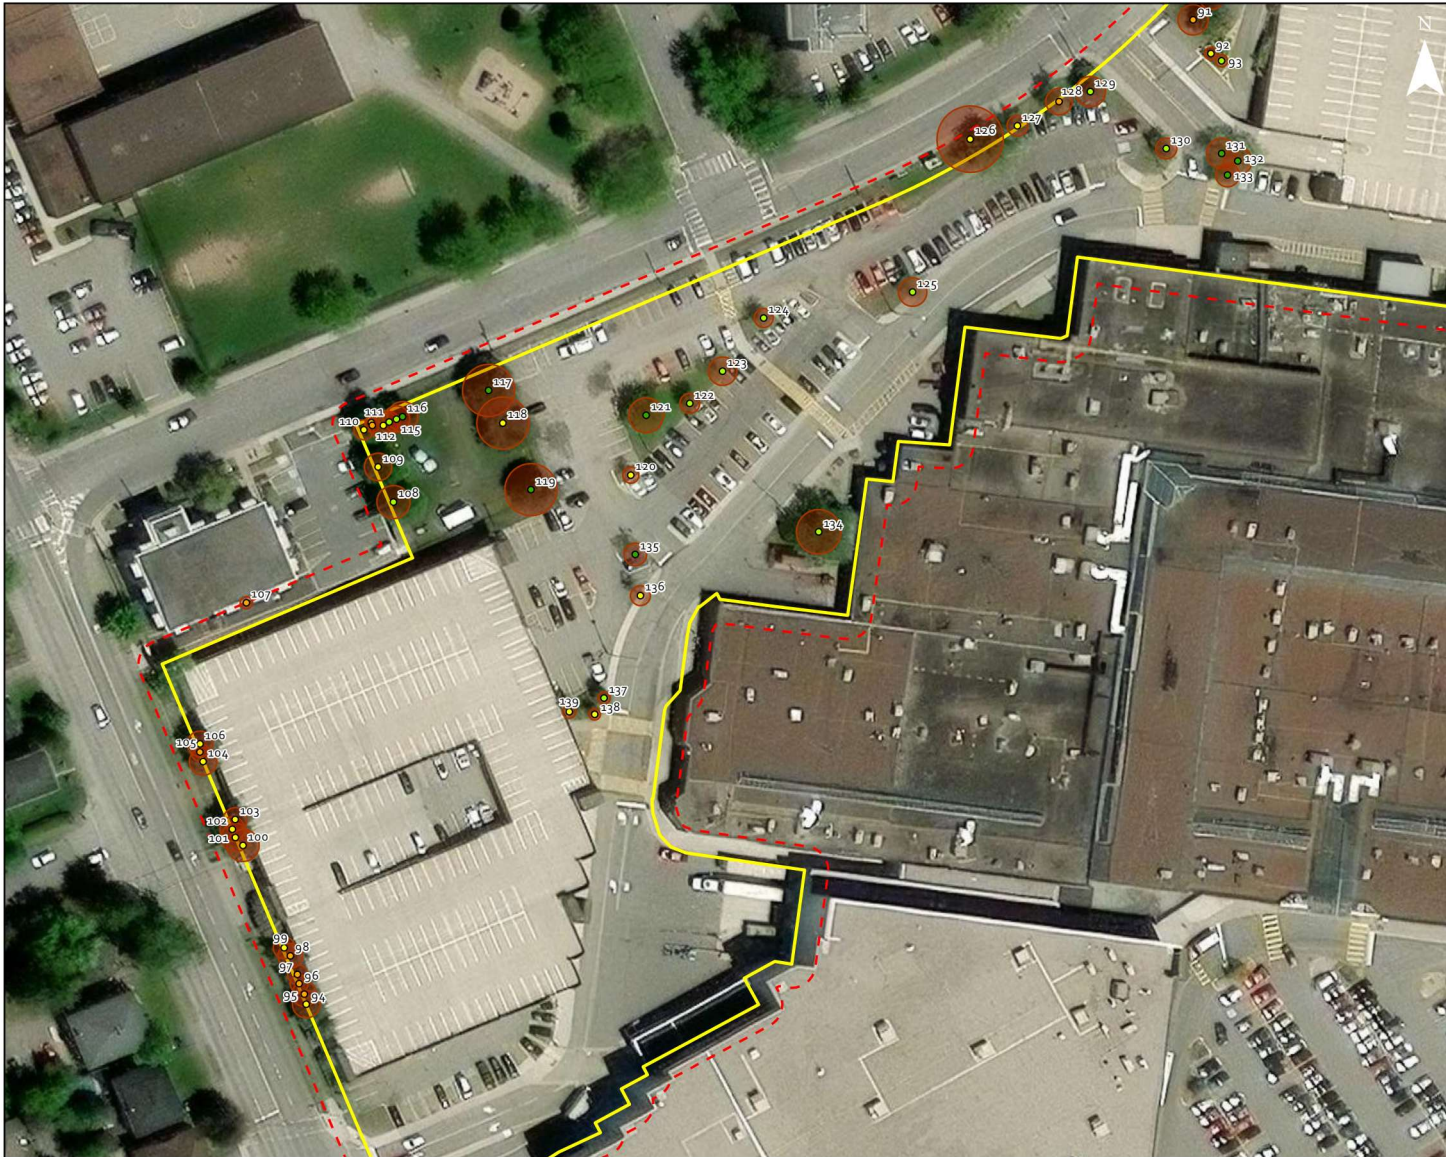
Figure: 2a

A total of 139 individual trees were assessed as part of this inventory. The condition of the trees on Site ranged from Excellent to Dead, approximately 83% of which were in Excellent - Good condition. The most common species are Red Pine (19%), Norway Spruce (16%), Norway Maple (13%), and Apple species (13%).

There are 40 trees that meet the definition of a 'Distinctive Tree' as per Tree Protection By-law No. 2020-340 (any tree located on private property with a DBH of 30 cm or greater, within the inner urban area). Trees 91, 131, and 132 are Distinctive trees that require removal based on the current design plans.

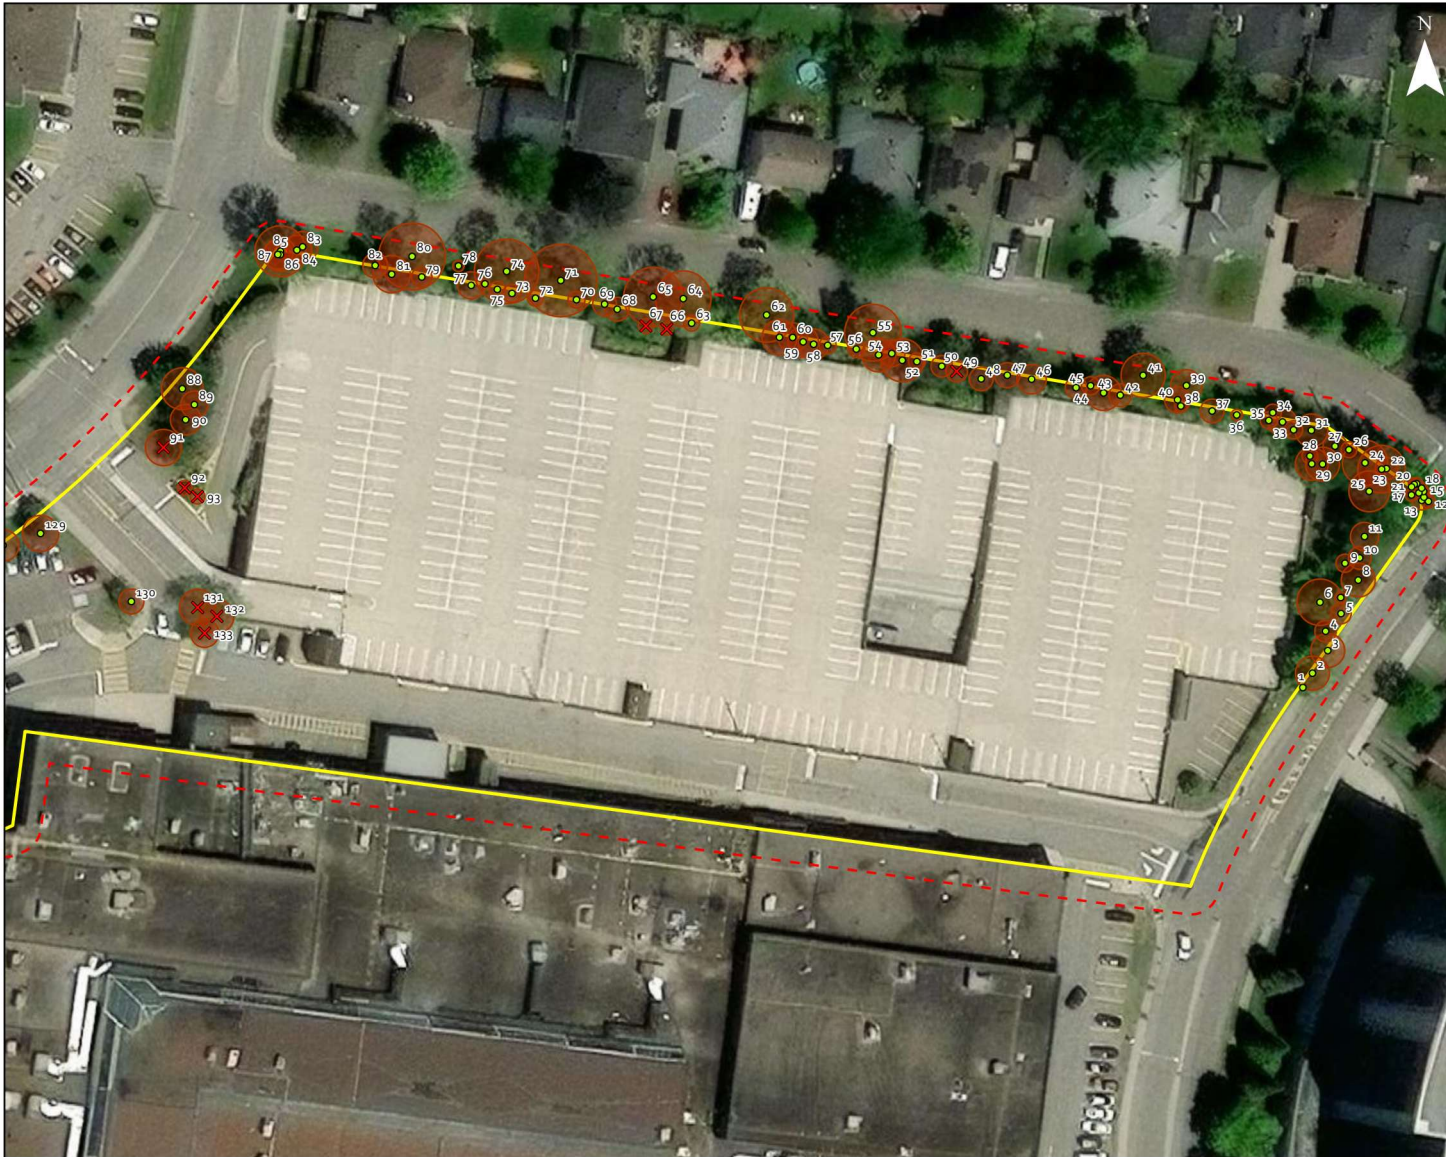
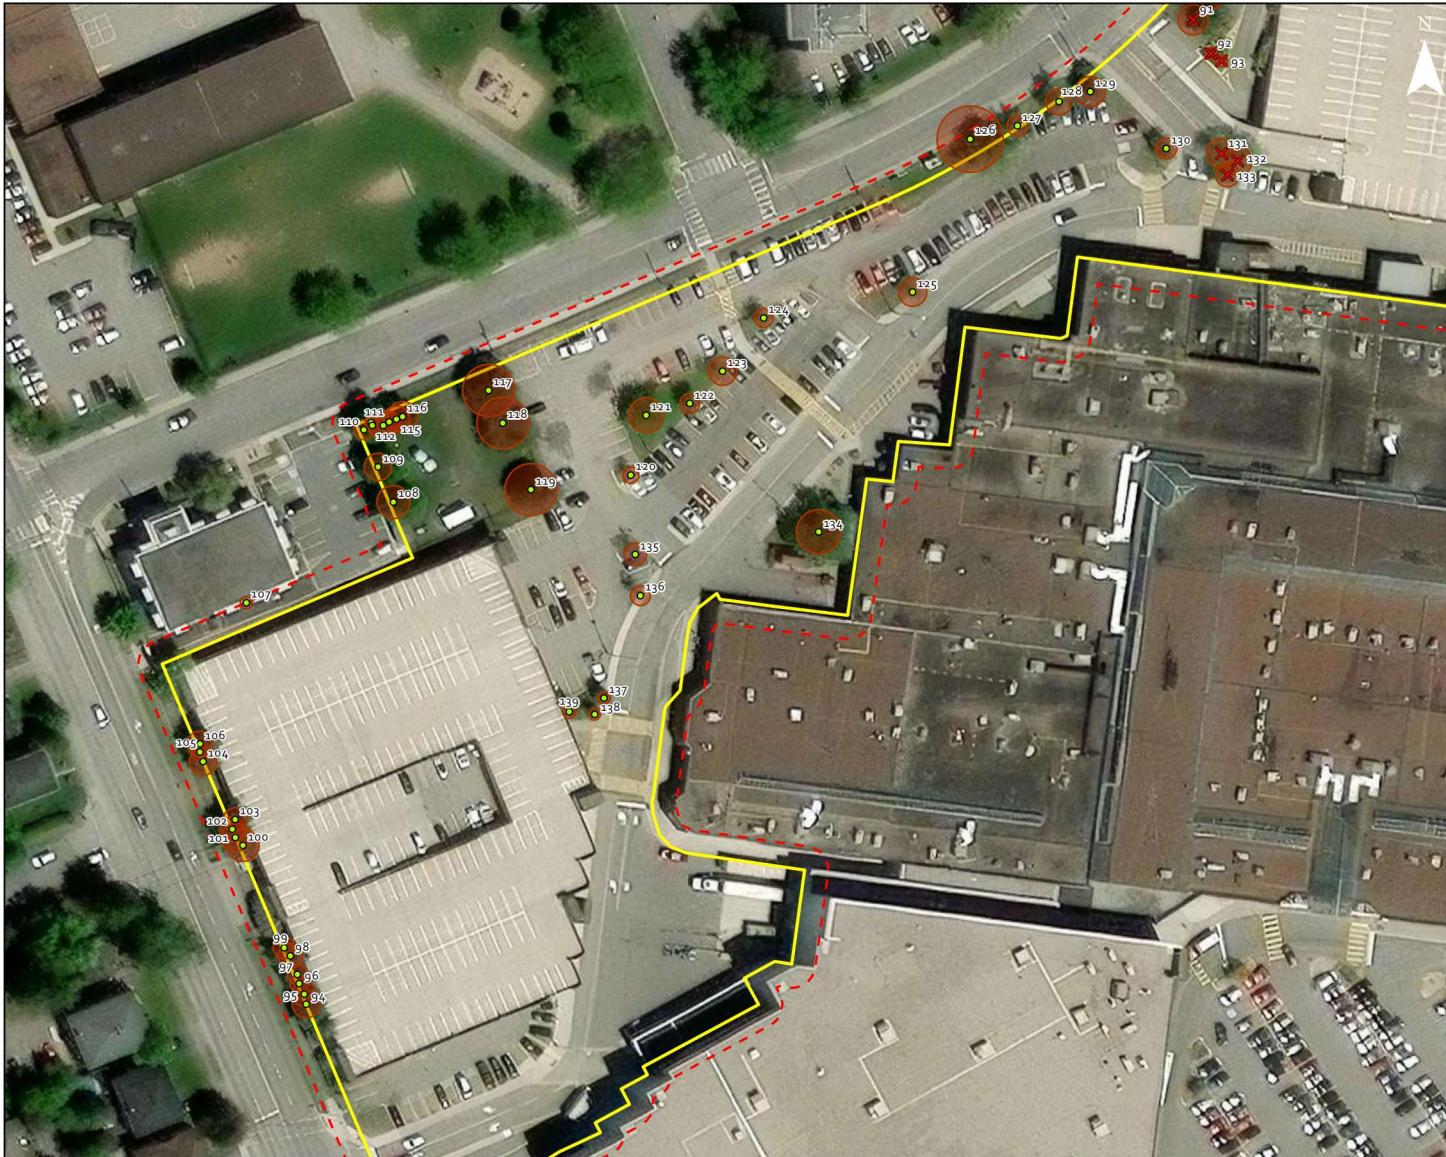
Figure: 3a

A review of the Site conditions indicates that most existing trees can be retained, except where the existing ramp will be demolished and drive lanes adjusted. All trees within and slightly beyond the footprint of the existing structure have been surveyed, as additional inventory information may help inform future development options. Based on the conditions of the trees and extent of the proposed construction limits, **Table 2** summarizes the impact and recommended actions of the 139 trees assessed within the Site.

It is anticipated that nine (9) trees >10 cm diameter at breast height (DBH) will need to be removed. These details are depicted on Mandatory Map 2 below, as per the City of Ottawa, 2021 (**Figure 3**), and outlined in the Tree Inventory and Assessment Table included in **Appendix A**.

Based on the proposed project design and existing conditions of the trees on site, 9 trees have been recommended for removal. The following recommendations are provided:

- Retain a Certified Arborist during site layout operations to confirm recommended tree removals, pruning, and tree protection fencing in proximity to the construction limits.
