December 15, 2020

RE: TREE CONSERVATION REPORT FOR 770-774 BRONSON AVENUE, OTTAWA

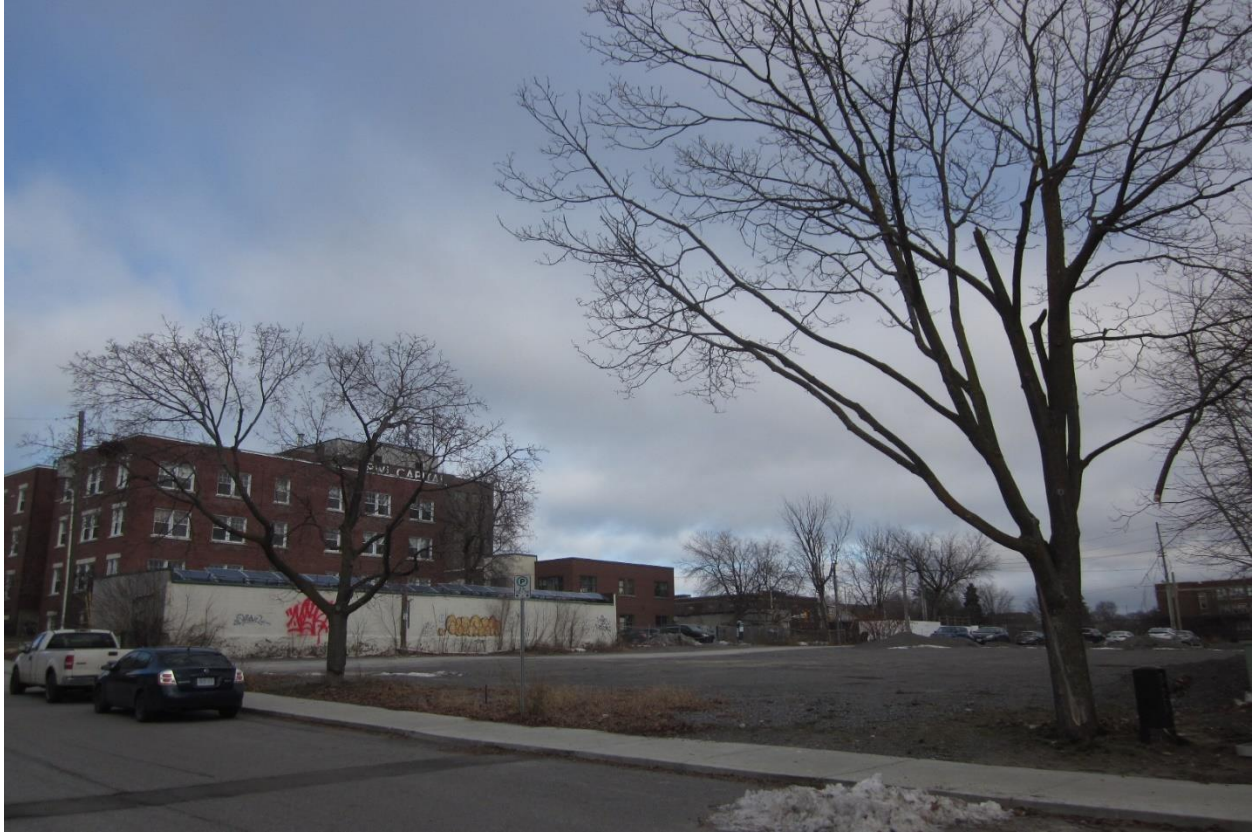
Picture 1. Trees #2 and 3 (right to left), city Norway maples located adjacent to 770-774 Bronson Avenue

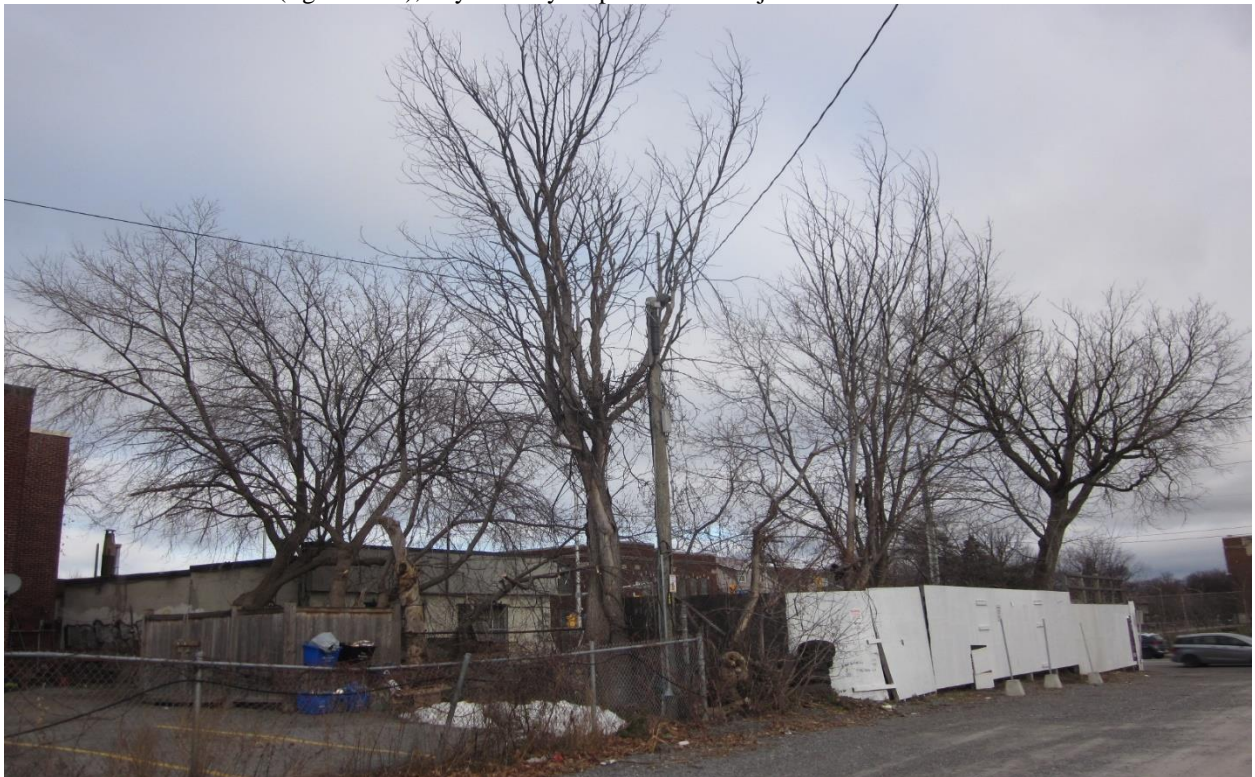
4	Manitoba maple	Dead	+/-15 avg.	Private	Maturing; coppice growth from old stump; to be removed
5	White elm (<i>Ulmus americana</i>)	Dead	+/-55	Shared	Mature; native species; likely killed by Dutch elm disease (<i>Ophiostoma ulmi/novo-ulmi</i>); to be removed (hazardous)
6	Manitoba maple	Poor	+/-25	Shared	Mature; coppice growth from old stump; embedded in fence; to be removed (due to poor condition)
7	Manitoba maple	Poor	+/-25	Shared	Mature; divergent form towards north; embedded in fence; to be removed (due to poor condition)

8	Manitoba maple	Poor	+/-60	Shared	Mature; topped at 4.5m – dense regrowth; very broad crown; embedded in fence; to be removed (due to poor condition)
9	Manitoba maple	Good	+/-30	Shared	Mature; central dominant stem; crown divergent towards east (over subject property); to be removed (conflicts with construction)
10	Hackberry (<i>Celtis occidentalis</i>)	Good	14.1	City	Maturing; dominant central stem for half height; co-dominant, divergent leaders at 3m; restricted rooting area; native species; to be preserved and protected
11	Hackberry	Good	13.7	City	Maturing; dominant central stem with competing laterals starting at 2m – broad crown; restricted rooting area; to be preserved and protected
12	Hackberry	Very good	13.9	City	Maturing; dominant central stem for most of height with parallel leaders at 4m – upright crown; restricted rooting area; to be preserved and protected
13	Manitoba maple	Good	+/-80	Private	Mature; generally upright form; core of crown in decline due to cluster of five laterals starting at 5m; to be removed (conflicts with construction)

Picture 2. Trees #5 (centre) through 13 (far right) shared or fully located on 770-774 Bronson Avenue

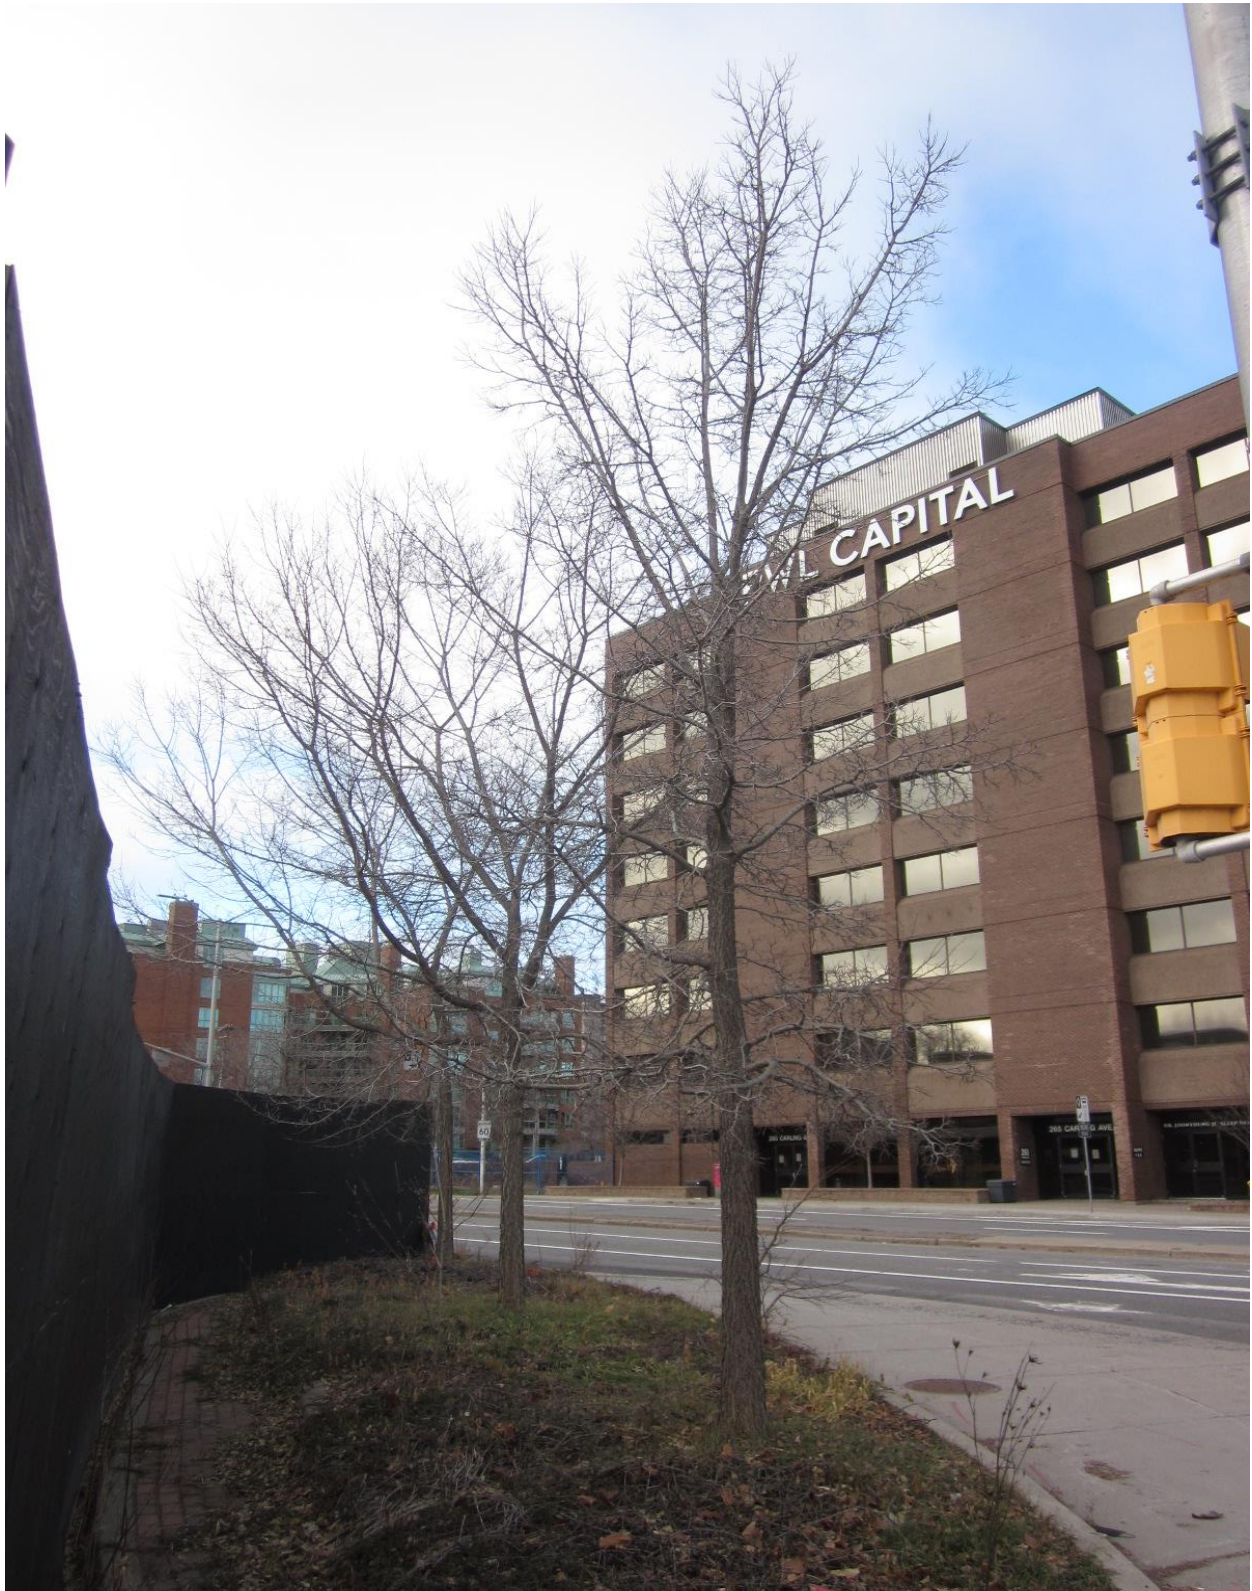
Picture 3. Trees #12 (foreground) and 11 and 10, city hackberries adjacent to 770-774 Bronson Avenue

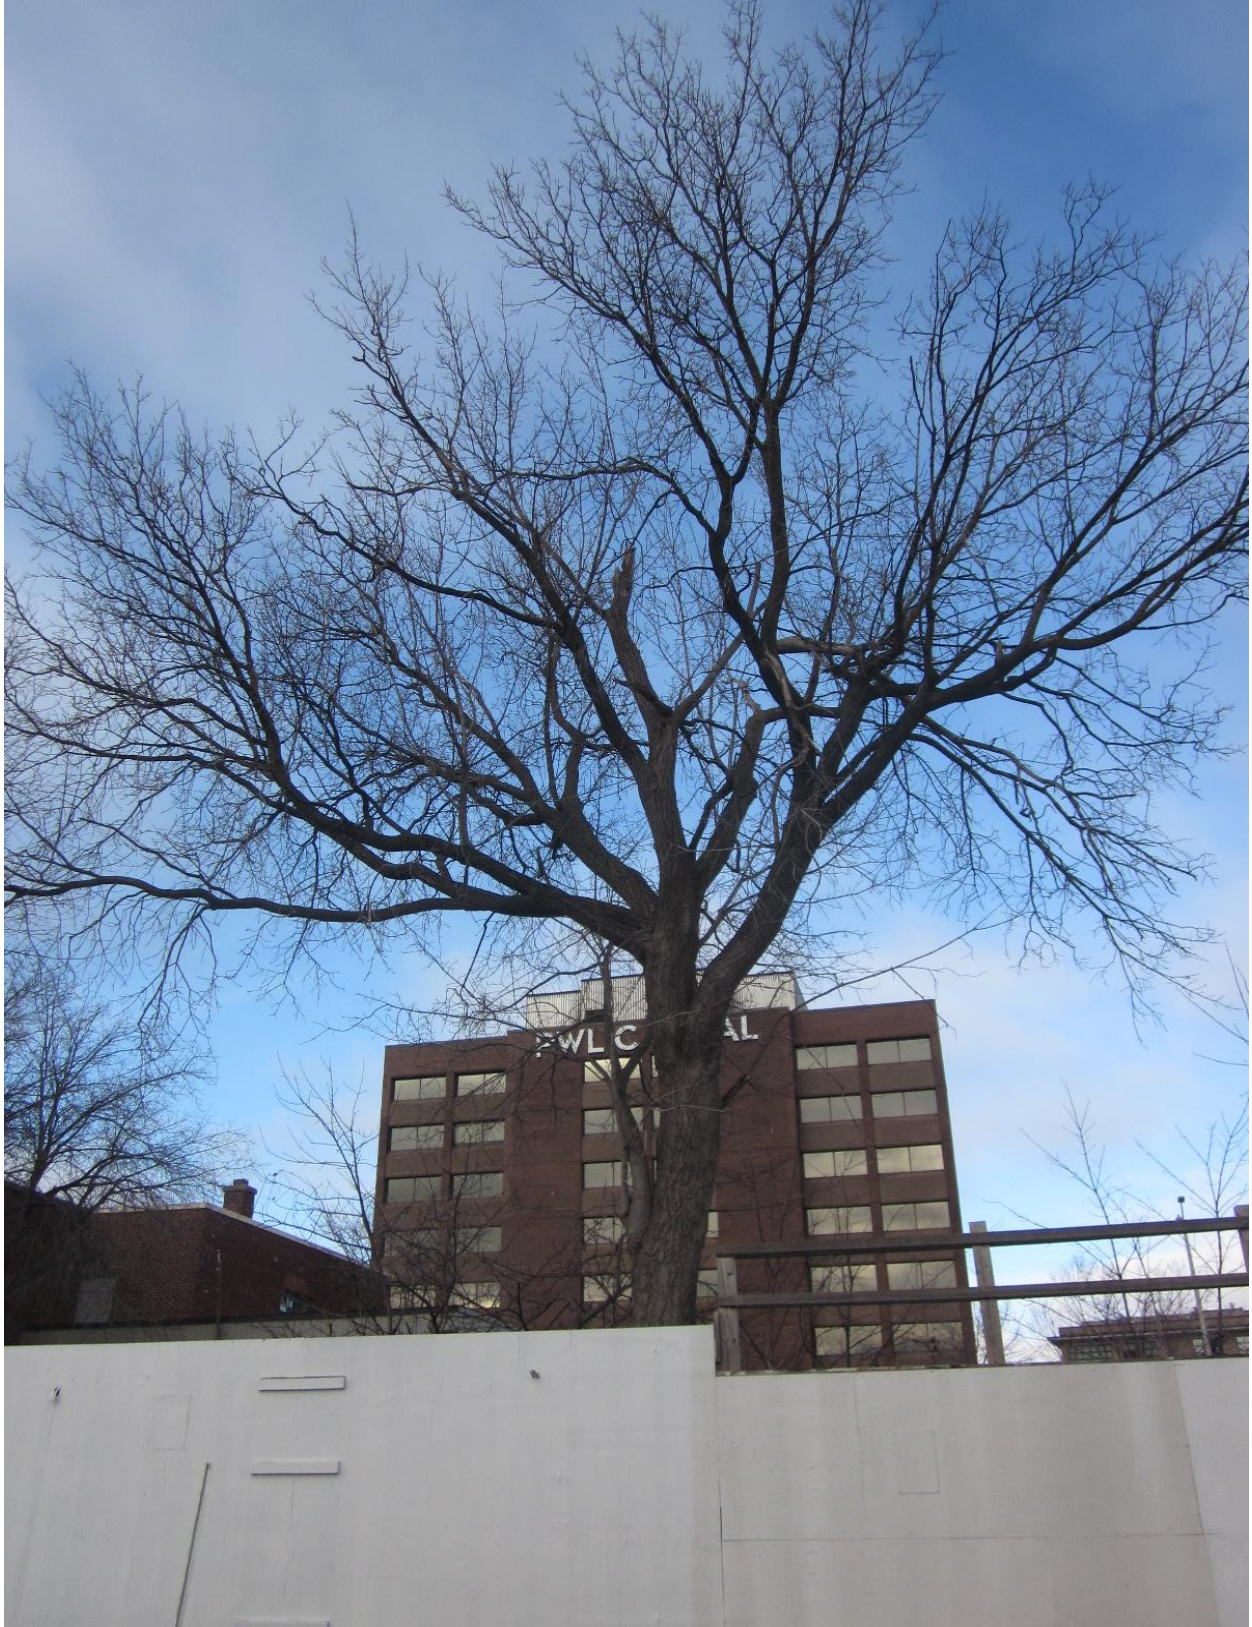
Picture 4. Tree #13 located on 770-774 Bronson Avenue
