January 24, 2013

Re: Tree Conservation Report – 120 Hearst Way, Kanata

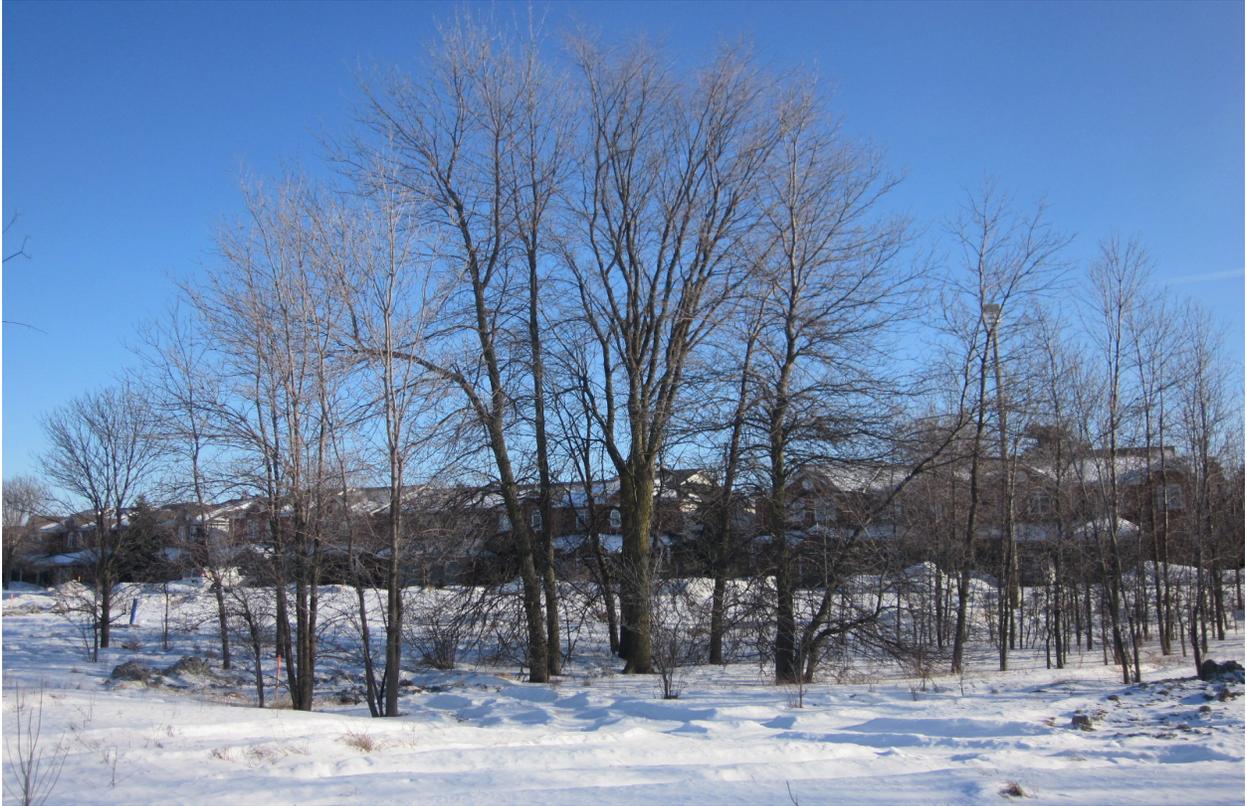
Picture 1. Mature and maturing ash and elm trees at 120 Hearst Way, Kanata.

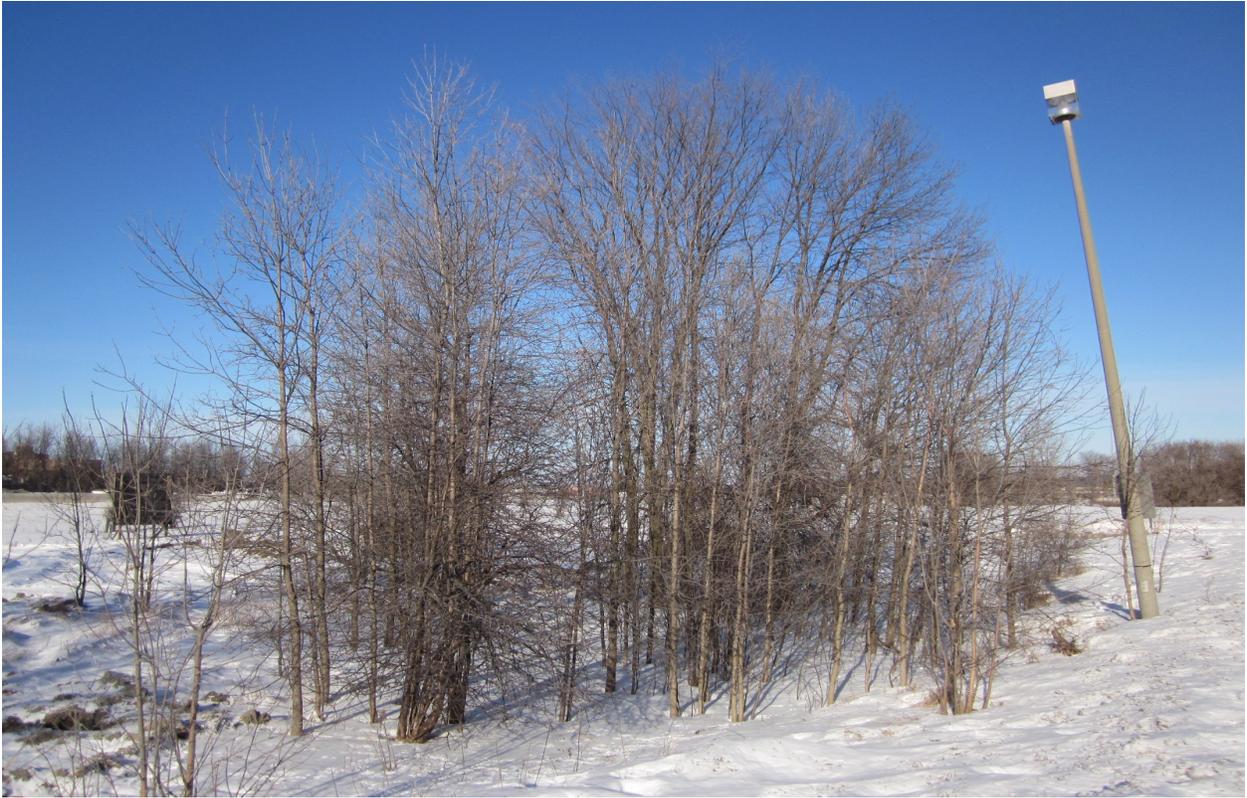
Picture 2. Grouping of juvenile/maturing ash trees at 120 Hearst Way, Kanata.

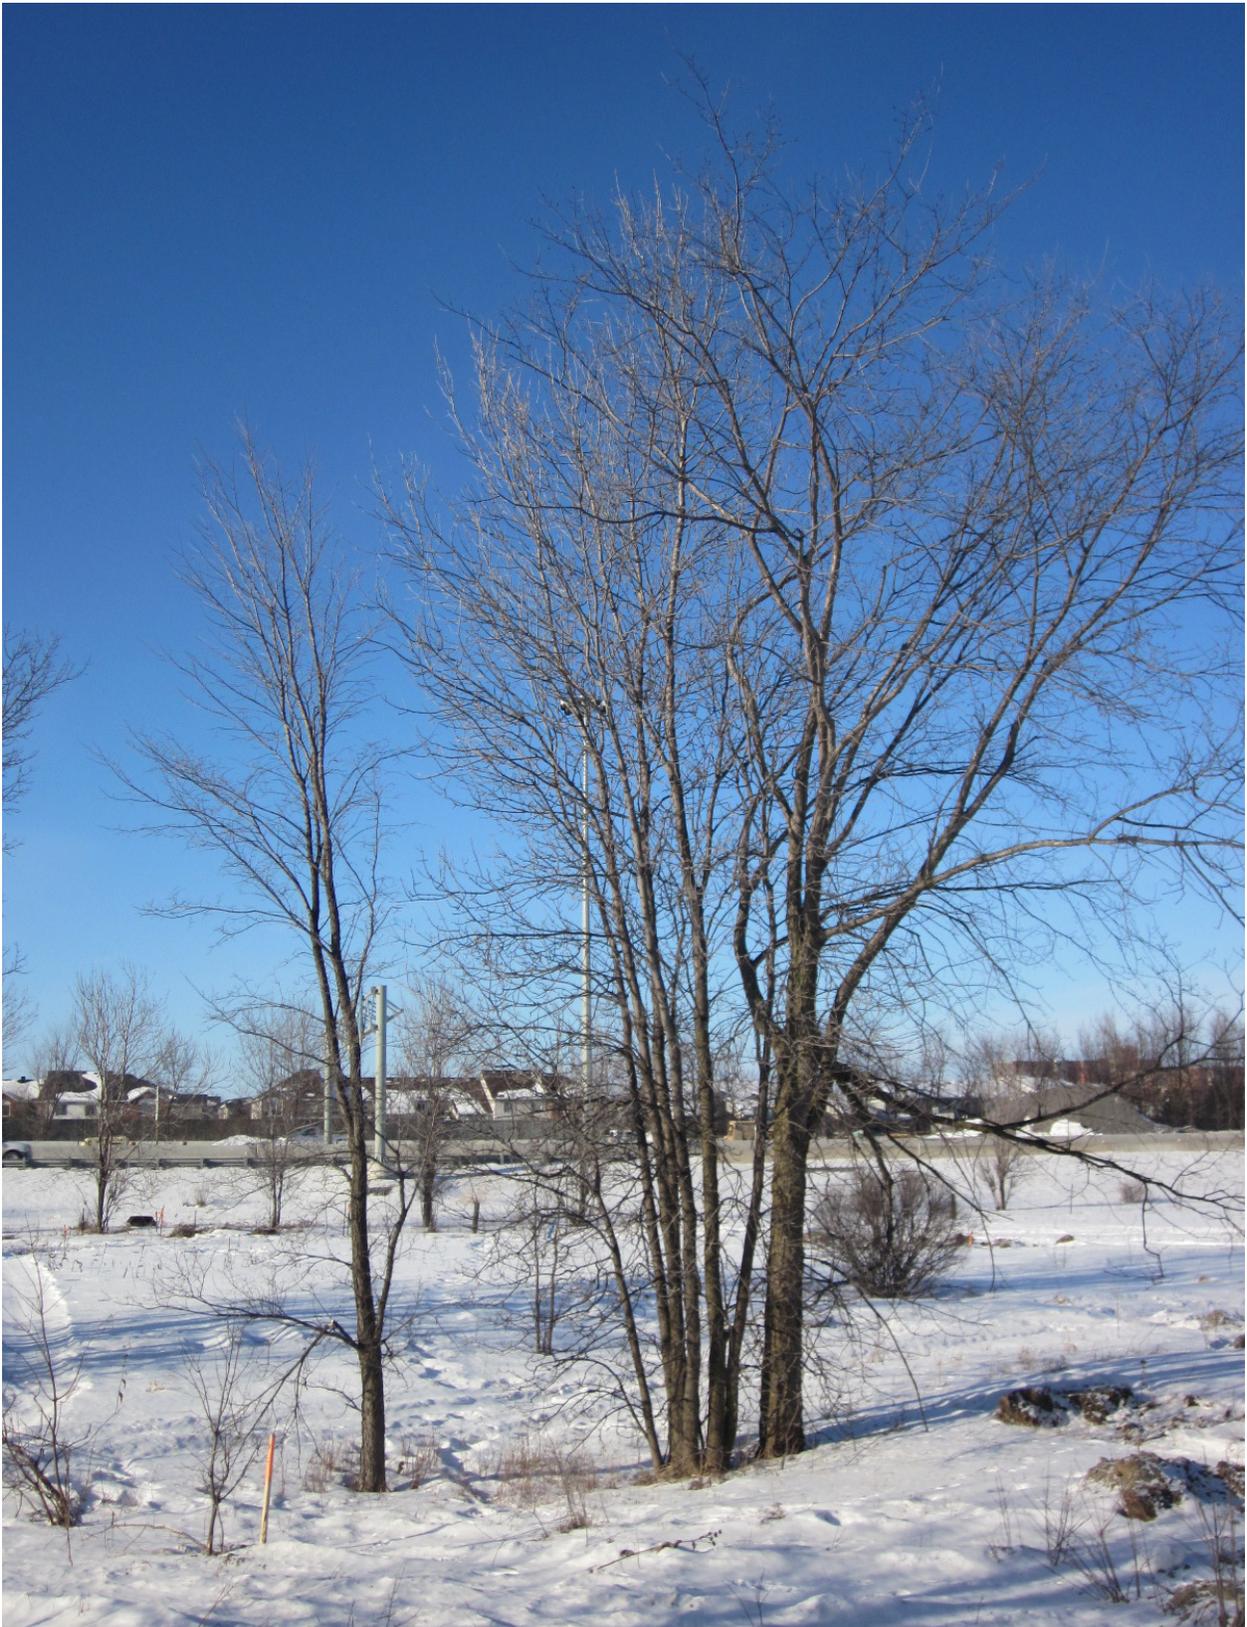
Picture 3. Mature and maturing ash and elm trees at 120 Hearst Way, Kanata.
