Urban Forestry & Forest Management Consulting

May 30, 2013

Re: Tree Conservation Report – 192, 196 Bronson Ave. & 31 Cambridge St., Ottawa

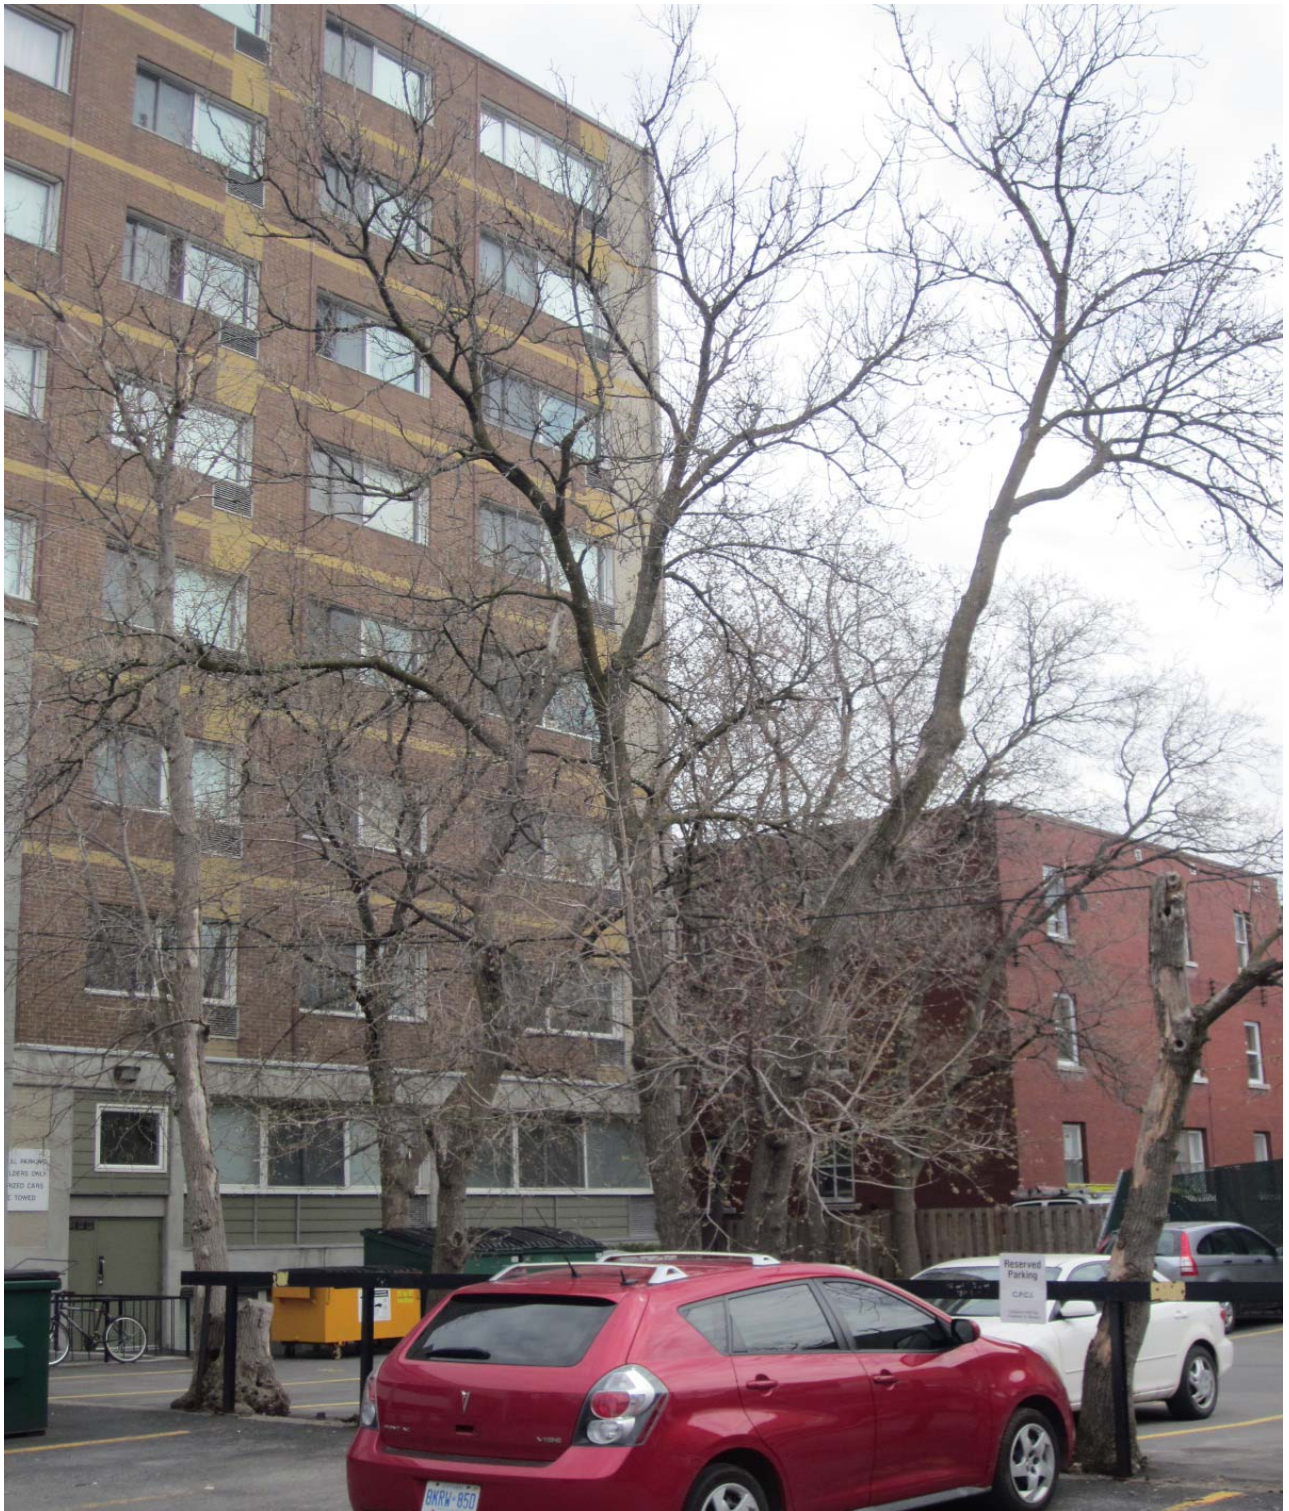
Tree No.	Tree Species	Condition (VP→E)	D.B.H (cm)	Tree Condition Notes & Status (to be removed, or retained)
1	Manitoba maple (<i>Acer negundo</i>)	Very poor	26	Co-dominant stem previously removed; decay throughout remaining stem - tree is hazardous; to be removed

Tree No.	Tree Species	Condition (VP→E)	D.B.H (cm)	Tree Condition Notes & Status (to be removed, or retained)
2	Manitoba maple	Poor	24	Cavity with decay @ 0.6m from grade; to be removed
3	Manitoba maple	Fair/Poor	28/25	Co-dominant stems @ 0.4m; to be removed
4	Manitoba maple	Very poor	28	Almost completely dead-only one secondary stem with viable buds; to be removed
5	Manitoba maple	Fair	27	Growing on moderate angle; shading tree #8; to be removed
6	Manitoba maple	Poor	33	Growing on heavy angle over road; pruned by Hydro; to be removed
7	Manitoba maple	Fair	34	Co-dominant stems @ 1.8m; heavily pruned by Hydro; to be removed
8	Norway maple (<i>Acer platanoides</i>)	Fair	9	Juvenile tree; shaded by tree #5-crown mildly asymmetrical; transplanting candidate; to be removed/transplanted
9	Norway maple	Good	7	Juvenile tree; transplanting candidate; to be removed/transplanted
10	Norway maple	Good	16	Maturing tree; transplanting candidate; to be removed/transplanted

Picture 1. Trees #1 through 4 on subject properties.

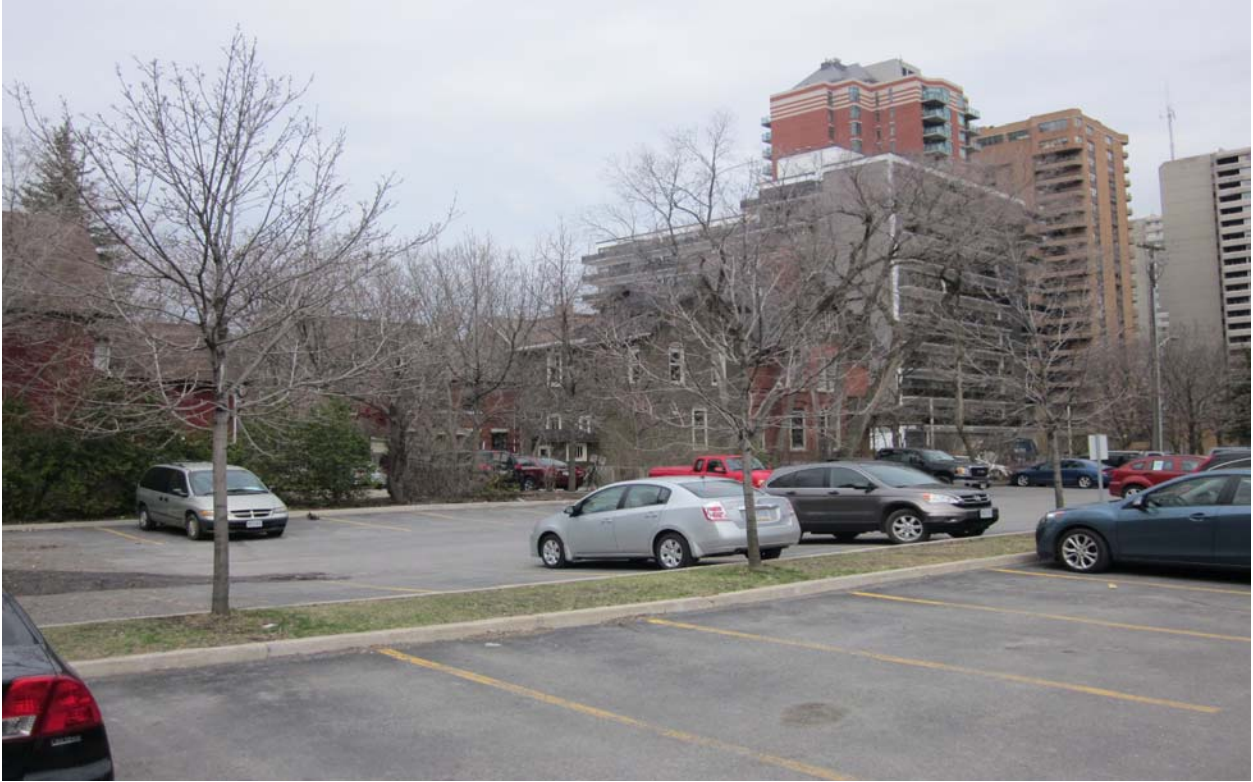
11	Norway maple	Good	13	Maturing tree; transplanting candidate; to be removed/transplanted
12	Norway maple	Good	11	Juvenile tree; transplanting candidate; to be removed/transplanted
13	Norway maple	Good	11	Juvenile tree; transplanting candidate; to be removed/transplanted
14	Norway maple	Good	11	Juvenile tree; transplanting candidate; to be removed/transplanted
15	Norway maple	Poor	24	On City property; heavily pruned by Hydro; to be removed
16	Norway maple	Fair	10	Juvenile tree; main stem vandalized (mechanically girdled); not a candidate for transplanting/ to be removed
17	Norway maple	Poor	22	On City property; heavily pruned by Hydro; to be removed
18	Norway maple	Poor	9	Juvenile tree; main stem vandalized (mechanically girdled); not a candidate for transplanting/ to be removed
19	Norway maple	Poor	19	On City property; heavily pruned by Hydro; to be removed

Picture 2. Trees #12, 13 and 14 on subject properties.

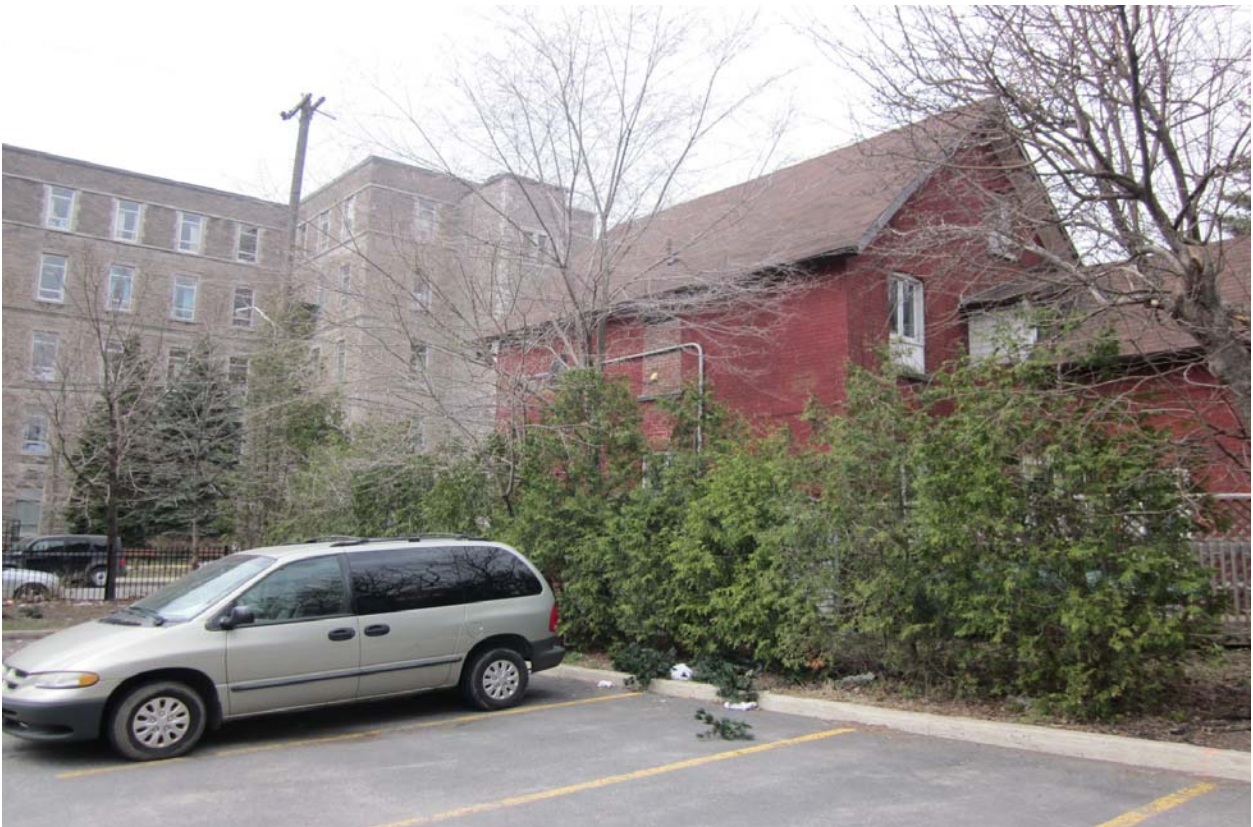
Tree No.	Tree Species	Condition (VP→E)	D.B.H (cm)	Tree Condition Notes & Status (to be removed, or retained)
20	Norway maple	Very poor	10	Juvenile tree; main stem vandalized (mechanically girdled); not a candidate for transplanting/ to be removed
21	White Cedar (<i>Thuja occidentalis</i>)	Fair	5 avg.	Maturing hedge; unmaintained but in generally good condition; seeded Manitoba maple and Siberian elm saplings competing for sunlight/ to be removed
22	Siberian elm (<i>Ulmus pumila</i>)	Good	25	On neighbouring private property; maturing tree; generally good growth form; invasive, undesirable species/ to be retained
23	Crab apple (<i>Malus</i> spp.)	Poor	33	Over-mature tree; major deadwood in crown-in advanced decline; trees #23-26 all with lilac underneath/ to be removed
24	Ash (<i>Fraxinus</i> spp.)	Fair	18	Early signs of Emerald ash borer (<i>Agrilus planipennis</i>) infestation-will soon be dead/ to be removed

Picture 3. Trees #20, 21 and 22 on subject properties.

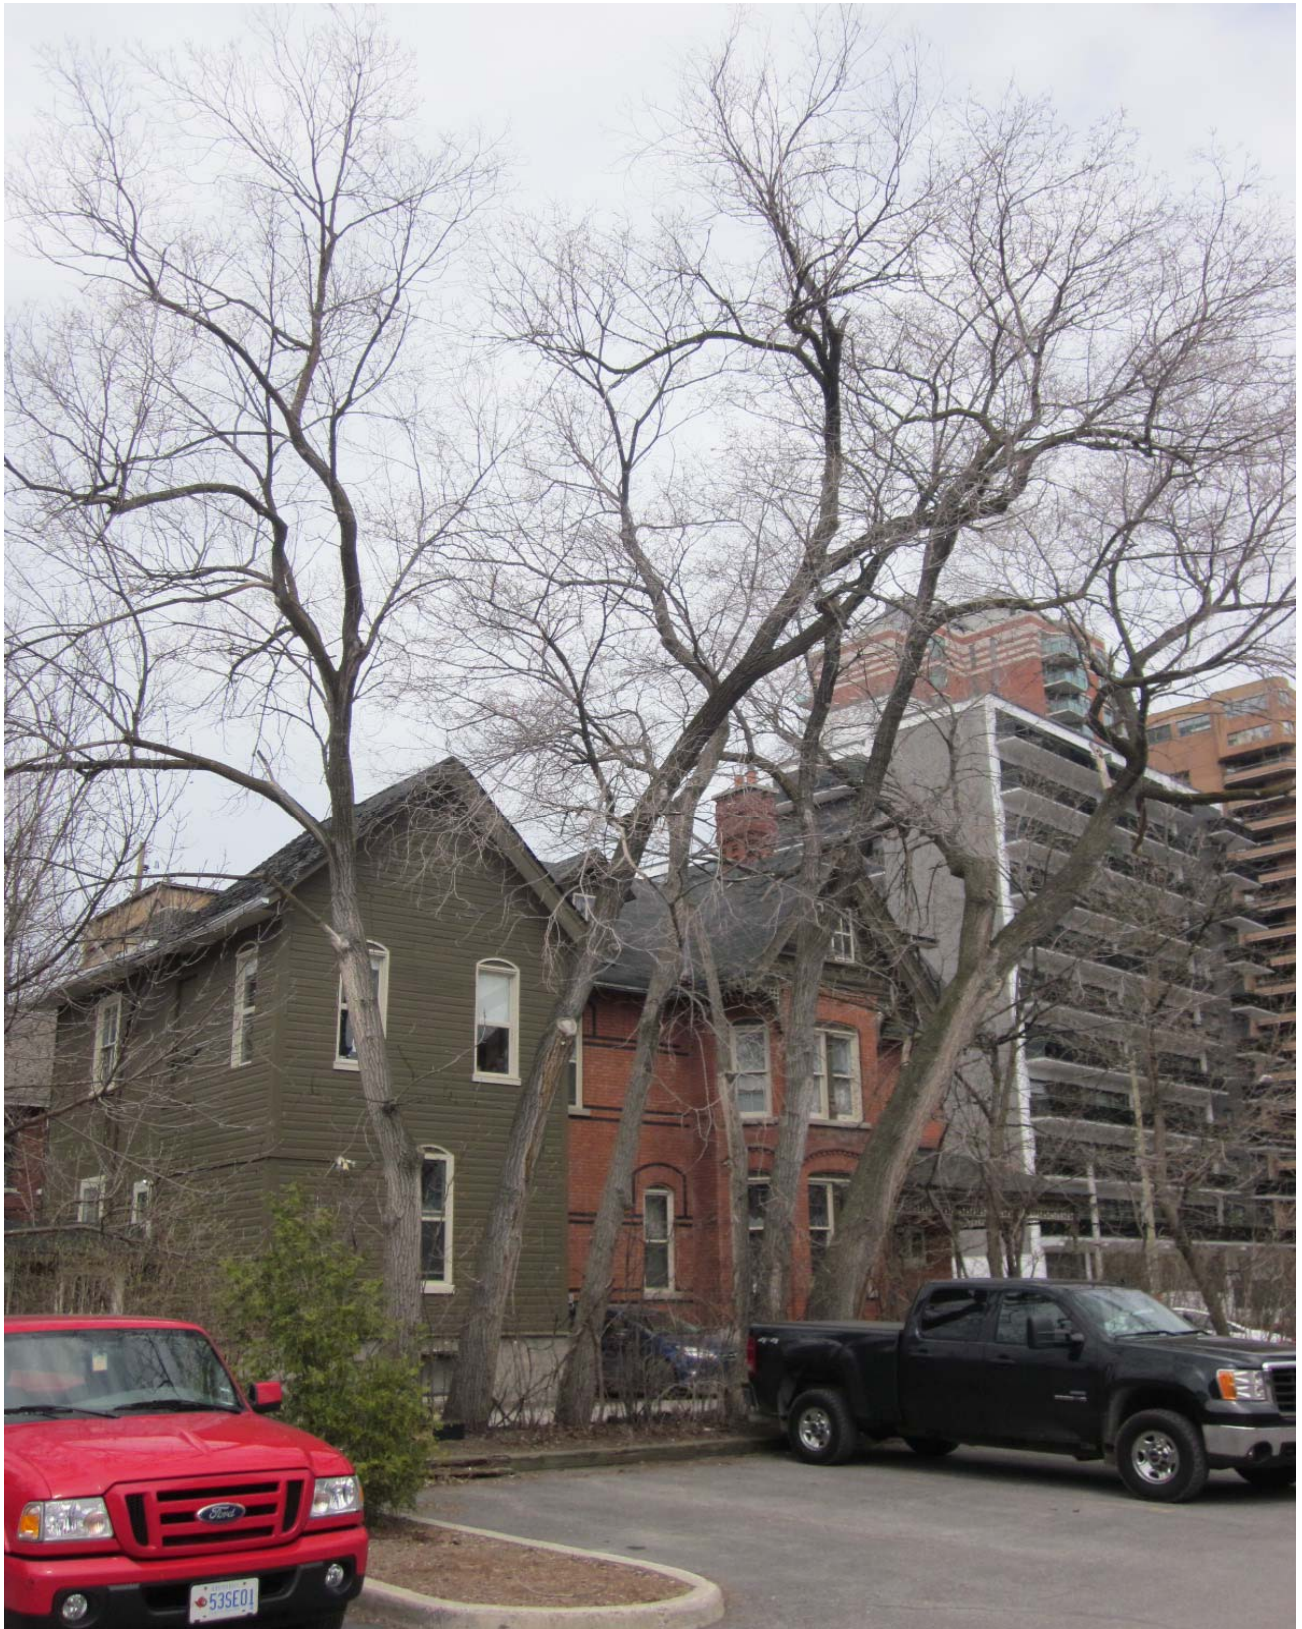
25	Little-leaf linden (<i>Tilia cordata</i>)	Good	20	Typical tear-drop growth form-will benefit from loss of adjacent ash/ to be removed
26	Ash	Fair	16	Early signs of Emerald ash borer (<i>Agrilus planipennis</i>) infestation-will soon be dead/ to be removed
27	Siberian elm	Fair	41	Mature tree; growing on mild angle; slime flux apparent in mid-crown; trees #27-31 each an invasive, undesirable species with chokecherry underneath/ to be removed
28	Siberian elm	Fair	40	Mature tree; growing on moderate angle due to intercompetition for sunlight/ to be removed
29	Siberian elm	Fair	31	On neighbouring private property; mature tree; growing on mild angle; slime flux apparent in mid-crown/ to be retained
30	Siberian elm	Fair	53	On neighbouring private property; mature tree; growing on mild angle/ to be retained
31	Siberian elm	Fair	59	On neighbouring private property; mature tree; growing on moderate angle due to intercompetition for light/ to be retained

Picture 4. Trees #27 through 31 on subject properties.

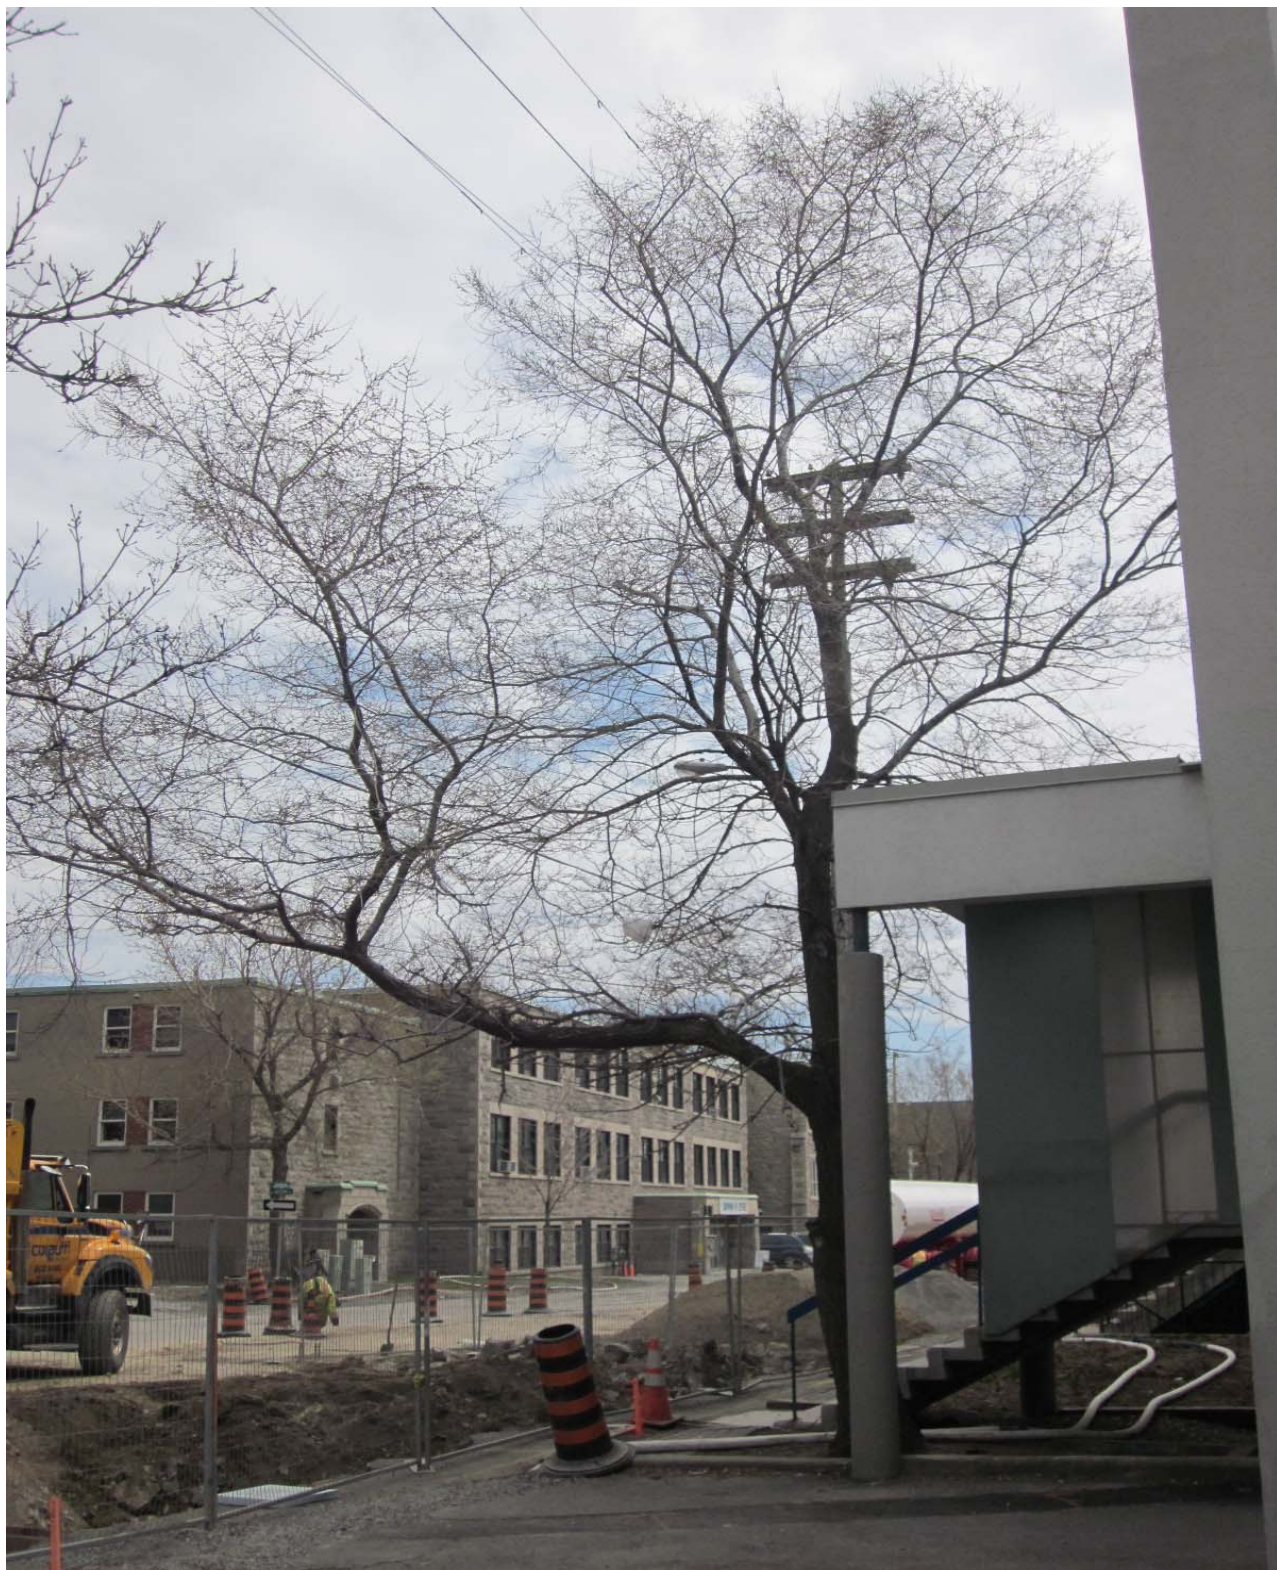
Tree No.	Tree Species	Condition (VP→E)	D.B.H (cm)	Tree Condition Notes & Status (to be removed, or retained)
32	Manitoba maple	Poor	14 avg.	On neighbouring private property; five-stemmed from grade-all divergent; trees #32 & 33 with Siberian pea-shrub underneath/ to be retained
33	Manitoba maple	Fair	23	On neighbouring private property; growing on mild lean/ to be retained
34	Norway maple	Good	24	Fair vigour and growth increment/ to be removed
35	Norway maple	Fair	23	Very restricted rooting area-low vigour, poor growth increment/ to be removed
36	Siberian elm	Fair	42	Crown asymmetrical due to proximity of building; invasive, undesirable species/ to be removed

Picture 5. Tree #36 on subject properties.
