TREE CONSERVATION REPORT - CHATEAU LAURIER RENTAL HOUSING EXPANSION, OTTAWA

October 30, 2015

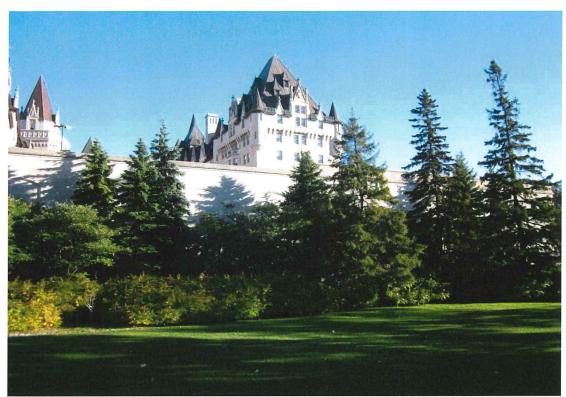
Picture 1. Line of trees in Major's Hill Park backing on to Chateau Laurier.

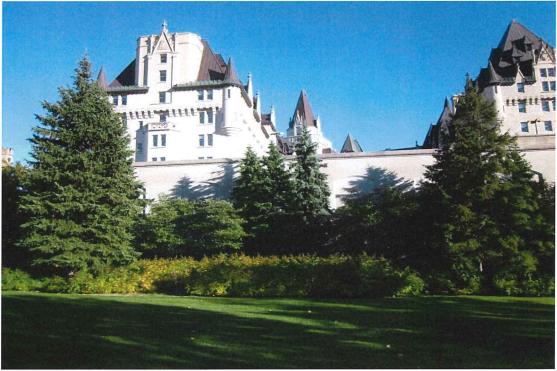
Picture 2. Line of trees in Major's Hill Park backing on to Chateau Laurier.

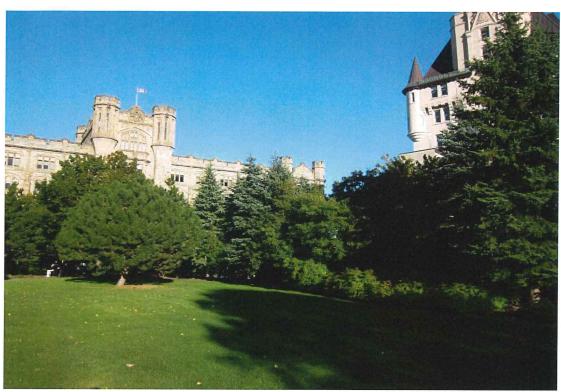
Picture 3. Line of trees in Major's Hill Park backing on to Chateau Laurier.

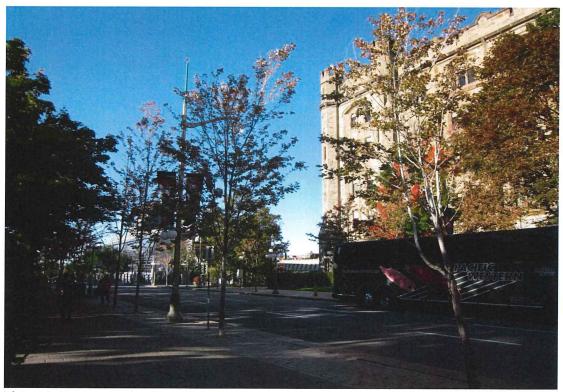
Picture 4. Freeman maples along Mackenzie Avenue adjacent to subject property.
