Condition of Existing Trees at 3802 and 3812 Green Bank Road.

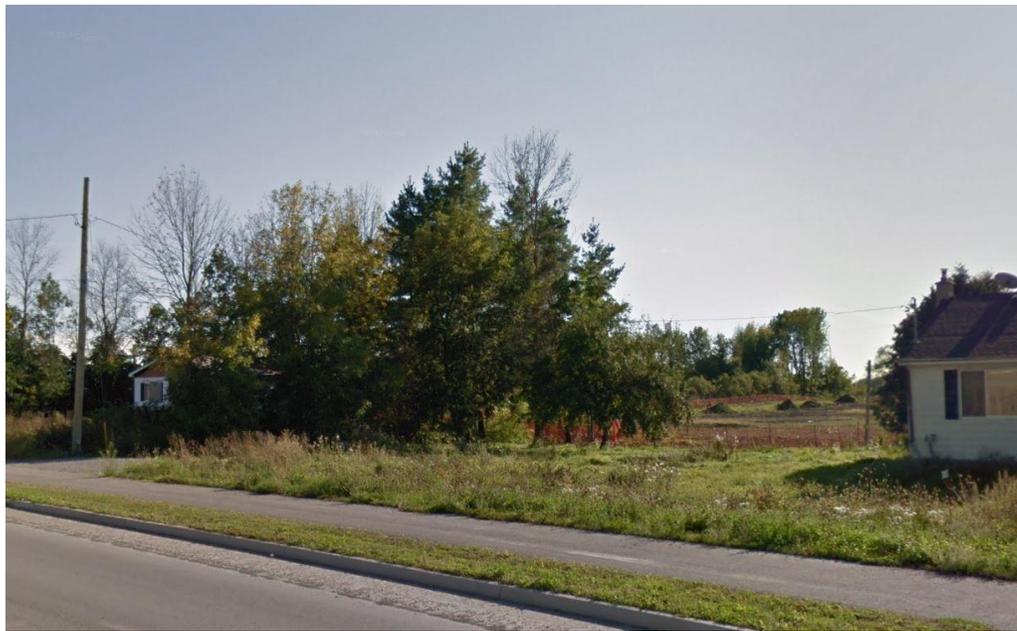
Summer 2014

In 2016 (bottom image) we can observe the considerable thinning of the row of trees bordering 3802 and 3812 Greenbank Rd when compared to the 2014 image (top).

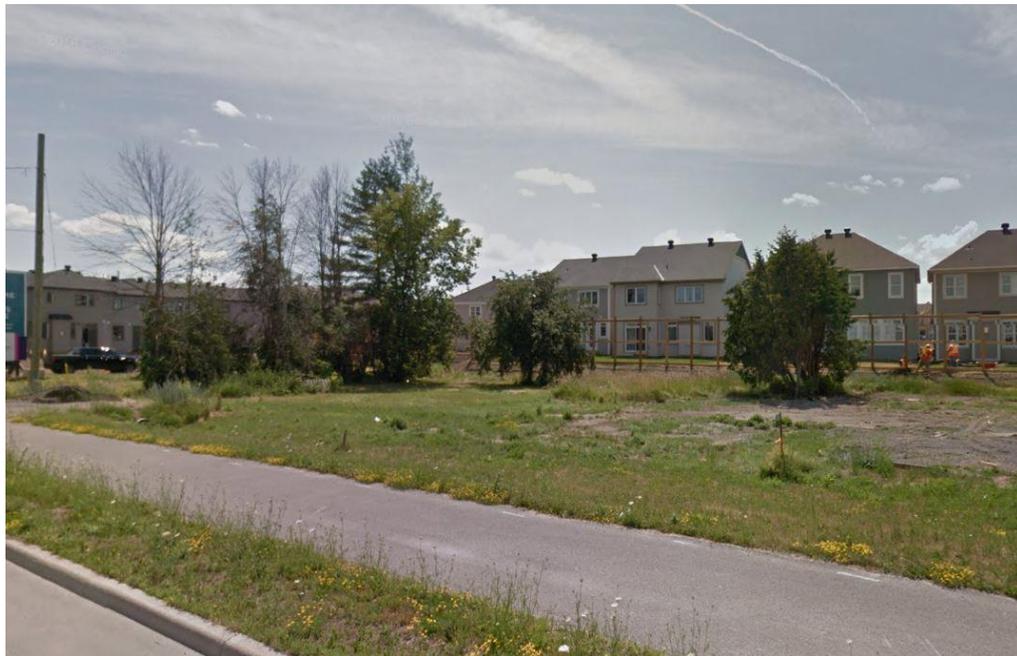
Summer 2016

Based on numerous site visits and utilizing Google Streetview image captures from Summer 2014 and Summer 2016, a noticeable decline in quantity and tree health can be observed on the subject site.

Based on these observations it is our opinion that there is no value in attempting to preserve any trees within this tree line as it would require a significant and difficult re-design of the proposed commercial building and it is unlikely the few remaining healthy trees would survive the construction in the long-run.

To mitigate the loss of trees on-site and improve the functional and aesthetic performance of the site, a substantial landscaping plan has been proposed. This plan will facilitate the planting of 17 trees along the periphery of the site to screen the proposed commercial use and surface parking lot from the surrounding residential community.
