**OTTAWA TRAIN YARDS PHASE 3 PARCEL 575-585-595**

**TREE INVENTORY & ARBORIST REPORT**

Sheet Number: ARB-1

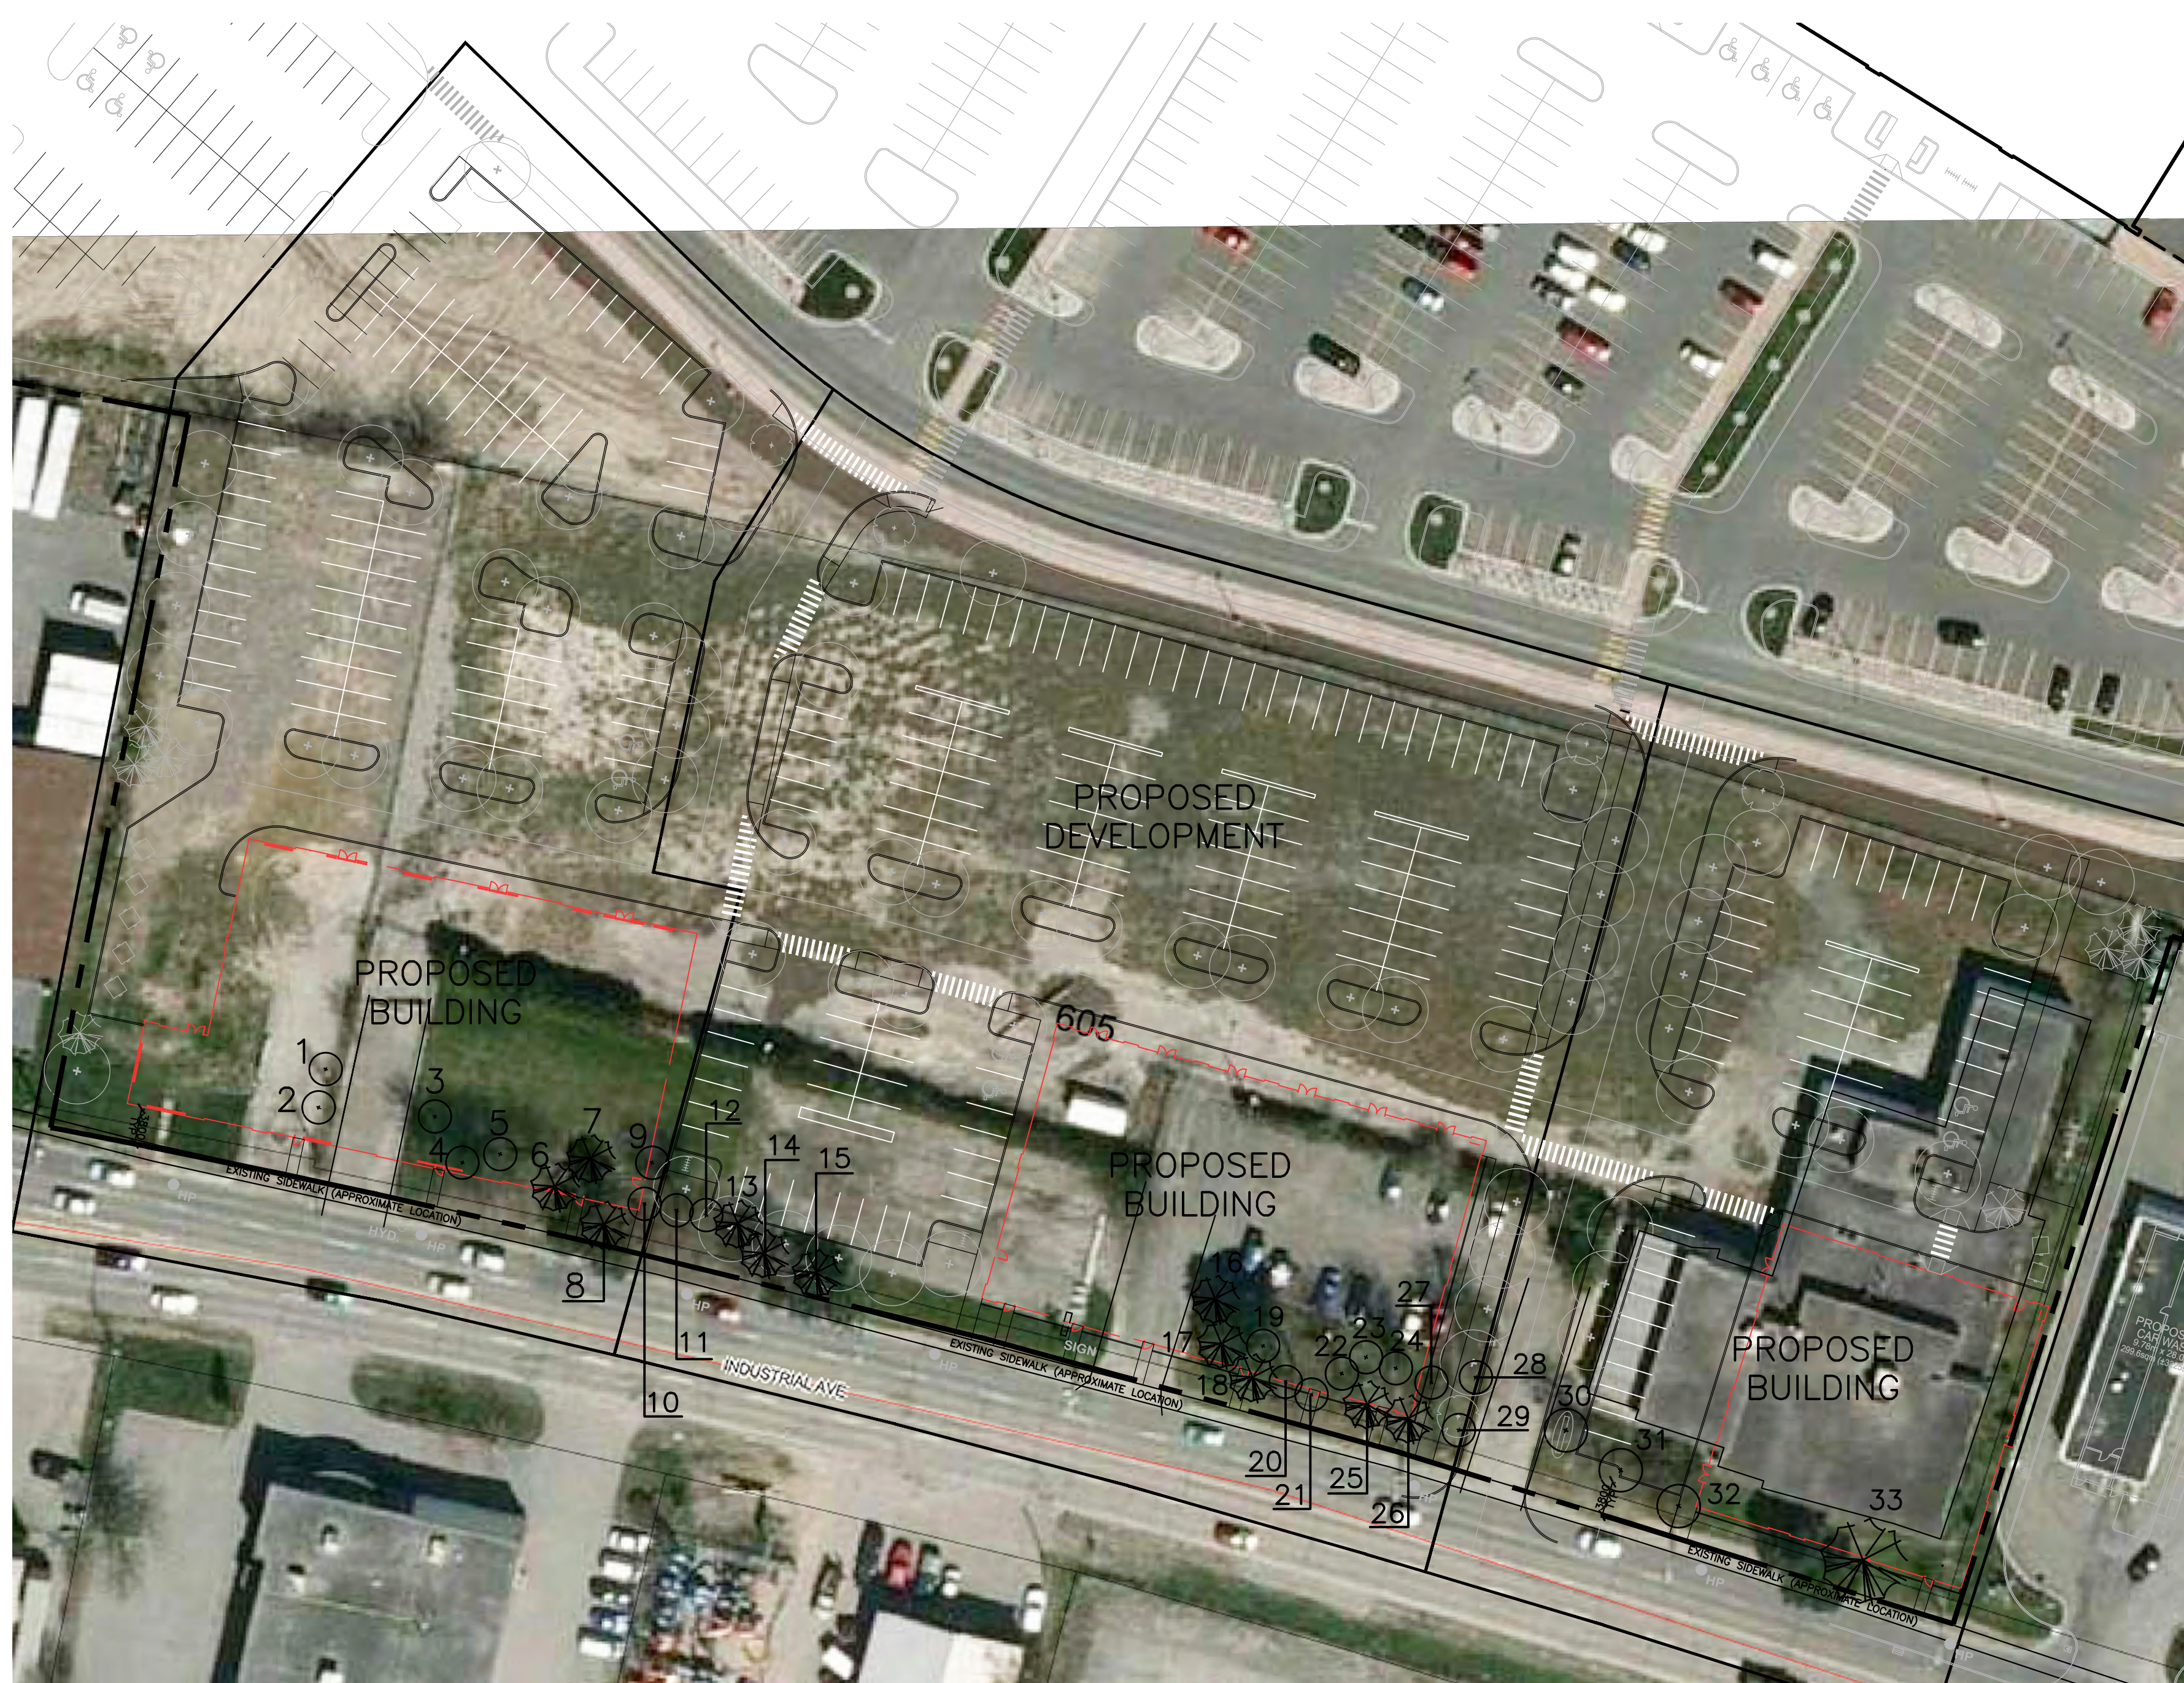
- ALL OF THE EXISTING TREES AND VEGETATION ON THE SITE ARE TO BE REMOVED. THIS IS DUE TO THEIR BEING SITUATED INSIDE THE FOOTPRINT OF THE PROPOSED ASPHALT PARKING AREAS AND PROPOSED BUILDINGS, AND THE NECESSARY REGRADING OF THE SITE. ALSO, SEVERAL OF THE TREES REQUIRE REMOVAL IMMEDIATELY (ALREADY DEAD).

- THERE ARE 33 TREES ON THE SITE, AT LEAST 3 OF WHICH ARE ALREADY DEAD. OF THE LIVING TREES, 17 ARE ASH TREES LIKELY ALREADY INFECTED BY EAB.
- THERE ARE 84 NEW TREES PROPOSED TO BE PLANTED ON THE REDEVELOPPED SITE. THESE WILL NOT BE SIMILAR IN SPECIES DISTRIBUTION TO THE VEGETATION REMOVED FROM THE SITE DUE TO THE UNSUITABILITY OF THE EXISTING SPECIES FOR THE PROPOSED DEVELOPMENT AND THE PROPENSITY OF ASH TREES TO DISEASE. THE PROPOSED NEW TREES WILL BE MAINLY DECIDUOUS TREES AND WILL INCLUDE MAPLE, HONEYLOCUST, OAK, CRABAPPLE, ELM AND SPRUCE. REFER TO THE LANDSCAPE DRAWINGS FOR A FULL PLANT LIST.

#	BOTANICAL NAME	COMMON NAME	CALIPER (cm)	CONDITION	APPROXIMATE AGE	HIGH QUALITY TREE	RARE TREE	COMMENTS	TO BE PRESERVED
1	Acer saccharum	Sugar Maple	24.2	POOR/ DEAD	41	NO	NO		NO
2	Acer saccharum	Sugar Maple	N/A	DEAD	N/A	NO	NO		NO
3	Fraxinus pennsylvanica	Green Ash	30-35cm approx	POOR	47	NO	NO	The tree is suckering heavily. It has been severely pruned for hydro clearance. There are no exit holes indicating an EAB infestation, and the tree is defoliated due to the season.	NO
4	Fraxinus pennsylvanica	Green Ash	42.0	POOR	66	NO	NO	The tree has been severely pruned for hydro clearance. There are no exit holes indicating an EAB infestation, and the tree is defoliated due to the season.	NO
5	Acer saccharum	Sugar Maple	N/A	DEAD	N/A	NO	NO		NO
6	Pinus nigra	Austrian Pine	38.4	MODERATE	68	NO	NO	The tree has been severely pruned for hydro clearance, but is otherwise in moderate condition.	NO
7	Pinus nigra	Austrian Pine	36.8	MODERATE	65	NO	NO	See notes for Tree 6	NO

8	Pinus nigra	Austrian Pine	31.4	MODERATE	56	NO	NO	See notes for Tree 6	NO
9	Fraxinus pennsylvanica	Green Ash	28 approx	POOR	44	NO	NO	See notes for tree 3	NO
10	Fraxinus pennsylvanica	Green Ash	35.6	POOR	56	NO	NO	See notes for tree 4	NO
11	Fraxinus pennsylvanica	Green Ash	29.6	POOR	47	NO	NO	See notes for tree 4	NO
12	Fraxinus pennsylvanica	Green Ash	N/A	DEAD	N/A	NO	NO		NO
13	Pinus nigra	Austrian Pine	MS (2) 27.2 & 21.0	MODERATE	45	NO	NO	The tree is in good health, but is beginning to grow into the overhead hydro lines.	NO
14	Pinus nigra	Austrian Pine	MS (2) 27.2 & 27.5	MODERATE-GOOD	49	NO	NO	See notes for Tree 13	NO
15	Pinus nigra	Austrian Pine	29.8	MODERATE-GOOD	53	NO	NO	See notes for Tree 13	NO
16	Pinus nigra	Austrian Pine	30.7	MODERATE-GOOD	55	NO	NO	The tree is in moderate to good condition.	NO
17	Pinus nigra	Austrian Pine	29.2	MODERATE	52	NO	NO	The tree is in moderate to good condition.	NO
18	Pinus nigra	Austrian Pine	41.4	MODERATE	74	NO	NO	The tree is in moderate to good condition.	NO

19	Fraxinus pennsylvanica	Green Ash	39.2	POOR	62	NO	NO	See notes for Tree 4	NO
20	Fraxinus pennsylvanica	Green Ash	38.2	POOR	60	NO	NO	See notes for Tree 4	NO
21	Fraxinus pennsylvanica	Green Ash	25.4	POOR	40	NO	NO	The tree has a severe lean, has been severely pruned for hydro, and has no exit holes indicating EAB. The tree is completely defoliated due to the season.	NO
22	Fraxinus pennsylvanica	Green Ash	MS (4) 22.4-32.0	POOR	42	NO	NO	See notes for Tree 4	NO
23	Fraxinus pennsylvanica	Green Ash	35.6	POOR	56	NO	NO	See notes for Tree 4	NO
24	Fraxinus pennsylvanica	Green Ash	35 approx	POOR	55	NO	NO	See notes for tree 3	NO
25	Pinus nigra	Austrian Pine	21.0	MODERATE-POOR	37	NO	NO	This tree has been topped for hydro clearance, and is otherwise in moderate to poor condition	NO
26	Pinus nigra	Austrian Pine	21.7	MODERATE-POOR	38	NO	NO	See notes for tree 25	NO
27	Fraxinus pennsylvanica	Green Ash	MS (2) 30 & 30 approx	MODERATE-POOR	47	NO	NO	This tree has not been pruned for hydro, and has no EAB exit holes, however it is suckering severely and the branches at the crown are discoloured and seem to indicate some crown-death	NO

28	Fraxinus pennsylvanica	Green Ash	35.1	MODERATE-POOR	55	NO	NO	See notes for tree 27	NO
29	Fraxinus pennsylvanica	Green Ash	40.8	MODERATE-POOR	64	NO	NO	See notes for tree 27	NO
30	Fraxinus pennsylvanica	Green Ash	25 approx	MODERATE-POOR	39	NO	NO	See notes for tree 27	NO
31	Fraxinus pennsylvanica	Green Ash	30 approx	MODERATE-POOR	47	NO	NO	See notes for tree 27	NO
32	Malus sp.	Crabapple	39.4	MODERATE	63	NO	NO	The tree is in relatively good condition, however it has a large split in the trunk, which has resulted in the death of a main branch.	NO
33	Pinus nigra	Austrian Pine	41.8	GOOD	73	NO	NO	The tree is in good condition. The lower limbs have been pruned, but the leader is intact and in good condition.	NO
