Tree Conservation Report

2112 Bel Air Drive, Ottawa, Ontario

August 2019
Prepared for Uniform Developments

RE: Tree Conservation Report for 2112 Bel Air Drive, Ottawa, Ontario

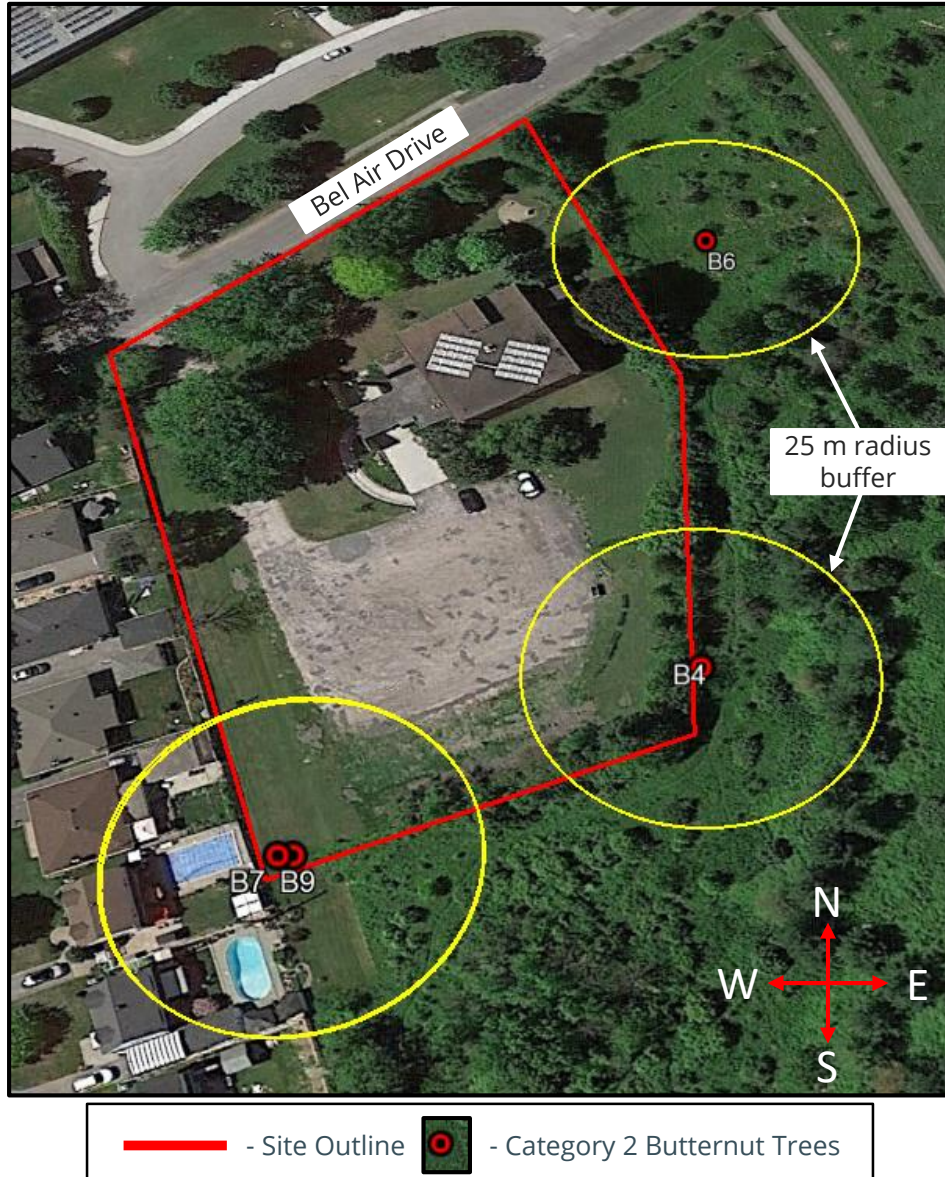
FIGURE 3: BUTTERNUT TREE LOCATIONS

Butternut Trees #4, #6, #7, and #9 were determined to be Category 2 (retainable) Butternut Trees. The locations of the Category 2 Butternut Trees are shown below in Figure 3. The rules and regulations of the Ontario ESA establish a 25 m buffer zone surrounding Butternut Trees. Any development activities that have the potential to harm Butternut Trees are considered an 'impact' to those trees if they occur within 25 m. Butternuts #5 and #7 occur within the redevelopment area and hence will be removed by the redevelopment. Butternut #4 occurs at the property line and will be retained within the rear yard setbacks. Butternut #6 occurs beyond the property line within the adjacent National Capital Commission lands. Although Butternut #6 and #4 will not be removed by the redevelopment, each tree is considered 'impacted' by the redevelopment, as they occur within 25 m.

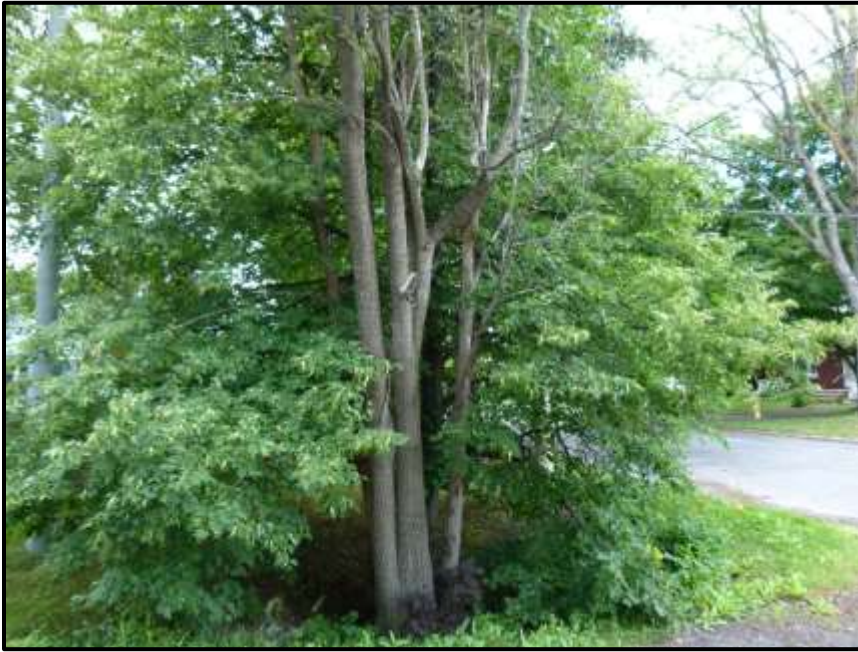
- **Vegetation Feature A:** Vegetation Feature A includes four (4) living stems of non-native Little Leaf Linden (*Tilia cordata*) that are 22 cm, 24 cm, 26 cm, and 30 cm diameter at breast height (dbh) in size. The feature also includes four (4) dead stems. The trees appear to have been planted as landscaping features.

Photograph 1: Looking west at Vegetation Feature A. Vegetation Feature A includes four (4) living stems of Little Leaf Linden and four (4) dead stems (August 9th, 2019).

- **Vegetation Features A, B, E, F, G, and X:** Vegetation Features A, B, E, F, G and X occur around the Site edges. Each feature consists of young to moderate sized trees. Where feasible and compatible with the grading and redevelopment requirements, existing trees that occur at the Site boundaries should be retained within the exterior side yard setbacks and/or the rear yard setbacks.

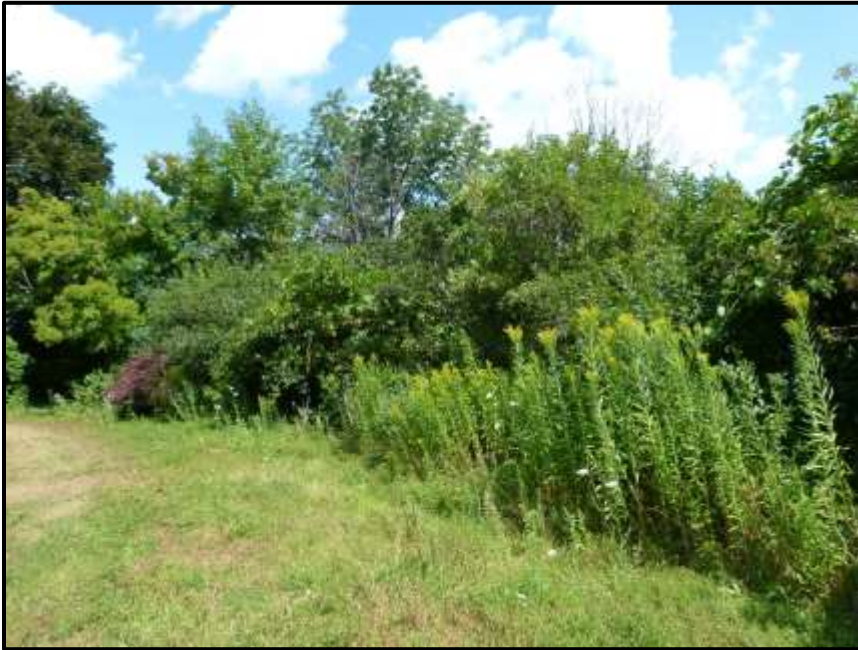
- **Vegetation Feature G:** Vegetation Feature G includes young recent regrowth shrubs and trees growing along the fence line. Species present include Common Buckthorn shrubs, as well as non-native Manitoba Maple and non-native Amur Maple (*Acer ginnala*) between 10 cm and 15 cm dbh in size.

Photograph 7: Looking north at Vegetation Feature G. Vegetation Feature G includes young recent regrowth shrubs and trees growing along the fence line (August 9th, 2019).

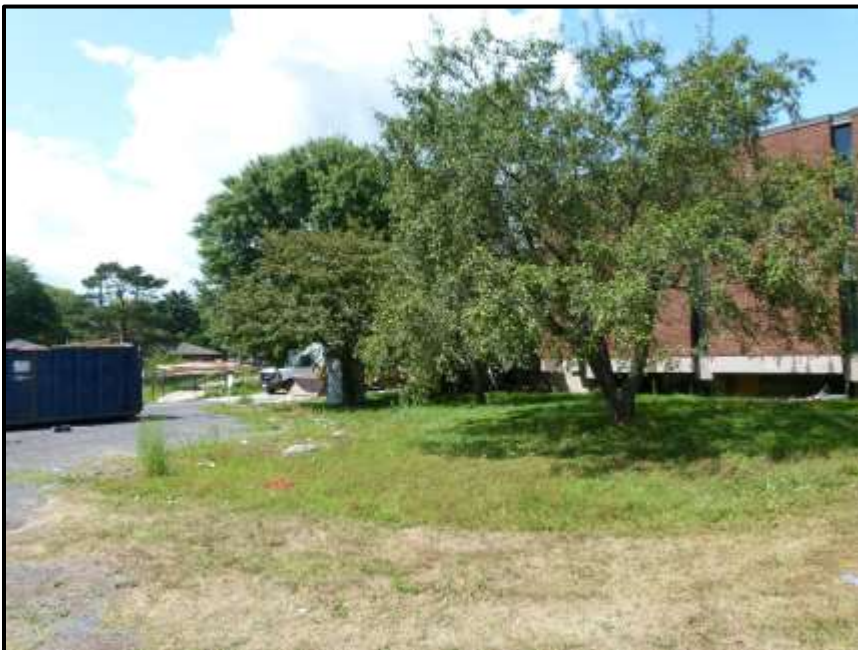
- **Vegetation Feature H:** Vegetation Feature H includes four (4) Crab Apple trees which are 31 cm, 34 cm, 26 cm, and 28 cm dbh in size. The trees appear to have been planted as landscaping features.

Photograph 8: Looking north at Vegetation Feature H. Vegetation Feature H includes four (4) Crab Apple trees (August 9th, 2019).

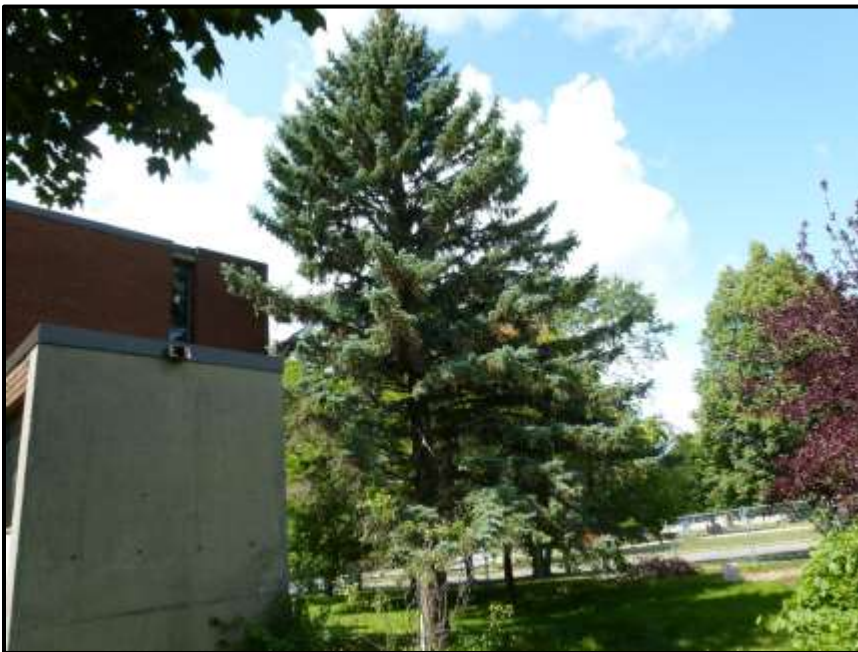
- **Vegetation Feature J:** Vegetation Feature J is a non-native 52 cm dbh Norway Spruce. The tree appears to have been planted as a landscaping feature.

Photograph 10: Looking north at Vegetation Feature J. Vegetation Feature J is a 52 cm dbh Norway Spruce (August 9th, 2019).

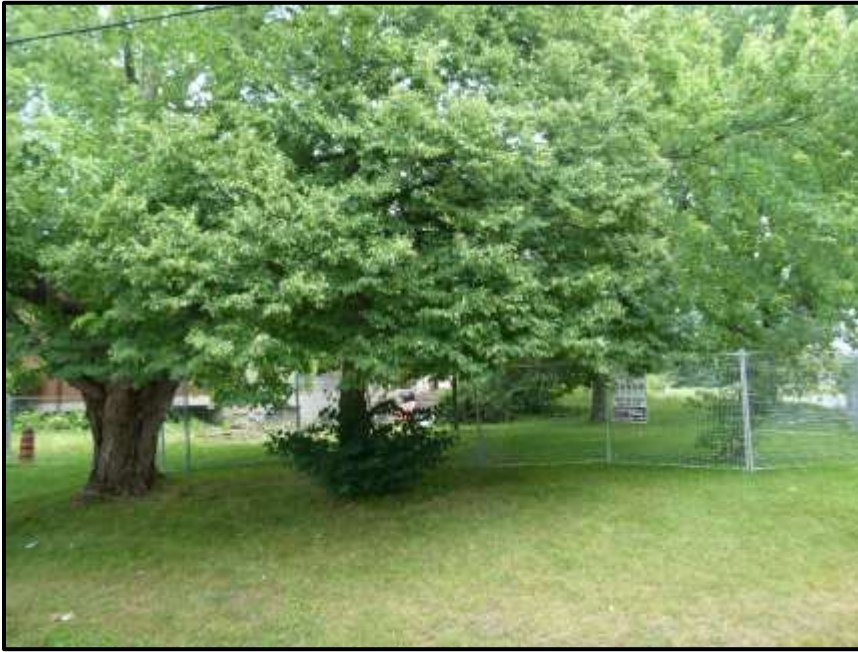
Photograph 17: Looking south at Vegetation Feature R. Vegetation Feature R is a 36 cm dbh Little Leaf Linden (August 9th, 2019).

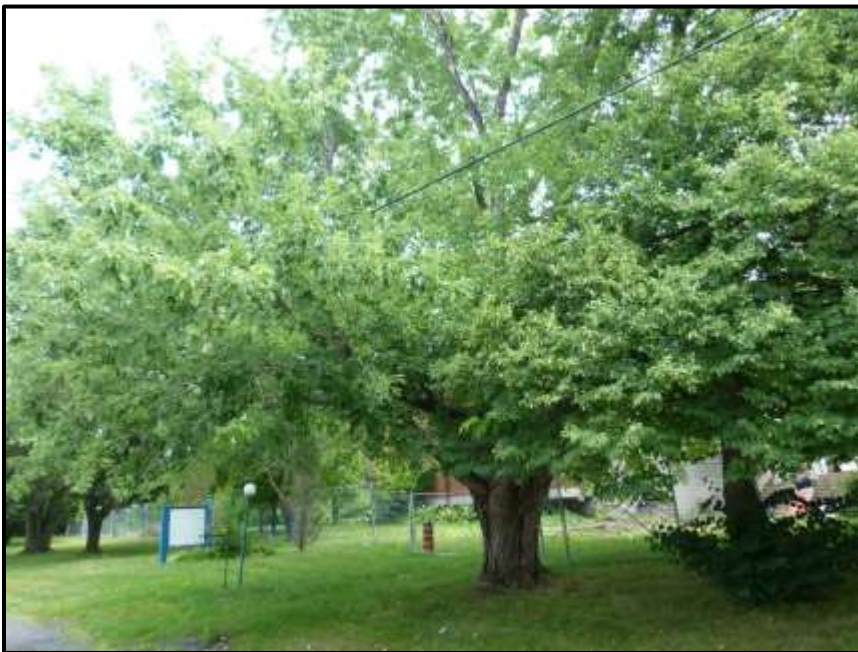
Photograph 18: Looking east at Vegetation Feature S. Vegetation Feature S is a 113 cm dbh Silver Maple (August 9th, 2019).

- **Vegetation Features S, T, and U:** Vegetation Feature S is a 113 cm dbh Silver Maple. Vegetation Feature T is a 59 cm dbh Norway Maple. Vegetation Feature U is a Silver Maple with six (6) stems. Although each of these trees are comparatively large, they occur within the proposed lots and access road, and hence cannot be retained.
