# Tree Conservation Report (Revised)

2112 Bel Air Drive, Ottawa, Ontario

May 2020  
Prepared for Uniform Developments

RE: Tree Conservation Report (Revised) for 2112 Bel Air Drive, Ottawa, Ontario

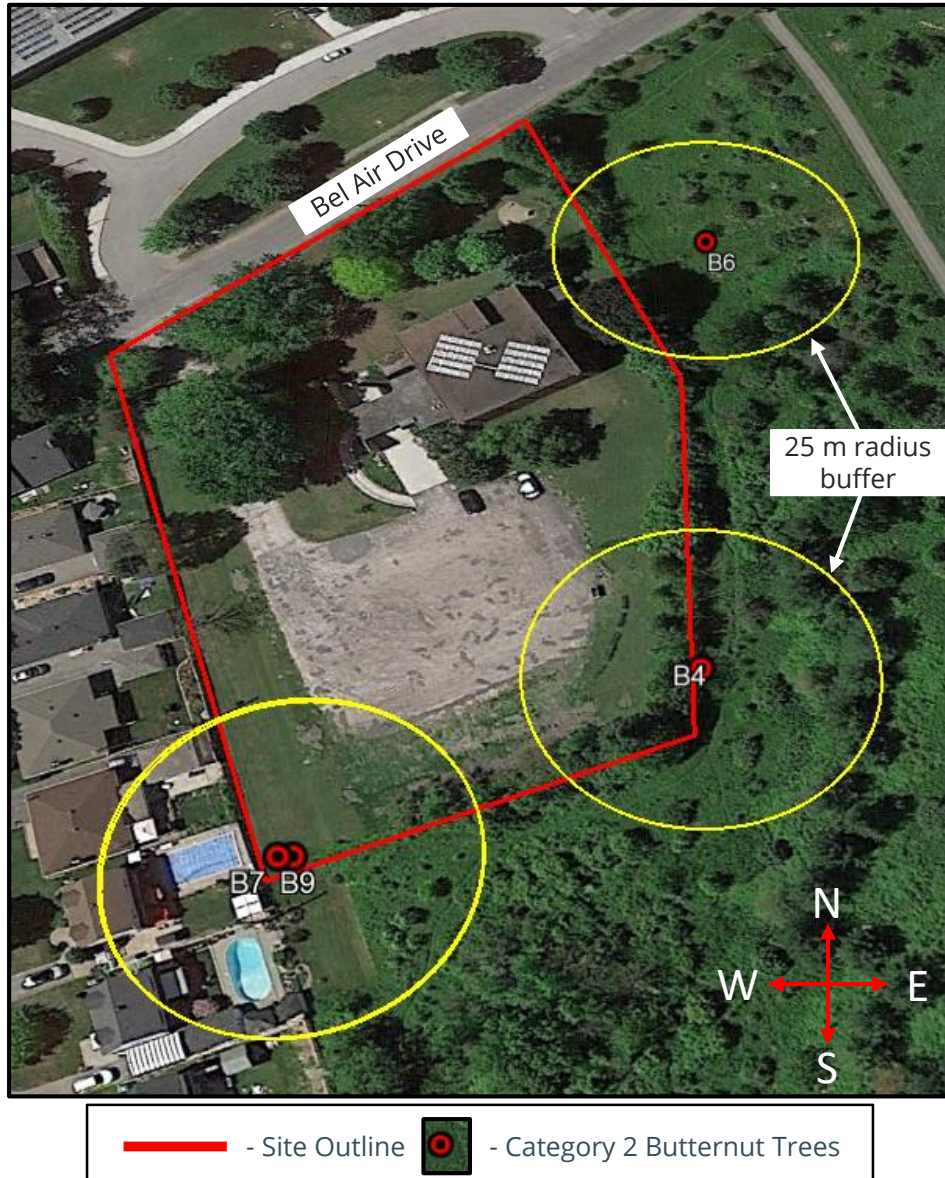
# FIGURE 3: BUTTERNUT TREE LOCATIONS

Butternut Trees #4, #6, #7, and #9 were determined to be Category 2 (retainable) Butternut Trees. The locations of the Category 2 Butternut Trees are shown below in Figure 3. The rules and regulations of the Ontario ESA establish a 25 m buffer zone surrounding Butternut Trees. Any development activities that have the potential to harm Butternut Trees are considered an 'impact' to those trees if they occur within 25 m. Butternuts #5 and #7 occur within the redevelopment area and hence will be removed by the redevelopment. Butternut #4 occurs at the property line and will be retained within the rear yard setbacks. Butternut #6 occurs beyond the property line within the adjacent National Capital Commission lands. Although Butternut #6 and #4 will not be removed by the redevelopment, each tree is considered 'impacted' by the redevelopment, as they occur within 25 m.

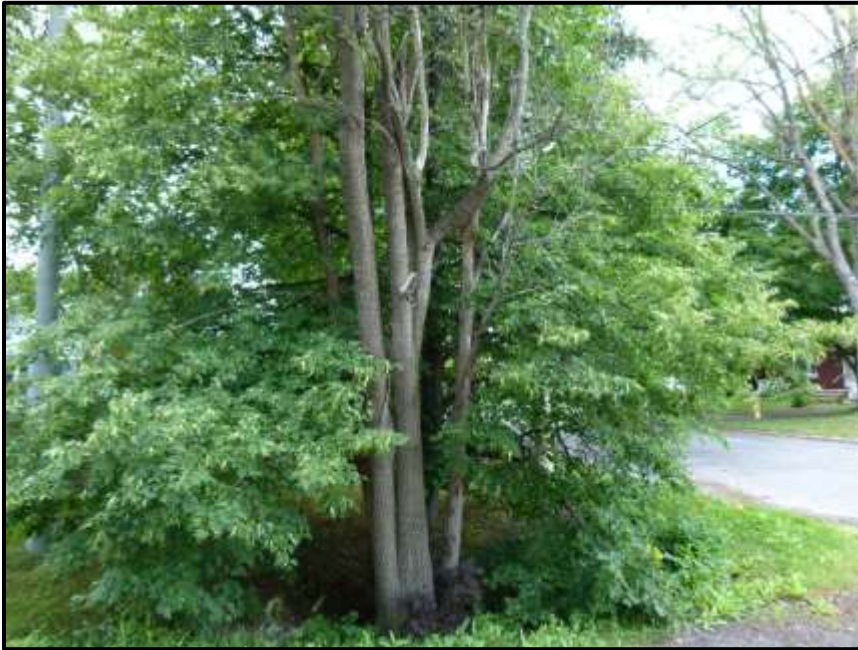
- **Vegetation Feature A:** Vegetation Feature A includes four (4) living stems of non-native Little Leaf Linden (*Tilia cordata*) that are 22 cm, 24 cm, 26 cm, and 30 cm diameter at breast height (dbh) in size. The feature also includes four (4) dead stems. The trees appear to have been planted as landscaping features.

**Photograph 1:** Looking west at Vegetation Feature A. Vegetation Feature A includes four (4) living stems of Little Leaf Linden and four (4) dead stems (August 9<sup>th</sup>, 2019).

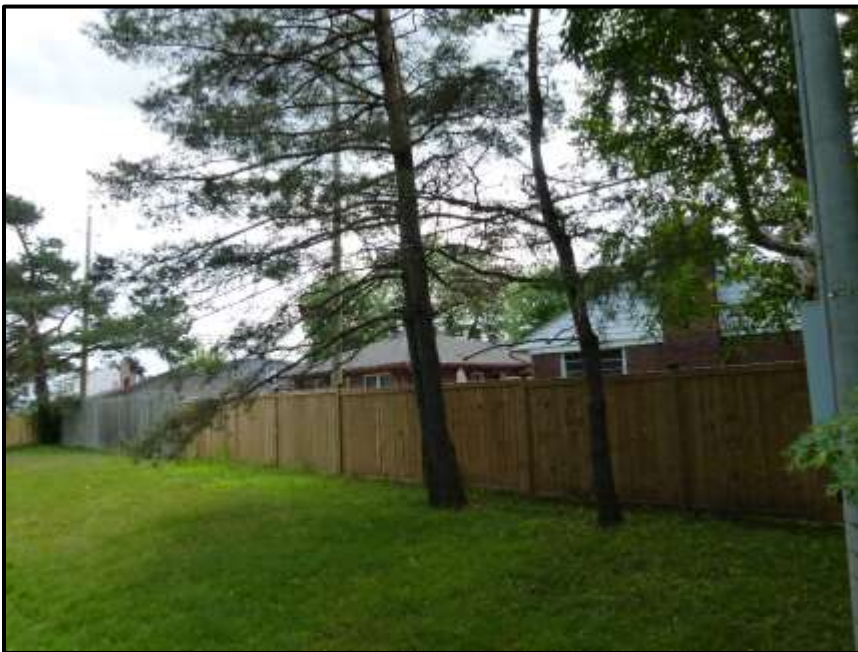
- **Vegetation Feature B:** Vegetation Feature B includes three (3) Red Pine (*Pinus resinosa*) which are 21 cm, 30 cm, and 35 cm dbh in size. The trees appear to have been planted as landscaping features.

**Photograph 2:** Looking south at Vegetation Feature B. Vegetation Feature B includes three (3) Red Pine (August 9<sup>th</sup>, 2019).

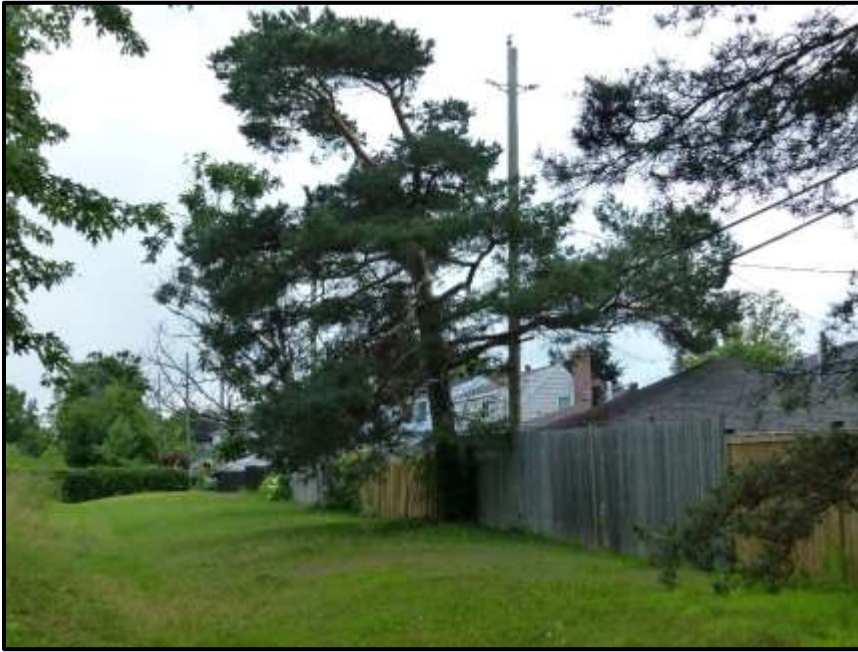
**Photograph 3:** Looking south at Vegetation Feature C. Vegetation Feature C includes a 50 cm dbh Red Pine (August 9<sup>th</sup>, 2019).

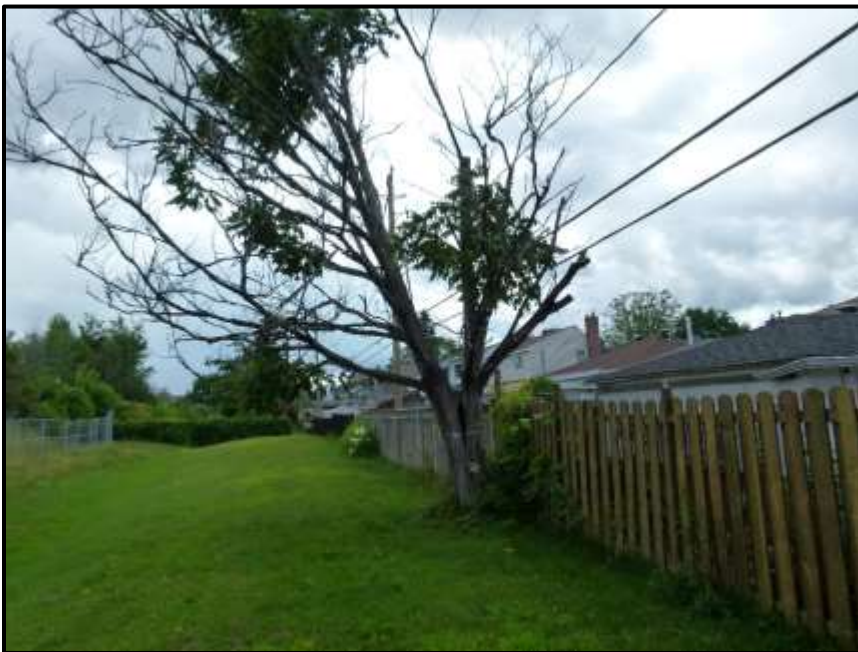
**Photograph 4:** Looking south at Vegetation Feature D. Vegetation Feature D includes a 59 cm dbh Butternut Tree (Butternut #1) (August 9<sup>th</sup>, 2019).

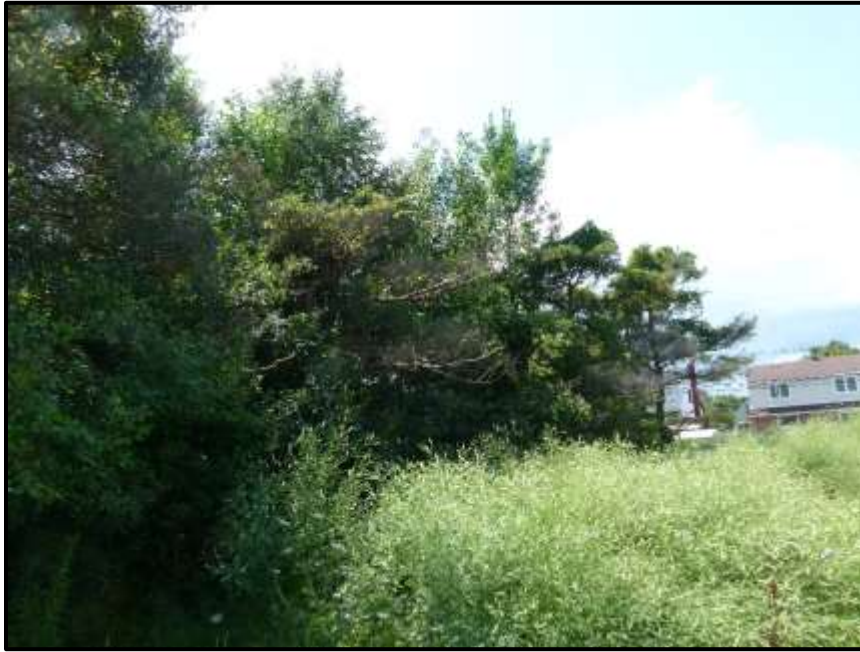
- **Vegetation Feature E:** Vegetation Feature E includes a row of four (4) living Red Pine which are 32 cm, 33 cm, 23 cm, and 25 cm dbh in size. The row also includes two (2) dead Red Pine. The Red Pines appear to have been planted as landscaping features. The trees occur at the fence line and are overgrown with Common Buckthorn (*Rhamnus cathartica*) shrubs, Riverbank Grape (*Vitis riparia*), and young recent regrowth (<15 cm dbh) stems of Manitoba Maple (*Acer negundo*), White Ash (*Fraxinus americana*), American Elm (*Ulmus americana*), and Crab Apple (*Malus sp.*).

**Photograph 5:** Looking west at Vegetation Feature E. Vegetation Feature E includes a row of four (4) living Red Pine and two (2) dead Red Pine, which are overgrown (August 9<sup>th</sup>, 2019).

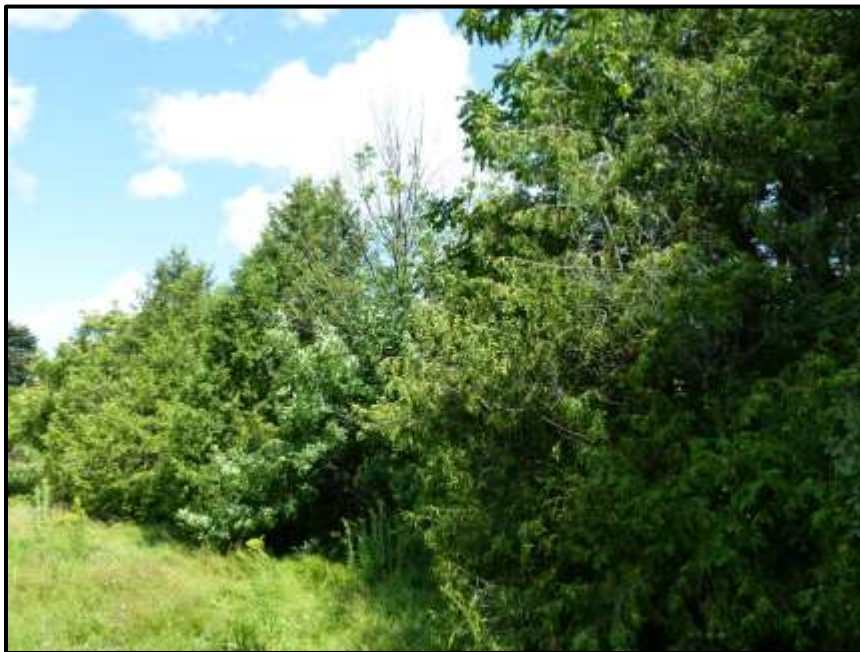
- **Vegetation Feature F:** Vegetation Feature F includes an overgrown White Cedar (*Thuja occidentalis*) hedge that includes several White Cedar stems between 10 cm and 25 cm dbh in size. The hedge includes two (2) non-native Norway Spruce (*Picea abies*) that are 28 cm and 27 cm dbh in size, as well as Butternut Tree #4, which is 29 cm dbh in size. With the exception of Butternut Tree #4, the trees appear to have been planted as landscaping features.

**Photograph 6:** Looking east at Vegetation Feature F. Vegetation Feature F includes an overgrown White Cedar hedge that includes two (2) Norway Spruce as well as Butternut Tree #4 (August 9<sup>th</sup>, 2019).

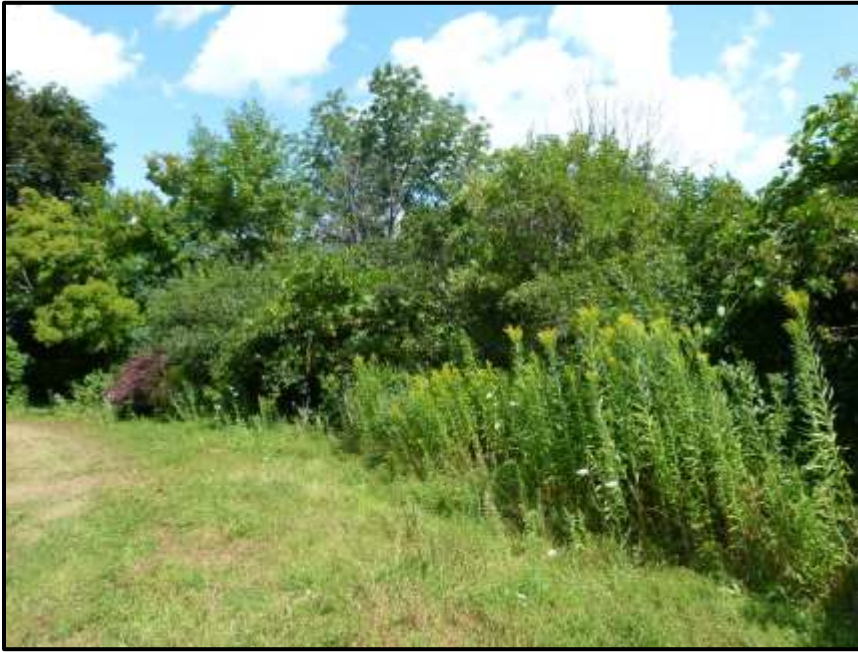
- **Vegetation Feature G:** Vegetation Feature G includes young recent regrowth shrubs and trees growing along the fence line. Species present include Common Buckthorn shrubs, as well as non-native Manitoba Maple and non-native Amur Maple (*Acer ginnala*) between 10 cm and 15 cm dbh in size.

**Photograph 7:** Looking north at Vegetation Feature G. Vegetation Feature G includes young recent regrowth shrubs and trees growing along the fence line (August 9<sup>th</sup>, 2019).

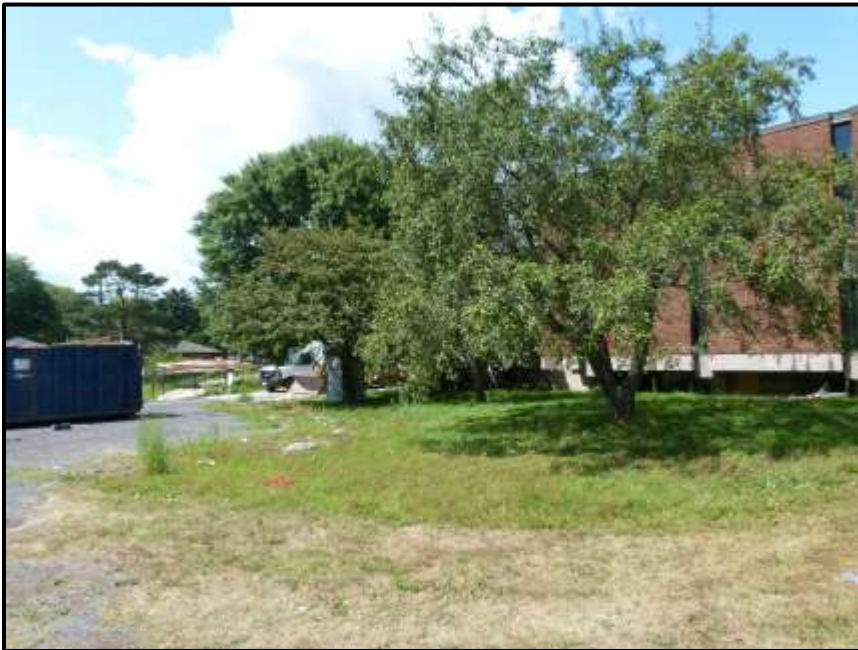
- **Vegetation Feature H:** Vegetation Feature H includes four (4) Crab Apple trees which are 31 cm, 34 cm, 26 cm, and 28 cm dbh in size. The trees appear to have been planted as landscaping features.

**Photograph 8:** Looking north at Vegetation Feature H. Vegetation Feature H includes four (4) Crab Apple trees (August 9<sup>th</sup>, 2019).

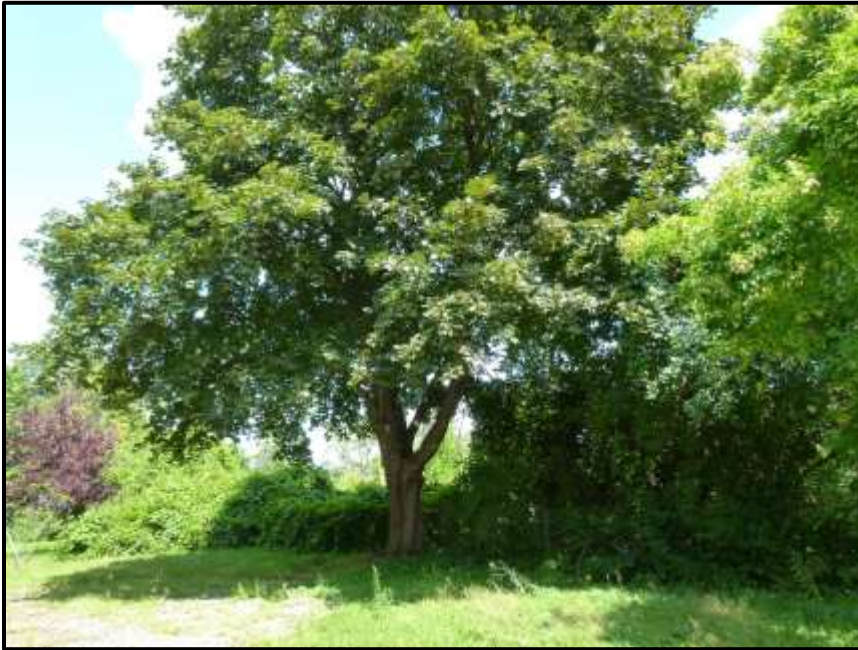
- **Vegetation Feature I:** Vegetation Feature I is a non-native 84 cm dbh Norway Maple (*Acer platanoides*). The tree appears to have been planted as a landscaping feature.

**Photograph 9:** Looking north at Vegetation Feature I. Vegetation Feature I is an 84 cm dbh Norway Maple (August 9<sup>th</sup>, 2019).

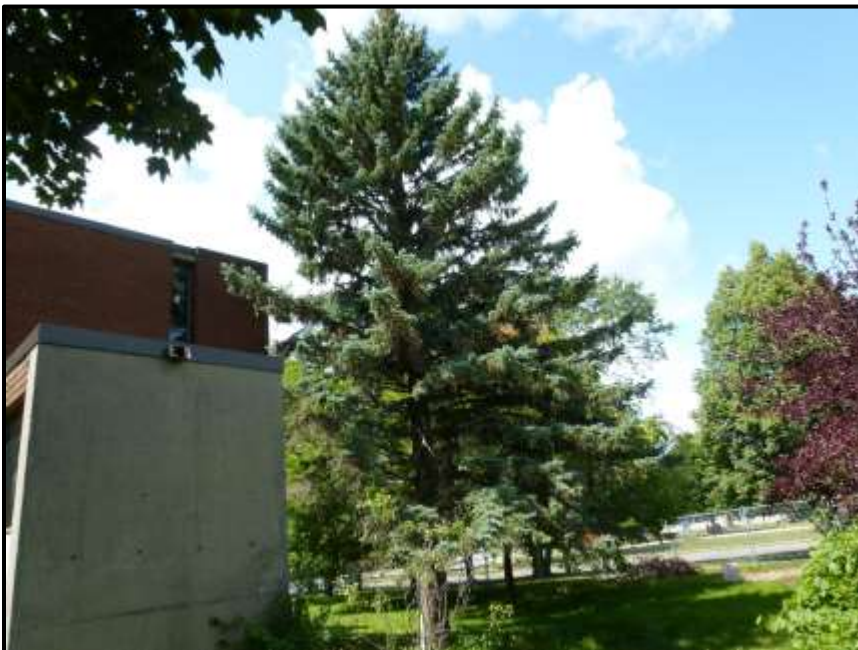
- **Vegetation Feature J:** Vegetation Feature J is a non-native 52 cm dbh Norway Spruce. The tree appears to have been planted as a landscaping feature.

**Photograph 10:** Looking north at Vegetation Feature J. Vegetation Feature J is a 52 cm dbh Norway Spruce (August 9<sup>th</sup>, 2019).

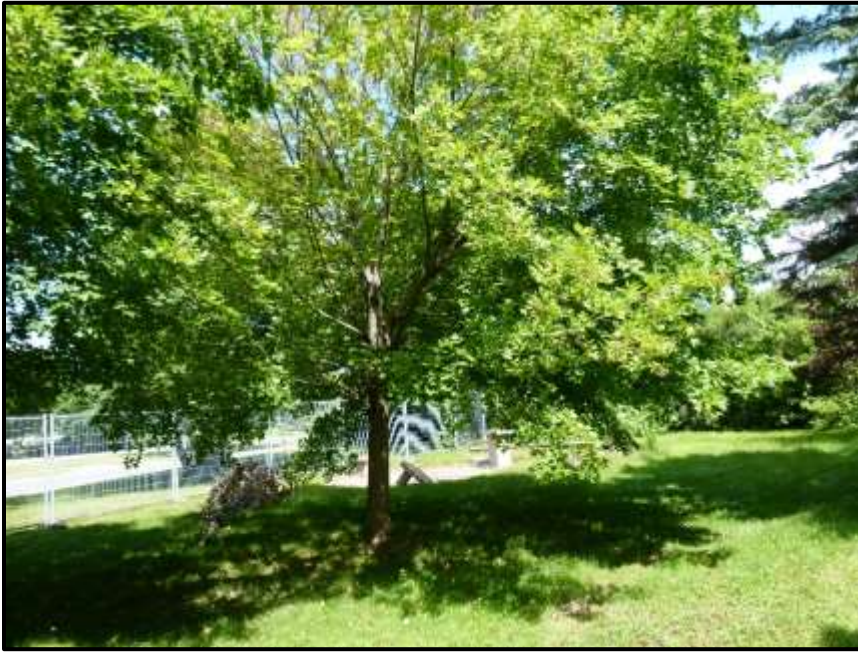
- **Vegetation Feature K:** Vegetation Feature K is a 26 cm dbh Sugar Maple (*Acer saccharum*). The tree appears to have been planted as a landscaping feature.

**Photograph 11:** Looking north at Vegetation Feature K. Vegetation Feature K is a 26 cm dbh Sugar Maple (August 9<sup>th</sup>, 2019).

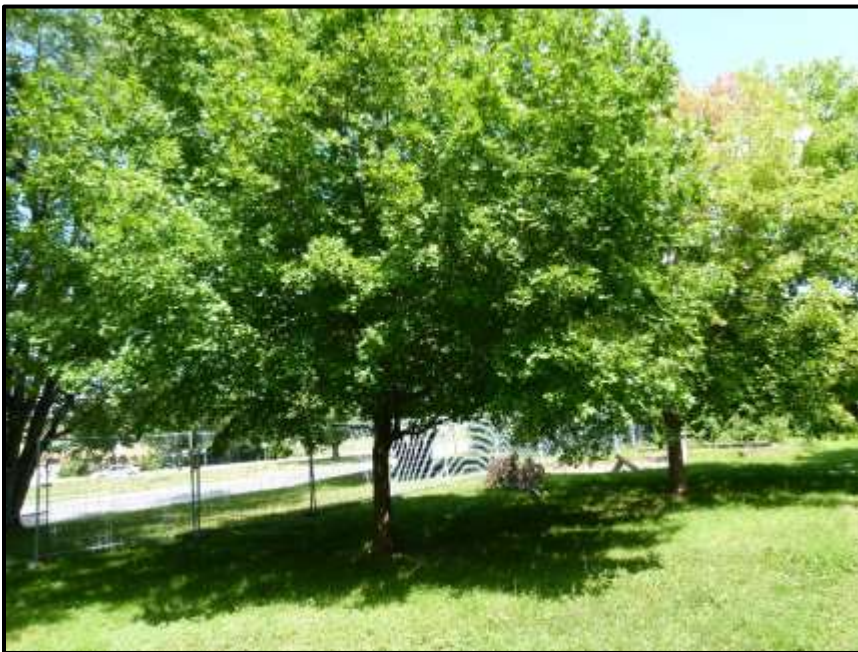
**Photograph 12:** Looking north at Vegetation Feature L. Vegetation Feature L is a 26 cm dbh Sugar Maple (August 9<sup>th</sup>, 2019).

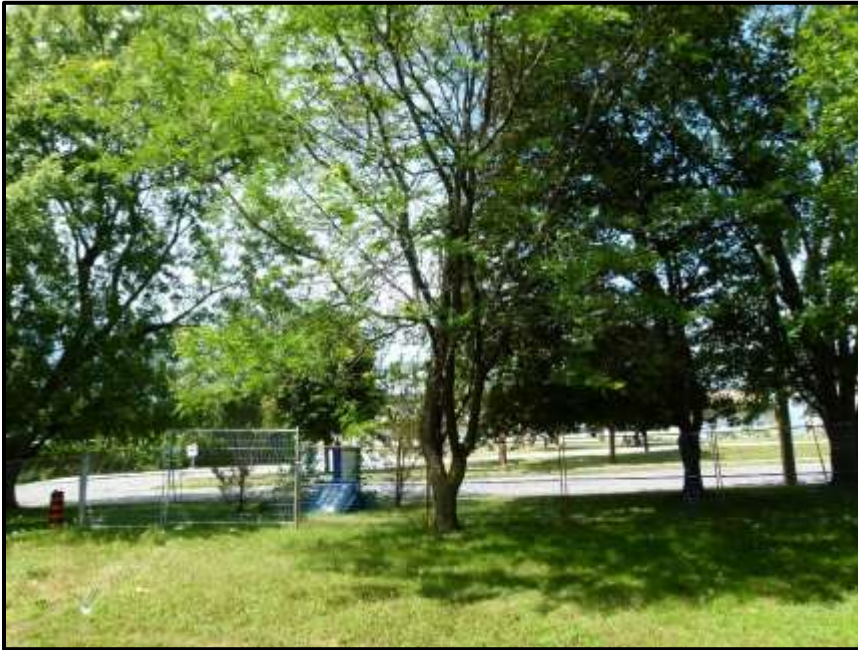
**Photograph 13:** Looking north at Vegetation Feature M. Vegetation Feature M is a domestic Honey Locust with two (2) stems (August 9<sup>th</sup>, 2019).

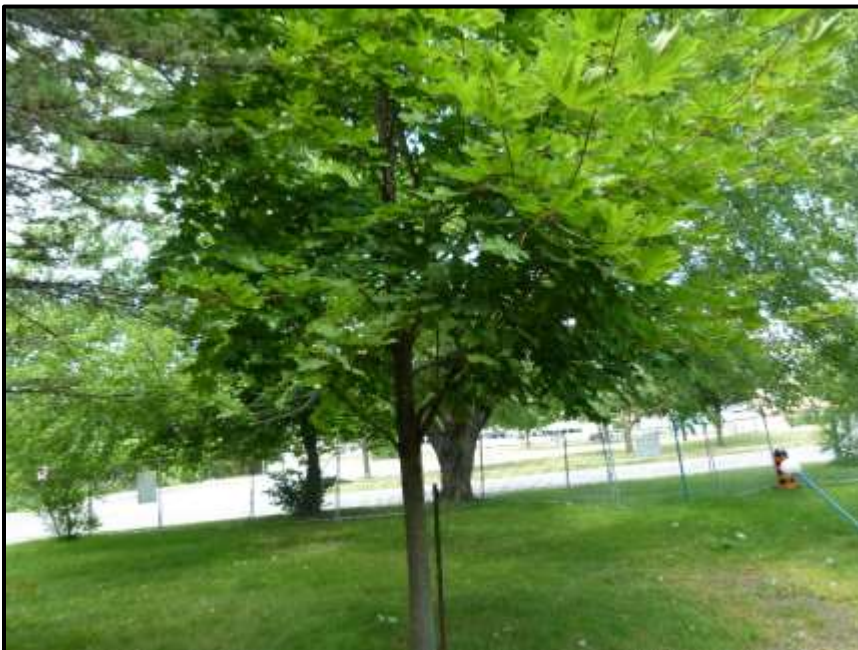
**Photograph 14:** Looking north at Vegetation Feature N. Vegetation Feature N is a 17 cm dbh Sugar Maple (August 9<sup>th</sup>, 2019).

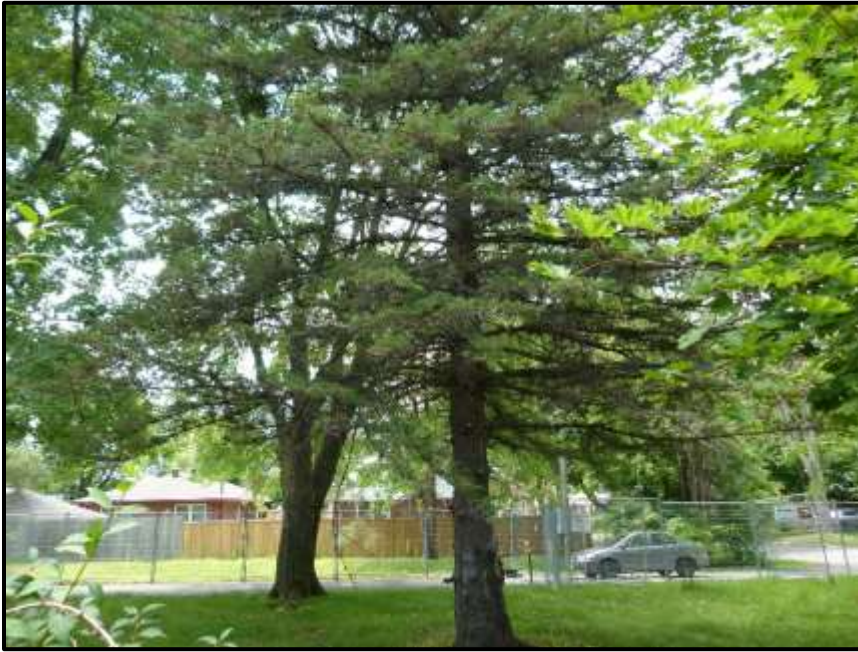
**Photograph 15:** Looking west at Vegetation Feature O (foreground). Vegetation Feature O is a 44 cm dbh White Spruce (August 9<sup>th</sup>, 2019).

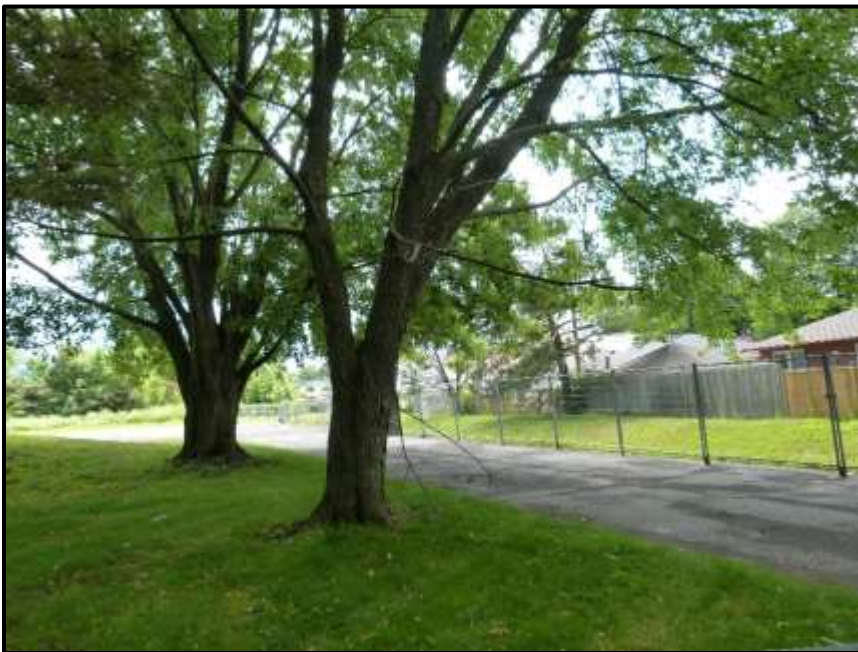
- **Vegetation Feature P:** Vegetation Feature P is a 78 cm dbh Silver Maple (*Acer saccharinum*). The tree appears to have been planted as a landscaping feature.

**Photograph 16:** Vegetation Feature P (foreground) is a 78 cm dbh Silver Maple. Vegetation Feature Q (background) is a 146 cm dbh Silver Maple (August 9<sup>th</sup>, 2019).

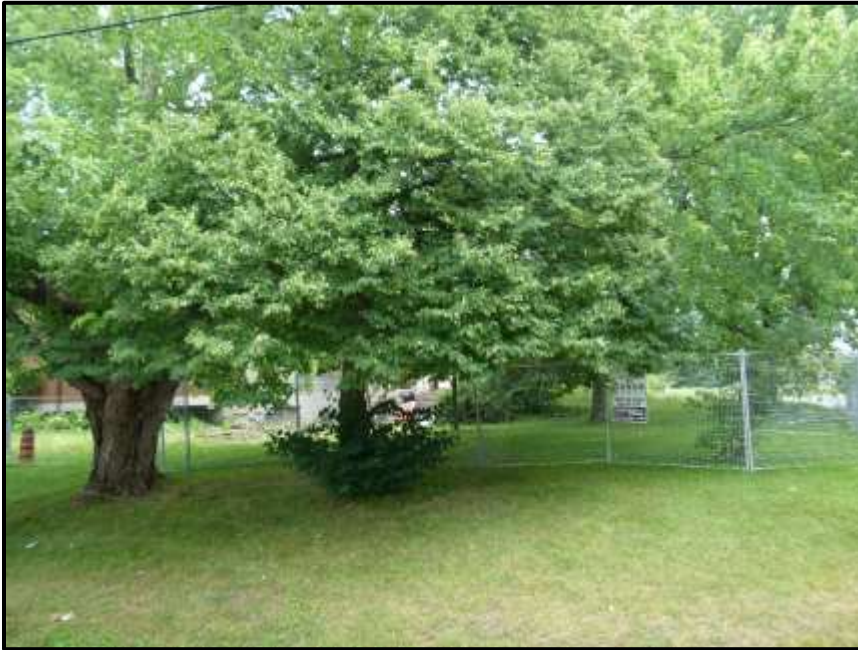
**Photograph 17:** Looking south at Vegetation Feature R. Vegetation Feature R is a 36 cm dbh Little Leaf Linden (August 9<sup>th</sup>, 2019).

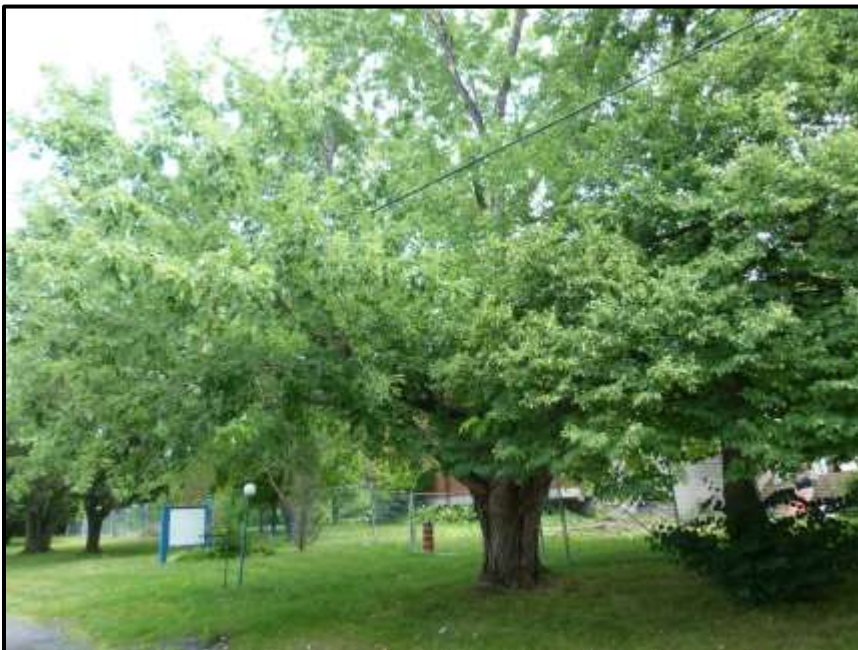
**Photograph 18:** Looking east at Vegetation Feature S. Vegetation Feature S is a 113 cm dbh Silver Maple (August 9<sup>th</sup>, 2019).

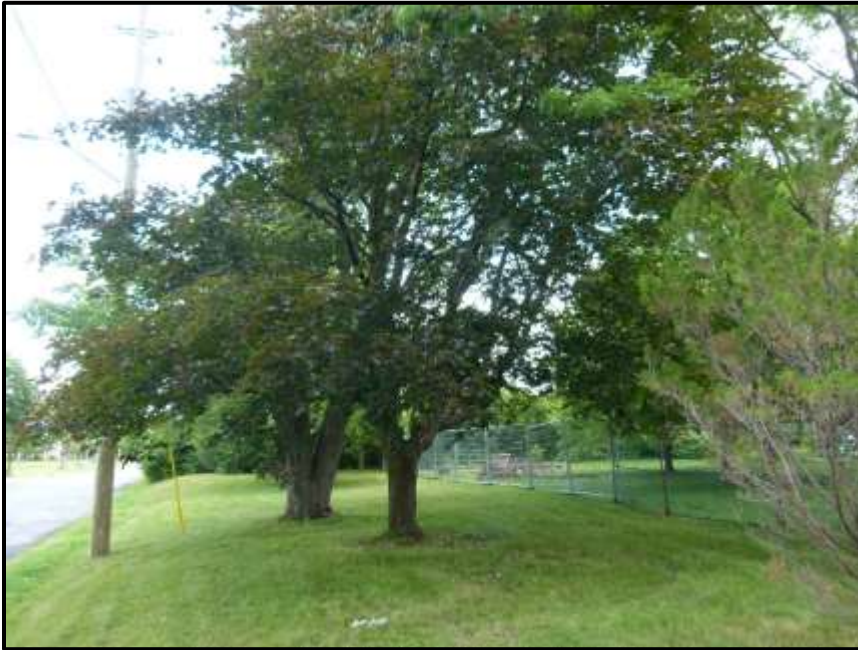
**Photograph 19:** Looking east at Vegetation Feature T. Vegetation Feature T is a 59 cm dbh Norway Maple (August 9<sup>th</sup>, 2019).

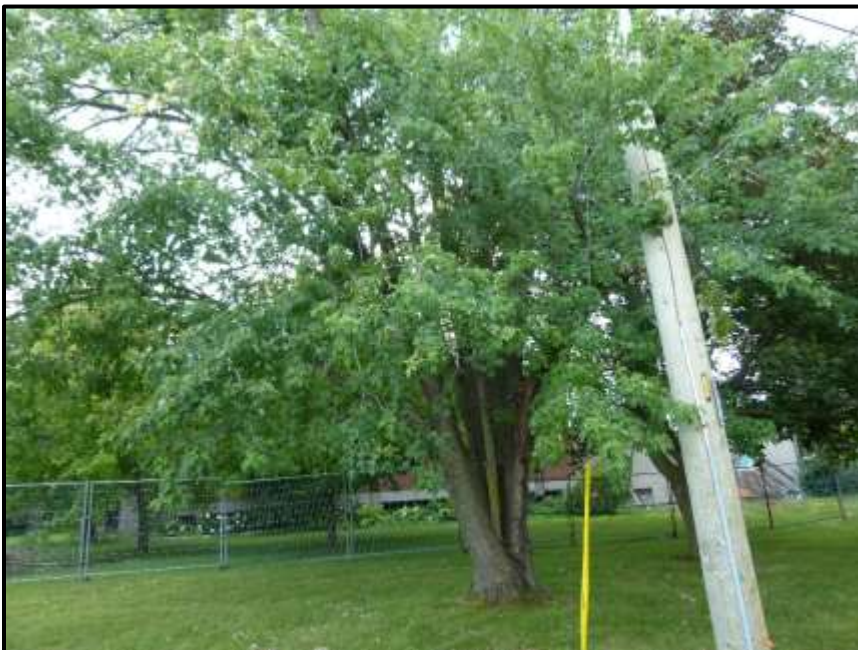
- **Vegetation Feature U:** Vegetation Feature U is a Silver Maple with six (6) stems. The stems measure 41 cm, 21 cm, 14 cm, 20 cm, 55 cm, and 19 cm dbh in size. The tree appears to have been planted as a landscaping feature.

**Photograph 20:** Looking south at Vegetation Feature U. Vegetation Feature U is a Silver Maple with six (6) stems (August 9<sup>th</sup>, 2019).

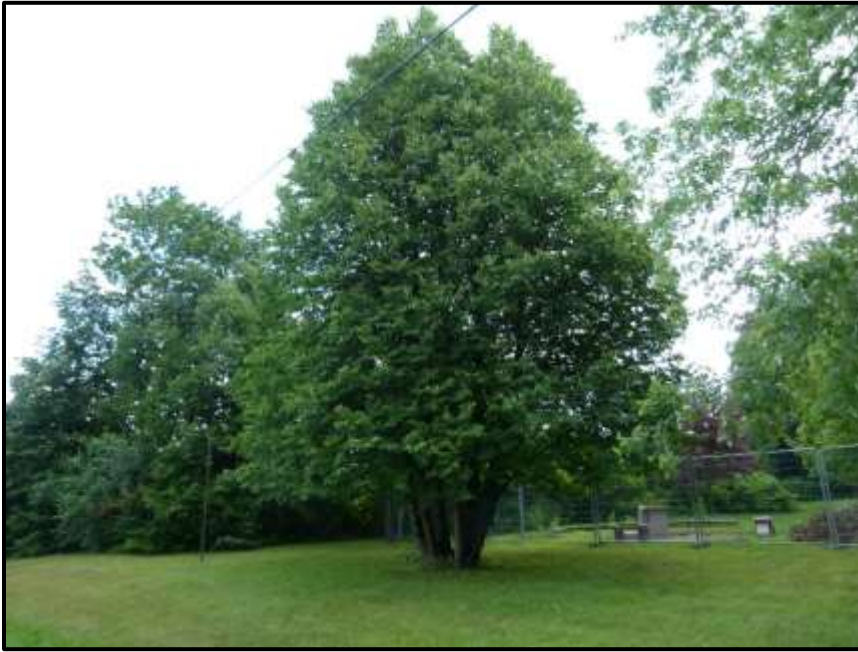
- **Vegetation Feature V:** Vegetation Feature V is a non-native Little Leaf Linden with eight (8) stems. The stems measure 15 cm, 21 cm, 23 cm, 23 cm, 24 cm, 14 cm, 28 cm, and 32 cm in size. The tree appears to have been planted as a landscaping feature.
- **Vegetation Feature W:** Vegetation Feature W is a 22 cm dbh Black Cherry (*Prunus serotina*). The tree appears to have been planted as a landscaping feature.
- **Vegetation Feature X:** Vegetation Feature X is a small stand of young Little Leaf Linden, White Cedar, Red Pine, and Honey Locust stems that vary in size between 10 cm and 15 cm dbh. The stand also includes Common Buckthorn shrubs.

**Photograph 21:** Looking east at Vegetation Feature V. Vegetation Feature V is a Little Leaf Linden with eight (8) stems (August 9<sup>th</sup>, 2019).

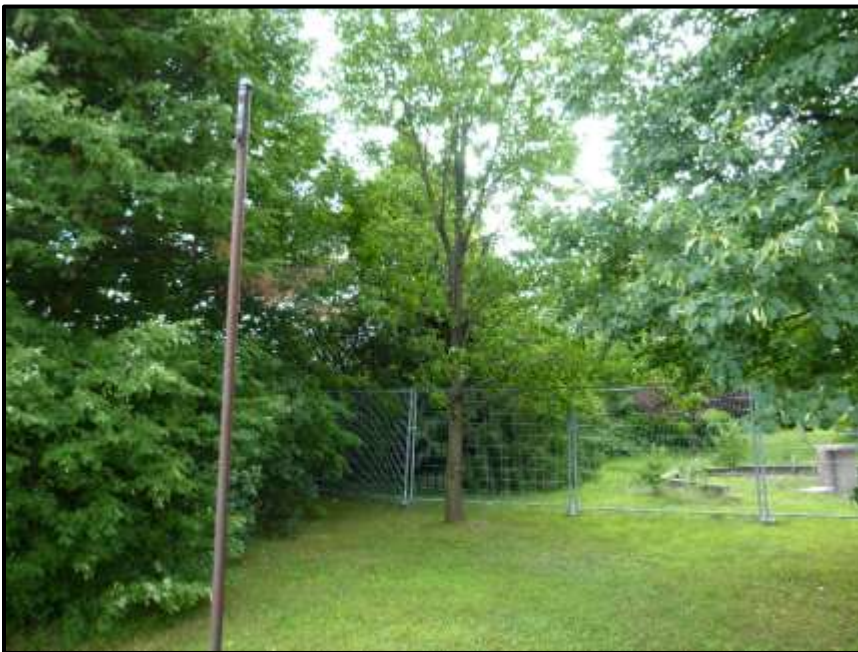
**Photograph 22:** Looking south at Vegetation Feature W. Vegetation Feature W is a 22 cm dbh Black Cherry (August 9<sup>th</sup>, 2019).

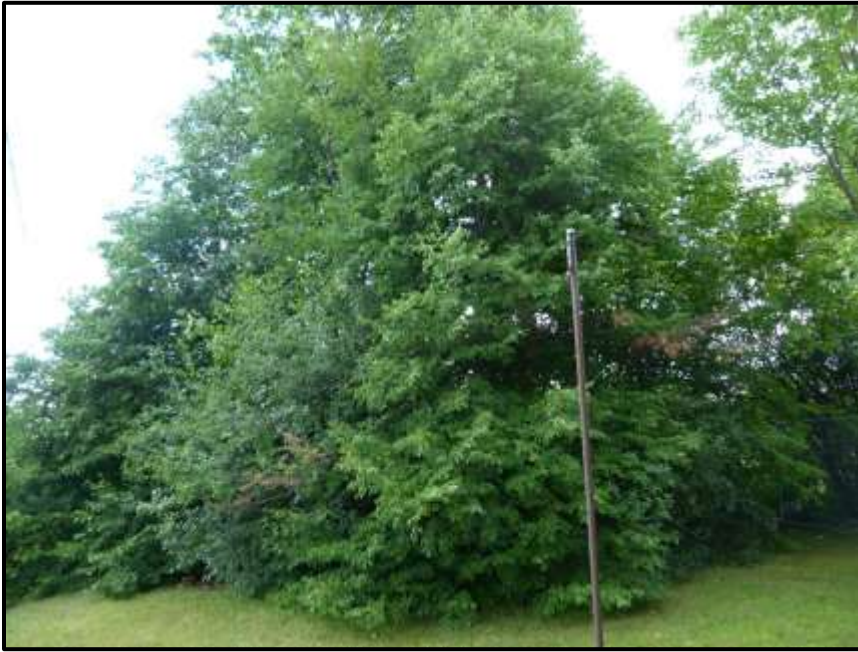
**Photograph 23:** Looking east at Vegetation Feature X. Vegetation Feature X is a small stand of young Little Leaf Linden, White Cedar, Red Pine, and Honey Locust stems (August 9<sup>th</sup>, 2019).
