**Headwater Drainage Feature Assessment
Phoenix Homes -
Old Montreal Road**

July 31, 2021

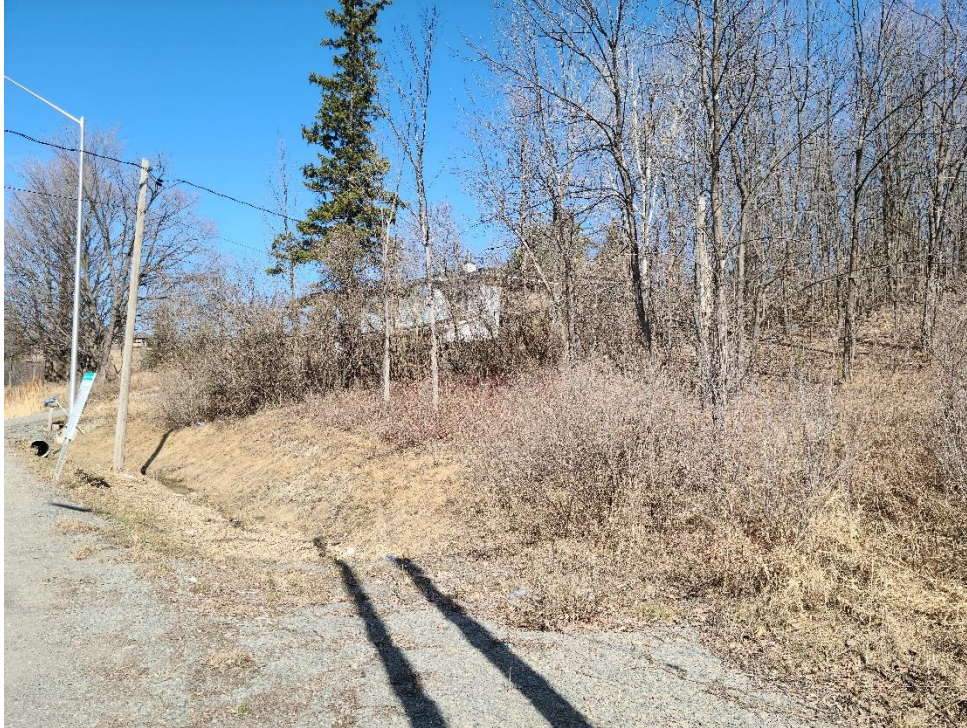
HDF1, the roadside ditch along Montreal Road, conveys road runoff and spring meltwater from the Site and surrounding area to Cardinal Creek ~250 m to the west. The feature has bankfull width of 5.4 m with a wetted width of 100 to 115 cm at the peak of the spring freshet a maximum depth of 17 cm. Flow was 0.32 m/s in the spring of 2018 but was barely detectable in the spring of 2021. No water was observed in the feature beyond the spring freshet. The substrate is muddy with significant grass growth. The left upstream bank (north) is the gravel shoulder to Montreal Road. The right upstream bank is a mix of yards and fields with some trees and shrubs along its length.

HDF1 - Roadside ditch along Old Montreal Road

This chain of classification descriptors leads to a management directive of **Mitigation**. The feature is not required to be maintained per se but if it is to be removed, its functionality must be replicated or enhanced through lot level conveyance measures as part of the site stormwater management system. Any replacement features/systems should be vegetated to mimic online wet vegetation pockets to the extent possible and must convey water to the same final receiver (i.e. Cardinal Creek). As a roadside ditch for a major arterial road, neither this feature nor a future replacement feature/system requires setbacks or a natural channel design.

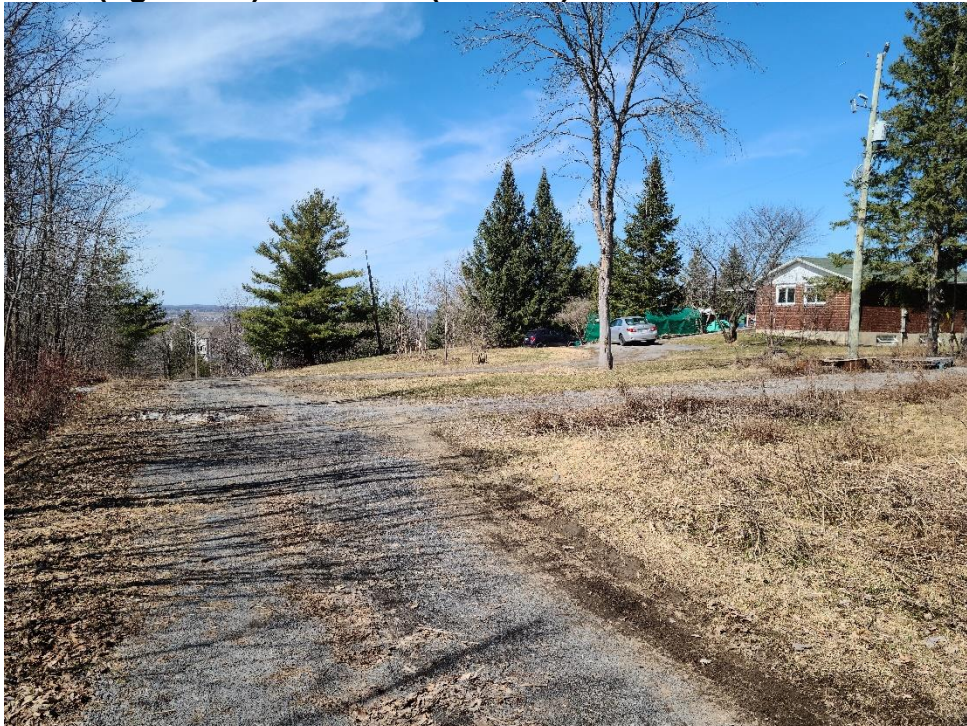
HDF2 and HDF 3 were small swales in 2018 located along the east and west sides respectively of the driveway running up the center of 1180 Old Montreal Road. They conveyed spring runoff norward down the slope. In 2018, both features were both very shallow with no definable banks and both flattened out completely before they reach HDF1 (i.e., had no discernible connection to HDF1). During the spring freshet in 2018, HDF2 had a wetted width of 55 to 110cm with a depth of 1 to 3 cm as it ran south down the length of the driveway. Water from the feature spread out at the bottom end with no detectable depth before, presumably, percolating into the HDF1. The feature was fully grassed with lawn through it and extending to the east. The west edge was the gravel driveway. In 2021 the shape of the feature was still evident though it was completely dry.

During the spring freshet 2018, HDF3 had a wetted width of 40 cm with a depth of 4 to 8 cm (in pockets) as it ran south down the length of the driveway. Water from the feature again spread out at the bottom end with no detectable depth. The feature had a mud and gravel substrate with some portions grassed. Shrubby vegetation grew along the west side; the east edge was the gravel driveway. By the spring of

2021, the length of the feature was inundated with new shrub growth, the channel form along most of its length was no longer evident and no water was present.

HDF2 (right side) and HDF3 (left side)

This chain of classification descriptors leads to a management directive of **Maintain Recharge**. There is no requirement to retain the feature per se, but the overall water balance for the area must be maintained by providing mitigation measures to infiltrate clean stormwater.
