15 August 2022

Subject: 4386 Rideau Drive, Manotick – Headwater Drainage Features Review and Assessment

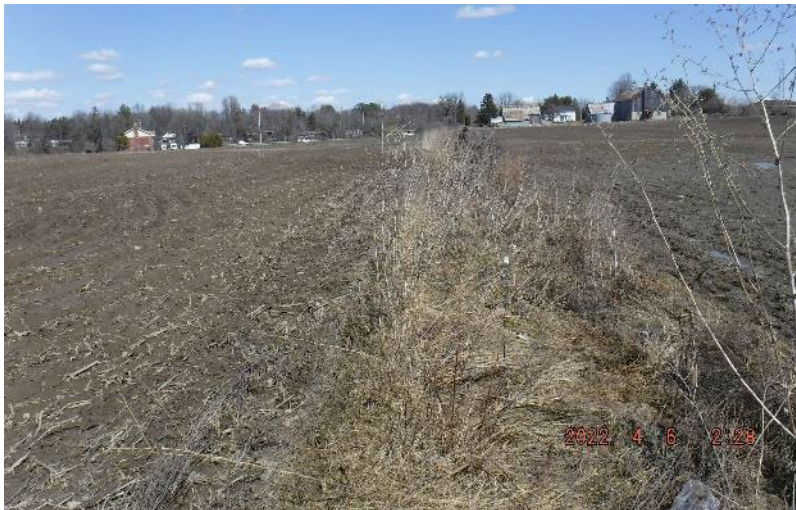
Photo 1: Looking upstream, towards the east, along the feature (April 5, 2022)

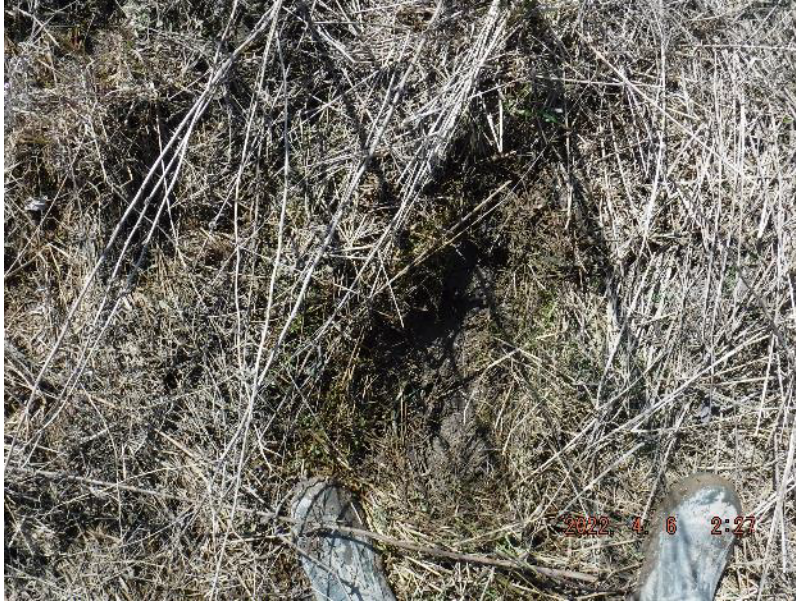
Photo 2: After moving vegetation aside, the lack of water was confirmed (April 5, 2022)

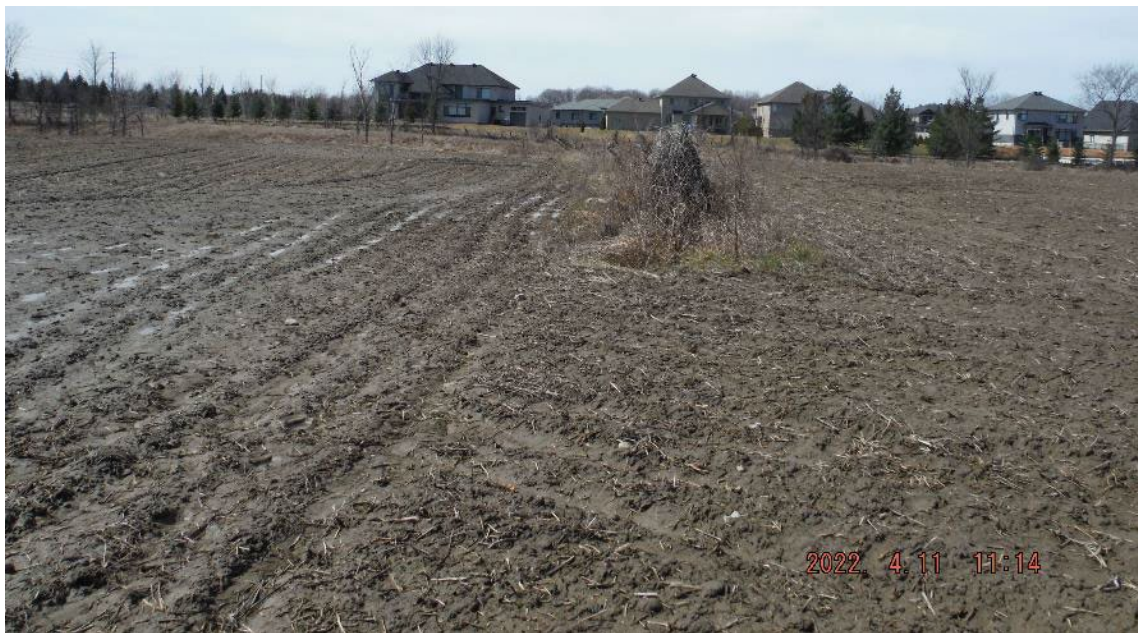
Photo 3: Section that was ploughed (looking downstream towards Wilson Cowan M. D.) (April 11, 2022)

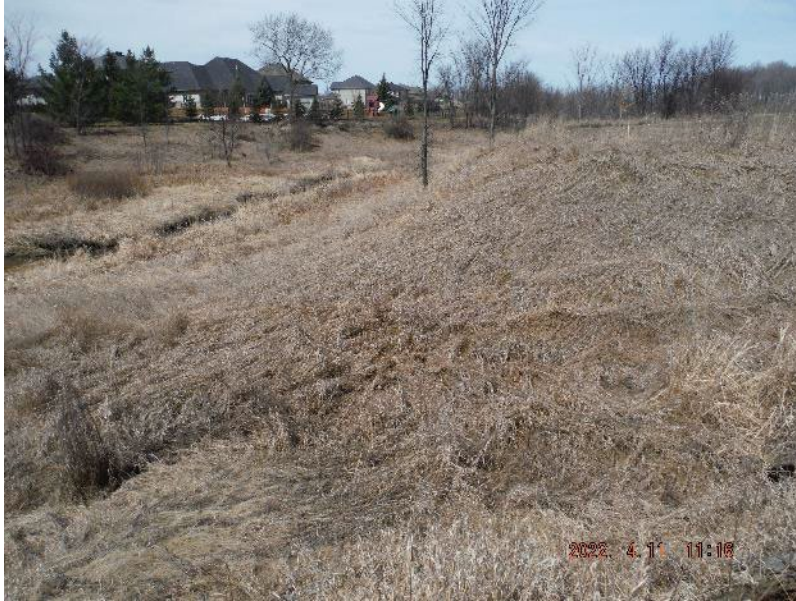
Photo 4: Looking north, across the slope of Wilson Cowan Municipal Drain, where the headwater feature would have flowed (no connection found in vegetation) (April 11, 2022)
