TREE CONSERVATION REPORT

DATE: December 7, 2022

SUBJECT: Tree Conservation Report Update – 1927 Maple Grove Road, Stittsville, Ontario
CIMA+ file number: A001347

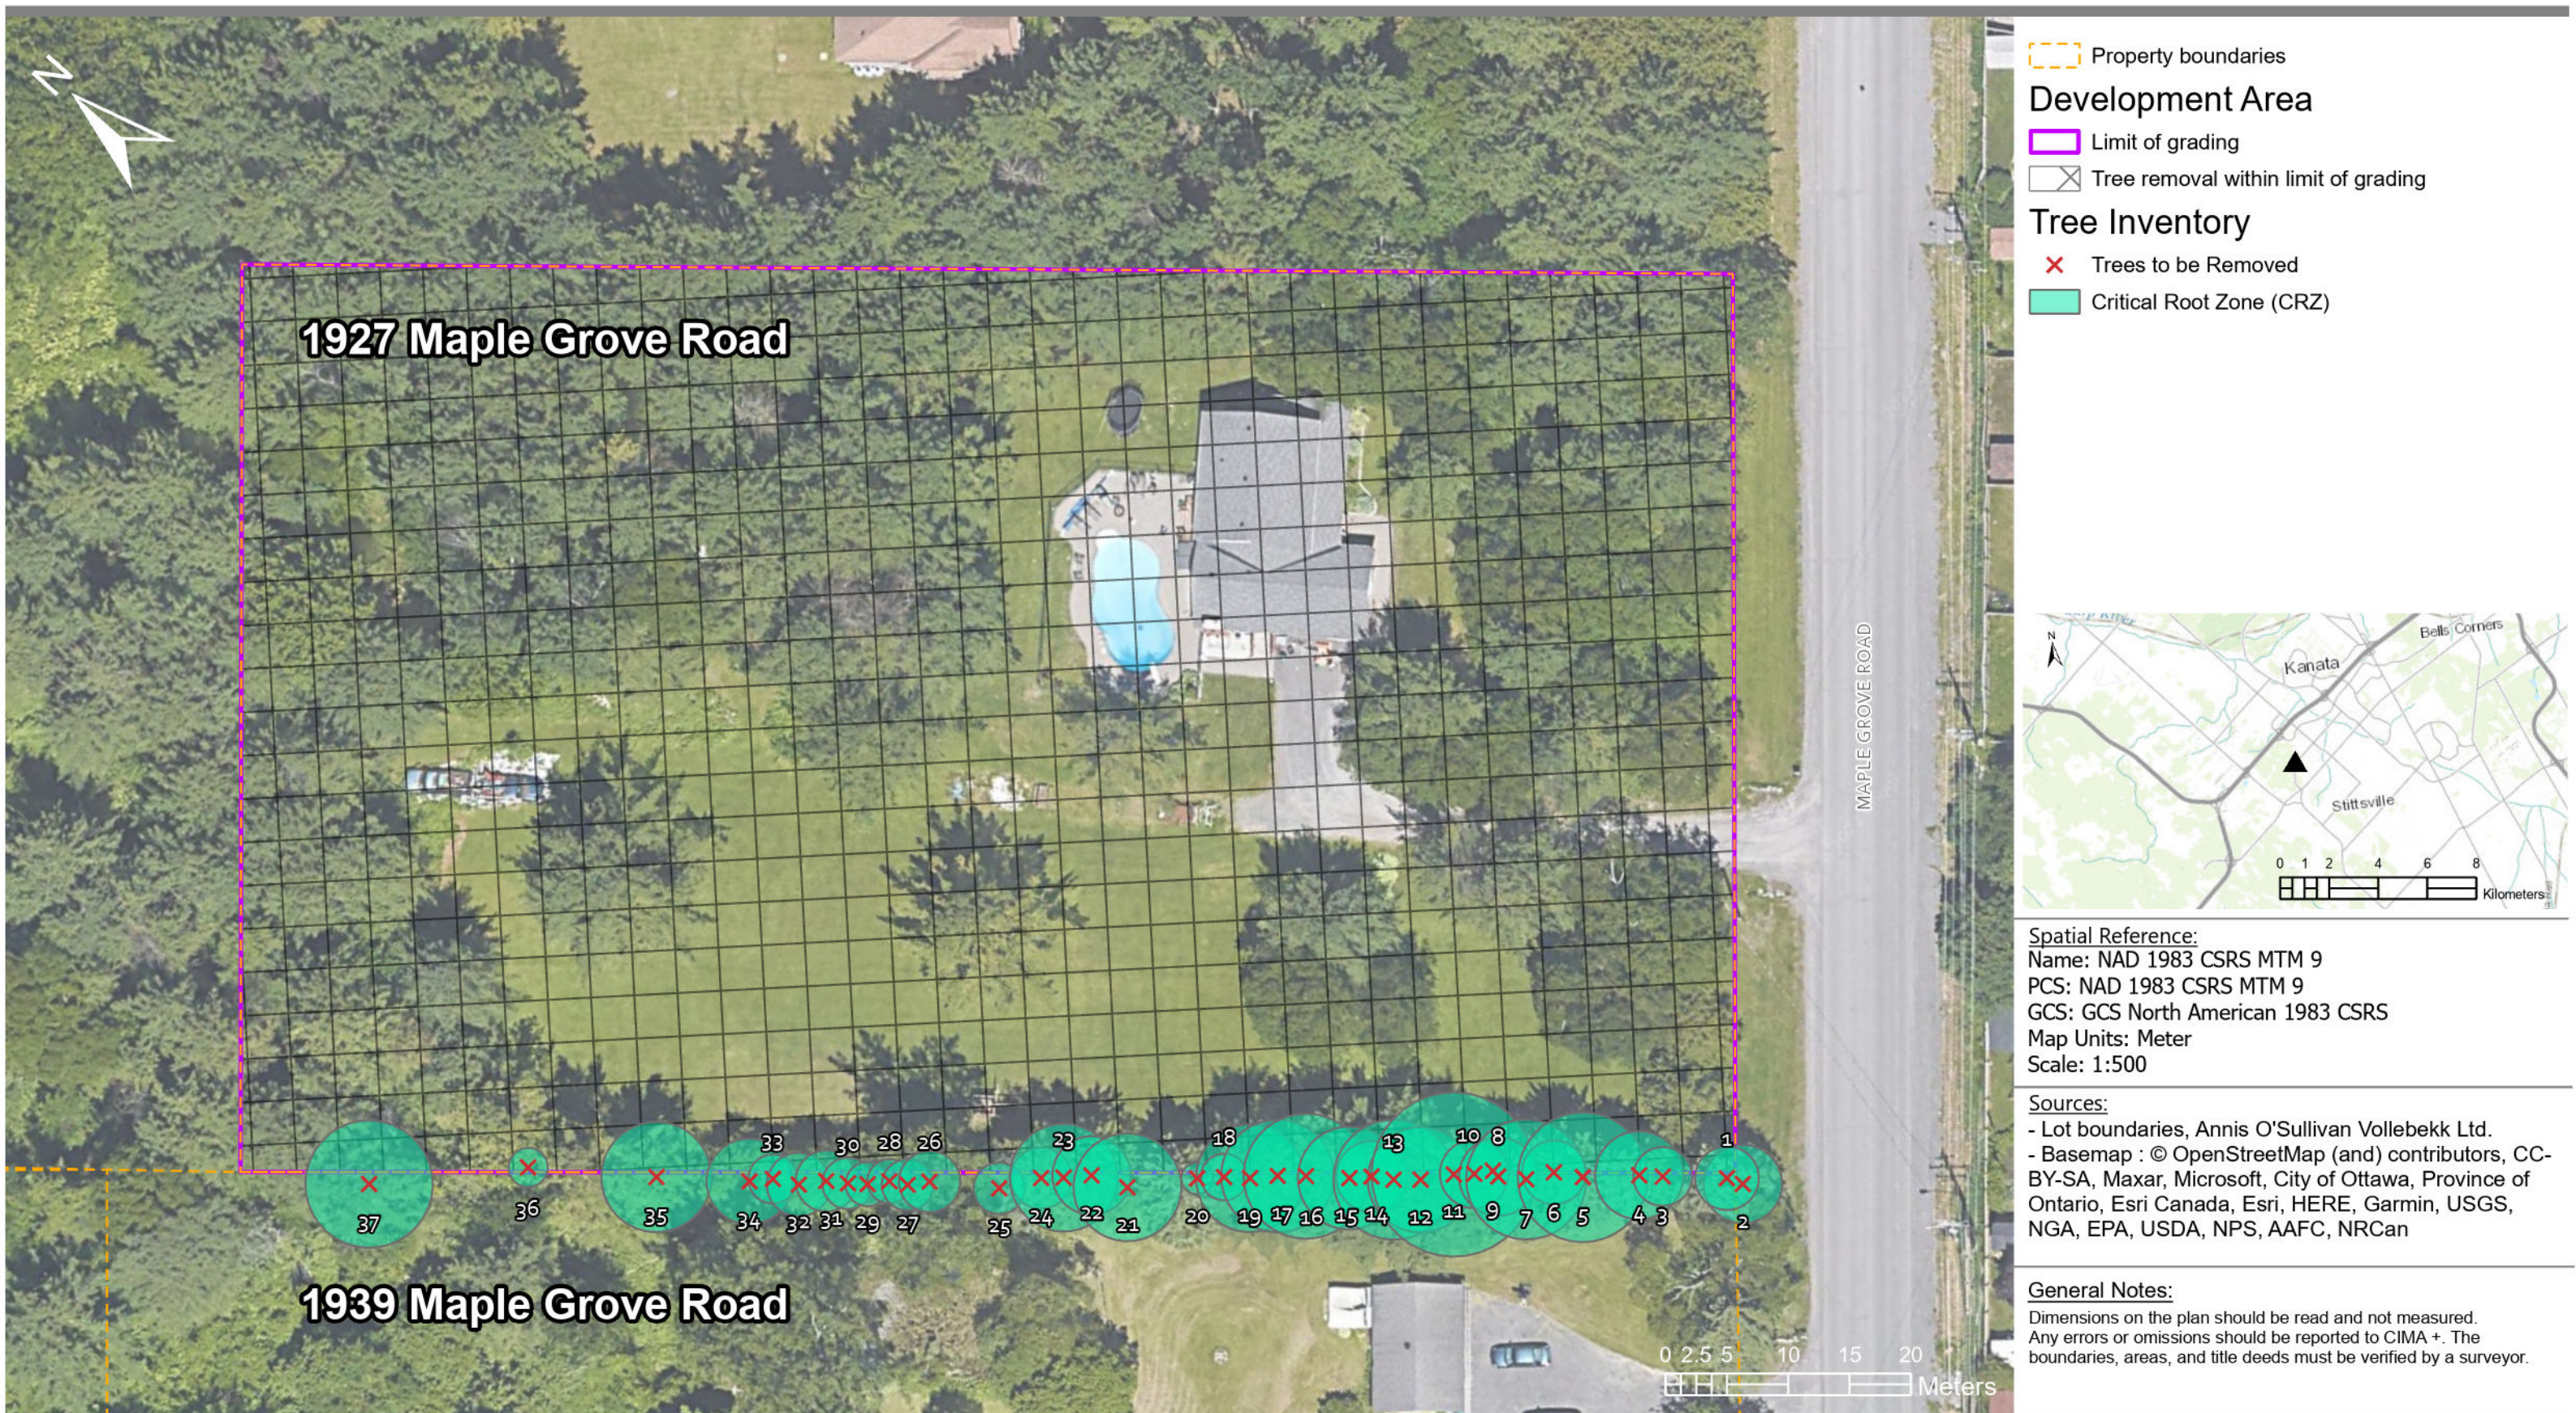
Figure 1 - Proposed Development and Tree Impacts

Based on the limits and type of proposed construction to the works located on 1927 Maple Grove Road, all 37 trees located along the property line located at 1939 Maple Grove Road will be impacted and are recommended for removal. These details are included in the Tree Inventory and Assessment Table and Figure 1 included in **Appendix A**.
