# 2510 St. Laurent Blvd – Tree Conservation Report

Claridge Homes

| REPORT TITLE: | 2510 St Laurent Blvd - Tree Conservation Report |
| ARCADIS REFERENCE: | 140253 |

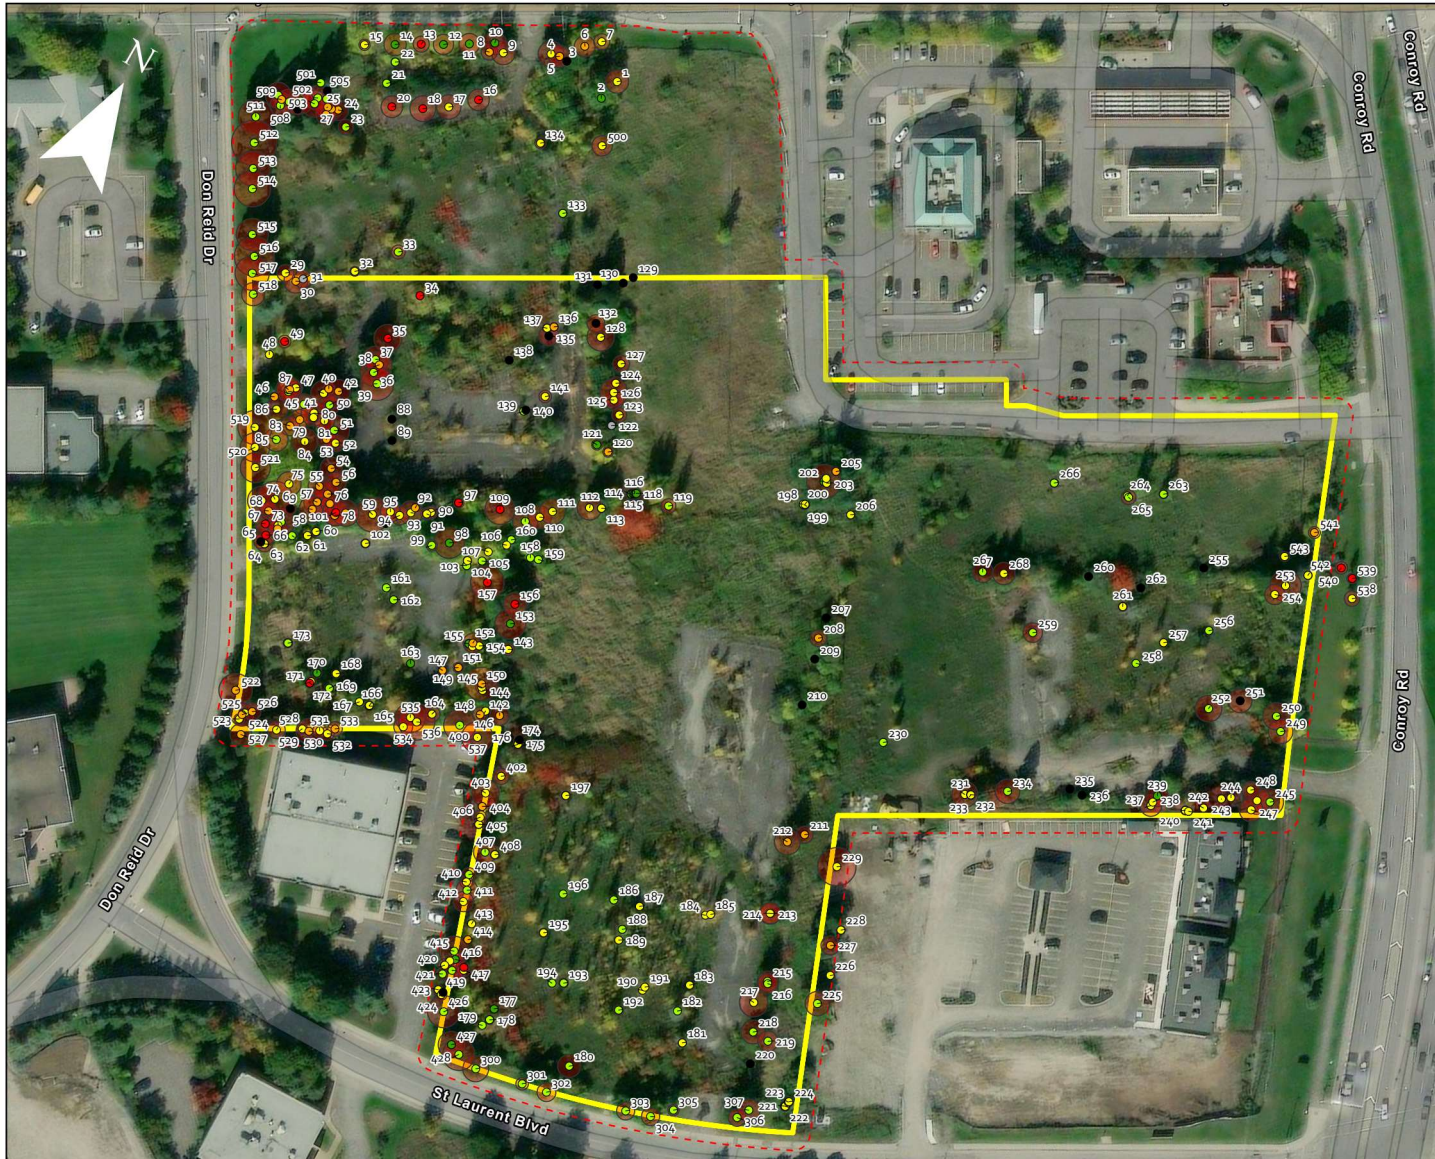
**Figure: 2**

The following **Table 1** provides a summary of the tree inventory results with a full Tree Inventory and Preservation Plan included in **Appendix A**. **Figure 2** below displays the tree locations and associated health conditions.

**2510 St. Laurent Blvd:  
 Current Vegetation  
 (Map 1 as per City Guidelines)**

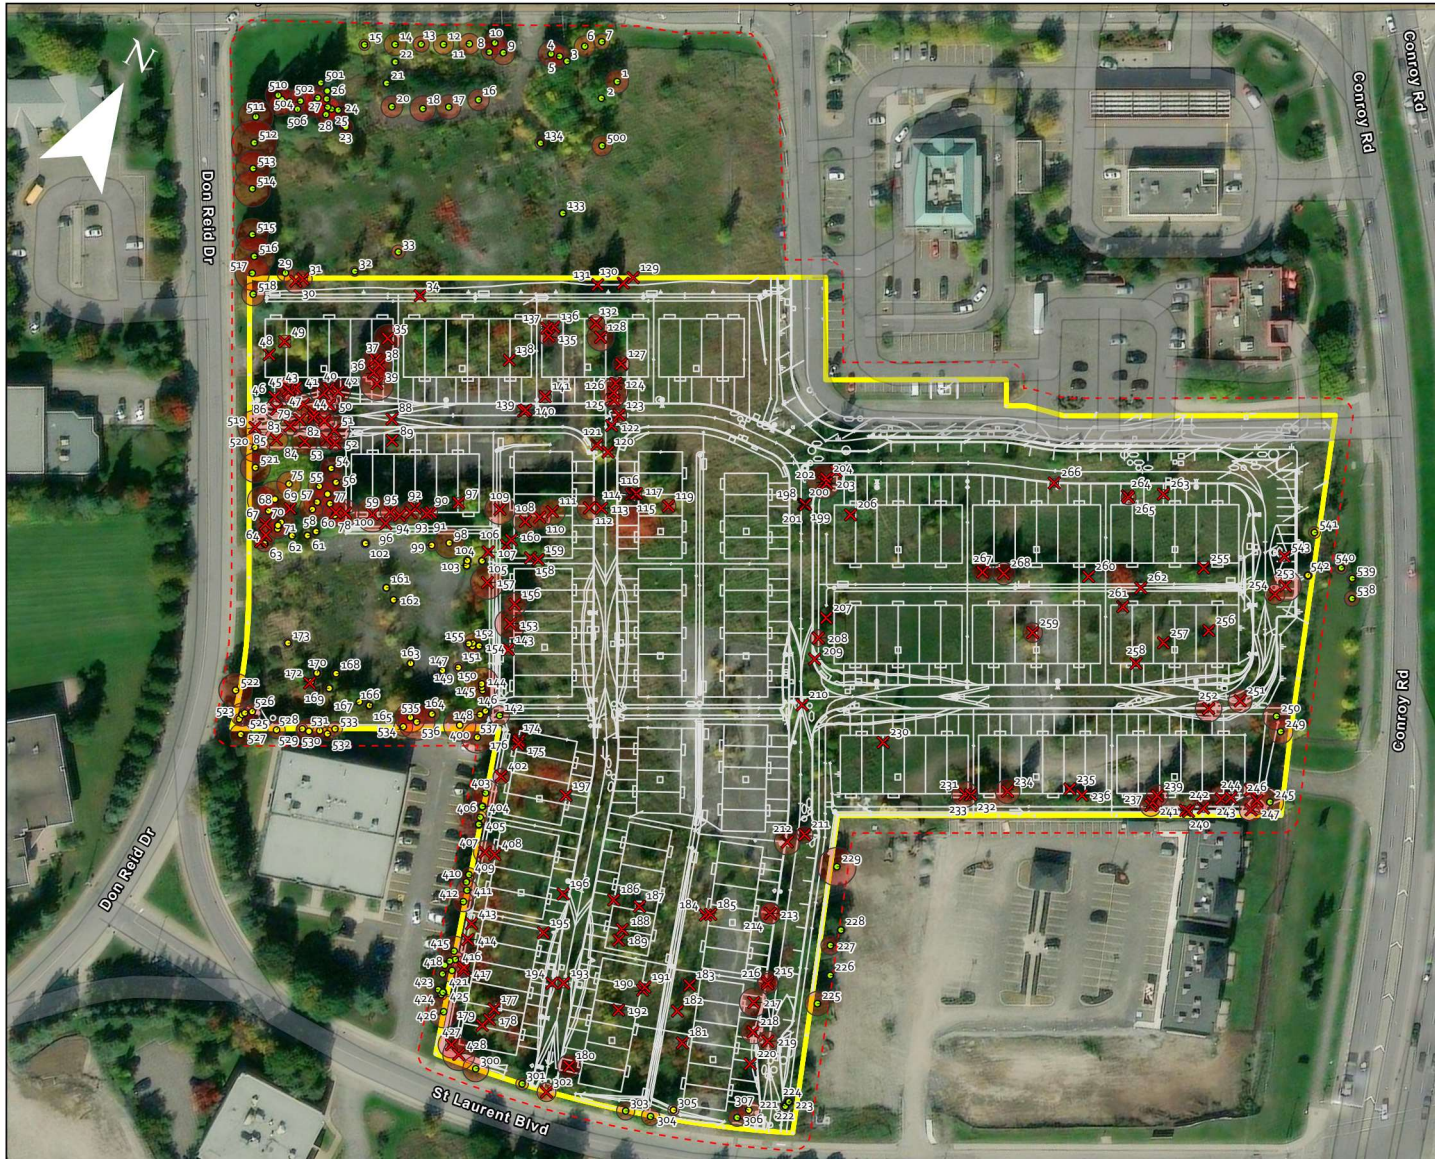
**Figure: 3**

**Figure 3** below displays the results of the tree inventory overlaid with the current site plan. Recommendations for removal, retention, and potential for retention are included.

The Critical Root Zone (CRZ) of **185 trees are in direct conflict with the proposed site plan and or grading limits and will require removal (Appendix A)**. Physical impacts on the CRZ by construction activities rapidly deteriorates the overall health, quality, and ecological service of the tree. Therefore, tree locations that will impact majority of the CRZ have been recommended for removal.

Trees have been considered for retention in instances where they do not conflict with the development footprint, or where there is limited anticipated impact to the CRZ of high-quality trees. Additionally, retention has been considered for trees owned by the City of Ottawa, or adjacent landowners. **A total of 91 trees has been identified as being considered for retention (Appendix A)**.

**There are 71 trees within the proposed park area or along the perimeter of the Site that are slated for Potential Preservation (Appendix A).** Once the Detail Design of the parkland is finalized impacts to trees in this area will be updated and included in a subsequent TCR.

Title: 2510 St. Laurent Blvd:  
 Tree Impact Assessment  
 and Recommendations  
 (Map 2 as per City Guidelines)
