# Findlay Creek Conceptual Channel Design

**4795 Bank Street Subdivision**  
Ottawa, Ontario

Submitted:  
July 24, 2026

GEO Morphix Project No. 26028

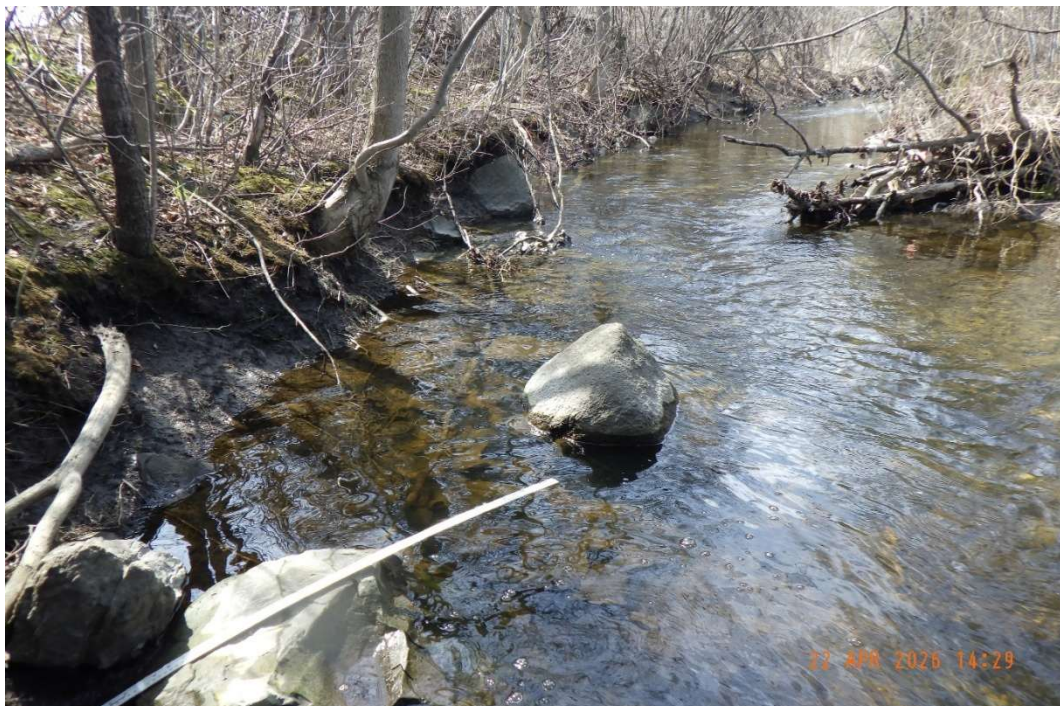
**Photo 8: Reach FC-1a**  
Findlay Creek, Ottawa, Ontario  
Photo Direction: Upstream

Bed substrate ranged from silt to boulders. While the substrate consisted mostly of gravel and cobble, large sporadic boulders and patches of fine sediments were found throughout the site

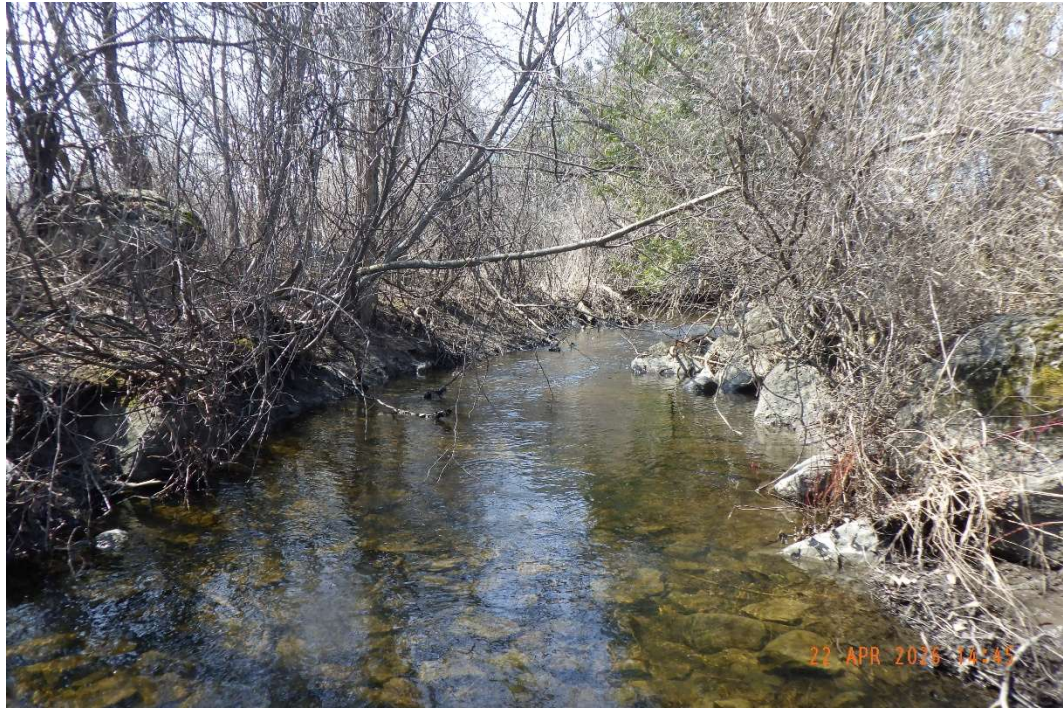
**Photo 9: Reach FC-1a**

Large boulders were present throughout the reach along the banks. Treefalls and leaning trees were common. The channel was generally straight with low sinuosity.

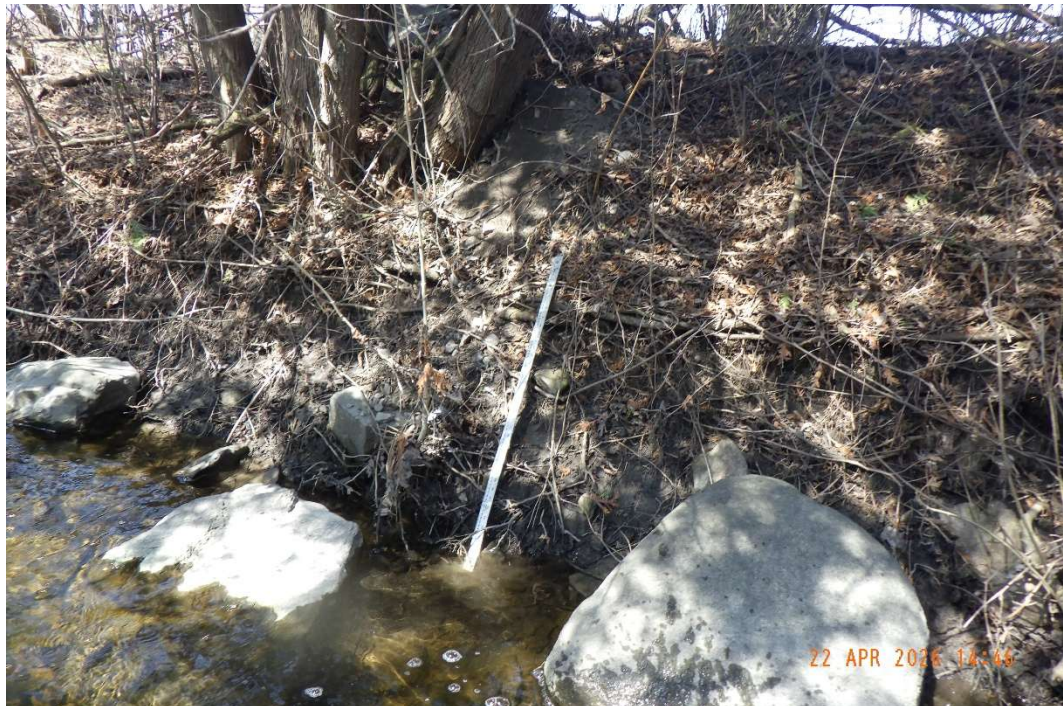
**Photo 10: Reach FC-1a**

Bankfull heights ranged from 0.63 to 0.73 m.  
The top of bank heights for some sections of the channel were greater than 1.0m.

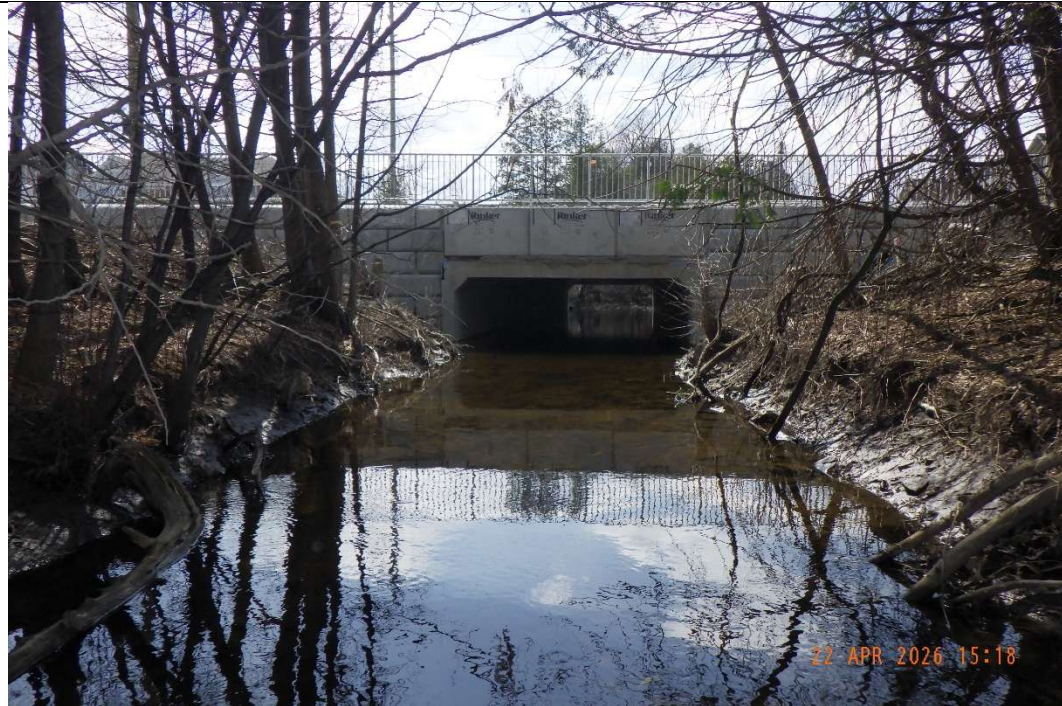
**Photo 12: Reach FC-1a**

Photo of the Bank Street crossing at the upstream extent of Reach FC-1a.  
Note bank erosion along both sides of the channel.

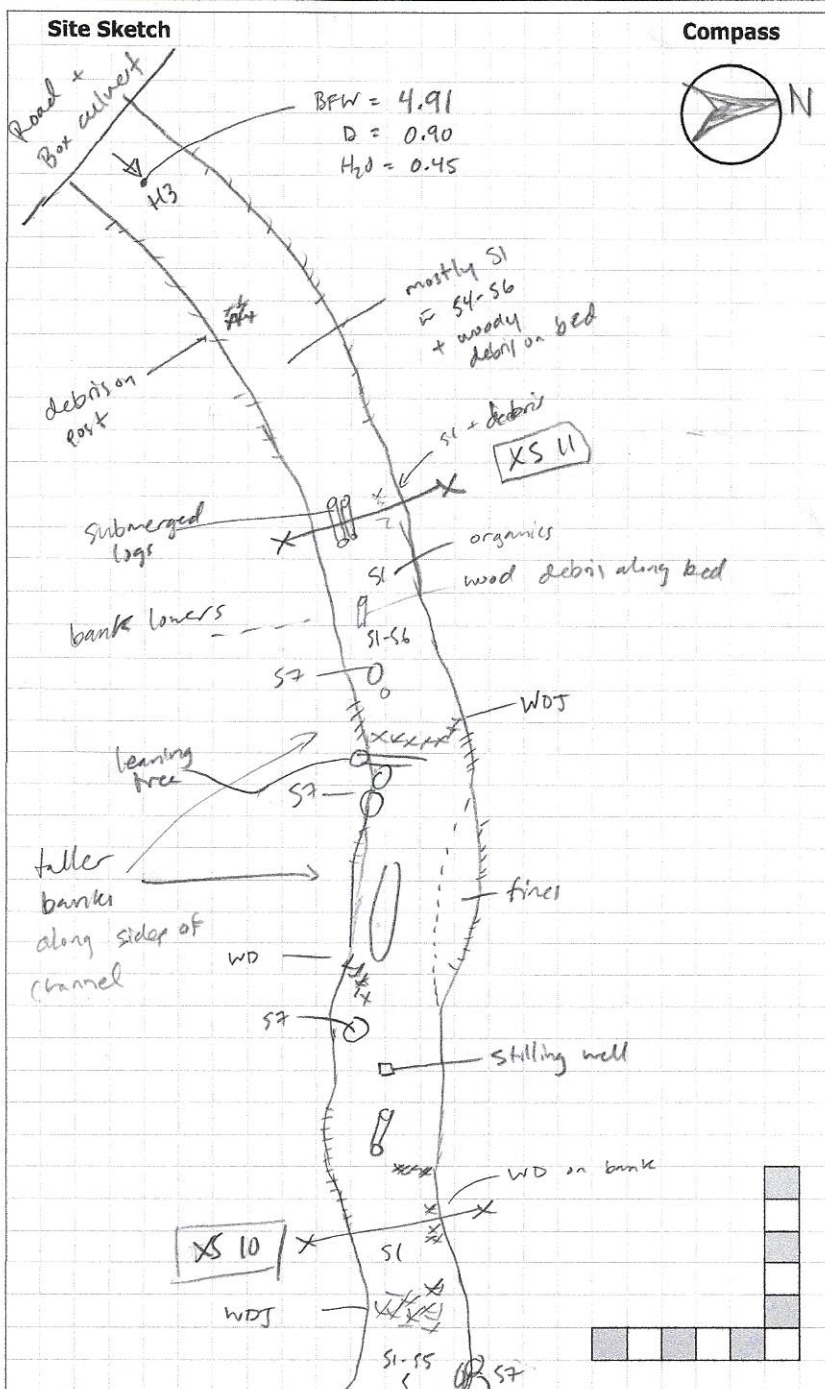
**Notes:** fines continue up

- fill piles / berms observed along channel banks (not continuous) but taller than 'natural' sections  
- bank erosion observed on both sides
