Appendix 5

Fluvial Geomorphological Detailed Information

FLUVIAL GEOMORPHOLOGY SUMMARY

Richmond VG-R2

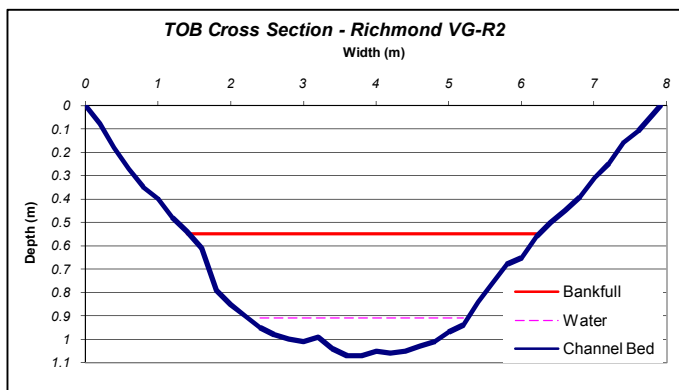
Range	Average
Bankfull Width (m)	4.50 - 5.49	4.99
Bankfull Depth (m)	0.38 - 0.43	0.39
Width / Depth	11.75 - 13.73	12.70
Wetted Width (m)	2.71 - 3.04	2.86
Water Depth (m)	0.09 - 0.15	0.12
Width / Depth	18.46 - 31.27	24.24
Entrenchment (m)	9.80 - 13.50	11.86
Entrenchment Ratio	2.04 - 3.00	2.40

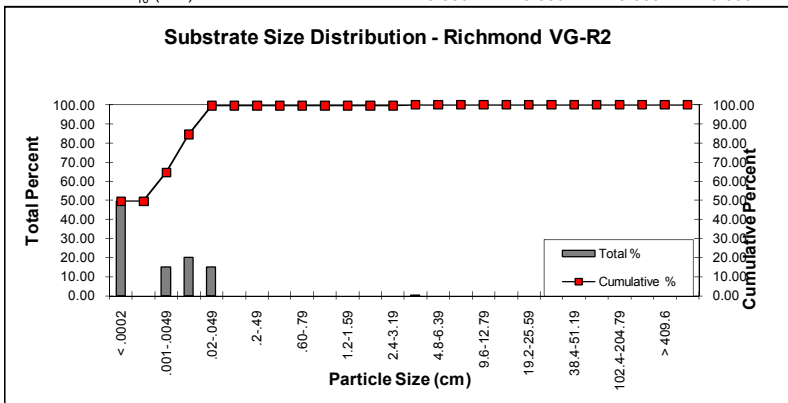
D10	0.0002 mm
D50	0.002 mm
D90	0.150 mm

D ₉₅ (mm):	0.020	0.255	0.300	0.255
D ₉₀ (mm):	0.010	0.165	0.255	0.165
D ₈₄ (mm):	0.005	0.023	0.201	0.095
D ₆₅ (mm):	0.001	0.002	0.084	0.010
D ₅₀ (mm):	0.001	0.001	0.006	0.001
D ₁₆ (mm):	0.000	0.000	0.000	0.000
D ₁₀ (mm):	0.000	0.000	0.000	0.000

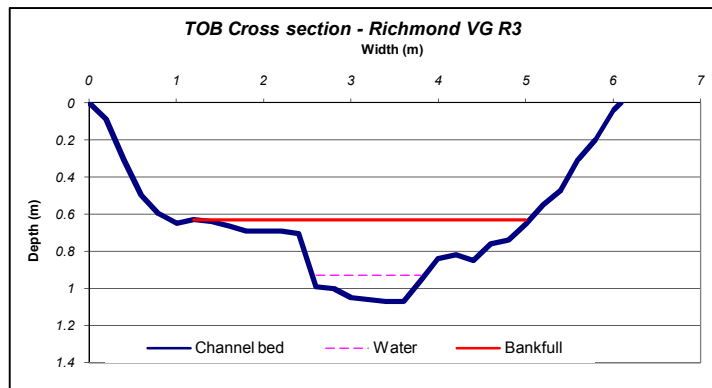
Range	Average
Bankfull Width (m)	4.00 - 4.65	4.28
Bankfull Depth (m)	0.23 - 0.35	0.29
Width / Depth	11.41 - 18.38	15.35
Wetted Width (m)	1.31 - 2.52	1.89
Water Depth (m)	0.07 - 0.09	0.09
Width / Depth	14.00 - 36.20	23.38
Entrenchment (m)	9.15 - 104.20	42.12
Entrenchment Ratio	1.97 - 24.81	10.01

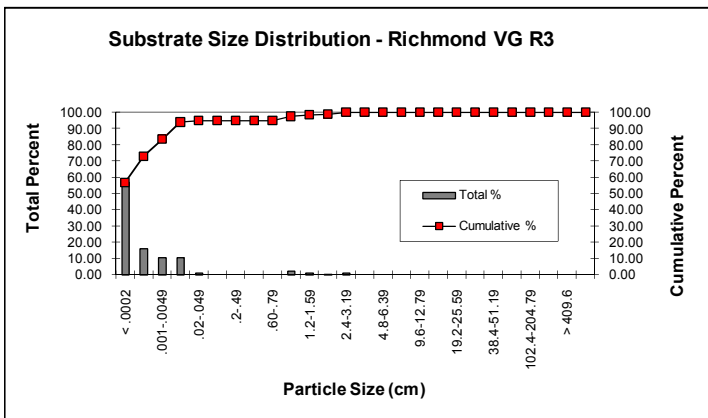
Pebble Counts			Grain Size Analysis	
D10	3.1500	mm			
D50	0.0110	mm		Not Sampled	
D90	0.0002	mm			
	XS1	XS2	XS3	XS4	XS5
D ₉₀ (mm):	0.04760	0.04760	12.5	0.0476	
D ₈₄ (mm):	0.02278	0.02278	9.286	0.02278	
D ₆₅ (mm):	0.00190	0.00190	0.05966667	0.0043	
D ₅₀ (mm):	0.00080	0.00080	0	0.0025	
D ₁₆ (mm):	0.00026	0.00026	0.00032	0.000427	
D ₁₀ (mm):	0.00016	0.00016	0.0002	0.000267
