3194 Jockvale Road Development Tree Conservation Report

December 2018
Prepared for Richcraft Homes Inc.

RE: Tree Conservation Report for the 3194 Jockvale Road Development

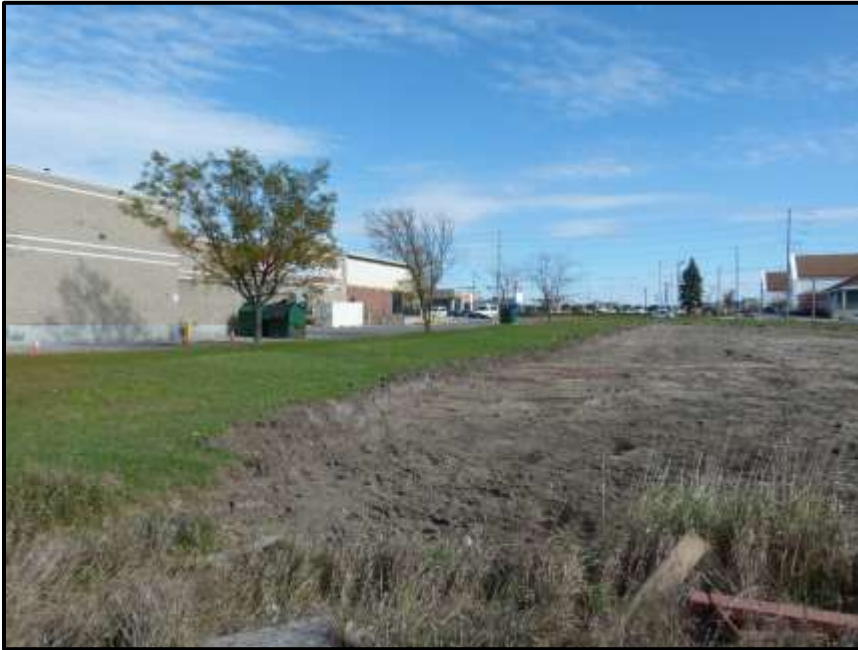
- **Tree Stand A:** Tree Stand A includes five (5) planted Honey Locust (*Gleditsia triacanthos*) located at the edge of the adjacent commercial property. Trees sizes are between 35 cm and 40 cm dbh.

Photograph 1: Looking northeast at Tree Stand A (Honey Locusts) (October 24th, 2018).

- **Tree Stands A, C, D, E, F, G and H:** Tree Stands A, C, D, E, F, G and H were planted as landscaping features and occur at the edge of the adjacent commercial property. Where feasible, these planted landscaping features should be retained on the adjacent property during development of the Site. Mitigation measures to protect retained trees on adjacent properties are discussed below.

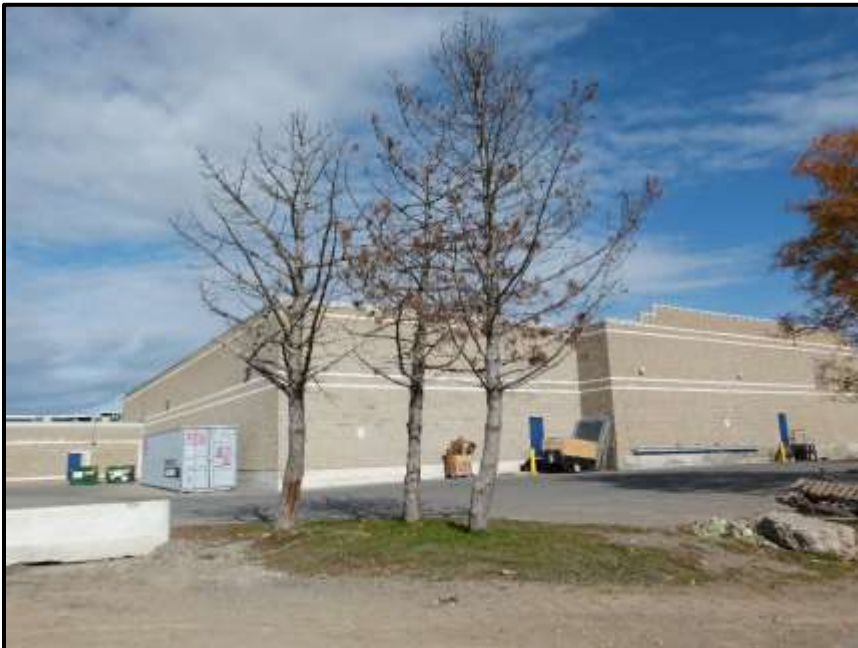
- **Tree Stand B:** Tree Stand B includes three (3) dead planted Red Pine (*Pinus resinosa*) located at the edge of the adjacent commercial property. All three (3) stems are approximately 22 cm dbh in size.

Photograph 2: Looking north at Tree Stand B (dead Red Pines) (October 24th, 2018).

- **Tree Stand B:** Tree Stand B was planted as a landscaping feature, and occurs at the edge of the adjacent commercial property. However, all stems within Tree Stand B are dead, and therefore measures to protect Tree Stand B are not required.

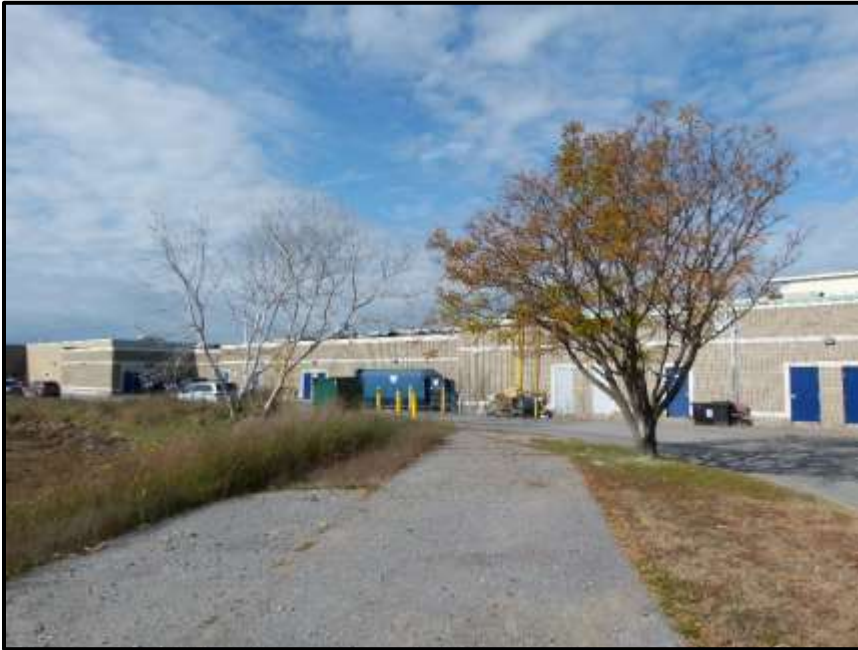
- **Tree Stand C:** Tree Stand C is a large Honey Locust with six (6) connected stems that are each between 15 cm and 20 cm dbh in size. Tree Stand C is located at the edge of the adjacent commercial property. There are also two (2) dead White Ash (*Fraxinus americana*) nearby.

Photograph 3: Looking north at Tree Stand C (Honey Locust and dead White Ash) (October 24th, 2018).

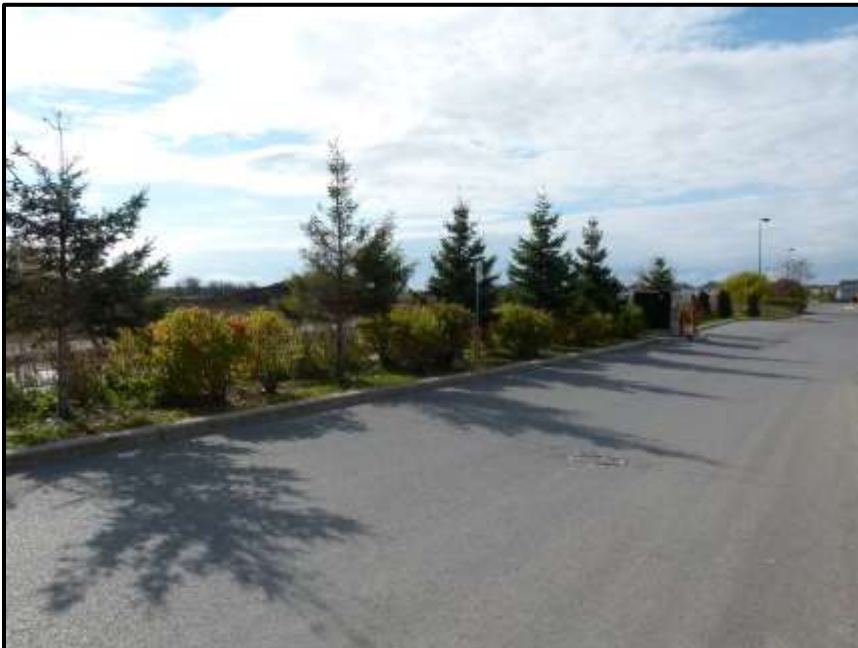
- **Tree Stand D:** Tree Stand D includes six (6) planted White Spruce (*Picea glauca*) that are each less than 10 cm dbh in size. Tree Stand D is located at the edge of the adjacent commercial property.

Photograph 4: Looking north at Tree Stand D (White Spruce) (October 24th, 2018).

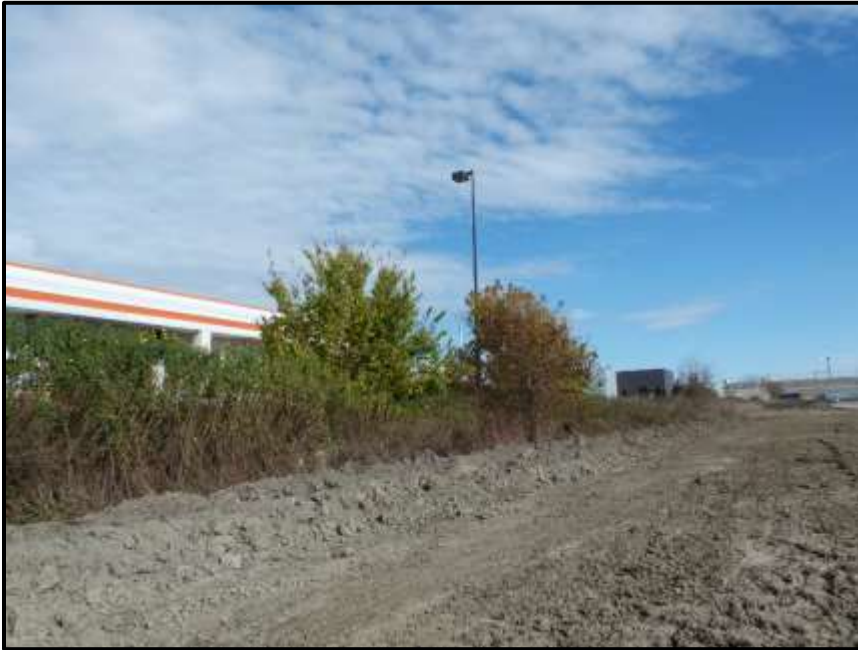
- **Tree Stand E:** Tree Stand E is present at the edge of the adjacent commercial property. Tree Stand E includes two (2) planted Hackberry Trees (*Celtis occidentalis*) and two (2) Manitoba Maples (*Acer negundo*). All four (4) stems are between 10 cm and 20 cm dbh in size.

Photograph 5: Looking north at Tree Stand E (Hackberry and Manitoba Maple) (October 24th, 2018).

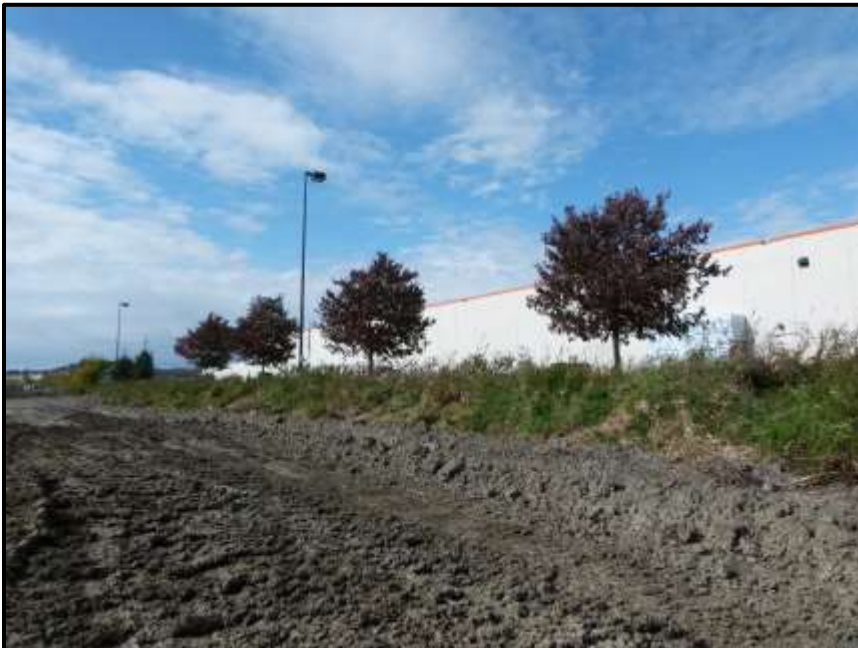
- **Tree Stand F:** Tree Stand F includes four (4) stems of a planted domestic Maple variety (*Acer sp.*), each of which are approximately 15 cm dbh in size. Tree Stand F is located at the edge of the adjacent commercial property.

Photograph 6: Looking north at Tree Stand F (domestic Maple variety) (October 24th, 2018).

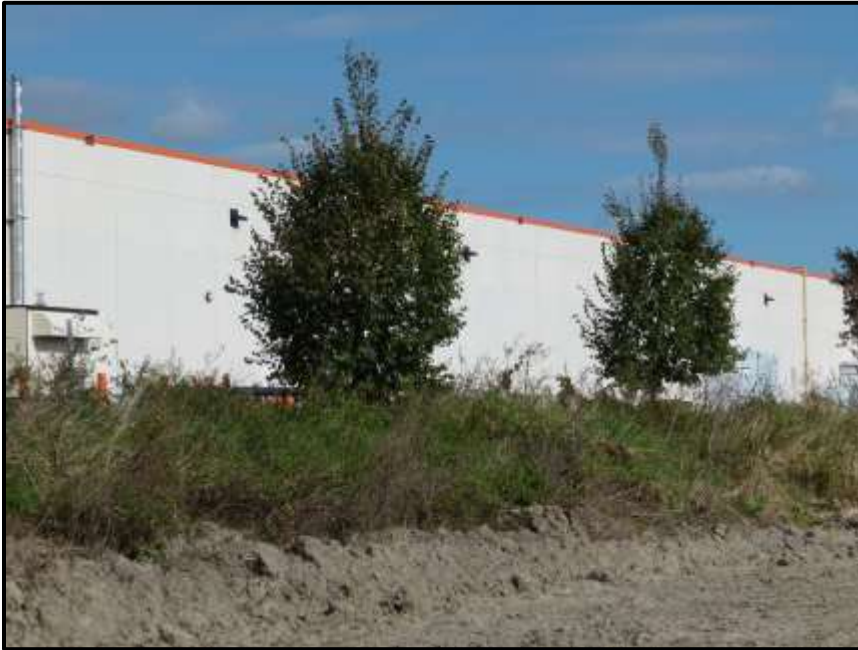
- **Tree Stand G:** Tree Stand G includes two (2) planted Linden (*Tilia americana*) that are both 13 cm dbh in size. Tree Stand G is located at the edge of the adjacent commercial property.

Photograph 7: Looking north at Tree Stand G (Linden) (October 24th, 2018).

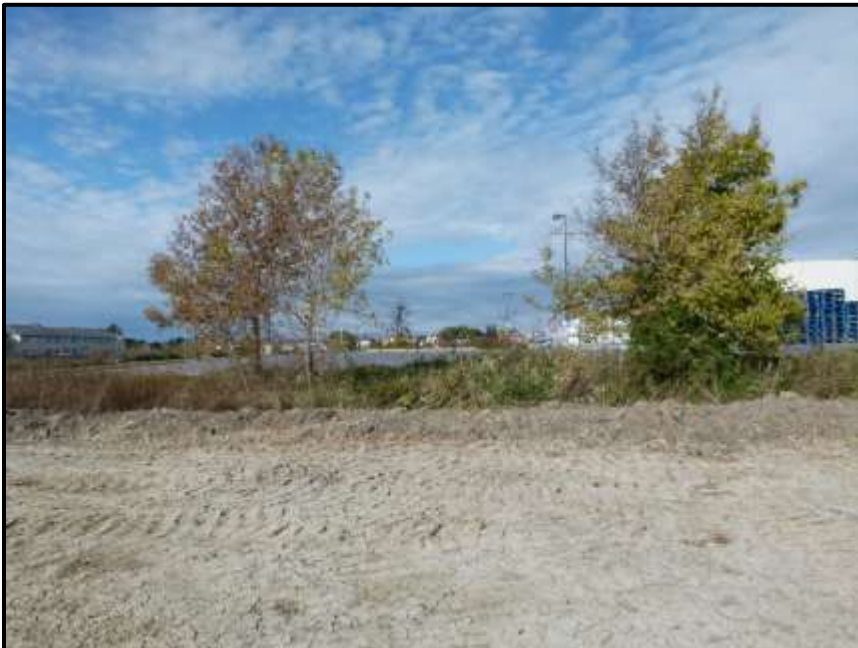
- **Tree Stand H:** Tree Stand H includes a 22.5 cm dbh and a 24 cm dbh Hackberry, located at the edge of the adjacent commercial property.
- **Tree Stand I:** Tree Stand I is a 69 cm dbh White Ash that is located on an adjacent property west of the Site, between the Site edge and the nearby Stormwater Management Pond. Tree Stand I is in poor condition due to the effects of the invasive Emerald Ash Borer.

Photograph 8: Looking north at Tree Stand H (Hackberry) (October 24th, 2018).

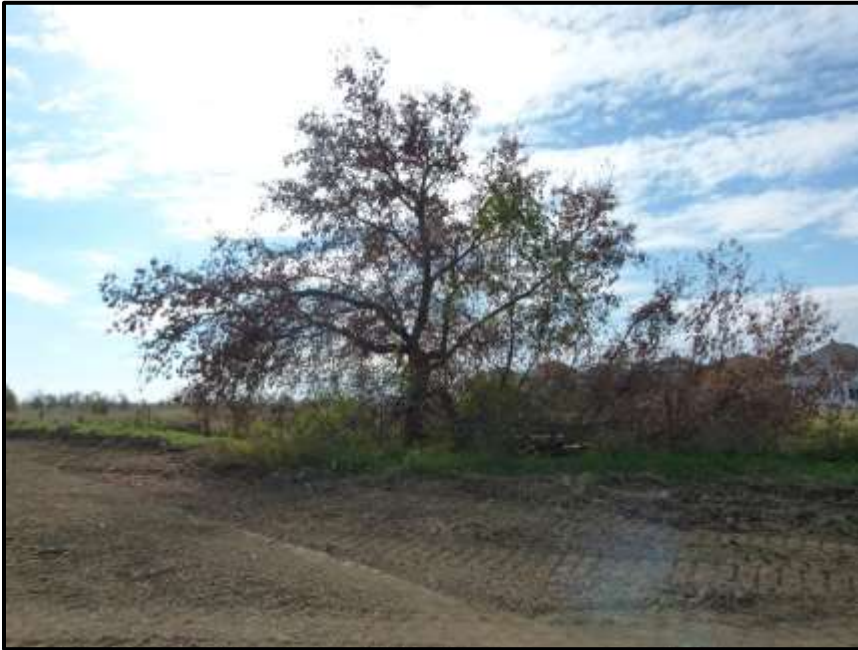
Photograph 9: Looking southwest at Tree Stand I (White Ash) (October 24th, 2018).

- **Tree Stands I, J, K and L:** Tree Stands I, J, K and L all consist of White Ash trees, some of which are surrounded by shrubs. All of the White Ash trees are either dead or dying due to the effects of the invasive Emerald Ash Borer, and therefore should not be retained.

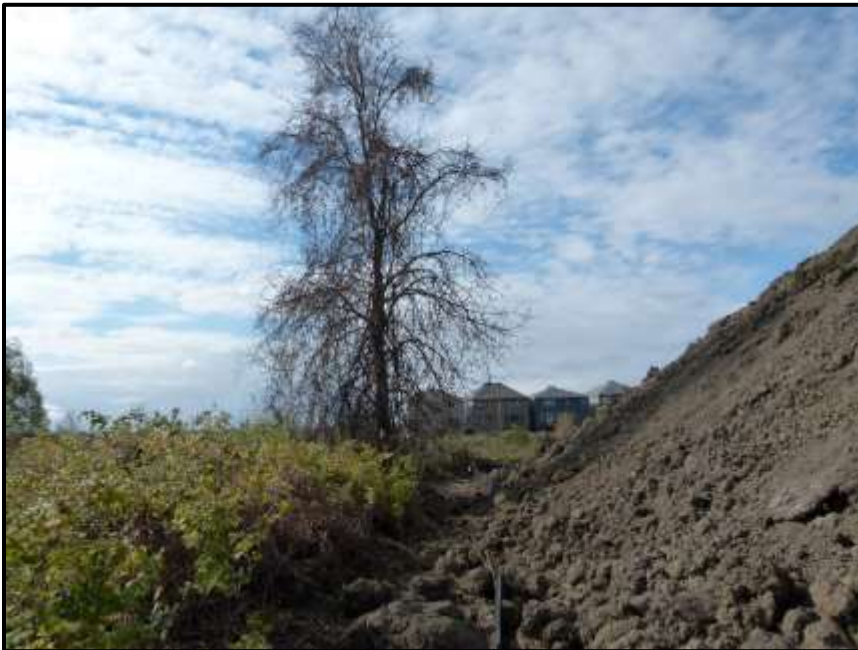
- **Tree Stand J:** Tree Stand J is a 36 cm dbh White Ash that is located at the edge of the Site. Tree Stand J is in poor condition due to the effects of the invasive Emerald Ash Borer.

Photograph 10: Looking west at Tree Stand J (White Ash) (October 24th, 2018).

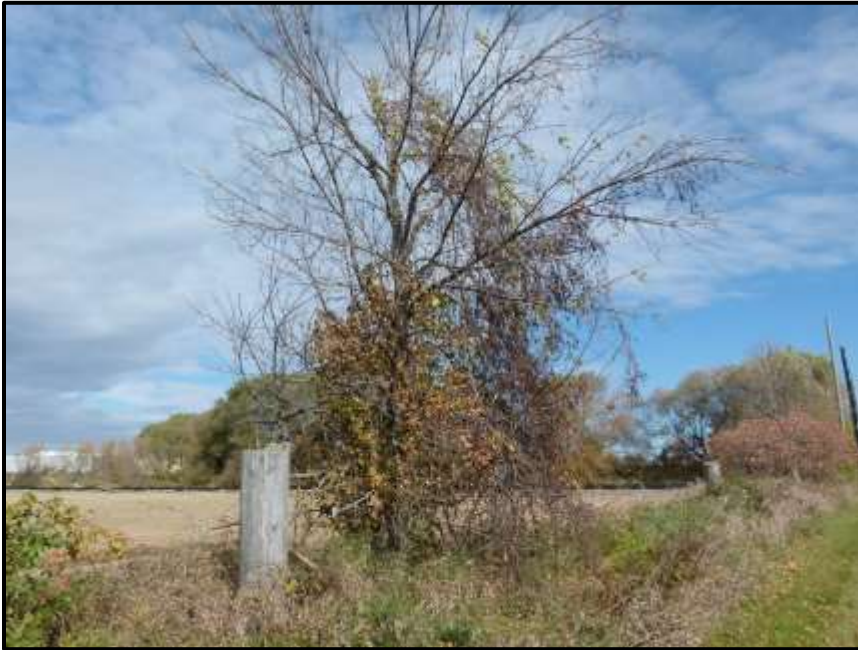
- **Tree Stand K:** Tree Stand K is a 30 cm dbh White Ash that is located at the edge of the Site. Tree Stand K is in poor condition due to the effects of the invasive Emerald Ash Borer.

Photograph 11: Looking northeast at Tree Stand K (White Ash) (October 24th, 2018).

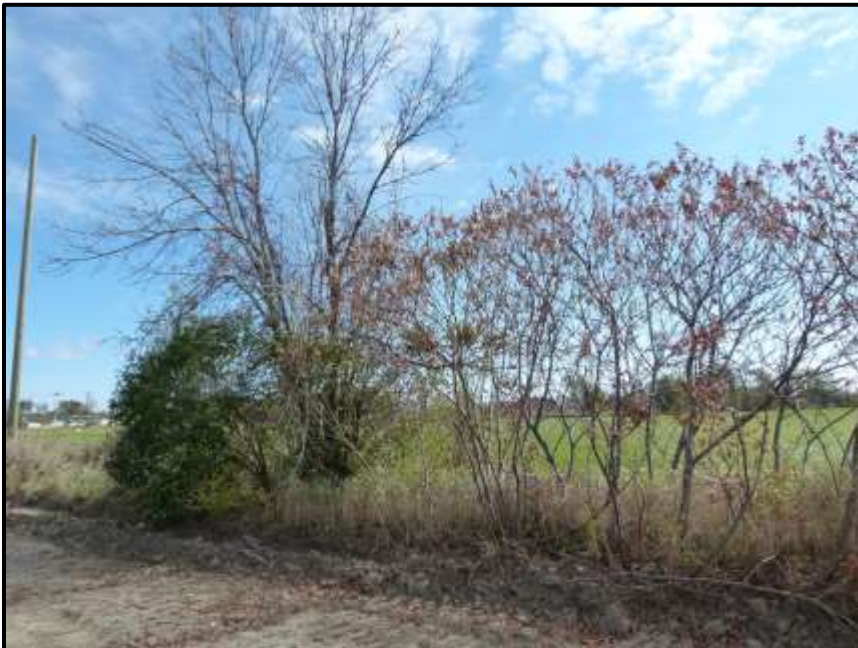
- **Tree Stand L:** Tree Stand L includes a small stand of Staghorn Sumac (*Rhus hirta*) and Common Buckthorn (*Rhamnus cathartica*) shrubs, with several young dead White Ash stems.

Photograph 12: Looking southeast at Tree Stand L (White Ash, Staghorn Sumac, and Common Buckthorn) (October 24th, 2018).

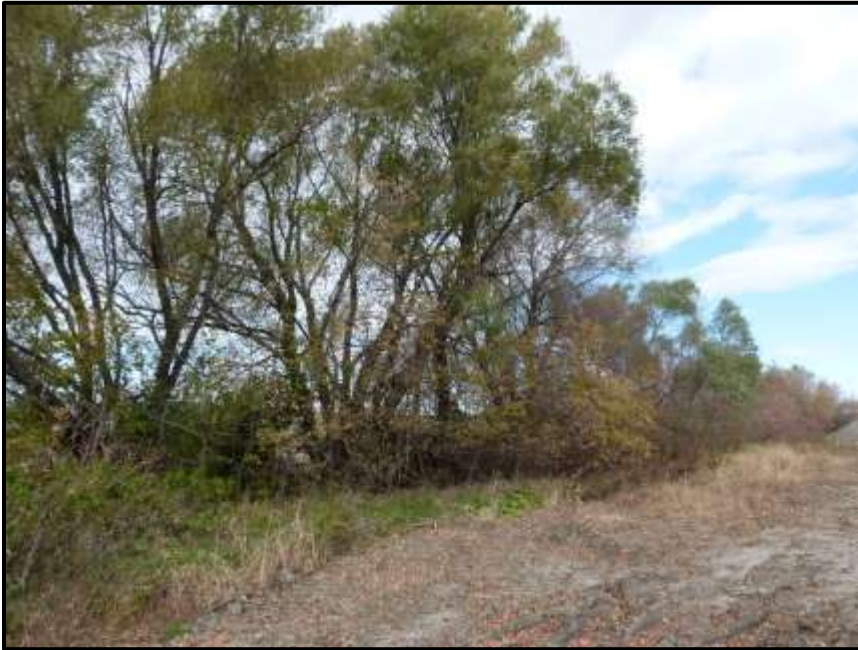
- **Tree Stand M:** Tree Stand M includes a Deciduous Hedgerow that is dominated by Crack Willow (*Salix fragilis*) between 25 cm and 50 cm dbh in size. As noted above, some of the Crack Willow began growing around 1976, and hence are approximately 40 years of age. However, the majority of stems are younger. Also present are Manitoba Maple and White Ash up to approximately 30 cm dbh in size, and small numbers of young Silver Maple (*Acer saccharinum*). Shrub cover is dominated by Wild Red Raspberry (*Rubus idaeus*), Red Osier Dogwood (*Cornus sericea*), and Common Buckthorn.

Photograph 13: Looking east at Tree Stand M (dominated by Crack Willow) (October 24th, 2018).

- **Tree Stands M and N:** Tree Stands M and N are Deciduous Hedgerows that are dominated by invasive Crack Willow, with a high proportion of invasive Manitoba Maple. Both features also include White Ash, which are dead and/or dying due to the effects of the invasive Emerald Ash Borer. Due to the fact that these features are dominated by invasive species and degraded, they should not be a priority for retention.

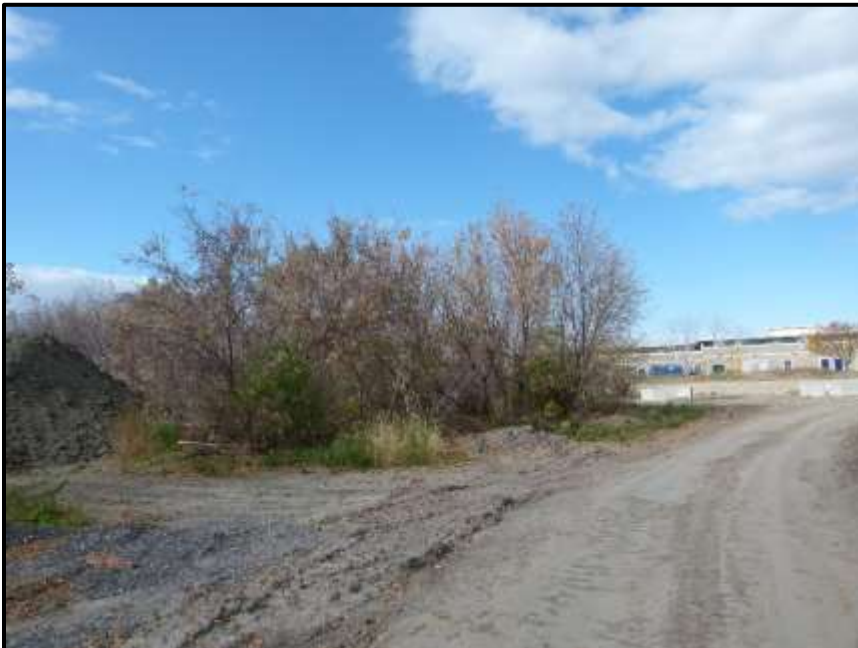
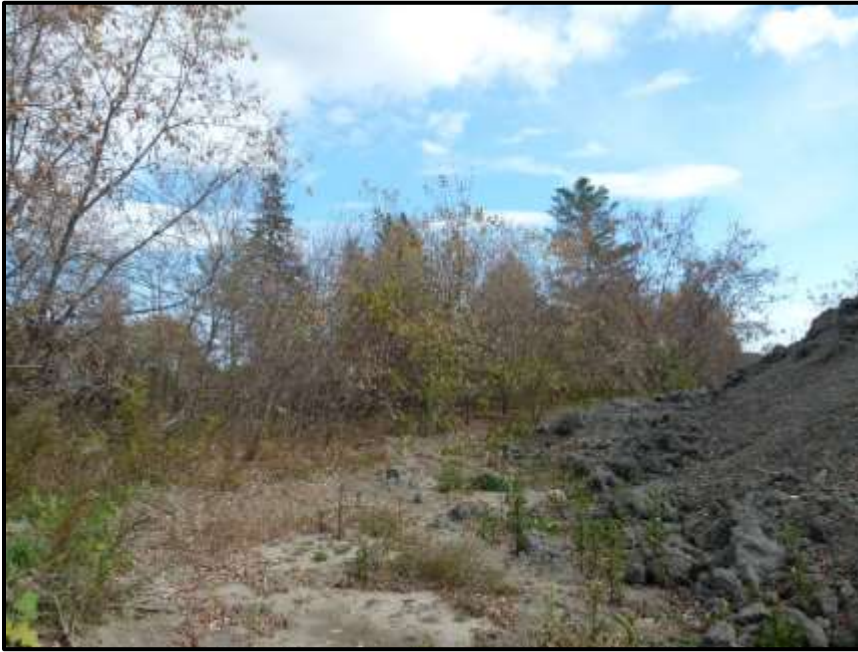
- **Tree Stand N:** Tree Stand N is a young tree stand dominated by Manitoba Maple, White Ash, and Crack Willow. Most trees are less than 15 cm dbh in size, although a few Manitoba Maple up to 30 cm dbh in size are present. Shrub cover includes Staghorn Sumac, Wild Red Raspberry, Common Buckthorn, and Red Osier Dogwood. As discussed below, one (1) Butternut (*Juglans cinerea*) seedling was noted within Tree Stand N.

Photograph 14: Looking north at Tree Stand N (dominated by Manitoba Maple, White Ash, and shrubs) (October 24th, 2018).

Photograph 15: Looking east at Tree Stand N (dominated by Manitoba Maple, White Ash, and shrubs) (October 24th, 2018).

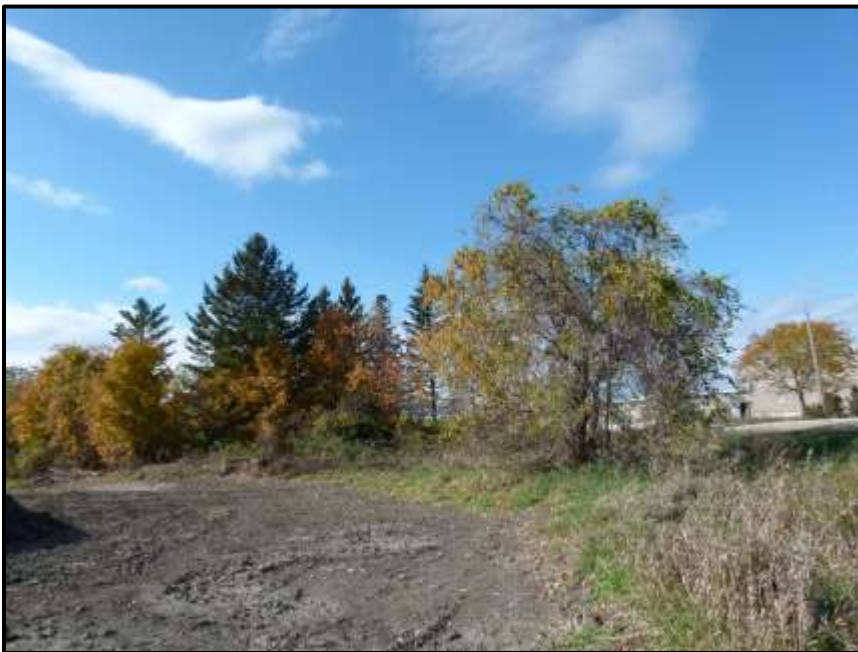
- **Tree Stand O:** Tree Stand O includes several mature trees, which were likely planted as landscaping features surrounding the historic farmhouse. These include White Pine (*Pinus strobus*) (36 cm and 48 cm dbh), White Spruce (64 cm, 43 cm, 41 cm, 29 cm, 45 cm, and 69 cm dbh), and a 41 cm dbh White Birch (*Betula papyrifera*). The mature trees are surrounded by younger recent regrowth White Ash, Sugar Maple (*Acer saccharum*), Manitoba maple, and a few American Elm (*Ulmus americana*) and White Birch, all between 10 cm and 25 cm dbh. Also present are two (2) dead mature White Spruce. Shrub cover includes Common Buckthorn, Staghorn Sumac, and Red Osier Dogwood.

Photograph 16: Looking north at Tree Stand O (mature White Spruce, White Pine and White Birch are visible) (October 24th, 2018).

- **Tree Stand O:** Tree Stand O includes several mature trees that were likely planted as landscaping features around the historic farmhouse. Although several mature stems are present, the majority of trees are relatively young recent regrowth. Tree Stand O cannot be retained, as it falls within the development area.

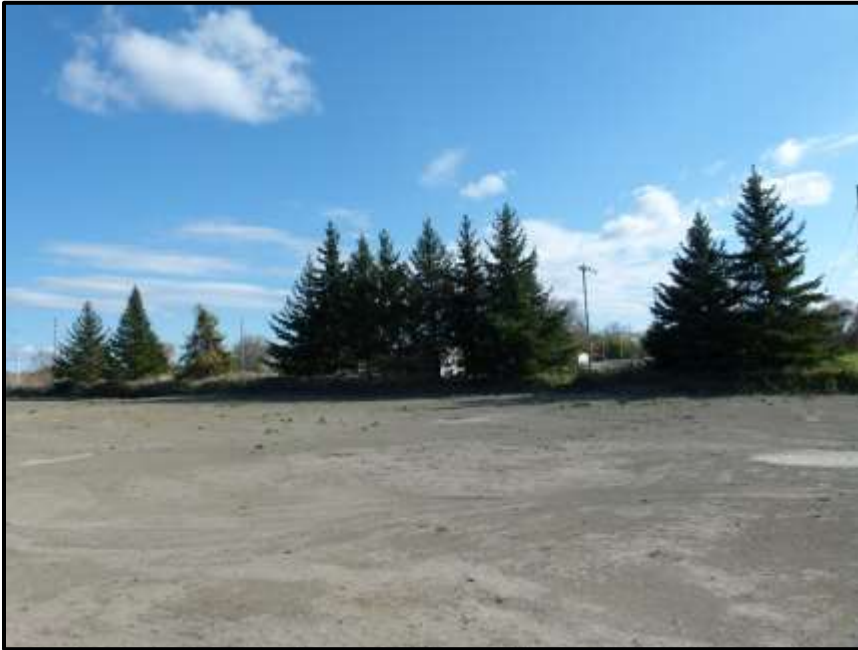
- **Tree Stand P:** Tree Stand P includes twelve (12) White Spruce that were planted along the property line as a visual barrier for the adjacent golf driving range. The White Spruce vary in size between approximately 15 cm and 25 cm dbh.

Photograph 17: Looking southeast at Tree Stand P (planted White Spruce) (October 24th, 2018).

- **Tree Stand P:** Tree Stand P includes the White Spruce stems that were planted along the property line as a visual barrier for the adjacent golf driving range. The White Spruce occur in the center of the future Street #1 road allowance, and hence cannot feasibly be retained.

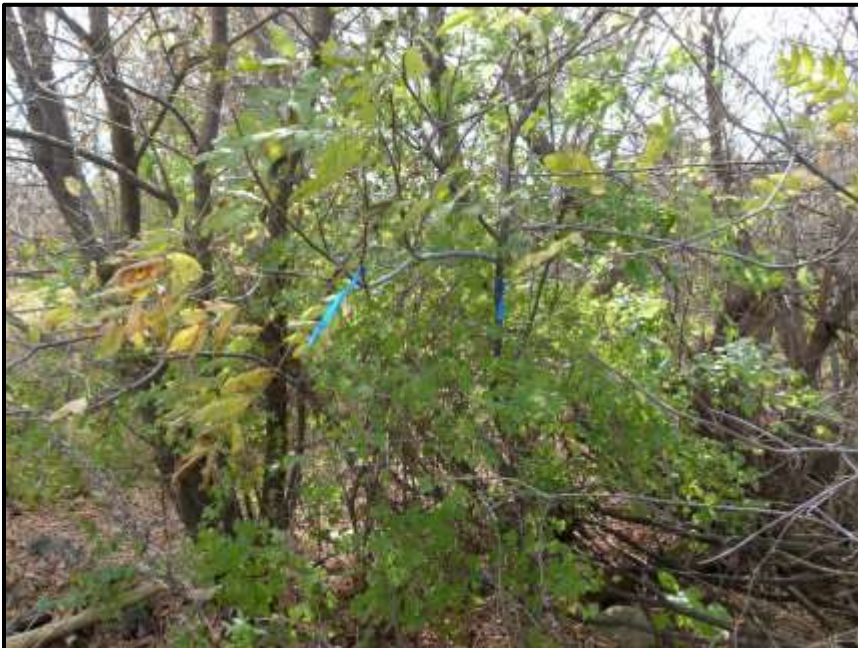
- **Butternut Tree:** As noted above, a single Butternut Tree (endangered) was found within Tree Stand N. A follow-up Butternut Health Assessment (BHA) (Appendix B) was completed for the Site, which confirmed that only one (1) Butternut Tree is present. The Butternut Tree has a dbh of 4 cm and was assessed as a Category 2 (retainable) tree.

Photograph 18: Butternut Tree within Tree Stand N (October 24th, 2018).

- **Butternut Tree:** The Butternut Tree occurs within the development area (Tree Stand N) and therefore cannot be retained. Regulatory requirements to remove the Butternut Tree are discussed below.

The rules and regulations of the Ontario Endangered Species Act (ESA) allow proponents to fulfill regulatory requirements for the removal of up to ten (10) Category 2 (retainable) Butternut Trees through the Ontario Ministry of Natural Resources and Forestry (OMNRF) online registration system. The removal of the one (1) Category 2 Butternut Tree will be registered through the online registry in January 2019, prior to removal of the tree. A copy of the Confirmation of Impact Registration will be provided to the City, following completion of the registration process. The rules and regulations of the ESA require that Richcraft provide compensation for the removal of the Butternut Tree by planting five (5) Butternut Seedlings and five (5) companion trees. Compensation planting requirements will be fulfilled off-site in collaboration with the Rideau Valley Conservation Foundation (RVCF).
