patersongroup

re:	Response to Community Comments
	Proposed Multi-Storey Building
	St. Joseph Boulevard and Duford Drive - Ottawa
to:	Fotenn - Ms. Julie Carrara - Carrara@fotenn.com
date:	January 19, 2018
file:	PG4083-MEMO.01R

Historical Photographs, Aerial and Street View Images

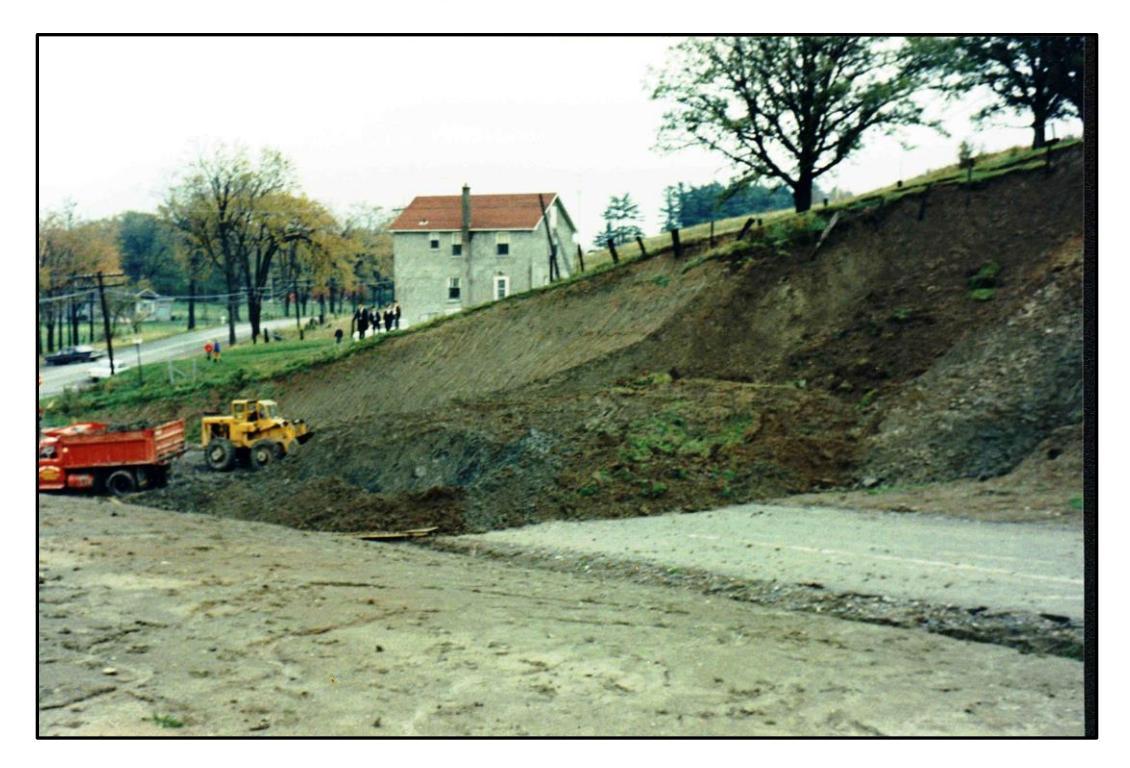
It is understood that a slope failure occurred along the east side of Duford Drive in the 1960s. Photographs of the slope failure were provided to Paterson for this response. Photographs 1 and 2 attached to the present report show a shallow slope failure across a limited section of overall slope face. Based on slope features noted in the photographs, such as lack of vegetation across the slope face and the soil surface in the area of Duford Drive, it appears that the slope failure occurred across a section of the slope, which had been recently re-shaped as part of the construction of Duford Drive.

The natural grade of the slope face was drastically changed during the construction of Duford Drive. It is expected that the slope failure can be directly contributed to the steepness of excavated slope face along with exposure to precipitation events before a vegetative layer could establish. It should be further noted that a vegetative layer across a slope face promotes surficial run-off during precipitation events and limits infiltration of rainwater into the slope soil. Infiltration of water from precipitation events into a slope reduces overall slope stability.

Photo 1: Localized slope failure occurring in the mid 1960s adjacent to Duford Drive. Subject site is located within the foreground of the photograph. St. Joseph Boulevard is in the background. Ground surface adjacent to Duford Drive is noted to be free of vegetation, which is indicative that construction of the subject roadway section and cutting of the subject slope was recently completed. It is suspected that the exposed slope was re-shaped to an unstable slope angle as part of the construction work at that time.

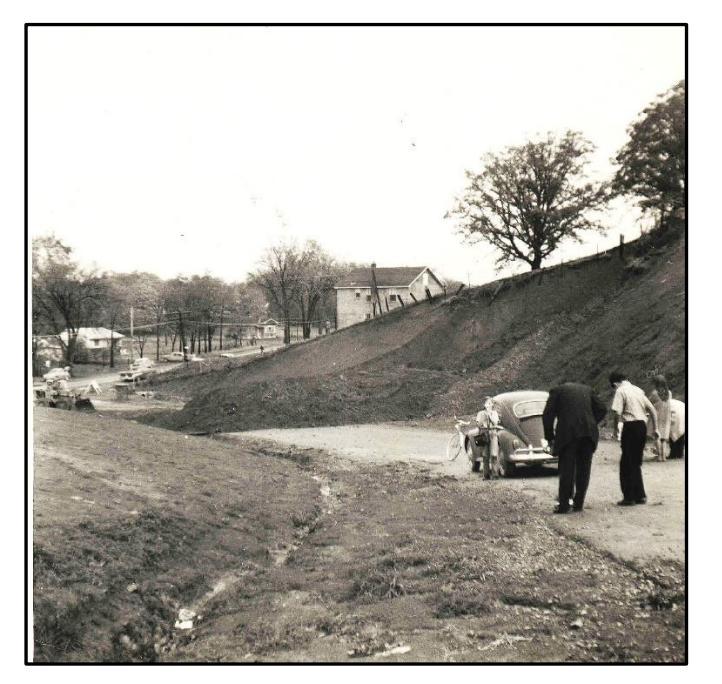
Photo 2: Same localized slope failure, which occurred in mid 1960s.

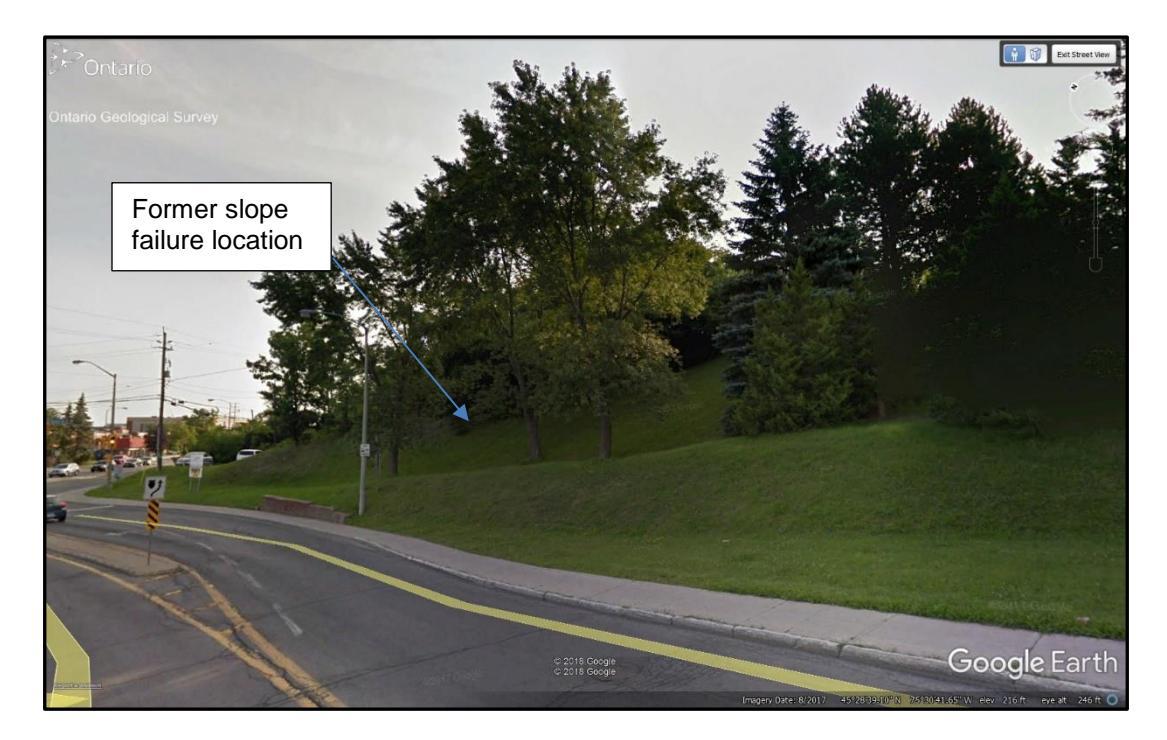
The current slope face was noted to include a terraced area along the base of the slope face in the area of the former slope failure (see Photos 3, 4 and 5). It is suspected that the terraced area was introduced after the initial slope failure to stabilize the reinstated slope. Currently, the slope face was noted to be grass covered with mature trees. No signs of slope instability were noted.

Photo 3: Street view image from Google Earth of former slope failure area (presented in Photos 1 and 2) adjacent to Duford Drive. Ground noted to be re-shaped with a terraced slope in front of reinstated slope.

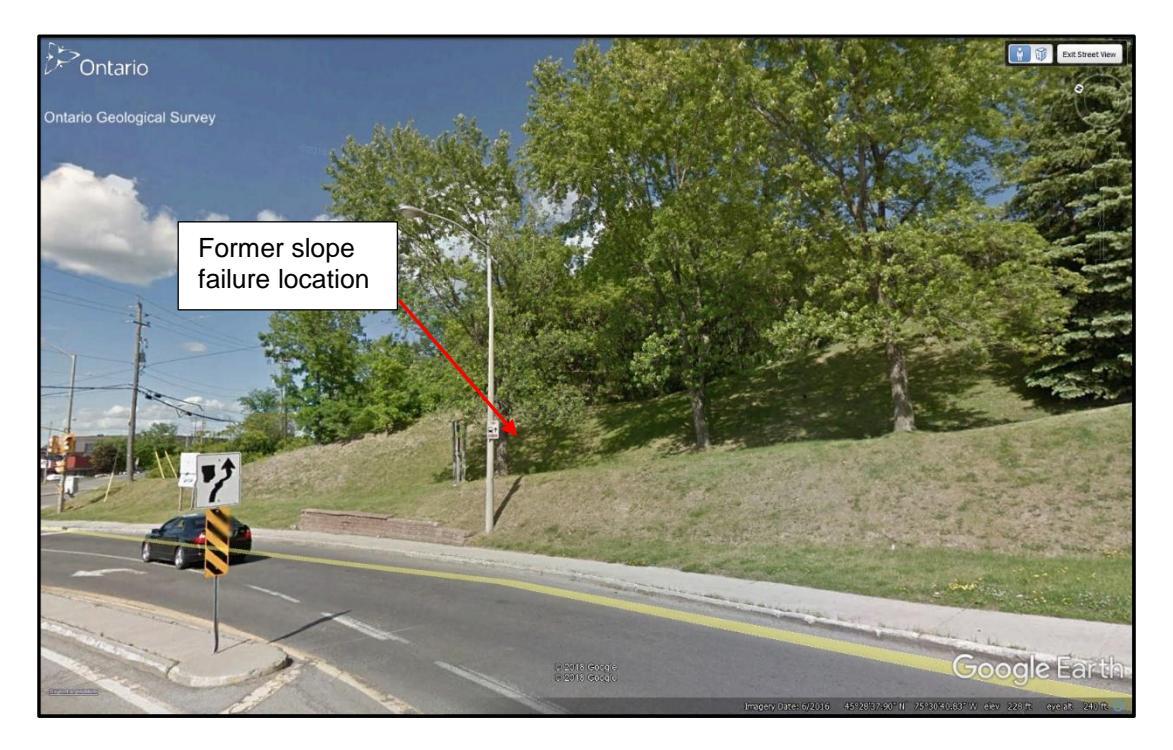
Photo 4: Street view image from Google Earth of the same former slope failure area presented in Photos 1 and 2. The ground surface is noted to be stable with no signs of slope instability.

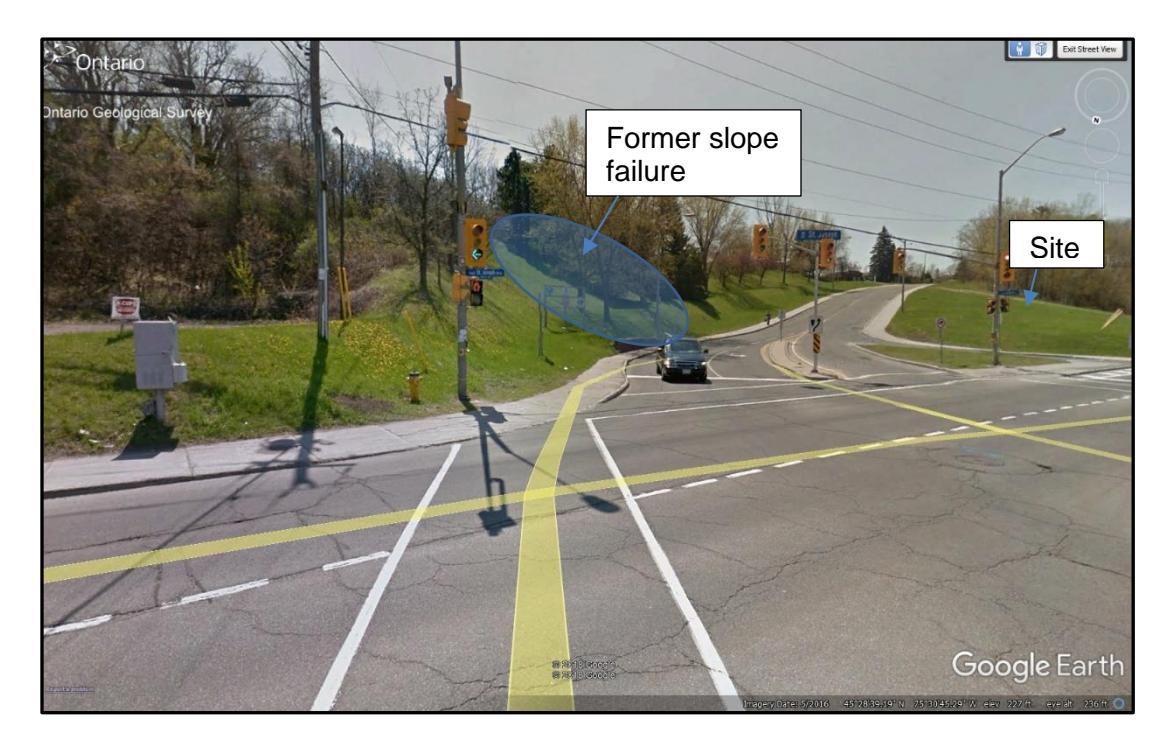
Photo 5: Area of former slope failure noted in Photos 1 and 2. Subject site is property along the right side of the photograph.
