Gladstone and Loretta

TREE CONSERVATION REPORT

| 1987-01 | TCR 1.0 |

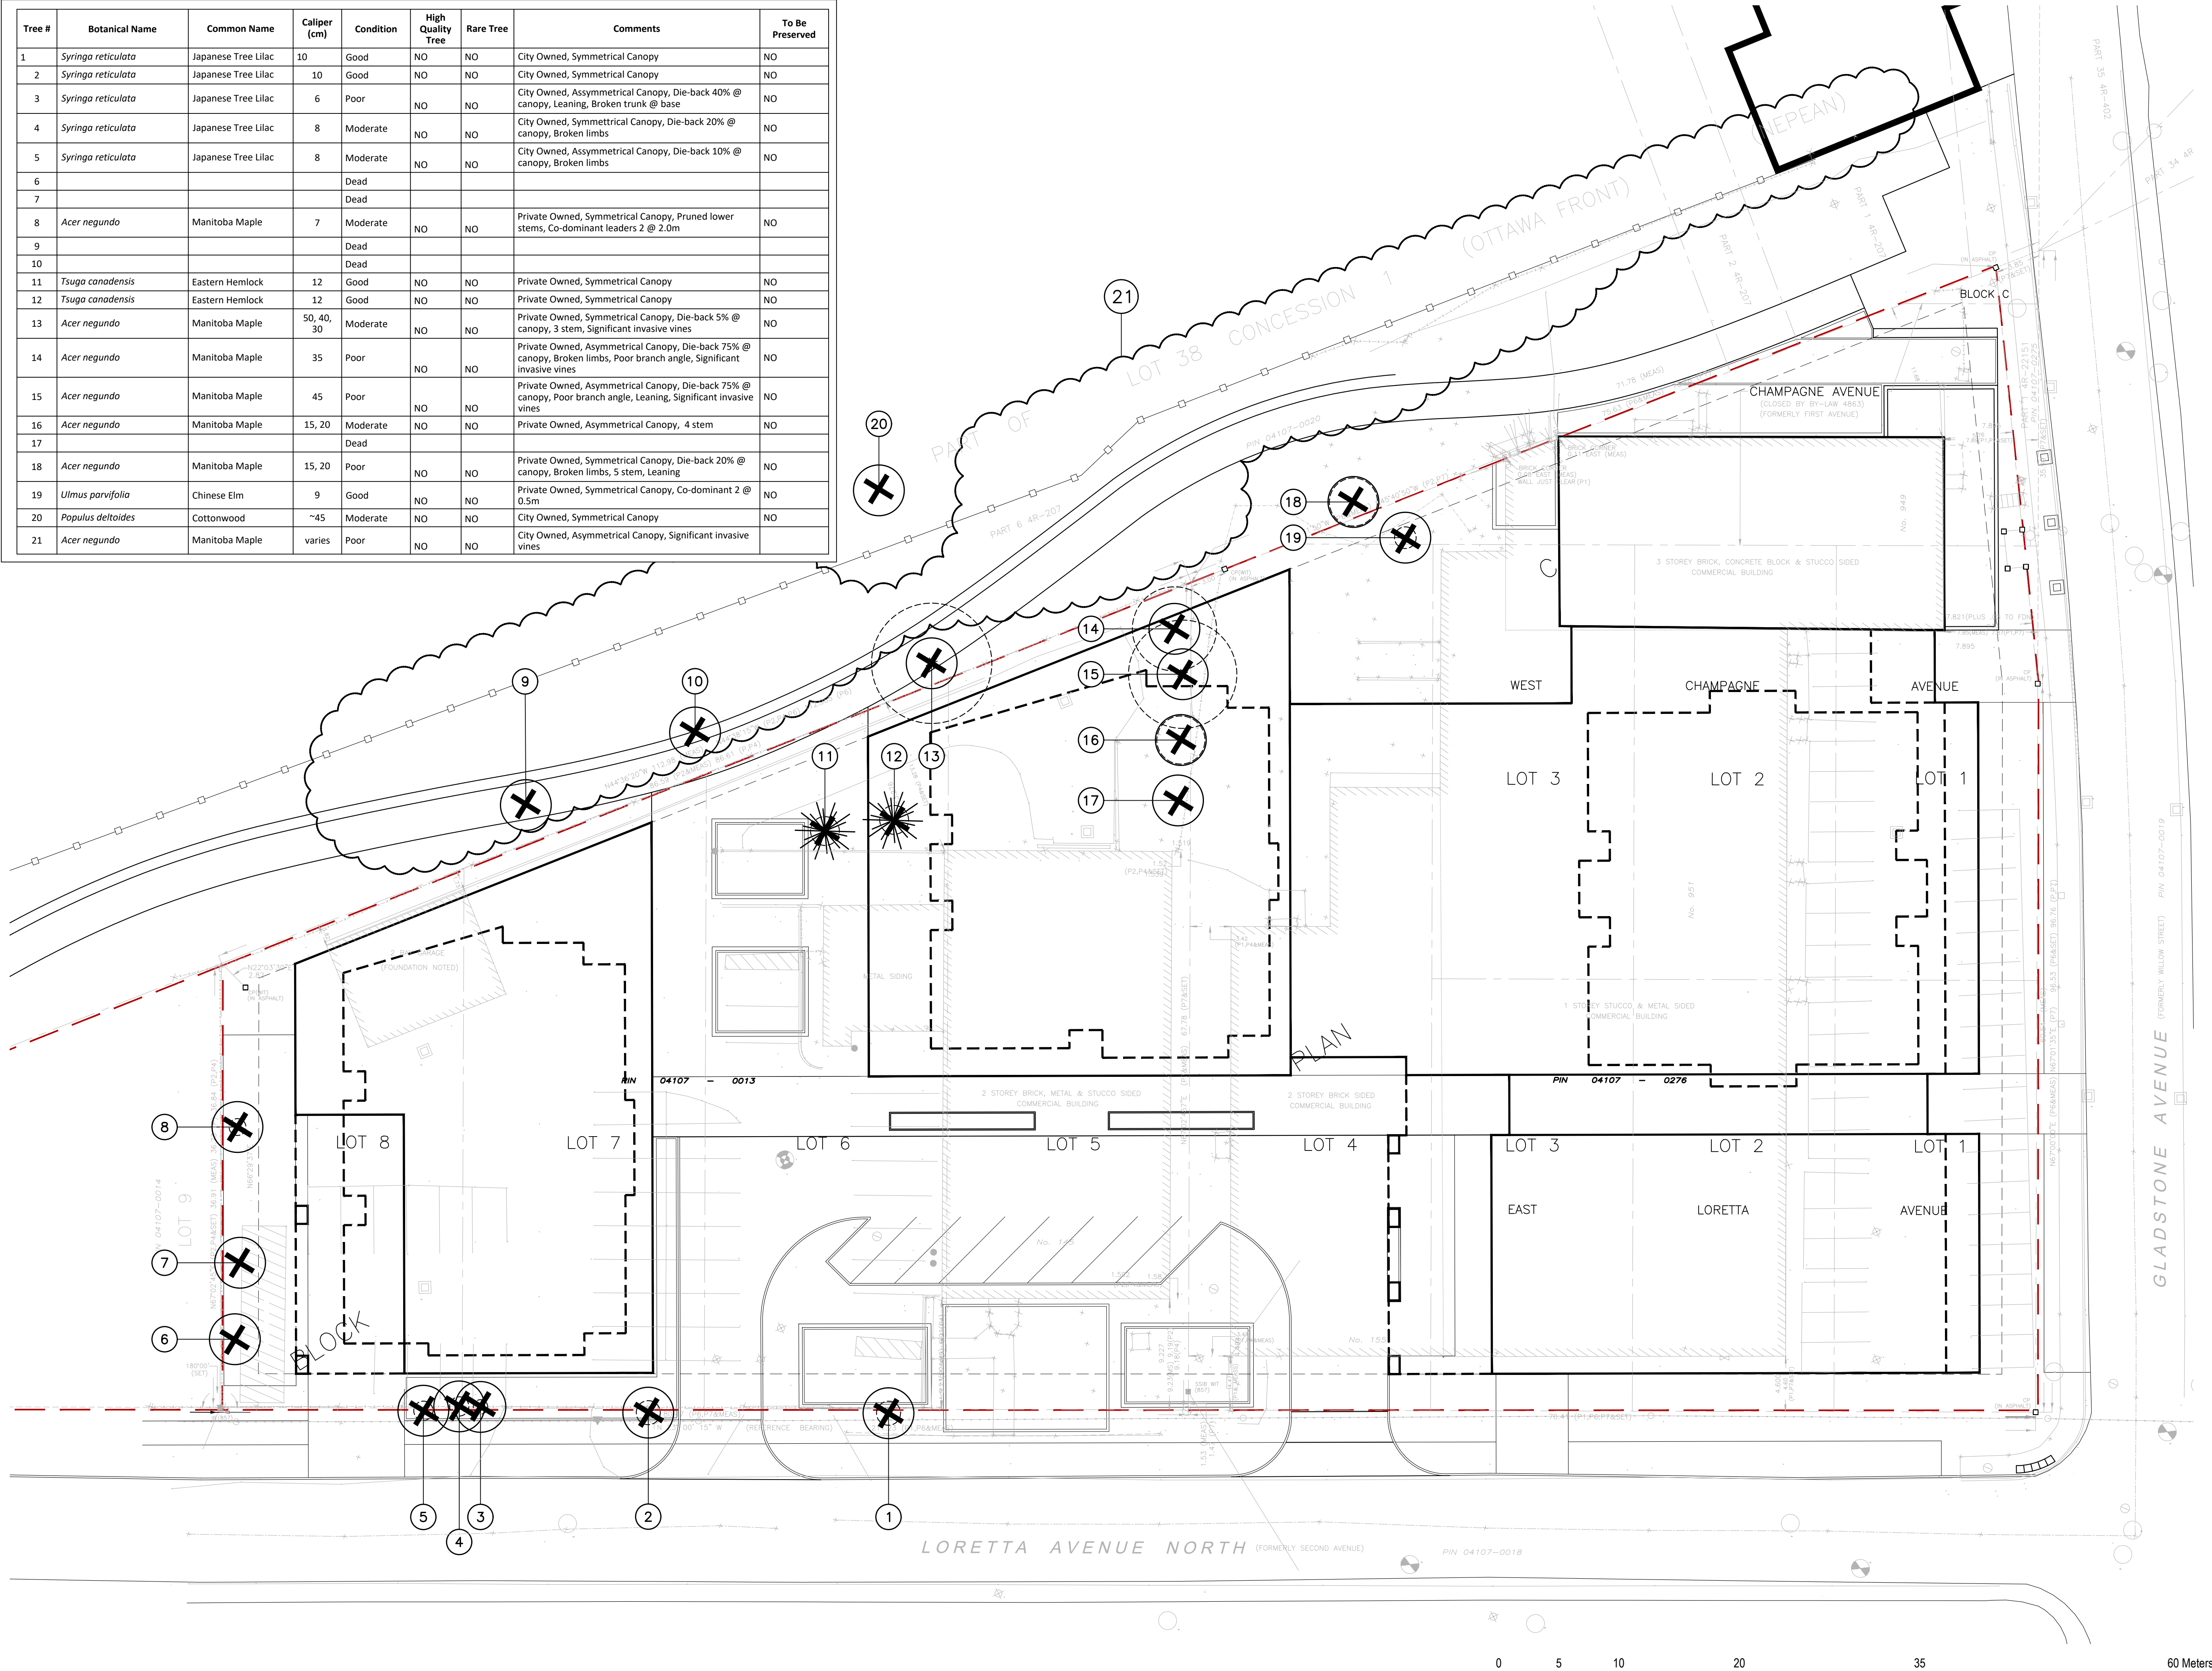
| Tree # | Botanical Name | Common Name | Caliper (cm) | Condition | High Quality Tree | Rare Tree | Comments | To Be Preserved |
|---|---|---|---|---|---|---|---|---|
| 3 | <i>Syringa reticulata</i> | Japanese Tree Lilac | 6 | Poor | NO | NO | City Owned, Assymetrical Canopy, Die-back 40% @ canopy, Leaning, Broken trunk @ base | NO |
| 14 | <i>Acer negundo</i> | Manitoba Maple | 35 | Poor | NO | NO | Private Owned, Asymmetrical Canopy, Die-back 75% @ canopy, Broken limbs, Poor branch angle, Significant invasive vines | NO |
| 15 | <i>Acer negundo</i> | Manitoba Maple | 45 | Poor | NO | NO | Private Owned, Asymmetrical Canopy, Die-back 75% @ canopy, Broken limbs, 5 stem, Leaning | NO |

THIS IS AN EXISTING COMMERCIAL SITE USED PRIMARILY AS BUSINESS SPACE FOR MULTIPLE TENANTS. MUCH OF THE SITE IS CURRENTLY OCCUPIED BY ASPHALT PARKING LOT. THE MAJORITY OF TREES ON SITE ARE AT THE PERIMETER EDGES. WITH THE EXCEPTION OF THE STREET TREES ALONG LORETTA AVE, MOST TREES HAVE ESTABLISHED POORLY AND ARE ILL SITUATED ALONG FENCE LINES OR DIRECTLY AT RETAINING WALLS.

THE LINEAR LANDSCAPE AREA NORTHEAST OF THE SITE RUNS ADJACENT TO THE EXISTING O-TRAIN TRACKS. THIS AREA IS SEPARATED FROM THE COMMERCIAL PROPERTIES WITH CHAIN LINK FENCE AT THE TOP OF A SLOPE. THE AREA IS DENSE WITH INVASIVE PLANTS SUCH AS MANITOBA MAPLE, WILD GRAPE VINE AND VIRGINIA CREEPER. THE AREA HAS A GREAT DEAL OF DEAD TREES AND MISCELLANEOUS DEBRIS MAKING THE AREA DIFFICULT TO ACCESS.

THE SITE LACKS SIGNIFICANT TREES OF VALUE. THE PRESENT TREES OFFER LITTLE BENEFIT TO THE SITE IN TERMS OF ECOLOGY, CHARACTER, OR SHADE VALUE. THE GENERAL CONDITION OF THE SITE'S TREES ARE POOR WITH A DECLINING STATE OF HEALTH.
