September 25, 2019

### **Re: Tree Conservation Report for 1131-1151 Teron Road, Ottawa**

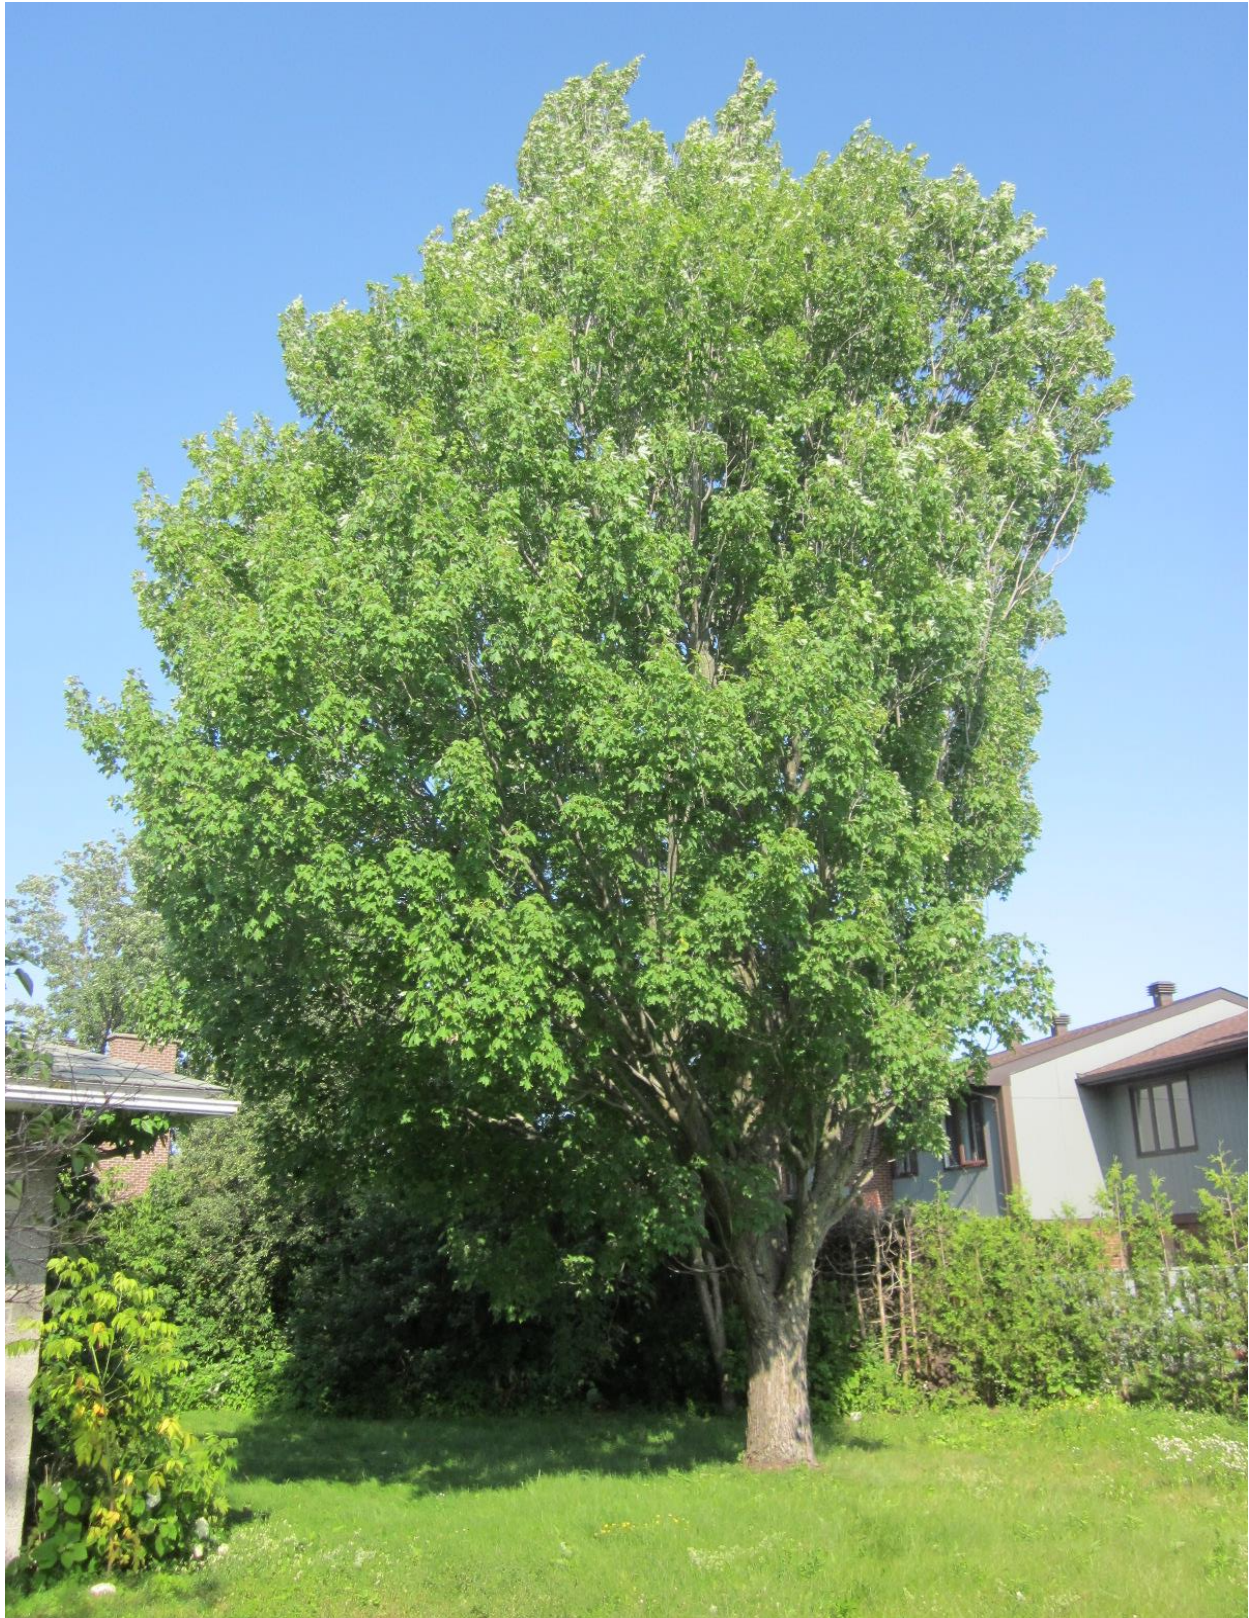
Picture 1. Tree #5, mature red maple located at 1131 Teron Road.

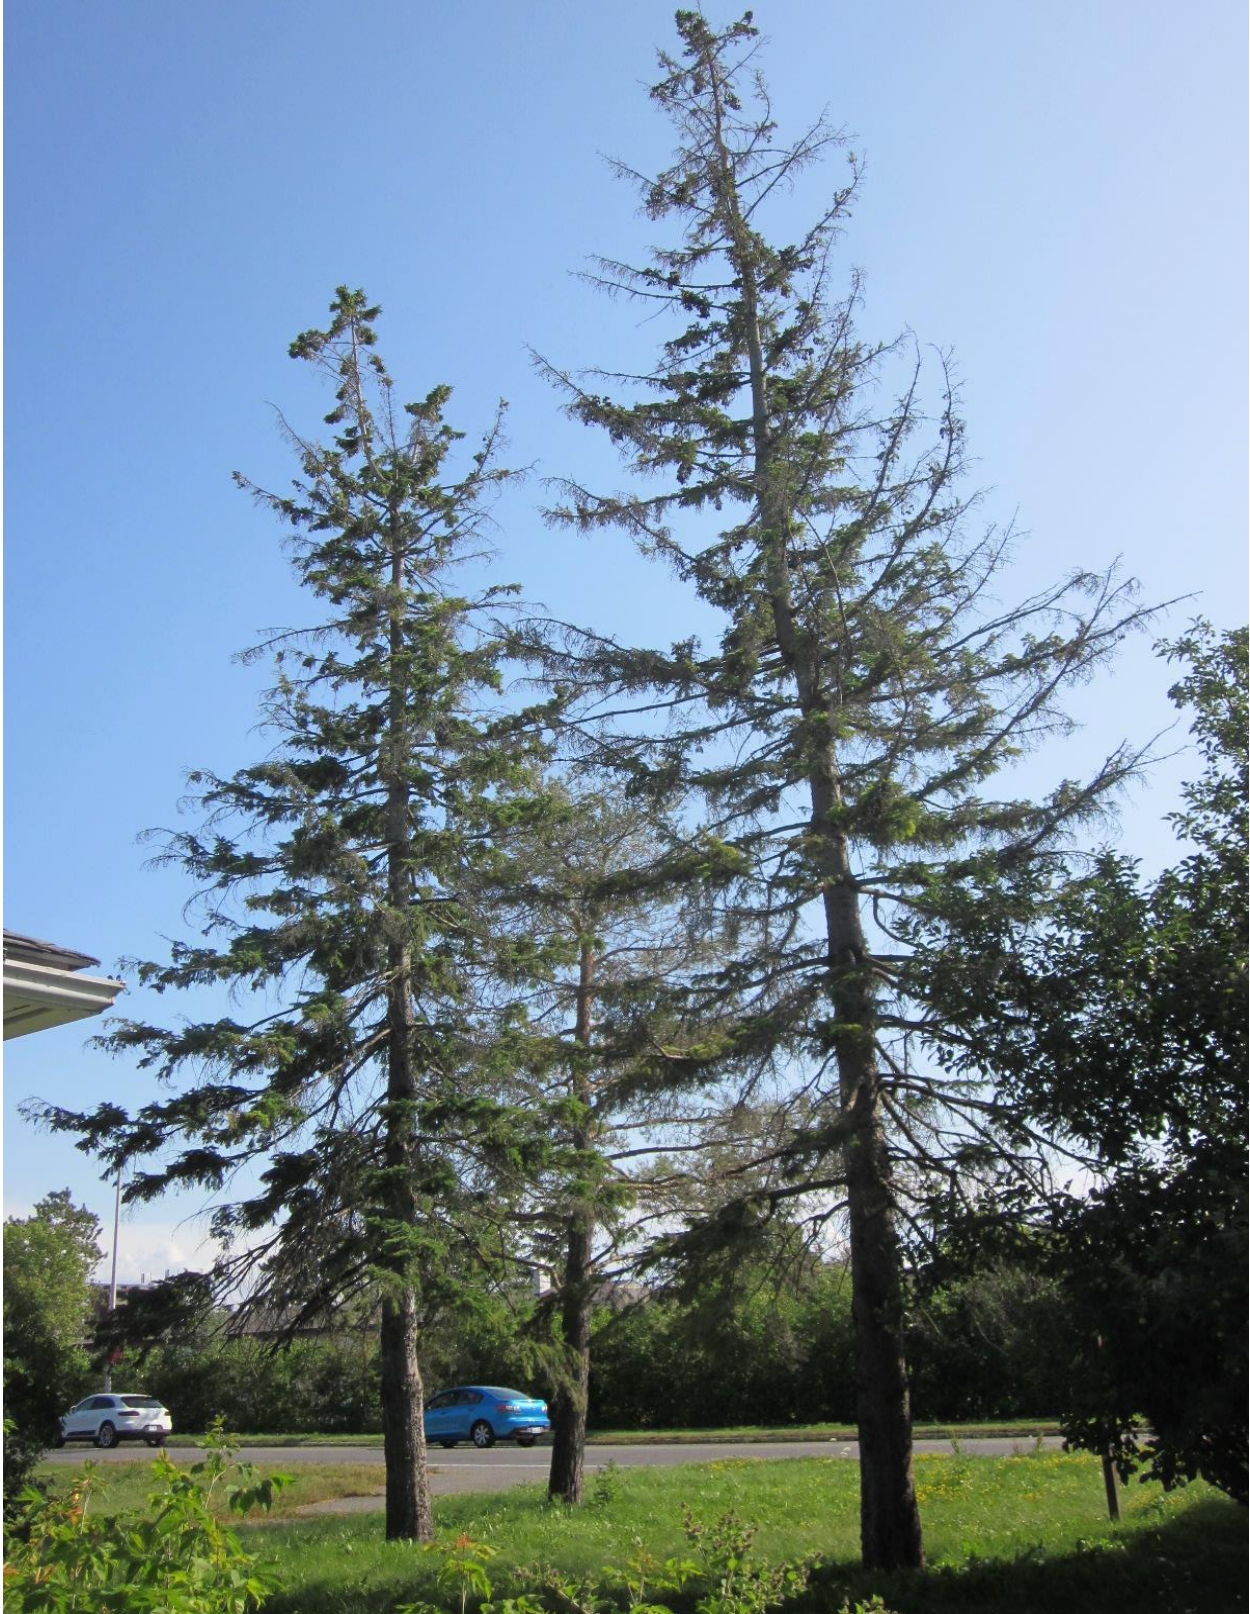
Picture 2. Trees #2, 3 and 4, mature spruce and pine located at 1131 Teron Road.

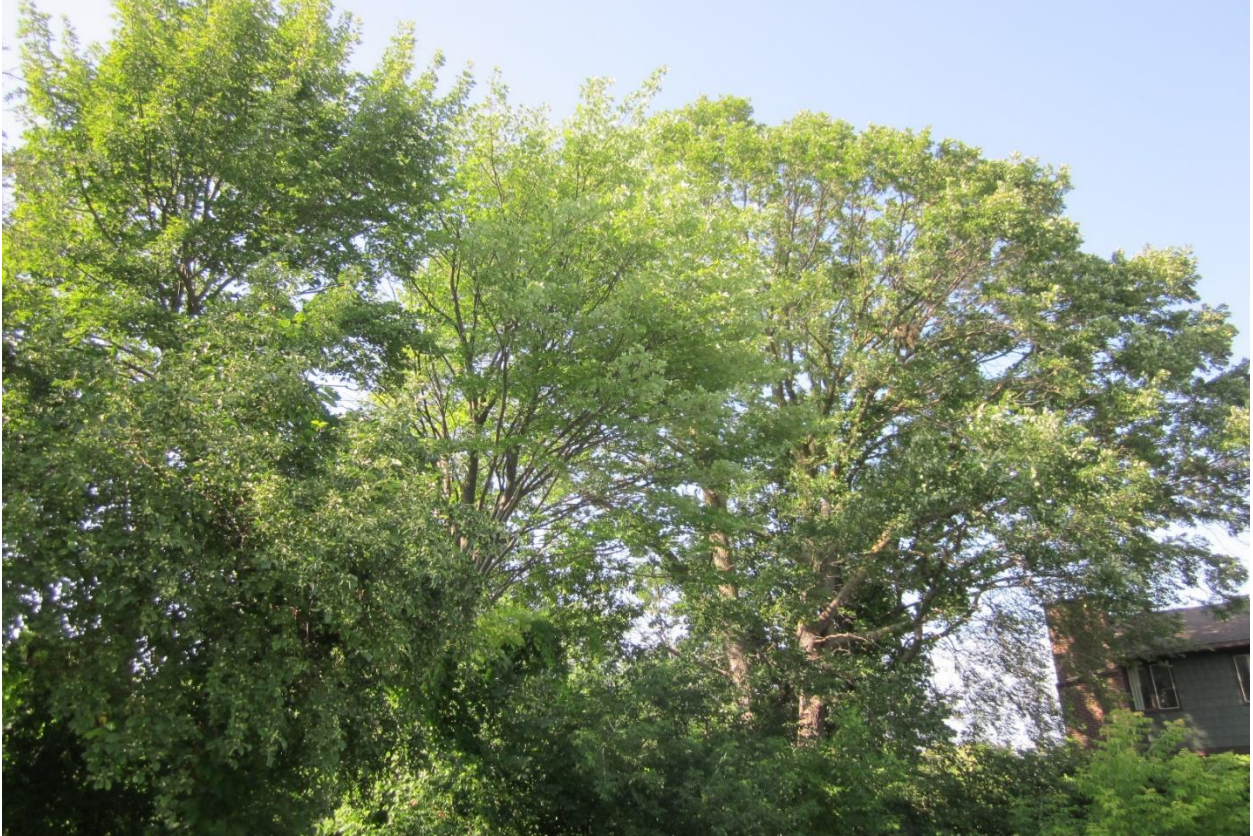
7	Bur oak ( <i>Quercus macrocarpa</i> ) and red maple ( <i>Acer rubrum</i> )	Oak: 48 avg. Maple: 36 avg.	Private	Mature; seven trees in total (3 oak, 2 red maple, 1 crab apple, 1 Manitoba maple and 1 Siberian elm); grown in dense grouping; oak and red maple are native species; <b>to be removed</b> (due to conflicts with proposed development)
9	Colorado spruce ( <i>Picea pungens</i> )	16 avg.	City	Poor-good; maturing; line of approximately 40 trees; introduced species; <b>majority to be preserved and protected</b> (several will be lost due to proposed access road to March Road)

Picture 3. Tree grouping #7 - line of mature red maples and bur oaks located at 1131 Teron Road.

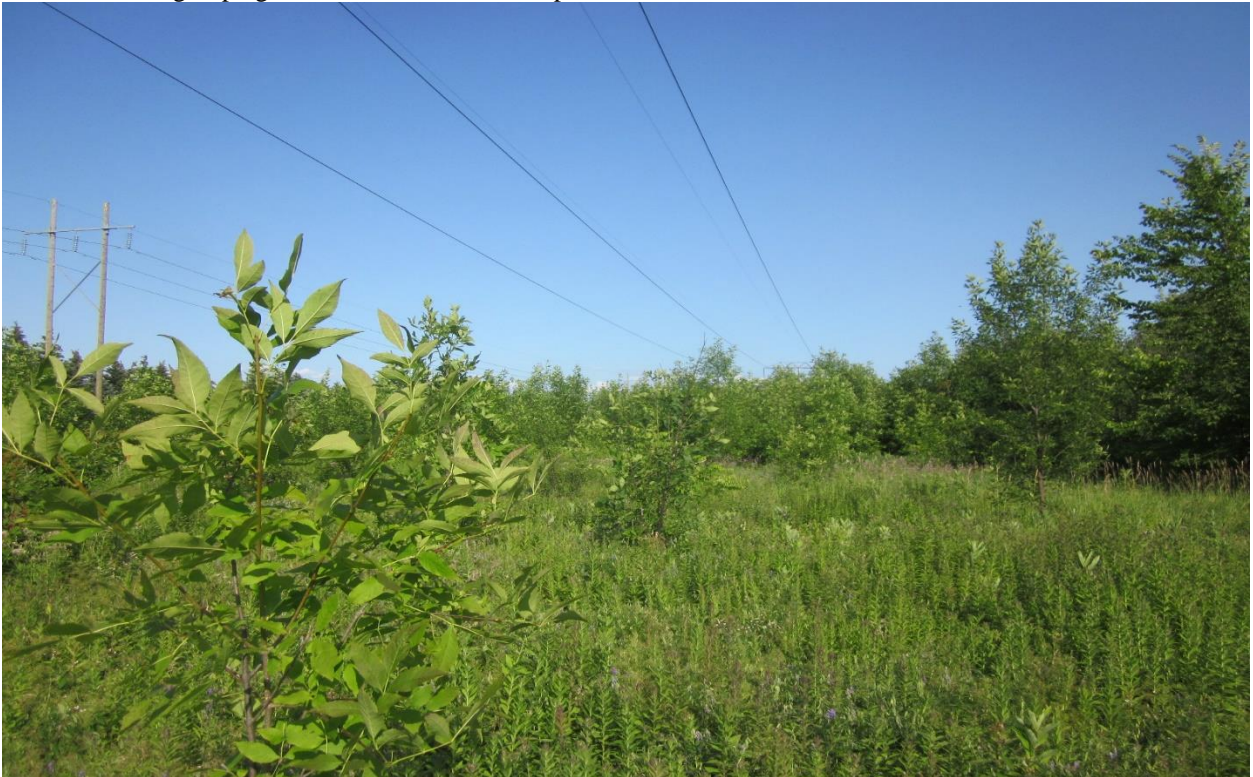
Picture 4. Typical vegetative conditions at 1151 Teron Road.

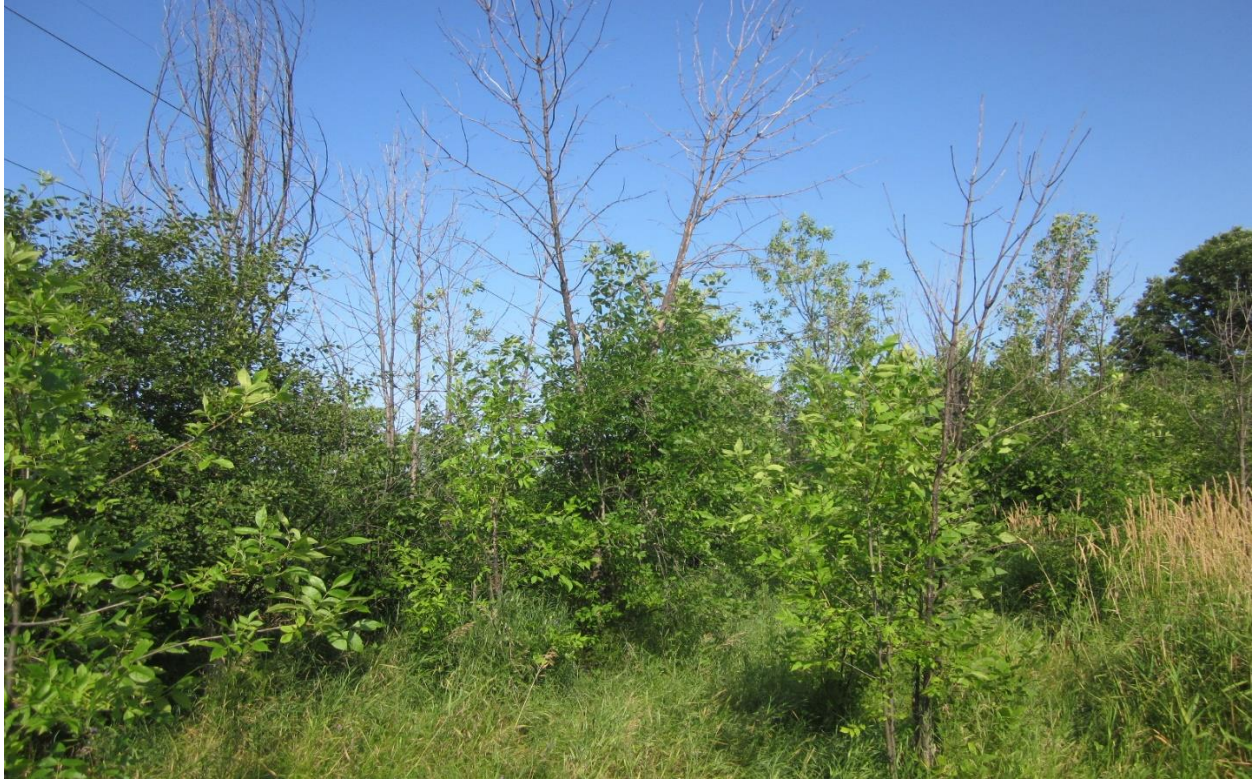
In terms of diseases and pests, some elms are dead or declining due to Dutch elm disease (*Ophiostoma ulmi* and *Ophiostoma novo-ulmi*) infections and many ash are either dead or showing signs of Emerald ash borer (*Agrilus planipennis*) infestations. Table 1 below details the species composition in this area:

Picture 5. Standing dead elm and ash at 1151 Teron Road.

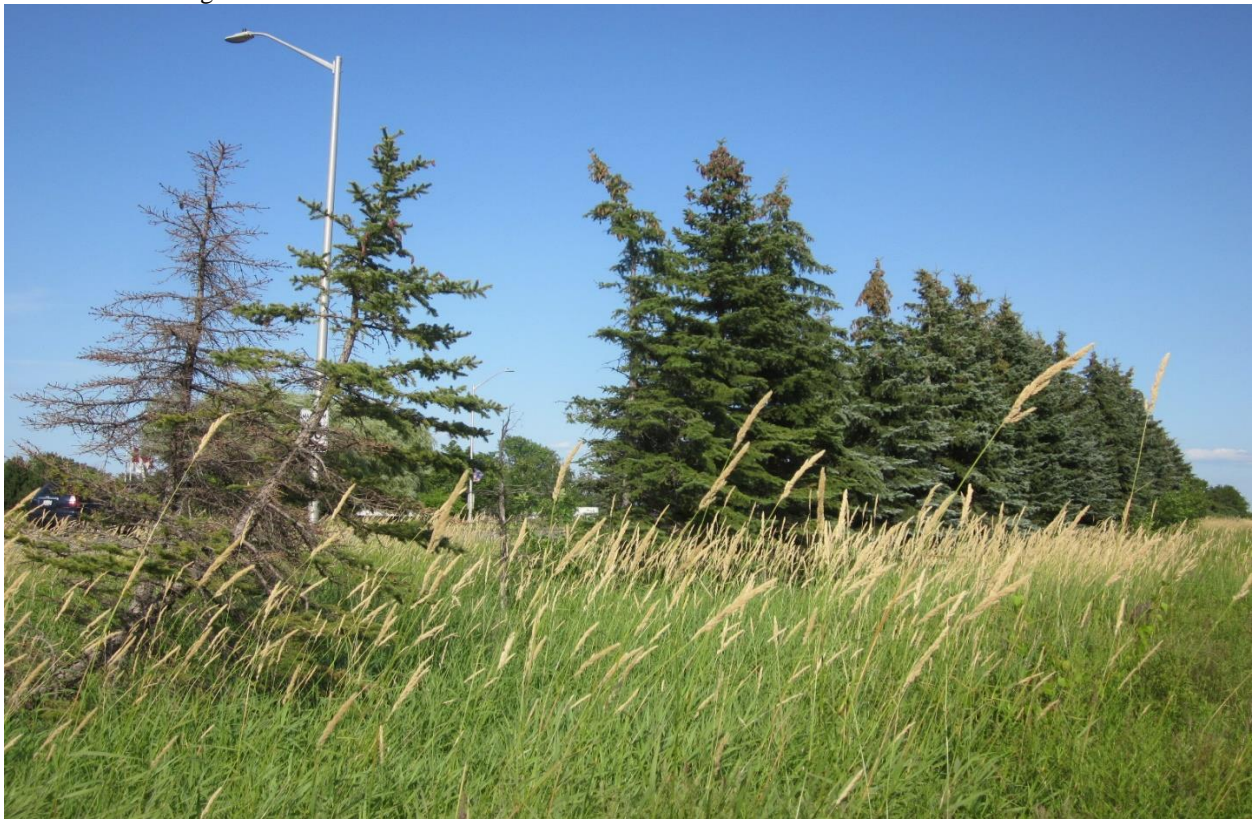
Picture 6. Line of Colorado spruce on City lands adjacent to 1151 Teron Road.
