ST. MARY'S COPTIC ORTHODOX CHURCH
1 CANFIELD ROAD

PROPOSED ST. MARY'S COPTIC
ORTHODOX CHURCH
OTTAWA, ON

CURRENT VEGETATION PLAN

PROPOSED DEVELOPMENT AND
TREE PRESERVATION PLAN

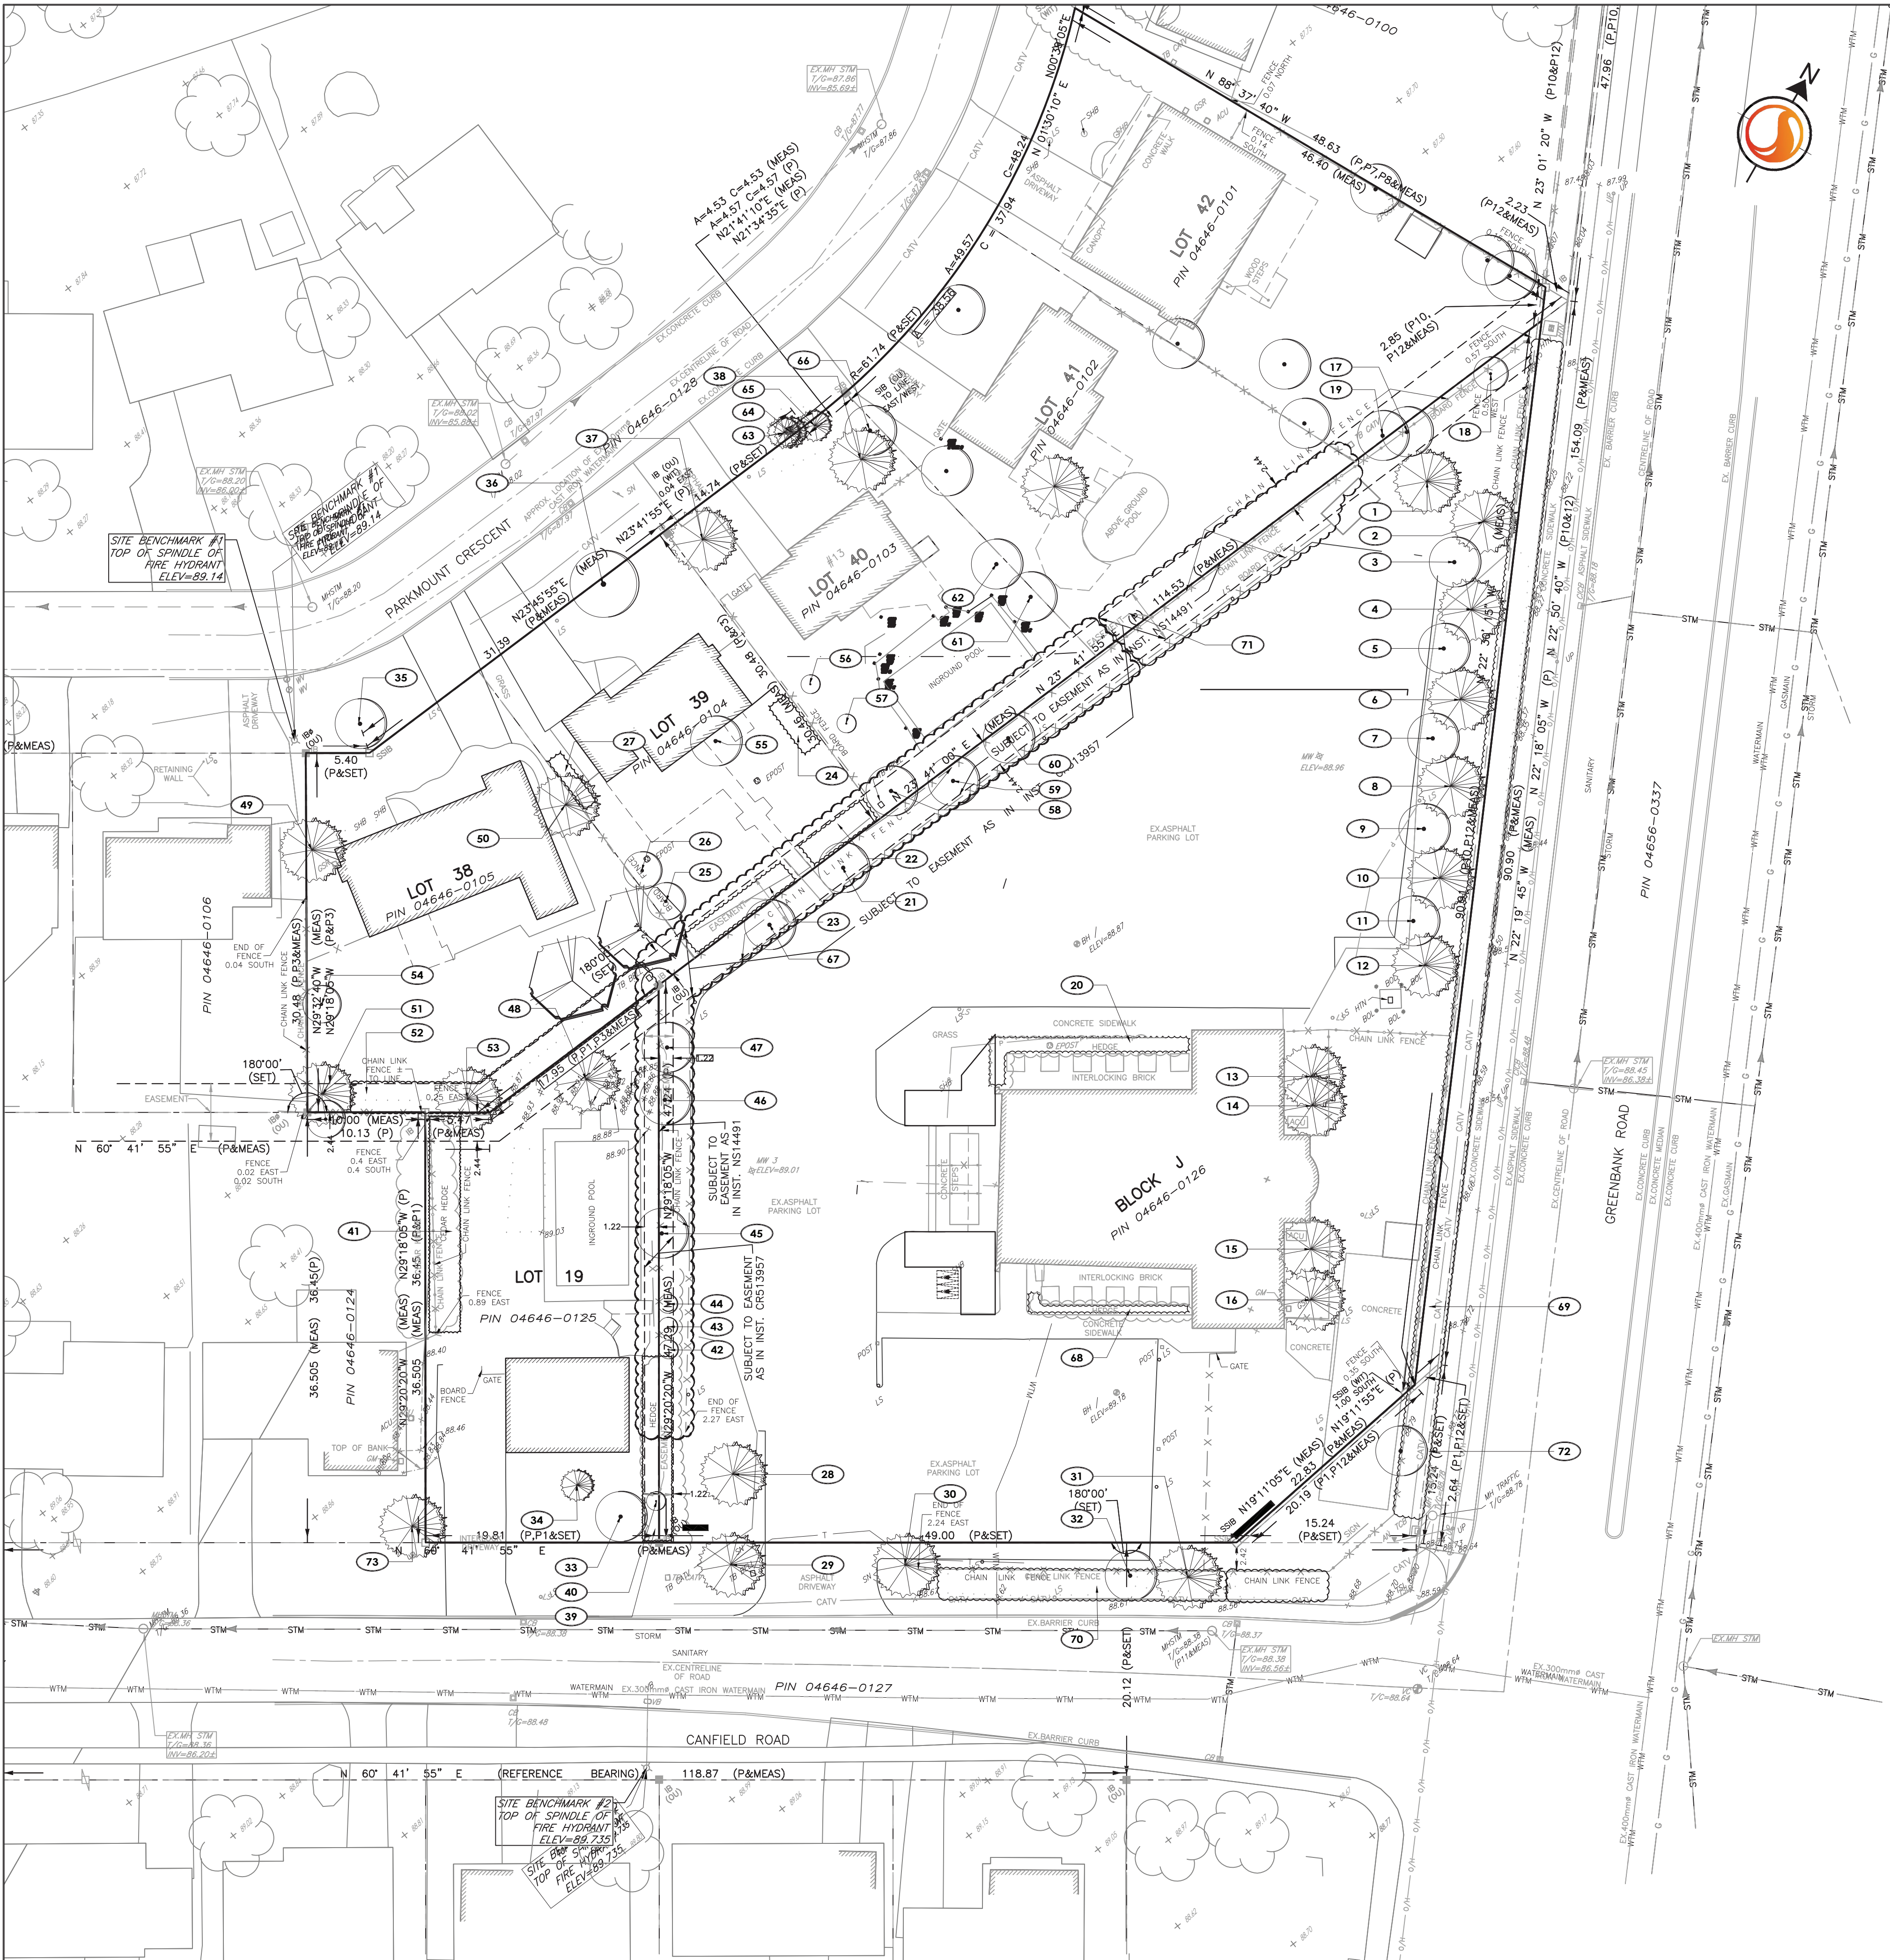
TREE ASSESSMENT CONDUCTED: July 15, 2019

PLANT ID	BOTANICAL NAME	COMMON NAME	DBH (cm)	HEALTH/ CONDITION	REMARKS
1	Picea abies	Norway Spruce	42	Good / Fair	Dead branches on the side facing the adjacent Norway Maples. Tree is not receiving enough sunlight.
2	Picea abies	Norway Spruce	30	Good / Fair	Dead branches on the side facing the adjacent Norway Maples. Tree is not receiving enough sunlight.
3	Acer platanoides 'Crimson King'	Crimson King Norway Maple	24	Good	
4	Picea abies	Norway Spruce	33	Good / Fair	Dead branches on the side facing the adjacent Norway Maples. Tree is not receiving enough sunlight.
5	Acer platanoides 'Crimson King'	Crimson King Norway Maple	30	Good	
6	Picea abies	Norway Spruce	27	Good / Fair	Dead branches on the side facing the adjacent Norway Maples. Tree is not receiving enough sunlight.
7	Acer platanoides 'Crimson King'	Crimson King Norway Maple	30	Good	
8	Picea abies	Norway Spruce	30	Good / Fair	Dead branches on the side facing the adjacent Norway Maples. Tree is not receiving enough sunlight.

9	Acer platanoides 'Crimson King'	Crimson King Norway Maple	31	Good	
10	Picea abies	Norway Spruce	26	Good / Fair	Dead branches on the side facing the adjacent Norway Maples. Tree is not receiving enough sunlight.
11	Acer platanoides 'Crimson King'	Crimson King Norway Maple	30	Good	
12	Picea abies	Norway Spruce	37	Good	
13	Picea pungens 'Glaucous'	Colorado Blue Spruce	25	Good	Lower branches have been trimmed. Poor form.
14	Picea pungens 'Glaucous'	Colorado Blue Spruce	29	Good	Lower branches have been trimmed. Poor form.
15	Picea pungens 'Glaucous'	Colorado Spruce	30	Good	
16	Picea pungens 'Glaucous'	Colorado Blue Spruce	36	Good	
17	Acer saccharum	Sugar Maple	33	Good	
18	Acer negundo	Manitoba Maple	5 @ 12, 16, 22, 13, 15	Good	Multi-stem tree
19	Malus spp.	Apple Tree	N/A	Good	Located on adjacent property
20	Thuja occidentalis	Eastern White Cedar	N/A	Good	Hedge
21	Acer negundo	Manitoba Maple		Poor	1 dead trunk, large cavity, dead branches.

22	Thuja occidentalis	Eastern White Cedar	N/A	Good	Hedge, 6 m height.
23	Thuja occidentalis	Eastern White Cedar	N/A	Good	Hedge, 6 m height.
24	Thuja occidentalis	Eastern White Cedar	N/A	Good	Hedge, 8 m height.
25	Acer negundo	Manitoba Maple	6	Good	
26	Acer negundo	Manitoba Maple	7	Good	
27	Thuja occidentalis	Eastern White Cedar	N/A	Good	Hedge, 6 m height.
28	Picea glauca	White Spruce	22	Fair	
29	Pinus banksiana	Jack Pine	32	Good	
30	Pinus banksiana	Jack Pine		Good	
31	Pinus sylvestris	Scots Pine	40	Good	
32	Acer negundo	Manitoba Maple	15	Good	
33	Betula papyrifera	White Birch	1 @ 25, 1 @ 27	Good	Multi-stem.
34	Picea pungens 'Hopsi'	Hopsi Blue Spruce	15	Good	
35	Acer platanoides 'Crimson King'	Crimson King Norway Maple	40	Good	
36	Acer negundo	Manitoba Maple	1 @ 66, 1 @ 70	Good	Multiple trunks.
37	Picea pungens 'Glaucous'	Colorado Blue Spruce	58	Good / Fair	
38	Picea pungens 'Glaucous'	Colorado Blue Spruce	30	Good

39	Thuja occidentalis	Eastern White Cedar	N/A	Good	Hedge, 5 m height.
40	Acer negundo	Manitoba Maple	11	Good	
41	Thuja occidentalis	Eastern White Cedar	N/A	Good	Hedge, 4 m height.
42	Acer ginnala	Amur Maple	5-15	Good	Multi-stem shrub / tree. Invasive. Non-native.
43	Acer ginnala	Amur Maple	5-15	Good	Multi-stem shrub / tree. Invasive. Non-native.
44	Acer ginnala	Amur Maple	5-15	Good	Multi-stem shrub / tree. Invasive. Non-native.
45	Acer saccharum	Sugar Maple	30	Good	
46	Acer negundo	Manitoba Maple	42	Good	
47	Acer negundo	Manitoba Maple	35	Poor	Many dead branches.
48	Picea pungens 'Glaucous'	Blue Colorado Spruce	35	Poor	
49	Picea glauca	White Spruce	30	Fair	Many dead branches.
50	Picea glauca	White Spruce	43	Fair	Many dead branches.
51	Pinus sylvestris	Scots Pine	33	Poor	Many dead branches.
52	Acer ginnala	Amur Maple	N/A	Good / Fair	Hedge. Some dead trunks. Invasive. Non-native.
53	Picea glauca	White Spruce	19	Poor	Many dead branches.

54	Syringa reticulata	Japanese Tree Lilac	5	Good	
55	Betula alleghensis	River Birch	7	Good	
56	Acer palmatum 'Bloodgood'	Bloodgood Japanese Maple	2.5 cm	Fair	25 cm. abrasion on the trunk. Otherwise healthy.
57	Acer palmatum 'Bloodgood'	Bloodgood Japanese Maple	2.5 cm	Fair	30 cm. abrasion on the trunk. Otherwise healthy.
58	Acer saccharum	Sugar Maple	1 @ 26, 1 @ 16	Good	Tree has 2 trunks.
59	Acer negundo	Manitoba Maple	N/A	Good	Tree is located between 2 fences. Inaccessible.
60	Acer negundo	Manitoba Maple	N/A	Good	Tree is located between 2 fences. Inaccessible.
61	Ulmus americana	American Elm	13	Good	
62	Malus spp.	Crabapple	17	Good	
63	Pinus sylvestris	Scots Pine	12	Good	
64	Pinus sylvestris	Scots Pine	7	Good	
65	Pinus sylvestris	Scots Pine	5	Good	
66	Acer ginnala	Amur Maple	4-15	Good	Multi-stem shrub / tree. Invasive. Non-native.
67	Acer saccharum	Sugar Maple	N/A	Good	Tree is located between 2 fences. Inaccessible.

68	Thuja occidentalis	Eastern White Cedar	N/A	Good	Hedge, 1.2 m height.
69	Lonicera spp.	Honeysuckle	N/A	Good	Hedge, 1.8 m height.
70	Lonicera spp.	Honeysuckle	N/A	Good	Hedge, 1.8 m height.
71	Acer negundo, Acer platanoides, Acer spp.	Manitoba Maple, Norway Maple, Maple	10-35	Good to Poor	Vegetation grouping.
72	Acer spp.	Maple	20	Good	
73	Picea pungens	Colorado Spruce		Good

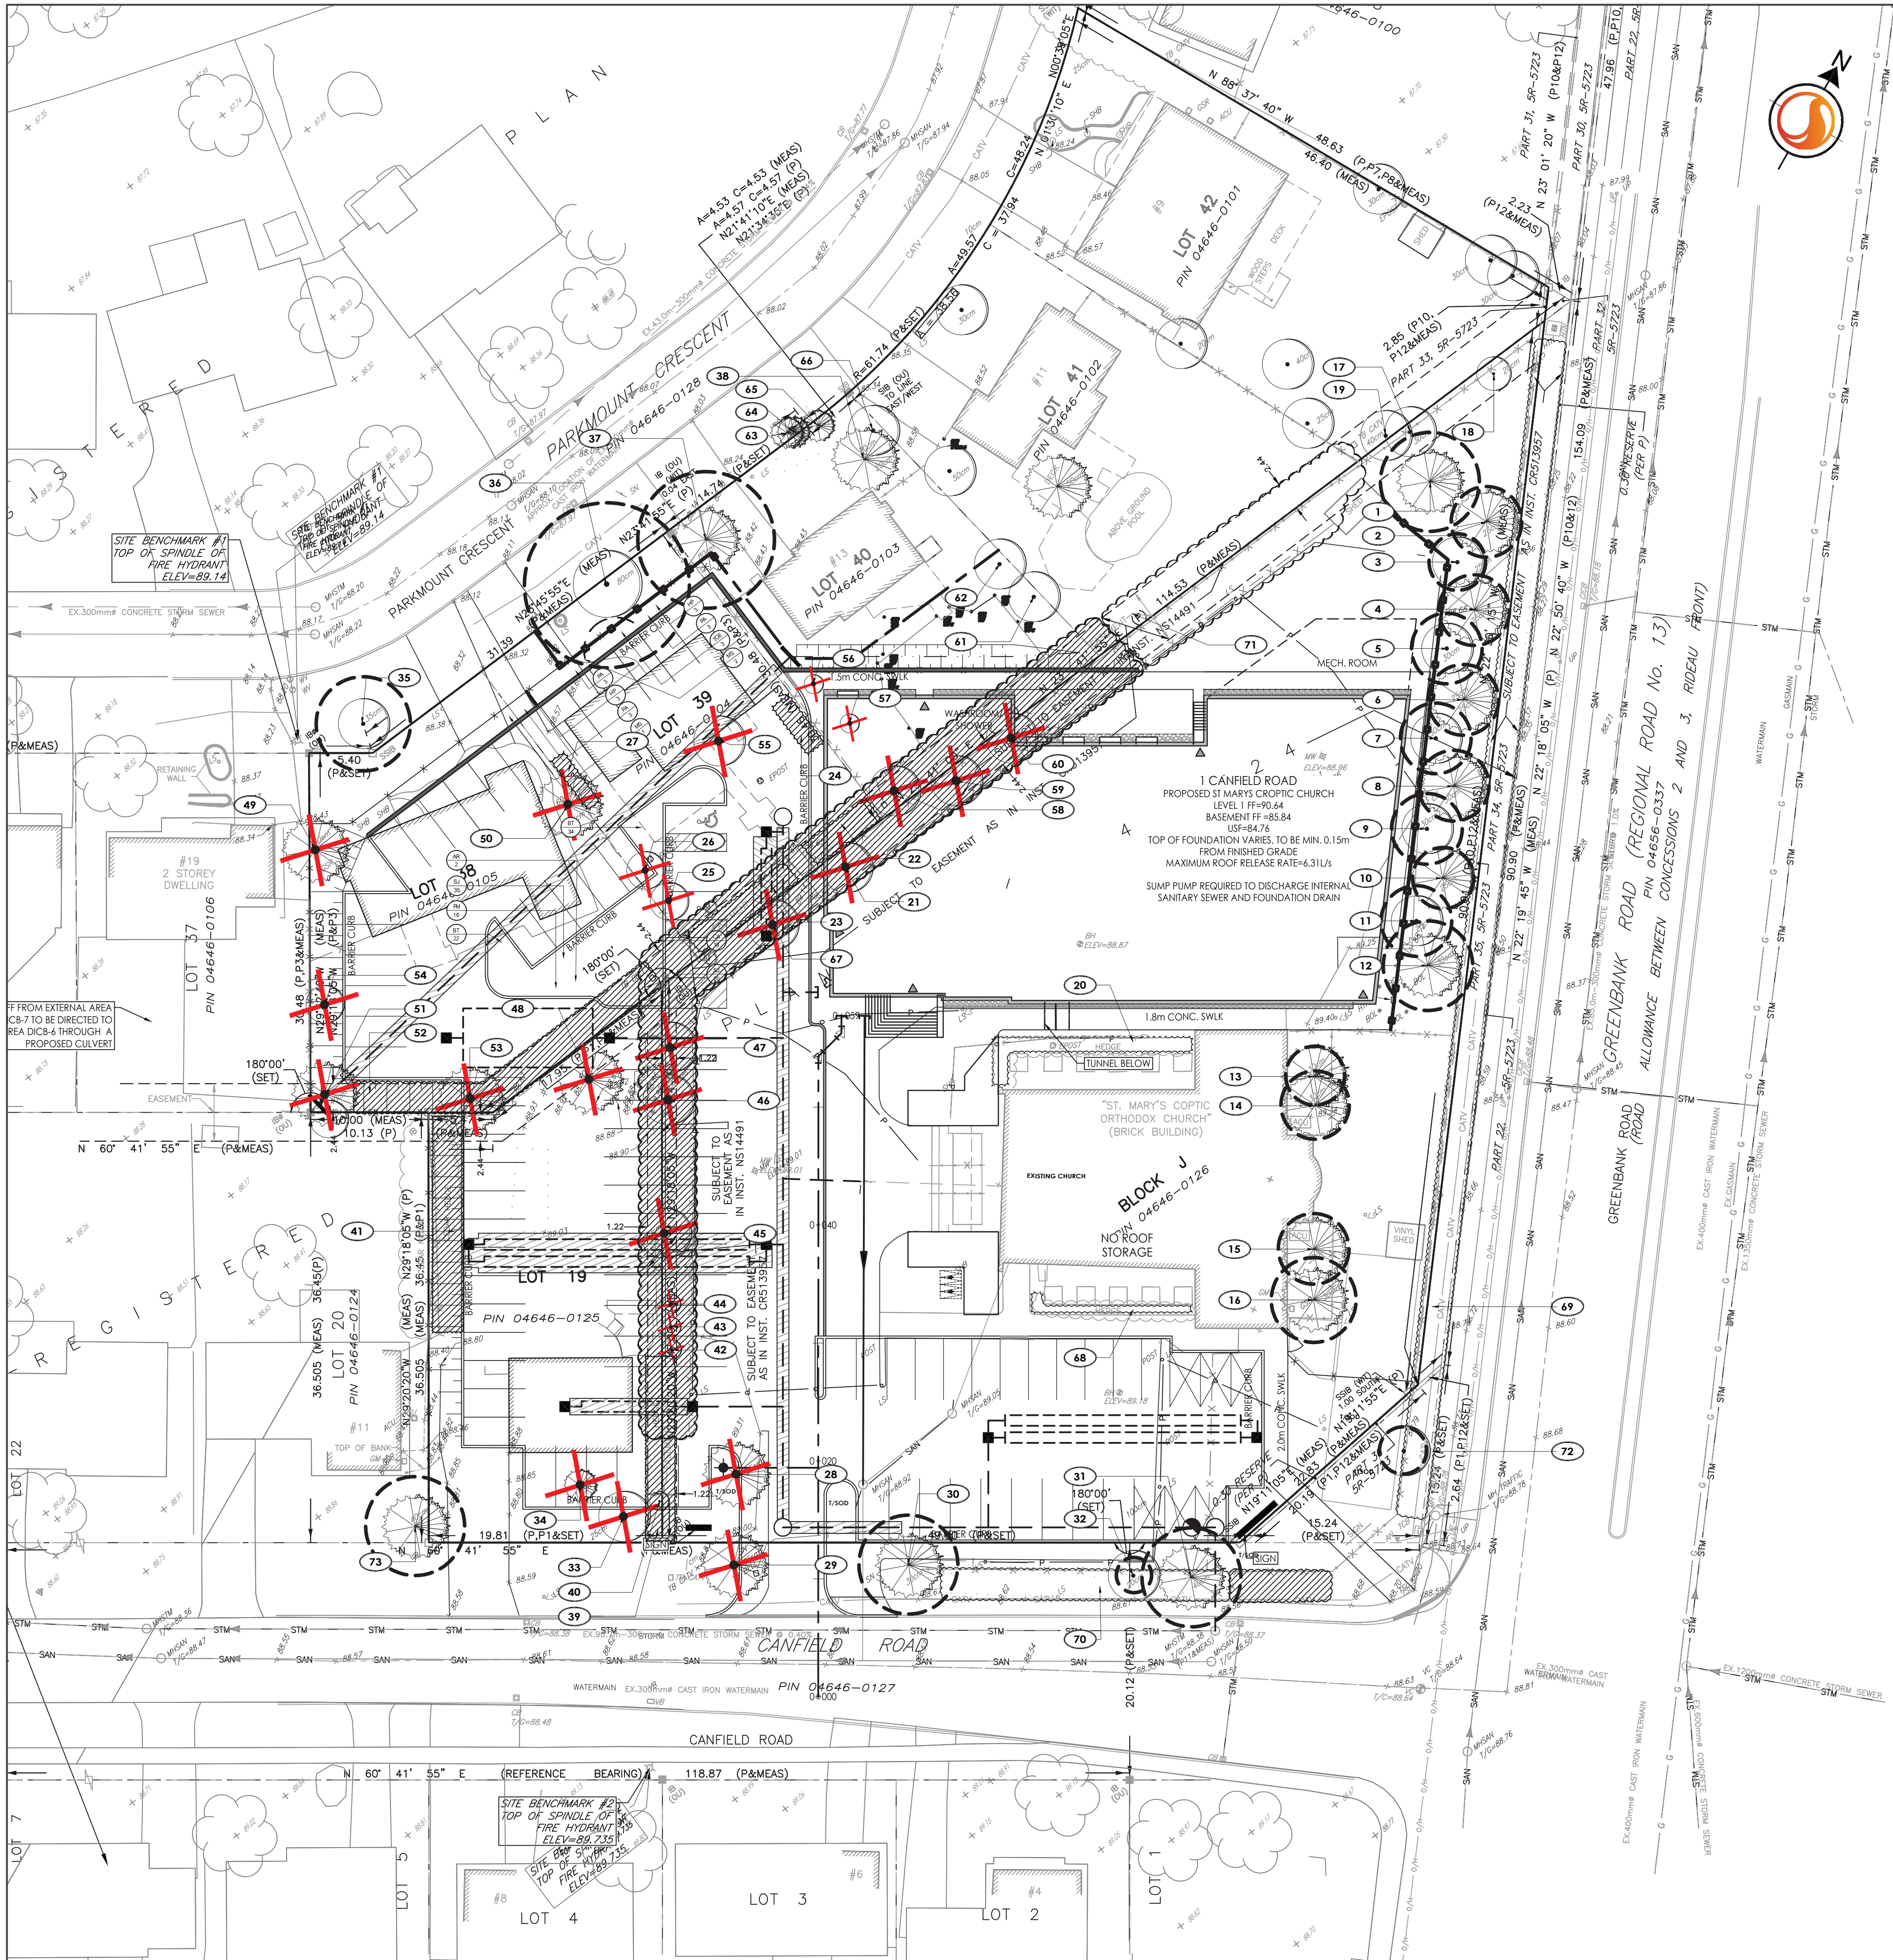
EXISTING VEGETATION SCHEDULE					
TREE ASSESSMENT CONDUCTED: July 15, 2019					
PLANT ID	BOTANICAL NAME	COMMON NAME	DBH (cm)	HEALTH/ CONDITION	REMARKS
1	Picea abies	Norway Spruce	42	Good / Fair	Dead branches on the side facing the adjacent Norway Maples. Tree is not receiving enough sunlight. TO BE PROTECTED.
2	Picea abies	Norway Spruce	30	Good / Fair	Dead branches on the side facing the adjacent Norway Maples. Tree is not receiving enough sunlight. TO BE PROTECTED.
3	Acer platanoides 'Crimson King'	Crimson King Norway Maple	24	Good	TO BE PROTECTED.
4	Picea abies	Norway Spruce	33	Good / Fair	Dead branches on the side facing the adjacent Norway Maples. Tree is not receiving enough sunlight. TO BE PROTECTED.
5	Acer platanoides 'Crimson King'	Crimson King Norway Maple	30	Good	TO BE PROTECTED.
6	Picea abies	Norway Spruce	27	Good / Fair	Dead branches on the side facing the adjacent Norway Maples. Tree is not receiving enough sunlight. TO BE PROTECTED.

7	Acer platanoides 'Crimson King'	Crimson King Norway Maple	30	Good	TO BE PROTECTED.
8	Picea abies	Norway Spruce	30	Good / Fair	Dead branches on the side facing the adjacent Norway Maples. Tree is not receiving enough sunlight. TO BE PROTECTED.
9	Acer platanoides 'Crimson King'	Crimson King Norway Maple	31	Good	TO BE PROTECTED.
10	Picea abies	Norway Spruce	26	Good / Fair	Dead branches on the side facing the adjacent Norway Maples. Tree is not receiving enough sunlight. TO BE PROTECTED.
11	Acer platanoides 'Crimson King'	Crimson King Norway Maple	30	Good	TO BE PROTECTED.
12	Picea abies	Norway Spruce	37	Good	TO BE PROTECTED.
13	Picea pungens 'Glauca'	Colorado Blue Spruce	25	Good	Lower branches have been trimmed. Poor form. TO BE RETAINED.
14	Picea pungens 'Glauca'	Colorado Blue Spruce	29	Good	Lower branches have been trimmed. Poor form. TO BE RETAINED.
15	Picea pungens	Colorado Spruce	30	Good	TO BE PROTECTED.

16	Picea pungens 'Glauca'	Colorado Blue Spruce	36	Good	TO BE PROTECTED.
17	Acer saccharum	Sugar Maple	33	Good	TO BE PROTECTED.
18	Acer negundo	Manitoba Maple	5 @ 12, 16, 22, 13, 15	Good	Multi-stem tree. TO BE PROTECTED..
19	Malus spp.	Apple Tree	N/A	Good	Located on adjacent property
20	Thuja occidentalis	Eastern White Cedar	N/A	Good	Hedge. TO BE PROTECTED.
21	Acer negundo	Manitoba Maple	N/A	Poor	1 dead trunk, large cavity, dead branches. TO BE REMOVED.
22	Thuja occidentalis	Eastern White Cedar	N/A	Good	Hedge. 6 m height. TO BE REMOVED.
23	Thuja occidentalis	Eastern White Cedar	N/A	Good	Hedge. 6 m height. TO BE REMOVED.
24	Thuja occidentalis	Eastern White Cedar	N/A	Good	Hedge. 8 m height. TO BE REMOVED.
25	Acer negundo	Manitoba Maple	6	Good	TO REMAIN.
26	Acer negundo	Manitoba Maple	7	Good	TO BE REMOVED.
27	Thuja occidentalis	Eastern White Cedar	N/A	Good	Hedge. 6 m height. TO BE REMOVED.
28	Picea glauca	White Spruce	22	Fair	TO BE REMOVED.

29	Pinus banksiana	Jack Pine	32	Good	TO BE REMOVED.
30	Pinus banksiana	Jack Pine	N/A	Good	TO BE PROTECTED.
31	Pinus sylvestris	Scots Pine	40	Good	TO BE PROTECTED.
32	Acer negundo	Manitoba Maple	15	Good	TO BE PROTECTED.
33	Betula papyrifera	White Birch	18 @ 25, 18 @ 27	Good	Multi-stem. TO BE REMOVED.
34	Picea pungens 'Hopsii'	Hopsi Blue Spruce	15	Good	TO BE REMOVED.
35	Acer platanoides 'Crimson King'	Crimson King Norway Maple	40	Good	TO BE PROTECTED.
36	Acer negundo	Manitoba Maple	1 @ 66, 1 @ 70	Good	Multiple trunks. TO BE PROTECTED.
37	Picea pungens 'Glauca'	Colorado Blue Spruce	58	Good / Fair	TO BE PROTECTED.
38	Picea pungens 'Glauca'	Colorado Blue Spruce	30	Good	TO REMAIN.
39	Thuja occidentalis	Eastern White Cedar	N/A	Good	Hedge. 5 m height. TO BE REMOVED.
40	Acer negundo	Manitoba Maple	11	Good	TO BE REMOVED.
41	Thuja occidentalis	Eastern White Cedar	N/A	Good	Hedge. 4 m height. TO BE REMOVED.
42	Acer ginnala	Amur Maple	5-15	Good	Multi-stem shrub / tree. Invasive. Non-native. TO BE REMOVED.

43	Acer ginnala	Amur Maple	5-15	Good	Multi-stem shrub / tree. Invasive. Non-native. TO BE REMOVED.
44	Acer ginnala	Amur Maple	5-15	Good	Multi-stem shrub / tree. Invasive. Non-native. TO BE REMOVED.
45	Acer saccharum	Sugar Maple	30	Good	TO BE REMOVED.
46	Acer negundo	Manitoba Maple	42	Good	TO BE REMOVED.
47	Acer negundo	Manitoba Maple	35	Poor	Many dead branches. TO BE REMOVED.
48	Picea pungens 'Glauca'	Blue Colorado Spruce	35	Poor	TO BE REMOVED.
49	Picea glauca	White Spruce	30	Fair	Many dead branches. TO BE REMOVED.
50	Picea glauca	White Spruce	43	Fair	Many dead branches. TO BE REMOVED.
51	Pinus sylvestris	Scots Pine	33	Poor	Many dead branches. TO BE REMOVED.
52	Acer ginnala	Amur Maple	N/A	Good / Fair	Hedge. Some dead trunks. Invasive. Non-native. TO BE REMOVED.
53	Picea glauca	White Spruce	19	Poor	Many dead branches. TO BE REMOVED.
54	Syringa reticulata	Japanese Tree Lilac	5	Good	TO BE REMOVED.
55	Betula alleghensis	River Birch	7	Good	TO BE REMOVED.

56	Acer palmatum 'Bloodgood'	Bloodgood Japanese Maple	2.5 cm ht.	Fair	25 cm. abrasion on the trunk. Otherwise healthy. TO BE REMOVED.
57	Acer palmatum 'Bloodgood'	Bloodgood Japanese Maple	2.5 cm ht.	Fair	30 cm. abrasion on the trunk. Otherwise healthy. TO BE REMOVED.
58	Acer saccharum	Sugar Maple	1 @ 26, 1 @ 16	Good	Tree has 2 trunks. TO BE REMOVED.
59	Acer negundo	Manitoba Maple	N/A	Good	Tree is located between 2 fences. Inaccessible. TO BE REMOVED.
60	Acer negundo	Manitoba Maple	N/A	Good	Tree is located between 2 fences. Inaccessible. TO BE REMOVED.
61	Ulmus americana	American Elm	13	Good	TO REMAIN.
62	Malus spp.	Crabapple	17	Good	TO REMAIN.
63	Pinus sylvestris	Scots Pine	12	Good	TO BE RETAINED.
64	Pinus sylvestris	Scots Pine	7	Good	TO BE RETAINED.
65	Pinus sylvestris	Scots Pine	5	Good	TO BE RETAINED.
66	Acer ginnala	Amur Maple	4-15	Good	Multi-stem shrub / tree. Invasive. Non-native. TO REMAIN.
67	Acer saccharum	Sugar Maple	N/A	Good	Tree is located between 2 fences. Inaccessible. TO BE REMOVED.

68	Thuja occidentalis	Eastern White Cedar	N/A	Good	Hedge. 1.2 m height. TO BE RETAINED.
69	Lonicera spp.	Honeysuckle	N/A	Good	Hedge. 1.8 m height. TO BE PROTECTED.
70	Lonicera spp.	Honeysuckle	N/A	Good	Hedge. 1.8 m height. TO BE PROTECTED.
71	Acer negundo, Acer platanoides, Acer spp.	Manitoba Maple, Norway Maple, Maple	10-35	Good to Poor	Vegetation grouping. TO BE REMOVED EXCEPT BEHIND LOT 41.
72	Acer spp.	Maple	20	Good	TO BE PROTECTED.
73	Picea pungens	Colorado Spruce	N/A	Good	TO BE PROTECTED.
