March 19, 2020

**RE: TREE CONSERVATION REPORT FOR 1330 CARLING AVENUE, OTTAWA**

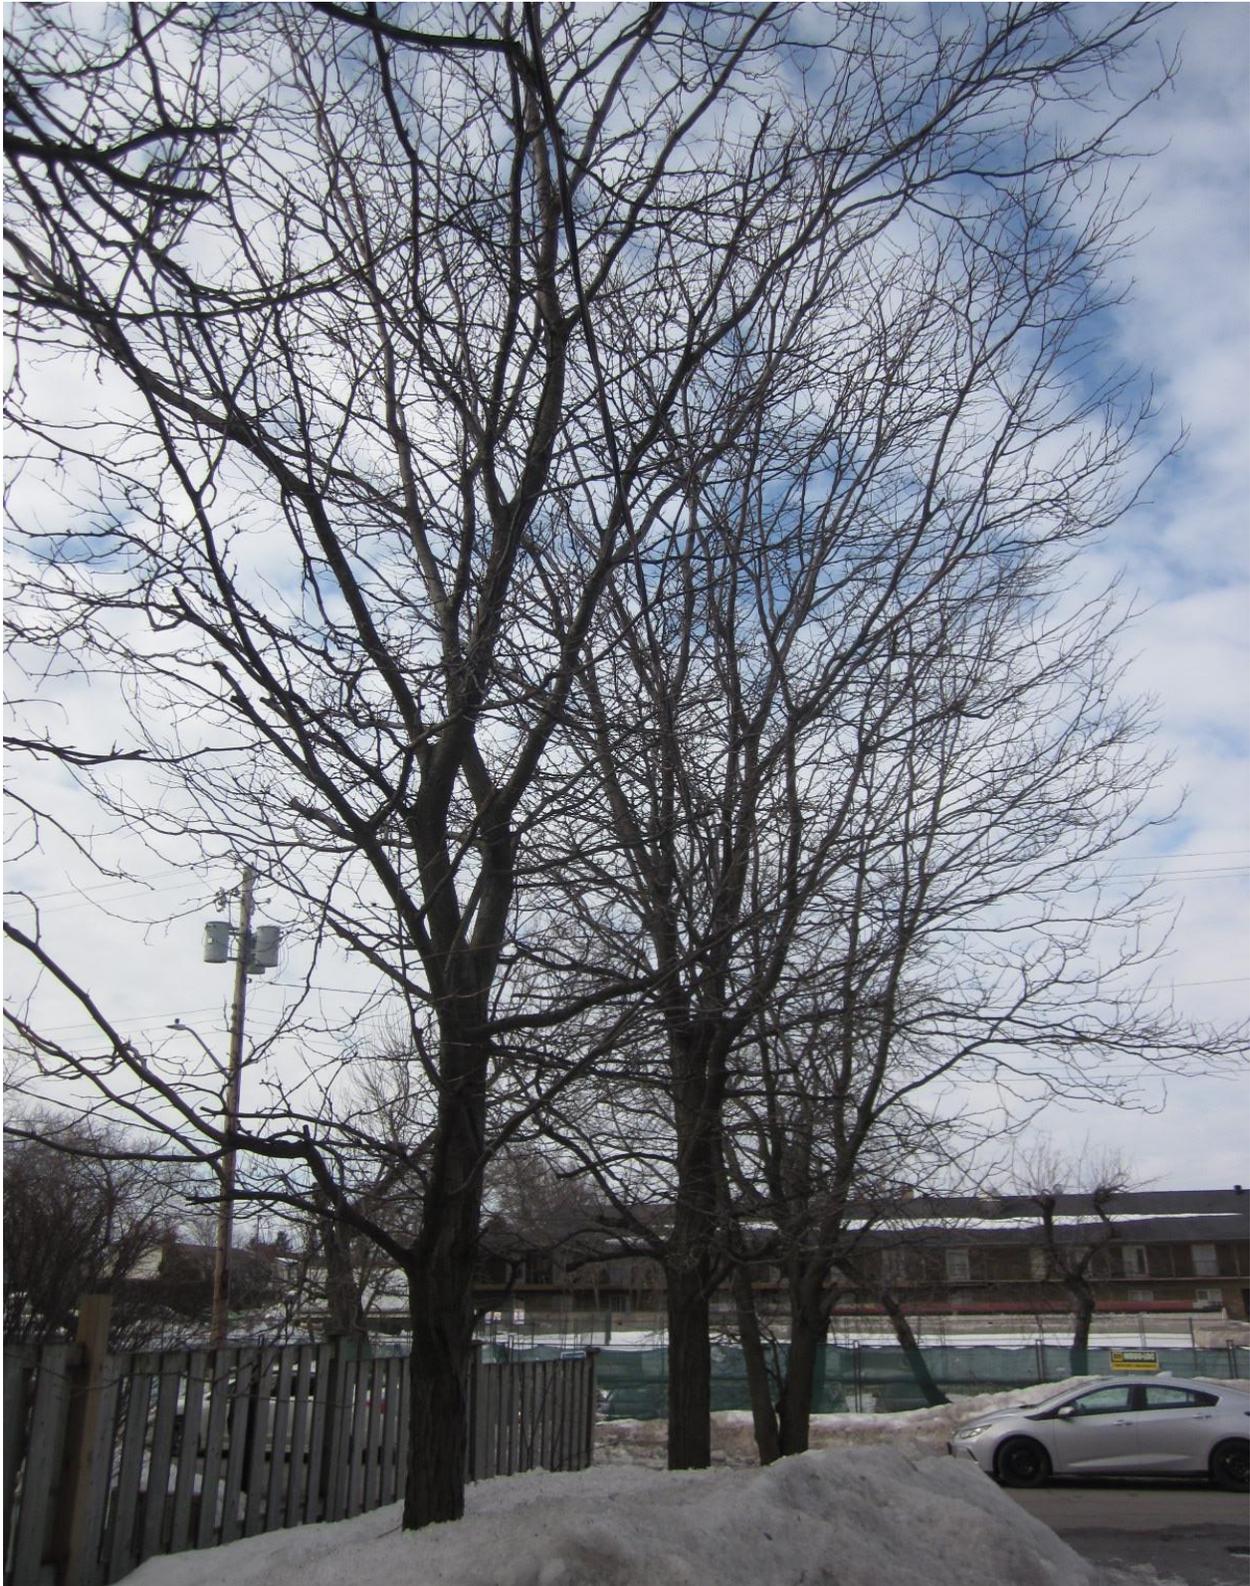
Tree No.	Tree species	Condition (VP→E)	DBH <sup>1</sup> (cm)	Owner -ship	Age class, tree condition notes & <b>preservation status</b> (to be removed or preserved and protected)
1	Honey-locust ( <i>Gleditsia triacanthos</i> )	Fair	24 & 20	City	Mature; double stemmed at 0.7m from grade; lower branch loss/damage from passing trucks; root collar obscured by piled snow; restricted rooting area; <b>to be removed</b>

2	Honey-locust	Good	30	Private	Mature; upright growth form due to proximity of building; root collar obscured by snow; restricted rooting area; <b>to be removed</b>
3	Honey-locust	Good	25	Private	Mature; upright growth form; root collar obscured by snow; restricted rooting area; <b>to be removed</b>
4	Honey-locust	Good	26	Private	Mature; upright growth form; central stem with competing lateral at 1.7m on south side; co-dominant leaders; good root collar; restricted rooting area; <b>to be removed</b>
5	Honey-locust	Good	23	Private	Mature; upright growth form; co-dominant leaders at 4m - Nectria dieback ( <i>Nectria cinnabarina</i> ) present at union; fair root collar – one embedded binding root; very restricted rooting area; <b>to be removed</b>
6	Honey-locust	Good	22	Private	Mature; strongly upright growth form; central stem with competing lateral at 2m – strong union; good root collar; very restricted rooting area; <b>to be removed</b>

Picture 1. Trees #1, 2 and 3 (background to foreground) located at 1330 Carling Avenue, Ottawa

All of the trees on the subject property are proposed for removal either due to conflicts with the extent of excavation required for the underground parking structure, in the case of trees #1 through 8, or due to their present poor condition - in the case of trees #9, 10 and 11. Permission for the removal of tree #11 should be sought first from the adjacent land owner.

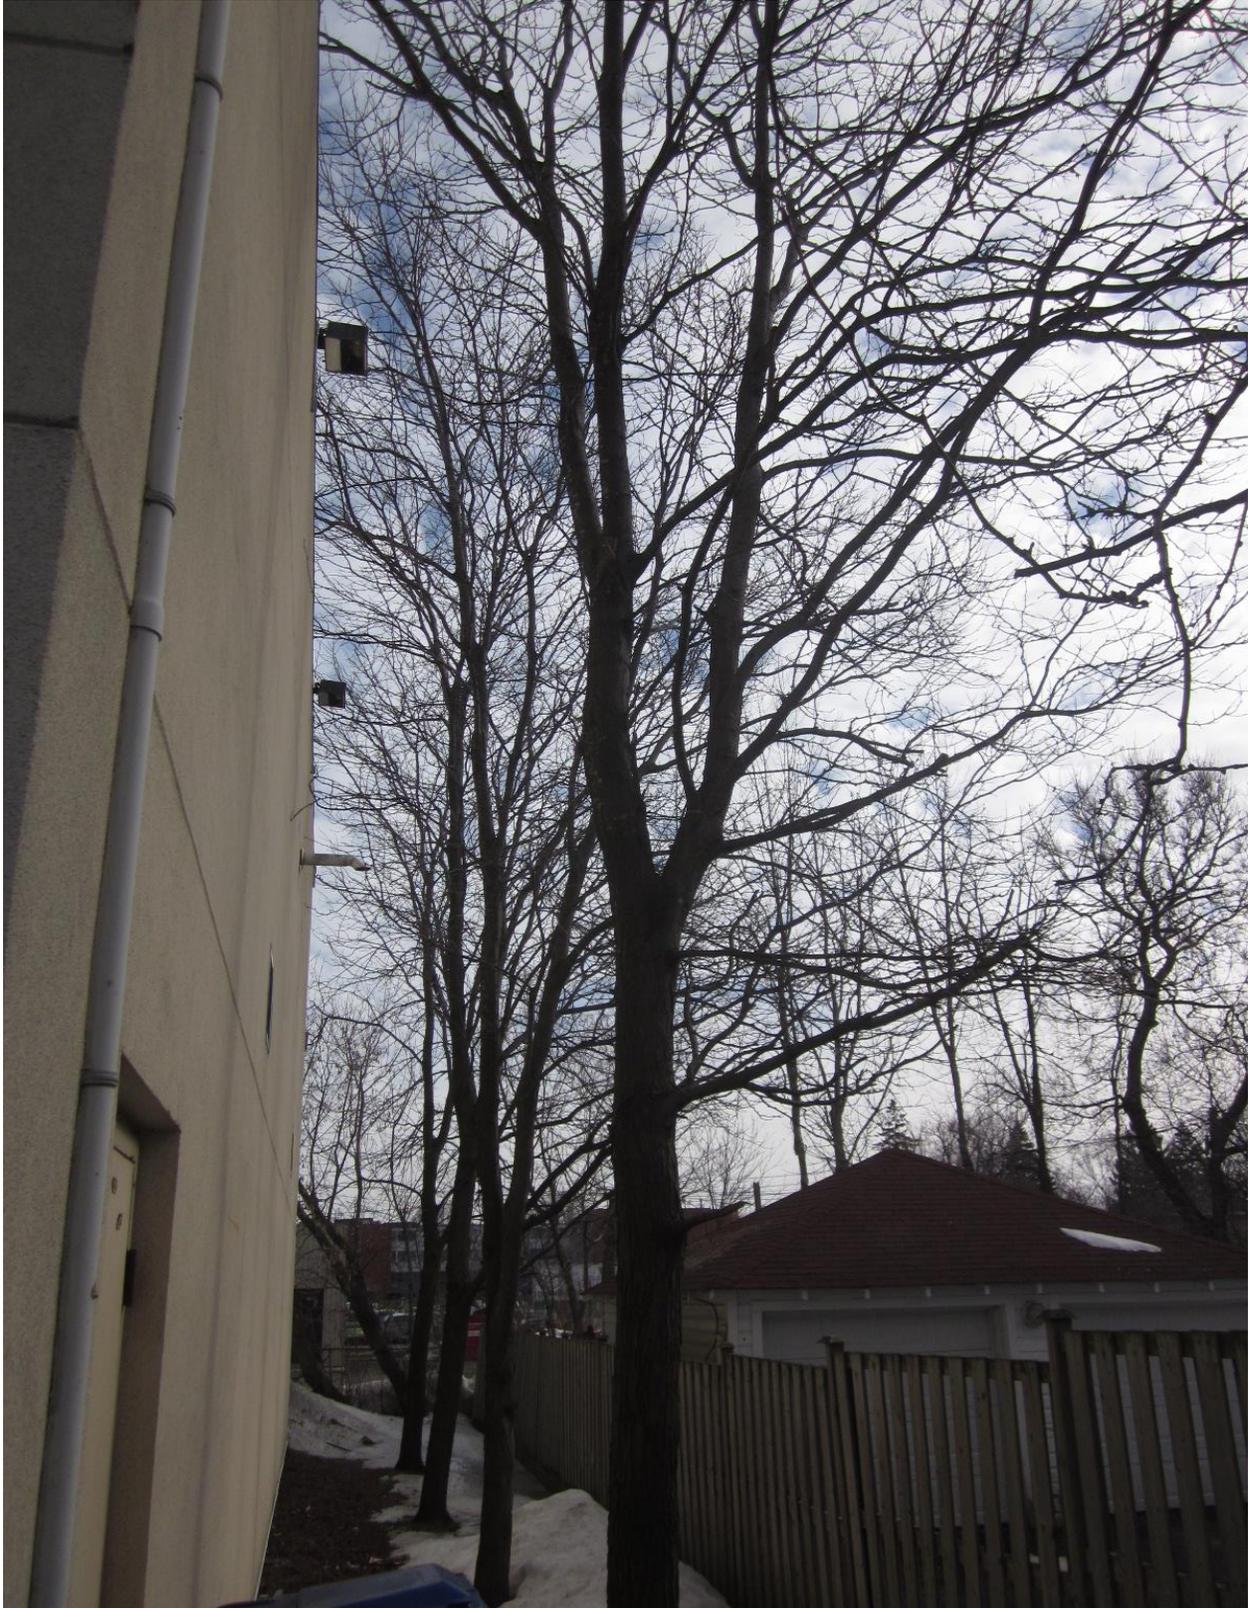
7	Honey-locust	Good	26	Private	Mature; strongly upright growth form; central stem with competing leaders at 4m; good root collar; <b>to be removed</b>
8	Honey-locust	Good	25	Private	Mature; upright growth form; central stem with competing lateral on east side at 3m and competing leaders at 4.5m; crown asymmetrical towards southeast; <b>to be removed</b>
9	Manitoba maple ( <i>Acer negundo</i> )	Poor	26	Shared	Mature; heavily divergent form towards north; located on outside of chain-link fence; naturalized species; <b>to be removed</b>
10	Manitoba maple	Poor	23	Shared	Mature; heavily divergent form towards north; located on inside of chain-link fence; <b>to be removed</b>
11	Ash ( <i>Fraxinus</i> spp.)	Dead	+/-25	Neighbour	Dead due to emerald ash borer ( <i>Agrilus planipennis</i> ); native species; <b>Recommended for removal</b>

Picture 2. Locust trees #5, 6, 7 and 8 (and maples #9 and 10 in background) located at 1330 Carling Avenue, Ottawa
