June 26, 2020

**RE: TREE CONSERVATION REPORT FOR 353-357 GARDNER STREET, OTTAWA**

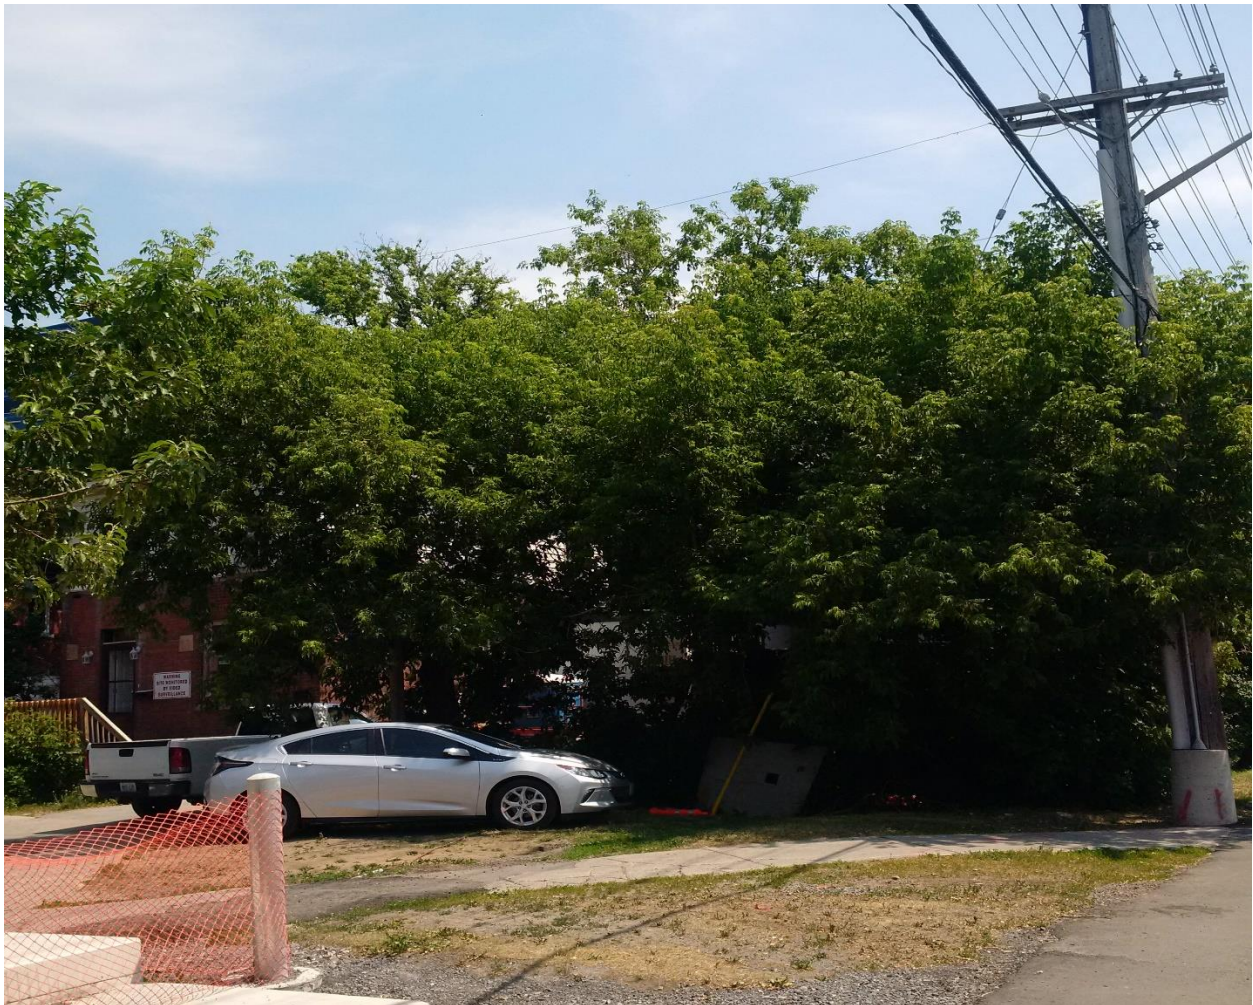
Picture 1. Tree #1, 2 and 3 (left to right) at 353-357 Gardener Street, Ottawa

Tree No.	Tree Species	Condition (VP→E)	DBH <sup>1</sup> (cm)	Owner-ship	Tree Condition Notes & <b>Preservation Status</b> (to be removed or preserved and protected)
1	Manitoba maple ( <i>Acer negundo</i> )	Poor	44 & 48	Private	Mature; double stemmed from grade (44cm stem previously cut at 1.5m); remaining stem divergent towards SW; naturalized species; <b>to be removed</b> (conflicts with construction)

Tree No.	Tree Species	Condition (VP→E)	DBH <sup>1</sup> (cm)	Owner-ship	Tree Condition Notes & <b>Preservation Status</b> (to be removed or preserved and protected)
2	Manitoba maple	Poor	13 & 16	Shared (with City)	Maturing; double stemmed from grade; divergent towards SW – topped by Hydro; <b>to be removed</b> (conflicts with construction)
3	Manitoba maple	Poor	35 avg.	Shared (with City)	Mature; central dominant stem with 3 competing laterals – broad crown; central stem divergent towards SE, all others topped by Hydro; <b>to be removed</b> (conflicts with construction)
4	Manitoba maple	Poor	26	Private	Mature; single stem divergent towards SE; has grown through chain link fence; <b>to be removed</b> (conflicts with construction)
5	Manitoba maple	Poor	40	Private	Mature; co-dominant stems at 3m from grade – one heavily divergent towards SW, other towards NW; <b>to be removed</b> (conflicts with construction)

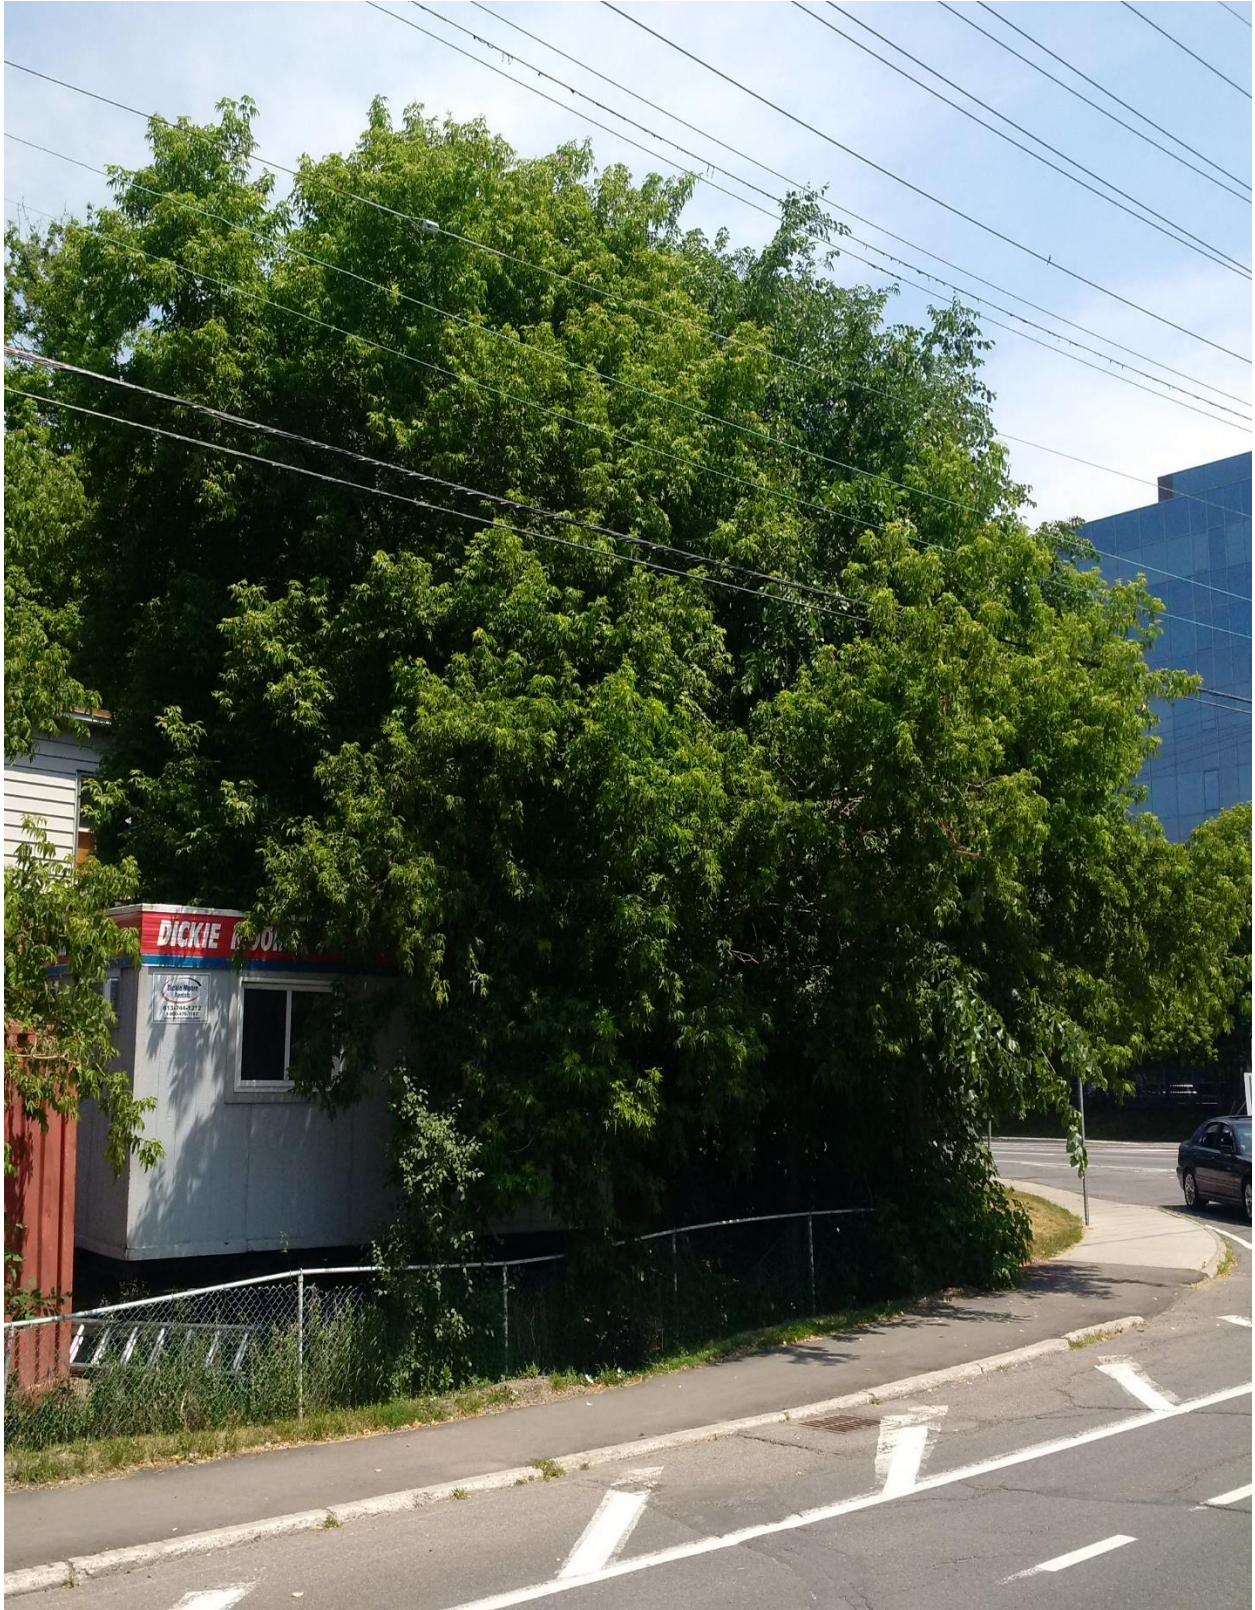
Picture 2. Trees #7, 8 and 9 at 353-357 Gardener Street, Ottawa

6	Manitoba maple	Poor	30	Private	Mature; single stem heavily divergent towards SW (has grown horizontally); <b>to be removed</b> (conflicts with construction)
7	White elm ( <i>Ulmus americana</i> )	Fair	17	Private	Maturing; single stem suppressed by neighbouring elm – leader divergent towards S; no outward signs of Dutch elm disease ( <i>Ophiostoma ulmi/novo-ulmi</i> )-DED; native species; <b>to be removed</b> (conflicts with construction)
8	Manitoba maple	Poor	34	Shared (with City)	Mature; co-dominant stems at 2m from grade; E stem removed at union, remaining stem topped by Hydro; <b>to be removed</b> (conflicts with construction)
9	White elm	Good	20 & 23	Private	Mature; co-dominant stems at 3m from grade – generally upright form; no outward signs of DED; <b>to be removed</b> (conflicts with construction)

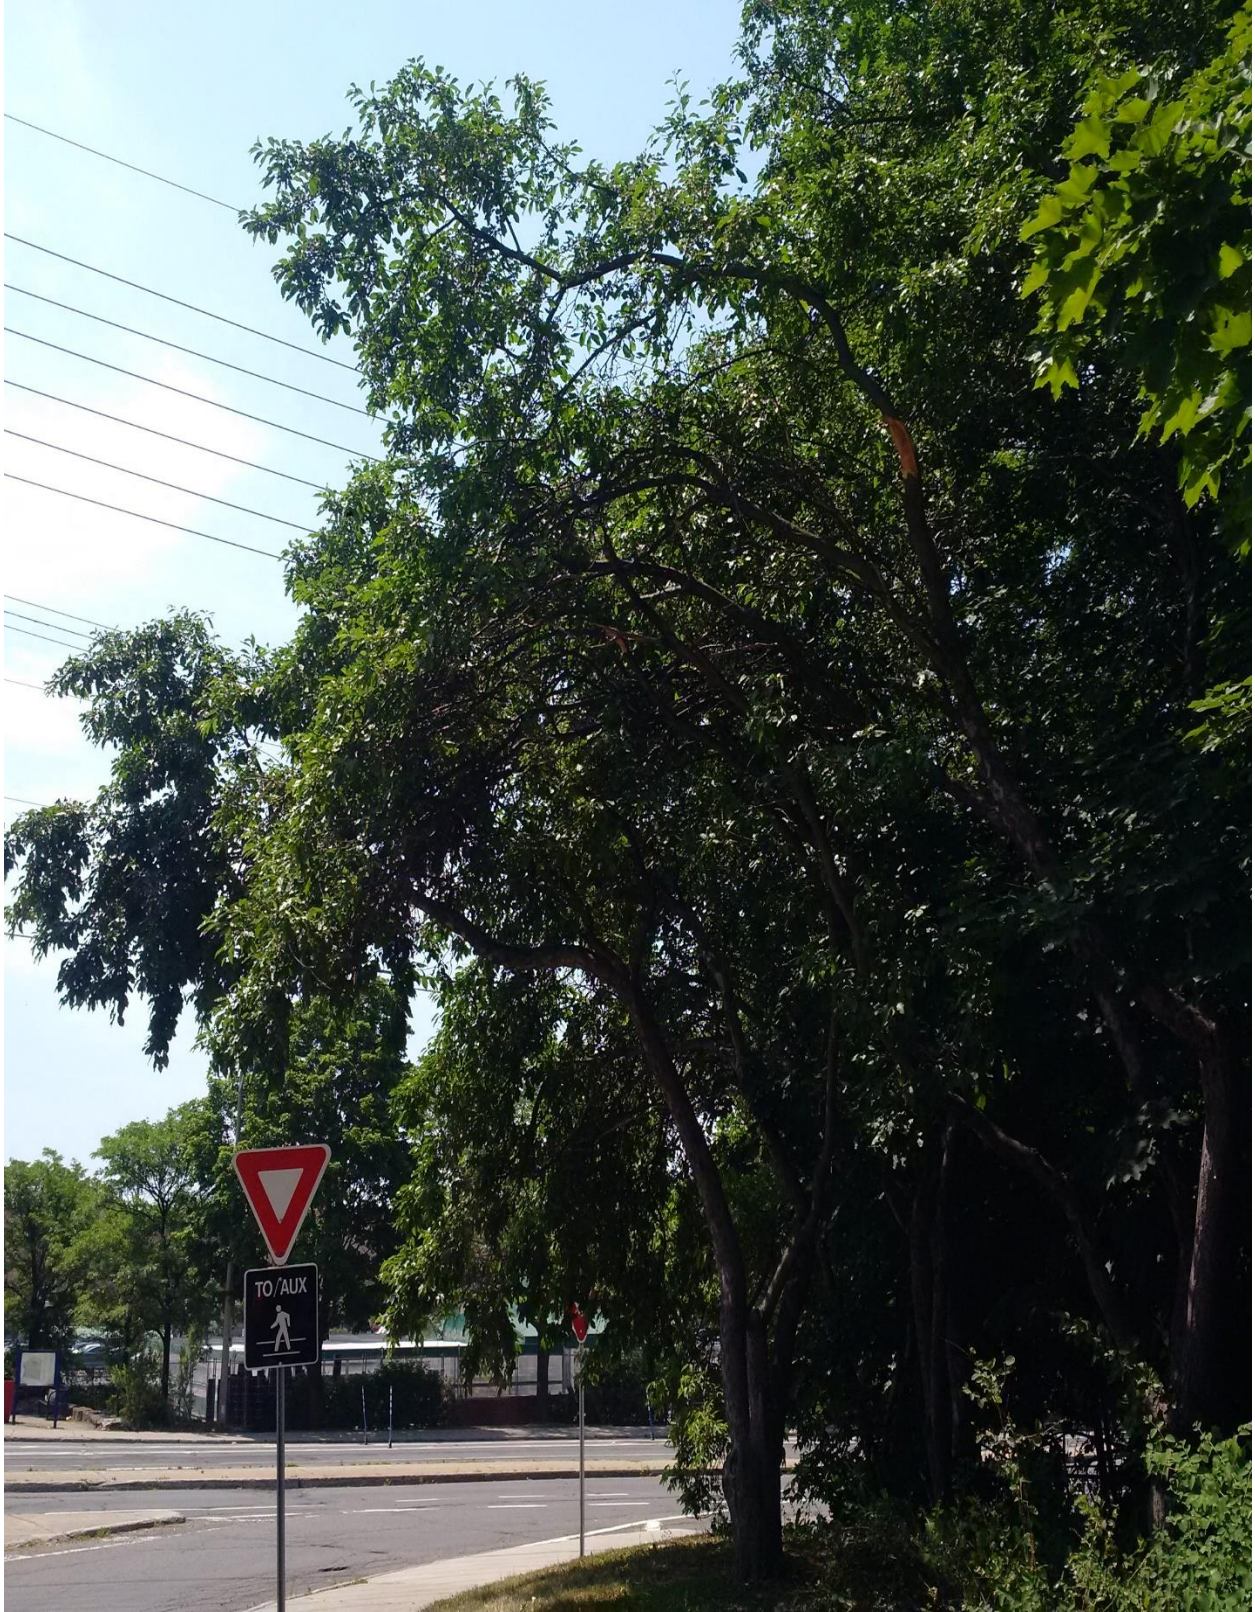
Picture 3. Trees #10 and 11 at 353-357 Gardener Street, Ottawa

Tree No.	Tree Species	Condition (VP→E)	DBH <sup>1</sup> (cm)	Owner-ship	Tree Condition Notes & <b>Preservation Status</b> (to be removed or preserved and protected)
10	Crab apple ( <i>Malus</i> spp.)	Poor	29 (at 0.3m)	Private	Mature; tri-stemmed at 0.5m from grade; one stem dead, others very divergent due to shade from adjacent trees; cultivated; <b>to be removed</b> (conflicts with construction)
11	Crab apple	Fair	29 (at 0.3m)	Private	Mature; tri-stemmed at 0.5m from grade; generally upright form; <b>to be removed</b> (conflicts with construction)
12	Crab apple	Poor	35 (at 0.3m)	Private	Mature; tri-stemmed at 0.5m from grade; one stem dead, others very divergent due to shade from adjacent trees; <b>to be removed</b> (conflicts with construction)
13	Norway maple ( <i>Acer platanoides</i> )	Fair	35	Private	Mature; co-dominant stems at 2m from grade – very weak union (open seam due to included bark); introduced invasive species; <b>to be removed</b> (conflicts with construction)

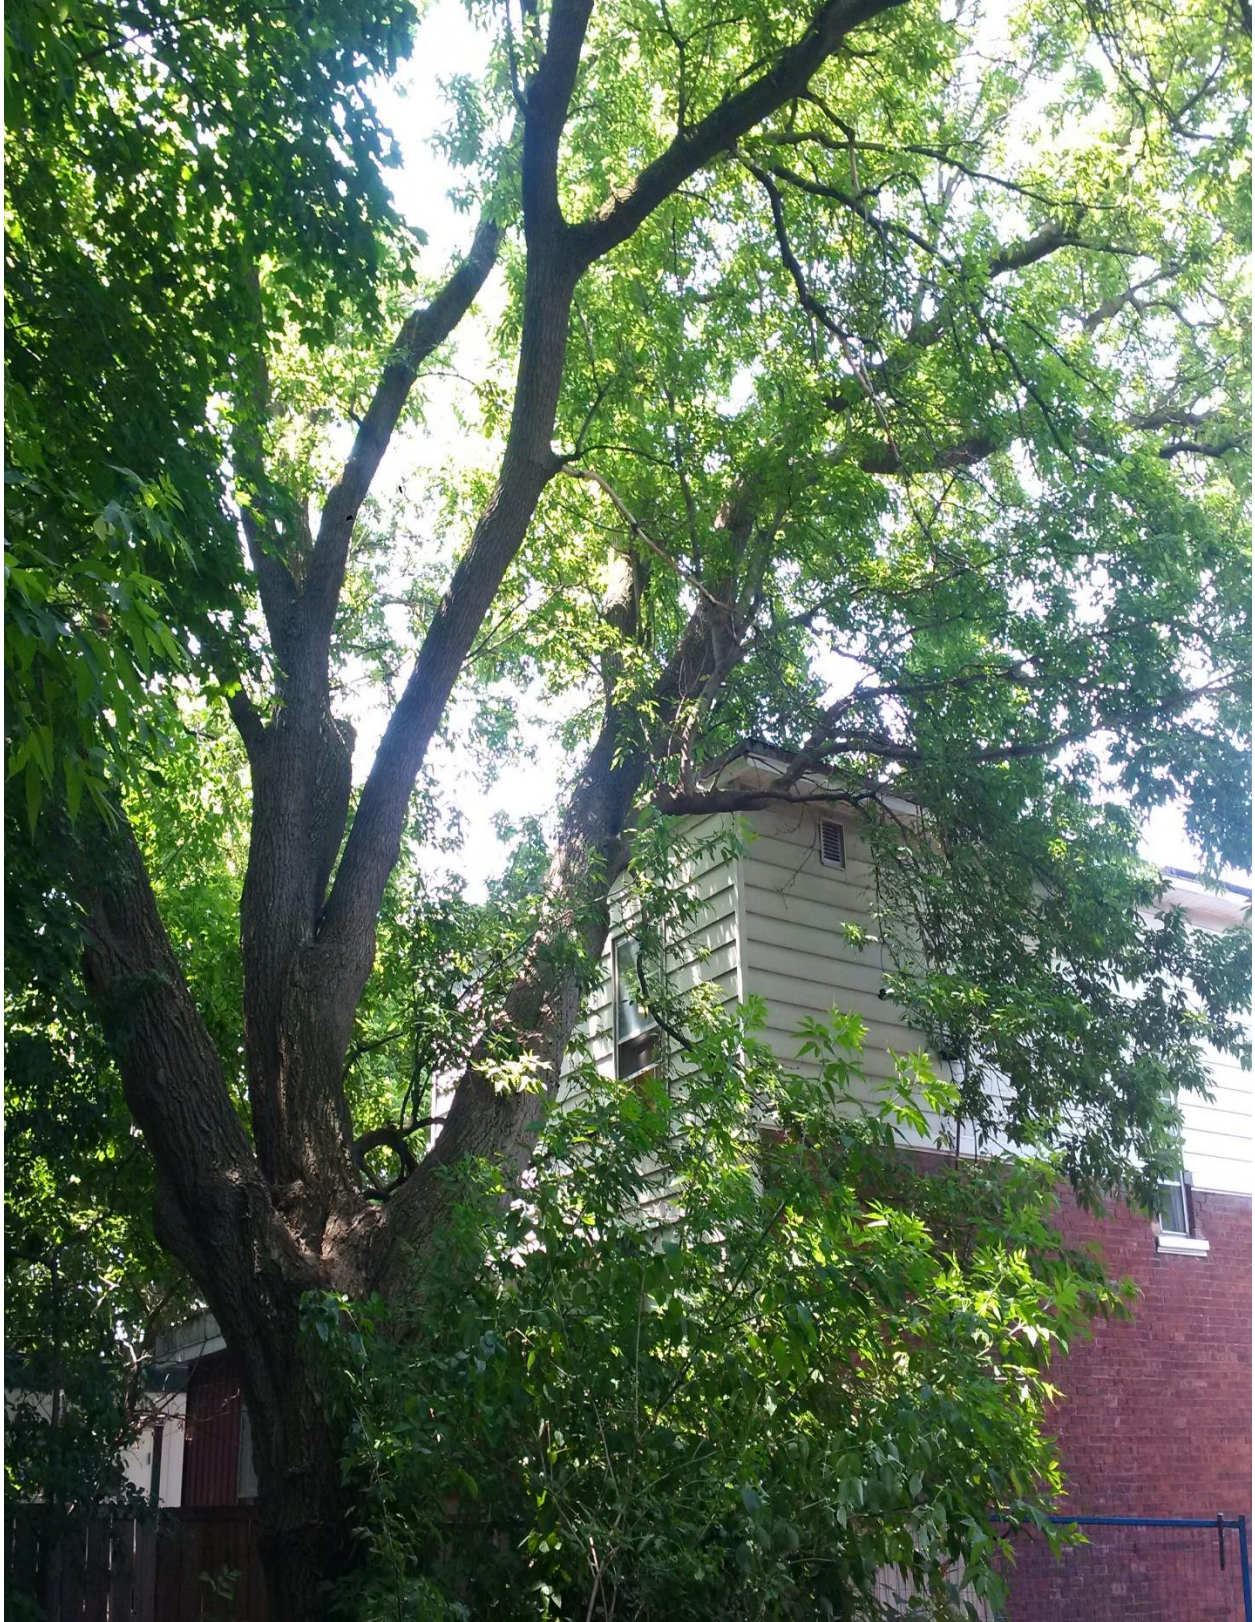
Picture 4. Trees #17 at 353-357 Gardener Street, Ottawa

14	Crab apple	Fair	33 (at 0.3m)	Private	Mature; co-dominant stems at 0.5m from grade; competing lateral stems at 1m on S and SW-broad crown; <b>to be removed</b> (conflicts with construction)
15	Norway maple	Good	19	Private	Maturing; upright dominant stem for most of height; <b>to be removed</b> (conflicts with construction)
16	Norway maple	Good	21	Private	Mature; generally upright form; leader suppressed, divergent due to tree #17; <b>to be removed</b> (conflicts with construction)
17	Manitoba maple	Fair	121	Private	Very mature; tri-dominant stems at 4m from grade; lower trunk divergent towards S/SE; very broad, dense crown; <b>to be removed</b> (conflicts with construction)

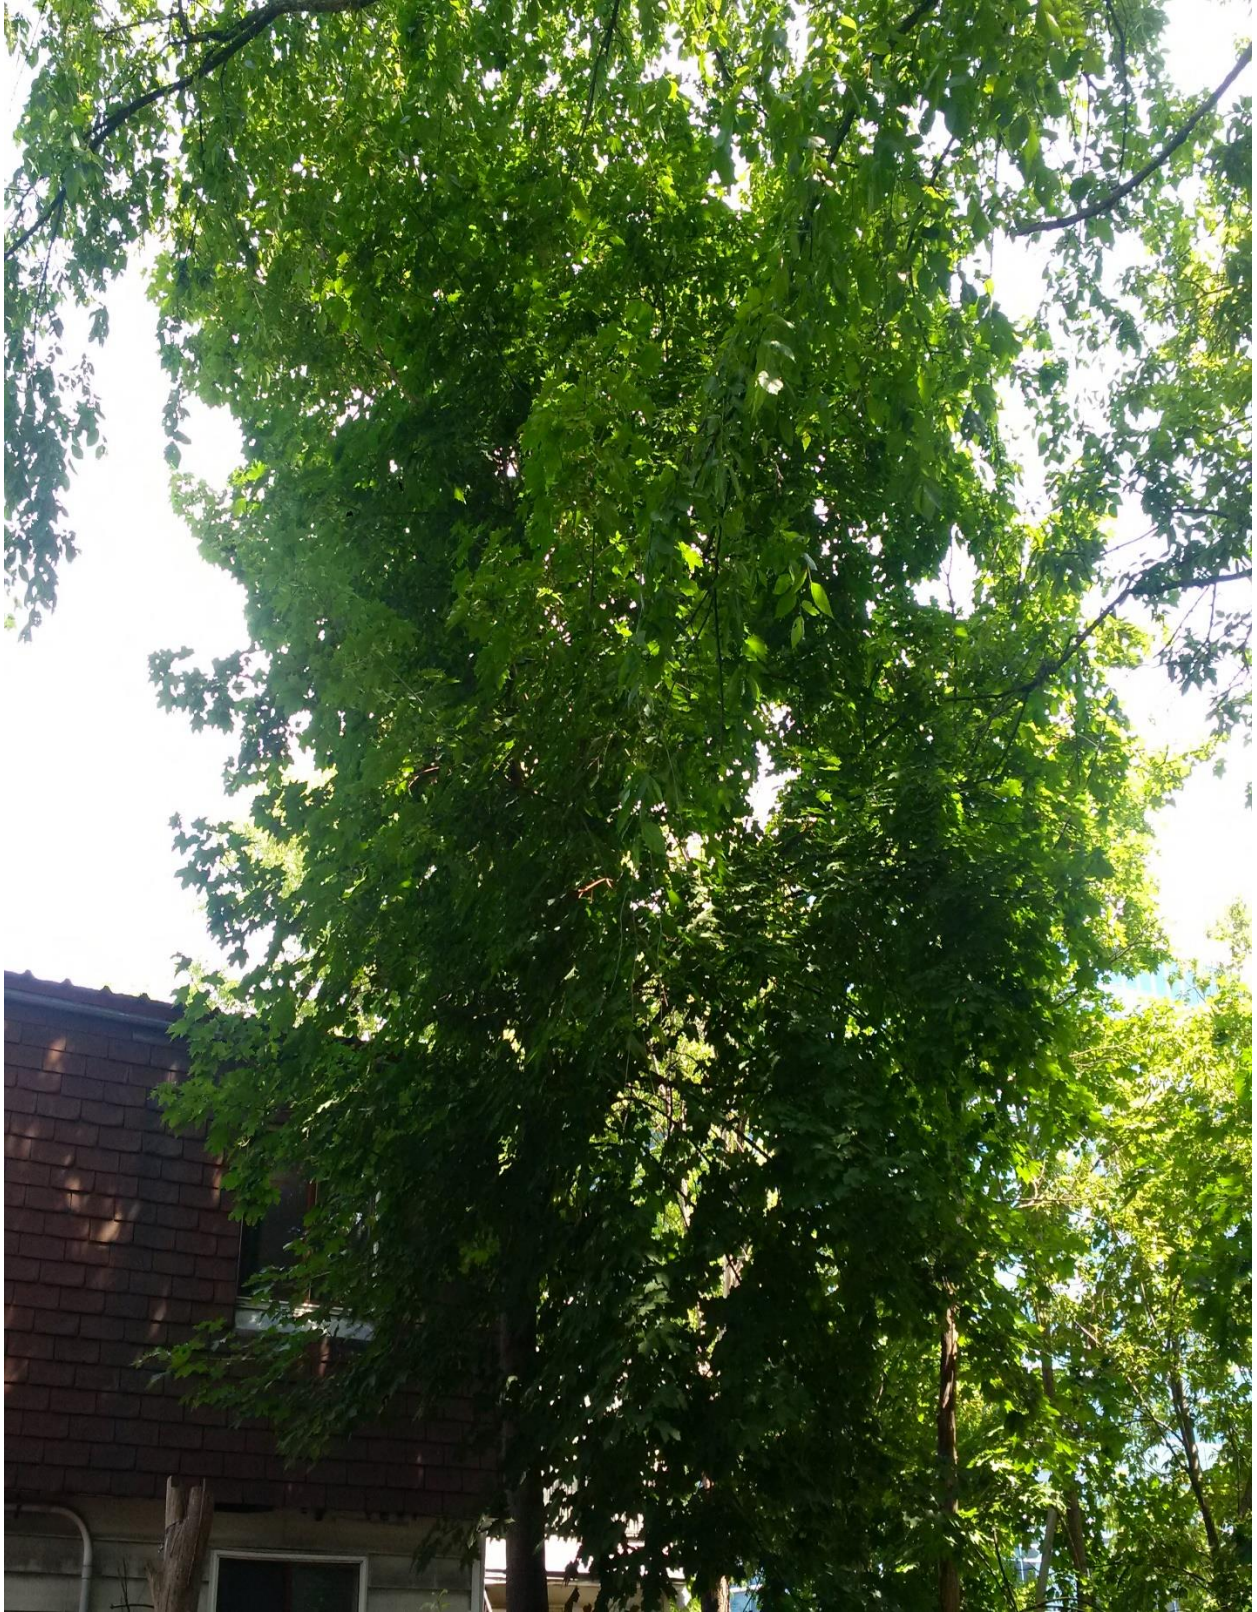
Picture 5. Tree #22 at 353-357 Gardener Street, Ottawa

Tree No.	Tree Species	Condition (VP→E)	DBH <sup>1</sup> (cm)	Owner-ship	Tree Condition Notes & <b>Preservation Status</b> (to be removed or preserved and protected)
18	White elm	Fair	48	Private	Mature; upright dominant stem to 6m - co-dominant leaders above; crown asymmetric due to shading from tree #19; no outward signs of DED; <b>to be removed</b> (conflicts with construction)
19	Manitoba maple	Fair	58	Private	Mature; divergent towards W/SW; central stem with competing laterals starting at 7m; co-dominant leaders at 9m – moderately broad crown; <b>to be removed</b> (conflicts with construction)
20	Manitoba maple	Fair	51	Shared (with City)	Mature; divergent towards E (wooden fence built around lower bole); <b>to be removed</b> (conflicts with construction)
21	White elm	Dead	17	Private	<b>To be removed</b> (hazardous)
22	Norway maple	Good	+/- 25	Shared (with 351)	Mature; generally upright form with broad, symmetric crown; <b>to be preserved and protected</b>
