URBAN FORESTRY & FOREST MANAGEMENT CONSULTING

July 29, 2020

RE: TREE CONSERVATION REPORT FOR 78-90 BEECHWOOD AVENUE & 69-93 BARRETTE STREET, OTTAWA

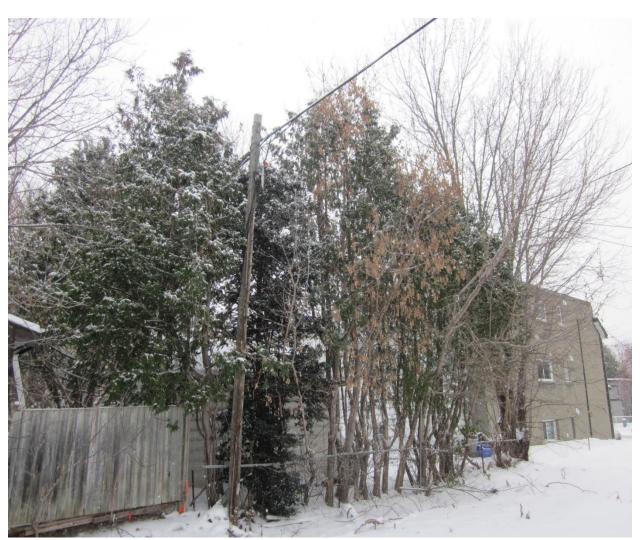
Table 1	. Tree conservatio	<u>II IIIIOI IIIauoi</u>	1101 / 6-	Decelling	voou Avenue & 09-93 Danette Street
Tree	Tree Species	Condition	DBH ¹	Owner-	Tree Condition Notes &
No.		(VP→E,	(cm)	ship	Preservation Status (to be removed
		or dead)			or preserved and protected)
1	Manitoba maple	Fair	12	Private	Mature; line of trees originated from
	(Acer negundo)		avg.		seed; naturalized species; to be
					removed (conflicts with
					construction)
2	Yew	Fair	13	Shared	Mature; upright; cultivated species -
	(Taxus spp.)				planted; to be preserved and
					protected
3	White cedar	Poor - fair	10	Private/	Mature; planted hedge with seeded
	(Thuja		avg.	Shared	maples – all divergent towards
	occidentalis)/				south/west due to intolerance to
	Manitoba maple				shade; native/naturalized species; to
	1				be preserved and protected
4	Silver maple	Fair	+/- 60	Shared	Mature; multi-stemmed at 0.6m
	(Acer		(at		from grade – coppicing stump;

Picture 1. Trees #2 (yew-left), 3 (cedar/Manitoba maple) and 4 (silver maple-right), shared with neighbouring property

saccharinum)		0.3m		broad crown; native species; to be
	,		<i>'</i>		preserved and protected
5	Silver maple	Good	64	City	Mature; tri-stemmed at 3m from
				,	grade; generally upright form due to
					past pruning from house and over
					road; very limited rooting area
					between foundation and sidewalk;
					native species; to be preserved and
					protected
6	Manitoba maple	Fair	55 &	Private	Mature; double-stemmed from
			60		grade; crown divergent towards
					northwest due to past pruning from
					house; broad, dense crown;
					originated from seed; naturalized
					species; to be removed (conflicts
					with construction)
7	Manitoba	Poor- fair	10	Private	Maturing; cluster of multiple species
	maple/hack-		avg.		- all originating from seed; growing
	berry (Celtis				over and damaging wooden privacy
	occidentalis)/				fence; to be removed (conflict with
	cherry				construction)
	(Prunus spp.)/				
	buckthorn

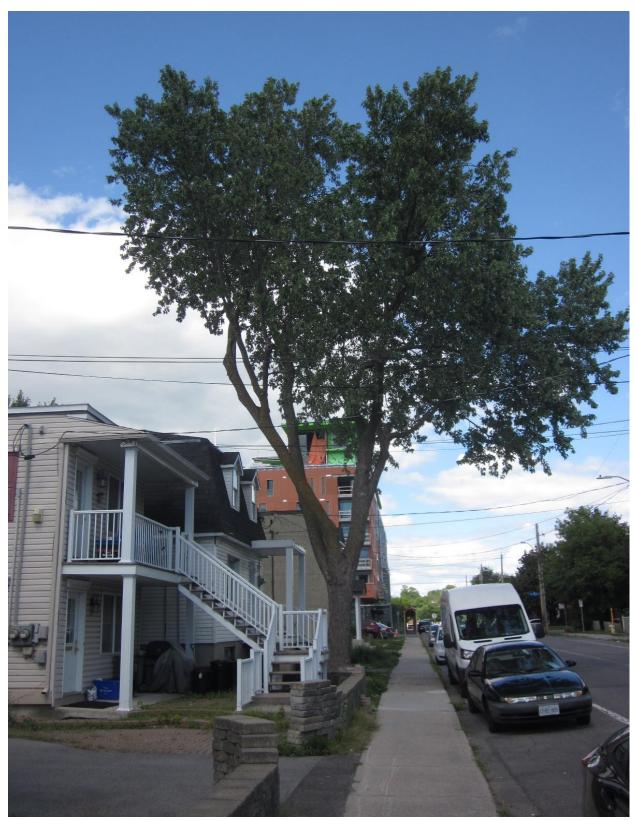
Picture 2. Tree #5 – city owned silver maple

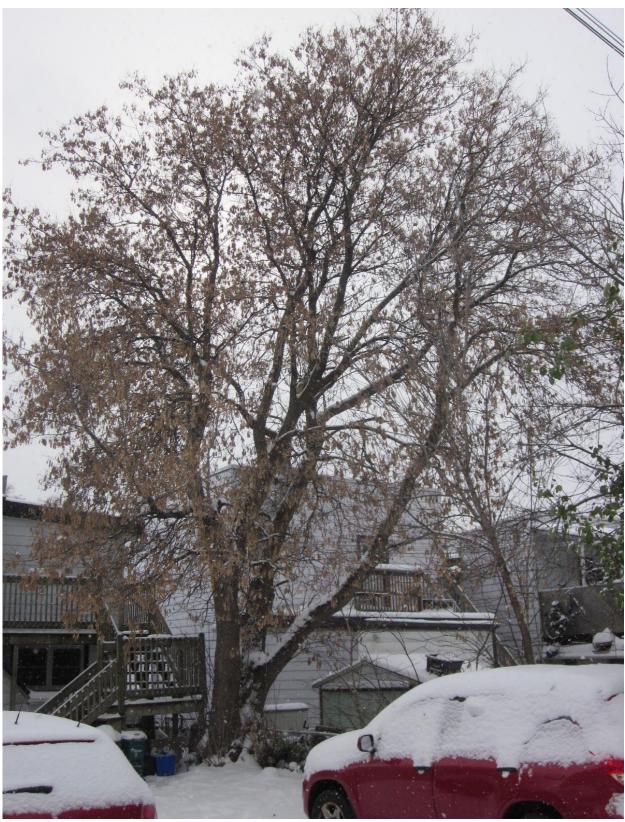
Picture 3. Manitoba maple #6 – on private (subject) property

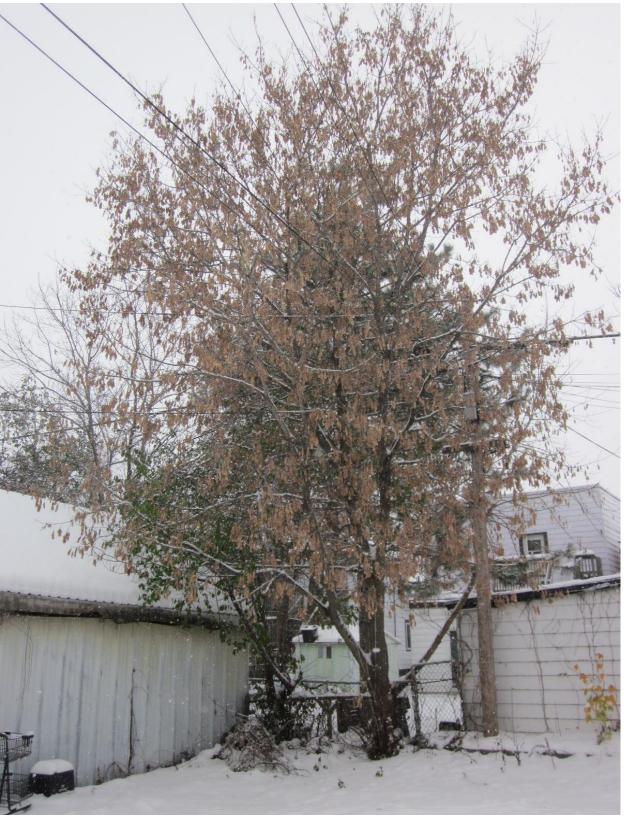
8	Manitoba maple	Fair	27	Private	Mature; codominant leaders at 2.5m with suppressed lateral at 1m on north side; growing into service wires; crown asymmetric towards northwest; naturalized species; to be removed (conflicts with construction)
9	Sugar maple (Acer saccharum)	Poor	23	Shared	Mature; multiple competing stems at 3m – broad, generally symmetric crown; growing into service wires; in advanced decline due to harsh growing environment (limited rooting area of poor and compacted soils) – scattered dead branches in upper crown; native species; to be preserved and protected
10	Austrian pine (Pinus nigra)	Very good	27	Private	Maturing; central dominant stem and leader; good crown density, growth increment and needle colour; introduced species; to be removed (conflicts with construction)
11	Chokecherry (Prunus virginiana)	Dead	23	City	'Schubert' variety; cultivar; to be removed (hazardous)

Picture 4. Manitoba maple #8 on private (subject) property

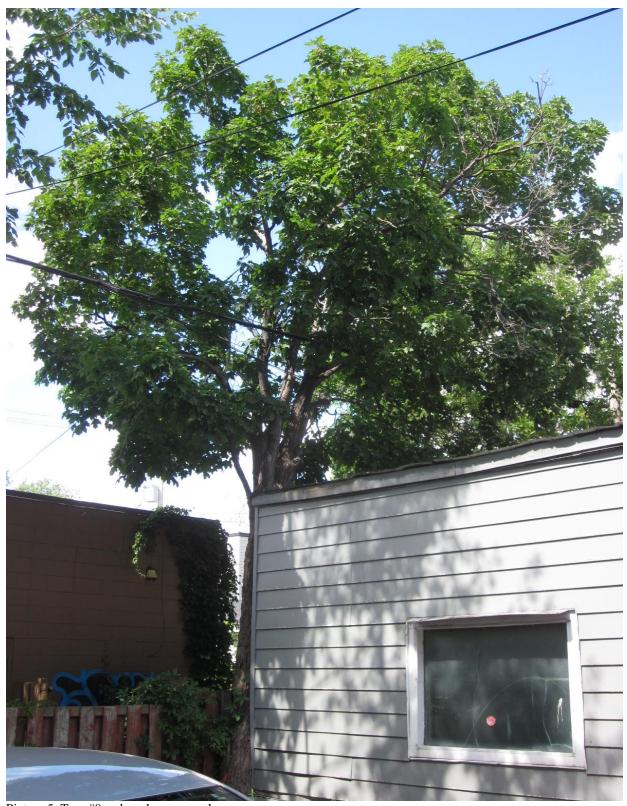
Picture 5. Tree #9 – shared sugar maple
