Tree Conservation Report 335 Roosevelt Avenue, Ottawa, Ontario

July 2020 Prepared for Uniform Urban Developments

RE: Tree Conservation Report for 335 Roosevelt Avenue, Ottawa, Ontario

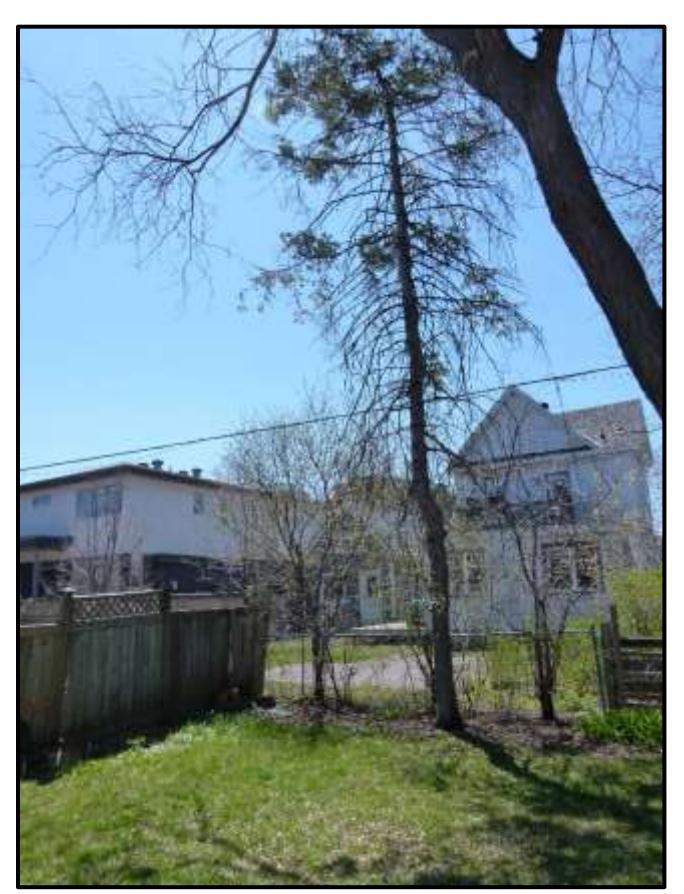
Photograph 8: Tree #9 – White Spruce in poor condition (24 cm dbh) (May 13th, 2020).

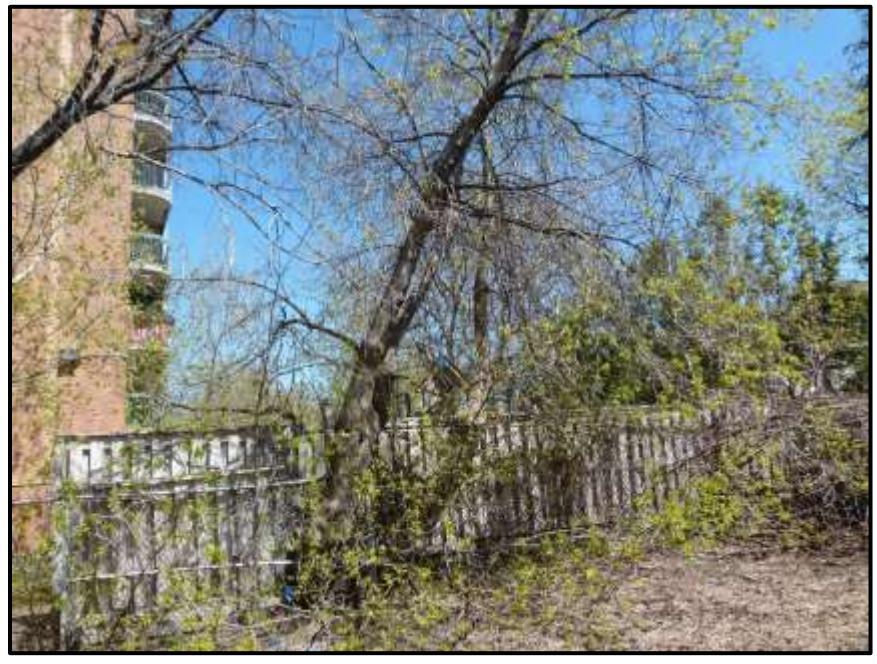
Photograph 19: Tree #20 – Manitoba Maple in poor condition (54 cm dbh) (May 13th, 2020).

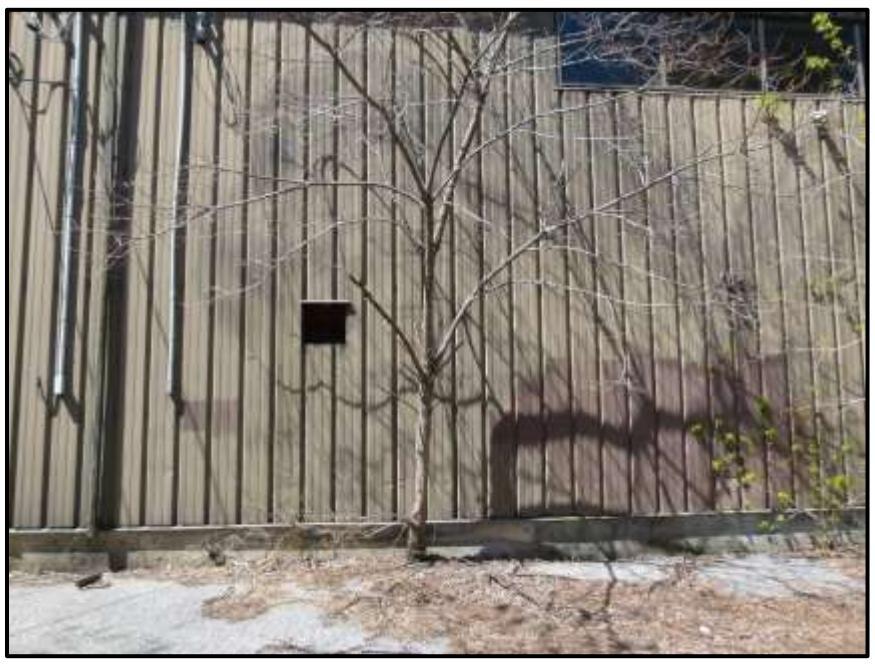
Photograph 20: Tree #21 – Dead American Elm (13 cm dbh) (May 13th, 2020).

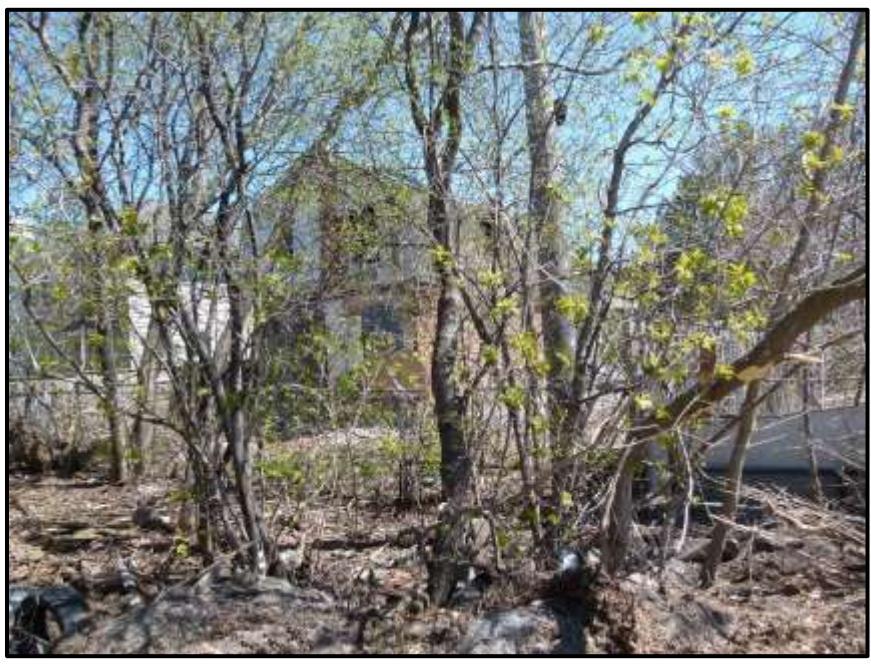
Photograph 21: Tree #22 – Manitoba Maple in poor condition (11 cm dbh) and Staghorn Sumac in poor condition (11 cm and 12 cm dbh) (May 13th, 2020).

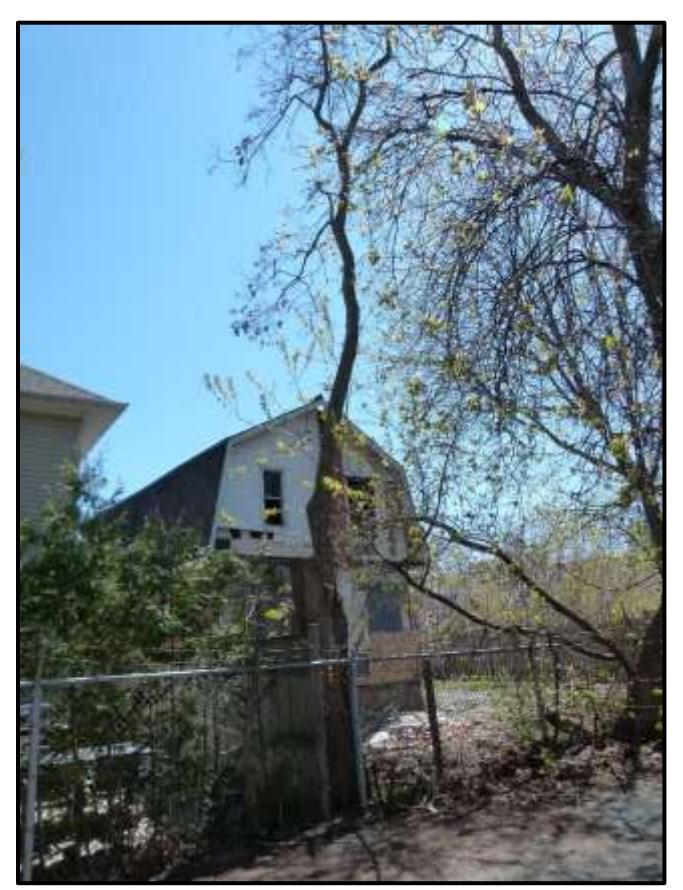
Photograph 25: Tree #26 – Honey Locust in poor condition (28 cm dbh) (May 13th, 2020).

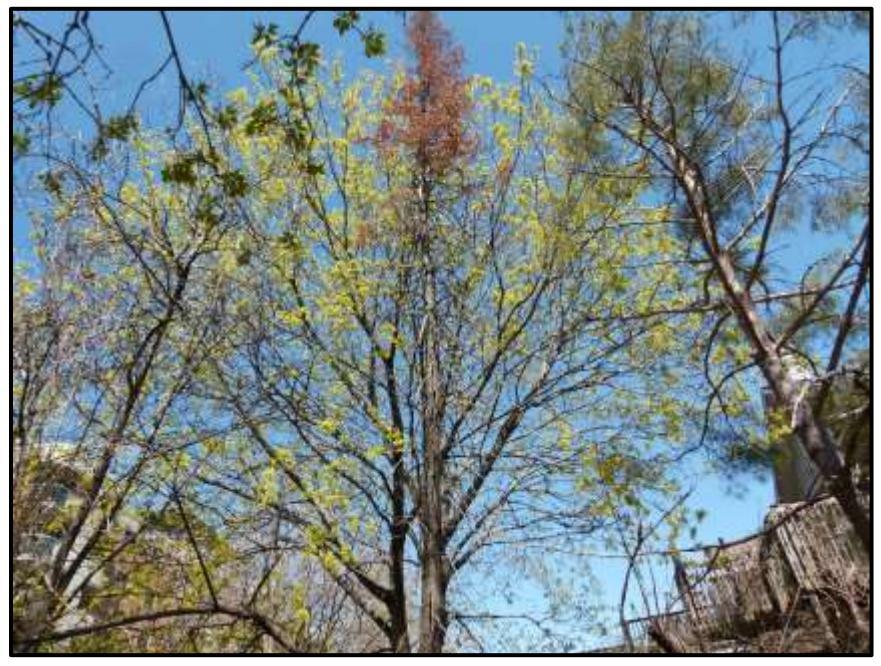
Photograph 29: Tree #30 – Dead Red Pine (17 cm dbh) (May 13th, 2020).

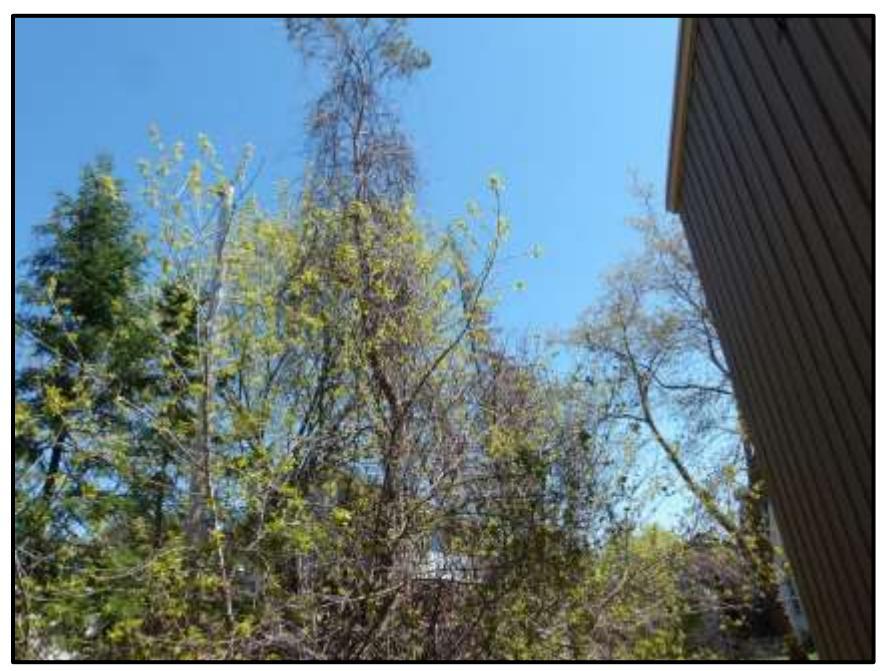
Photograph 30: Tree #31 – Red Pine in poor condition (15 cm dbh) (May 13th, 2020).
