LOCATION  
CITY OF OTTAWA  
1258 MARENGER STREET

DRAWING NAME  
**TREE CONSERVATION REPORT**

PROJECT No. 120041  
REV # 1  
DRAWING No. 120041-TCR

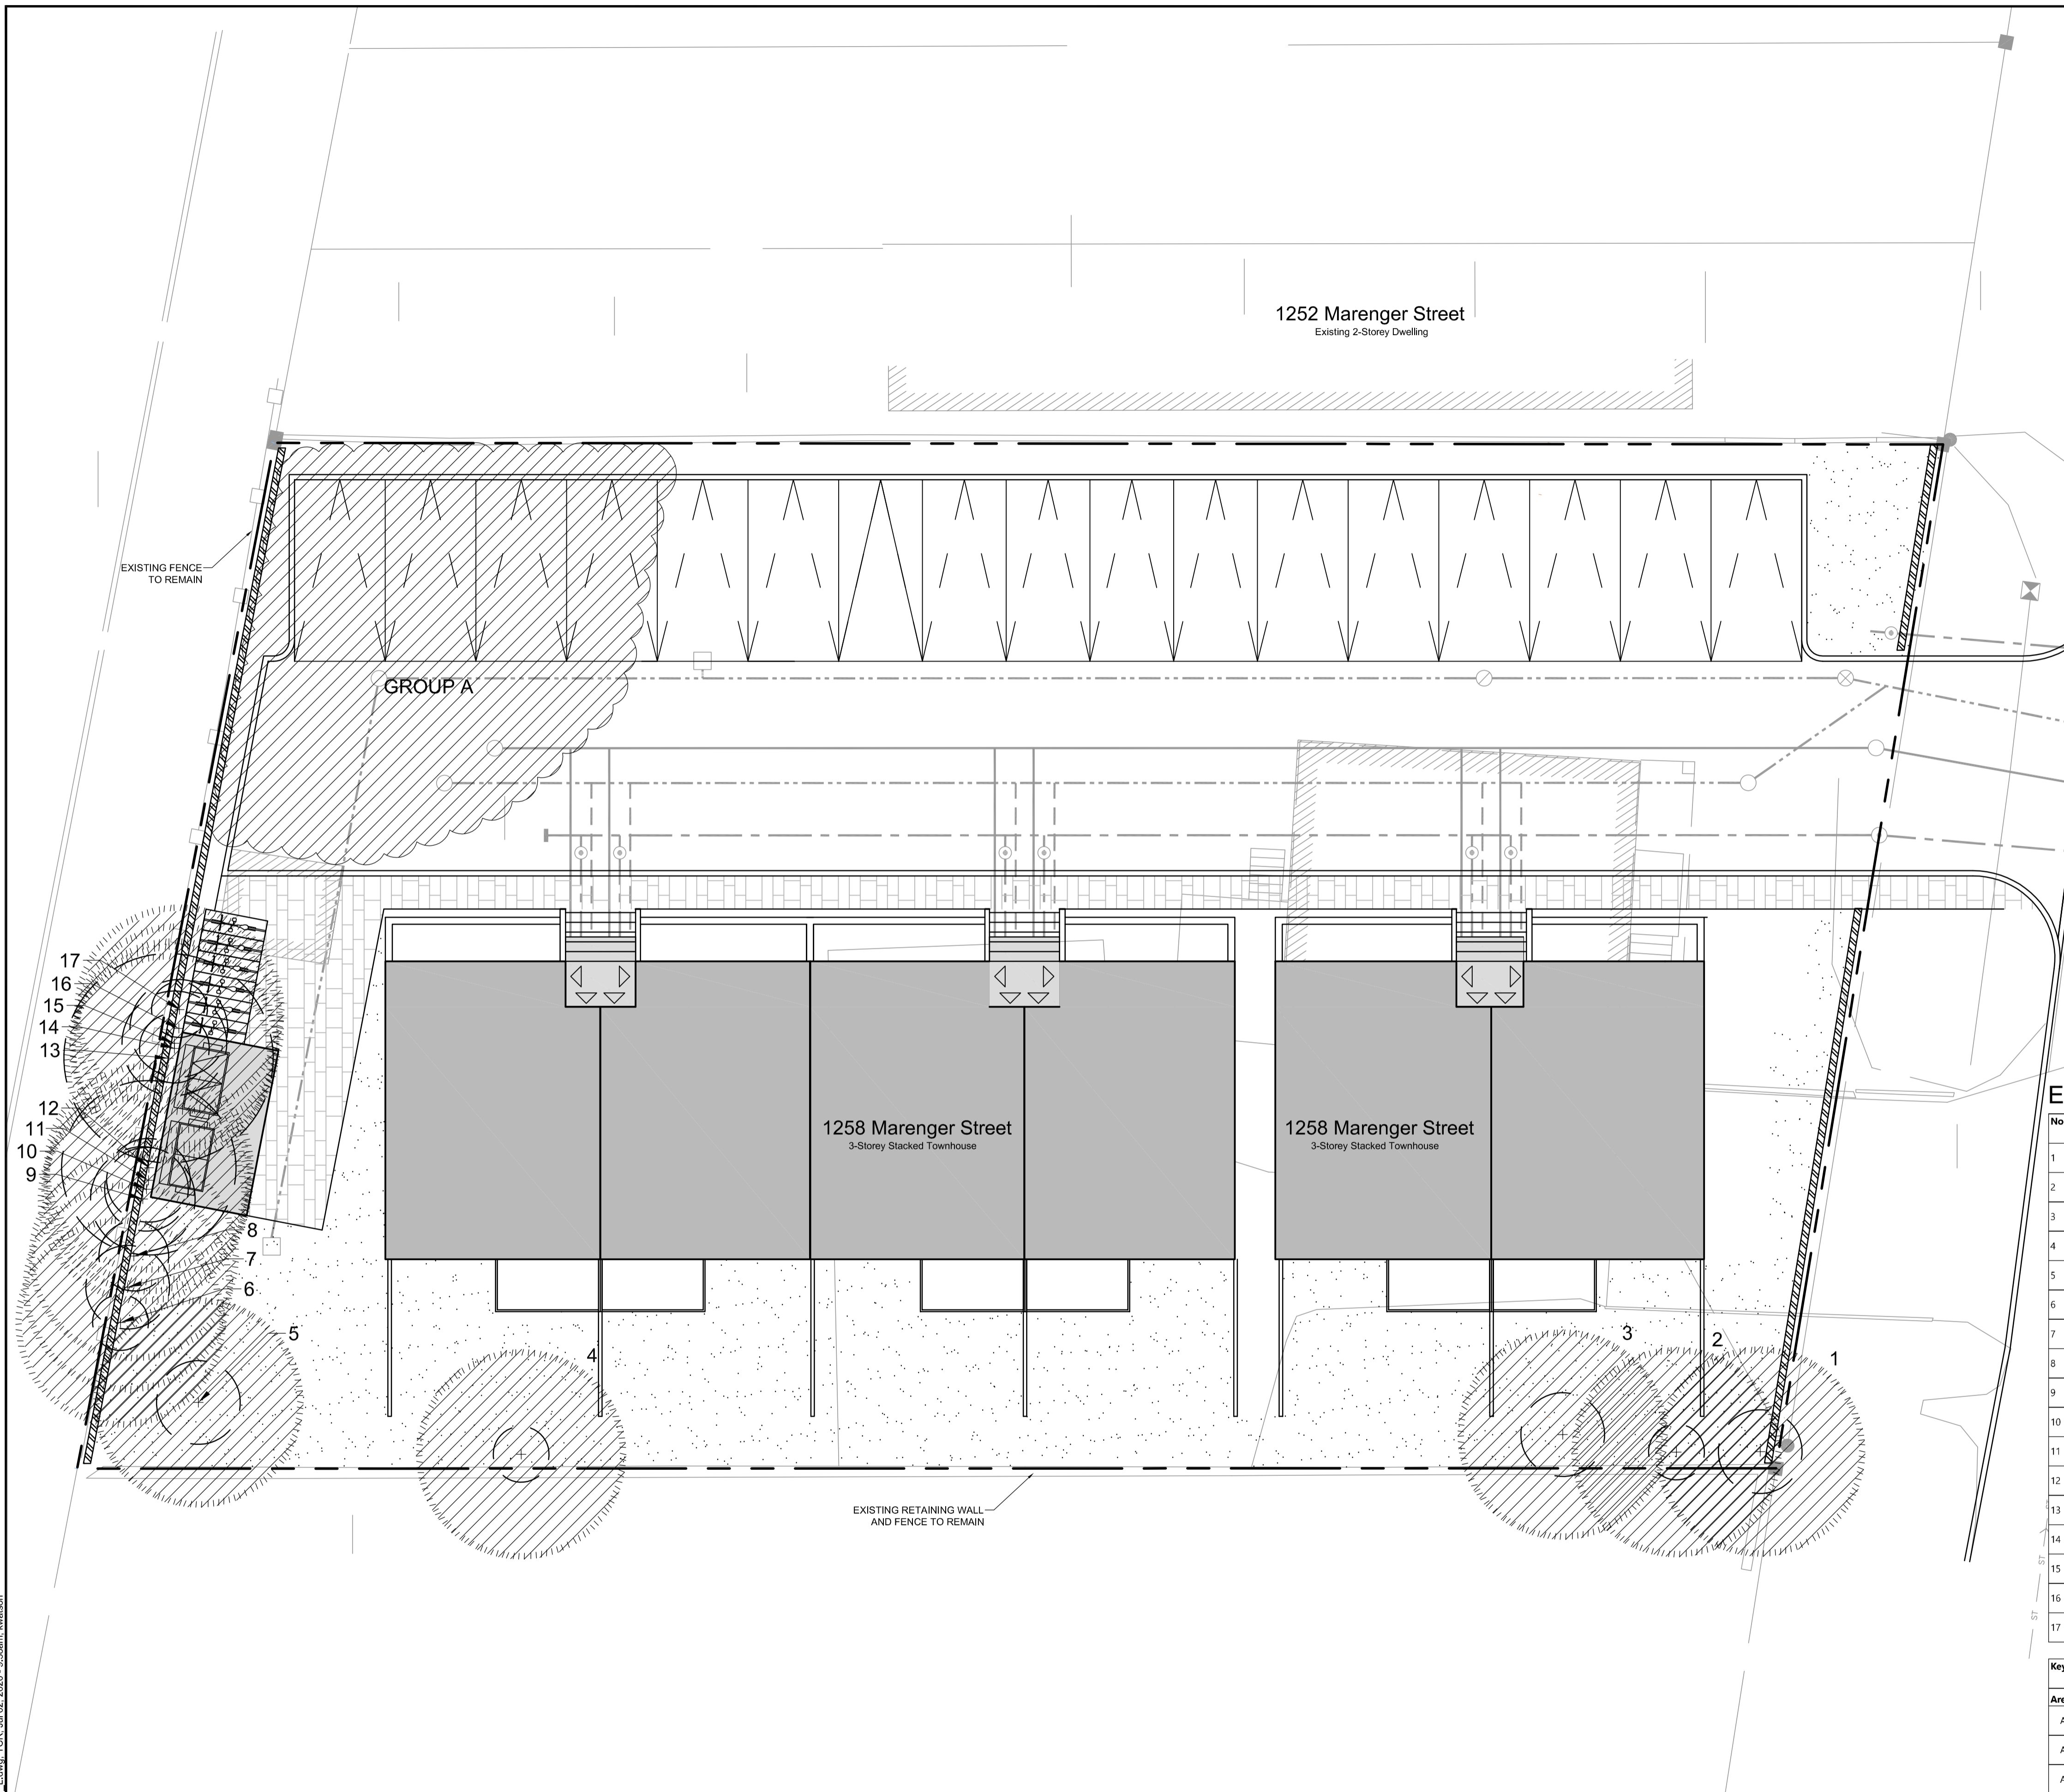
1. Due to the Plasticity Index being 47.8%, or "high plasticity", planting restrictions remain unchanged from the 2005 Clay Soils Policy where the tree setback must be equal to the mature height of the tree. Therefore, none of the existing trees may remain on site.

No.	Botanical Name	Common Name	DBH (m)	CRZ (m)	Condition	Owner	Remarks	Recomm.
1	Acer negundo	Manitoba Maple	0.12	1.20	G	1258 Marenger Street	Close to existing retaining wall	Remove
2	Acer negundo	Manitoba Maple	0.08	0.80	F	1258 Marenger Street	Close to existing retaining wall, multi-leader, wound in trunk	Remove
3	Quercus rubra	Red Oak	0.12	1.20	F	1258 Marenger Street	Leaf scorch	Remove
4	Acer negundo	Manitoba Maple	0.08	0.80	F	1258 Marenger Street	Close to existing retaining wall, crooked trunk	Remove
5	Quercus rubra	Red Oak	0.12	1.20	G	1258 Marenger Street	Small wound in bark	Remove
6	Acer negundo	Manitoba Maple	0.08	0.80	G	1258 Marenger Street		Remove
7	Acer negundo	Manitoba Maple	0.12	1.20	G	1258 Marenger Street		Remove
8	Acer negundo	Manitoba Maple	0.10	1.00	P	1258 Marenger Street	Bent over existing fence	Remove
9	Acer negundo	Manitoba Maple	0.15	1.50	G	1258 Marenger Street		Remove
10	Acer negundo	Manitoba Maple	0.12	1.20	G	1258 Marenger Street		Remove

11	Acer negundo	Manitoba Maple	0.12	1.20	G	1258 Marenger Street		Remove
12	Acer negundo	Manitoba Maple	0.25	2.50	G	1258 Marenger Street		Remove
13	Fraxinus americana	White Ash	0.30	3.00	G	1258 Marenger Street		Remove
14	Acer negundo	Manitoba Maple	0.10	1.00	VP	1258 Marenger Street	Dead	Remove
15	Acer negundo	Manitoba Maple	0.15	1.50	P	1258 Marenger Street	Trunk is wrapped around dead tree beside	Remove
16	Acer negundo	Manitoba Maple	0.14	1.40	G	1258 Marenger Street		Remove
17	Acer negundo	Manitoba Maple	0.08	0.80	G	1258 Marenger Street		Remove

Key	Botanical Name	Common Name	% Compos.	DBH Min-Max	DBH Avg	Owner	Remarks	Recomm.
Area A	Acer negundo	Manitoba Maple	85%	0.1-0.5	0.30			
A	Acer platanoides	Norway Maple	10%	0.1-0.3	0.20	1258 Marenger Street	Shrubby mass of new growth and weeds. No plants large enough to be worth keeping.	Remove
A	Fraxinus americana	White Ash	5%	0.1-0.3	0.20
