McKINLEY
ENVIRONMENTAL
SOLUTIONS

April 23rd, 2020

RE: Woodlot S-23 Large Tree Inventory – Minto Communities and Valecraft Homes Kanata North
Developments (Revised)

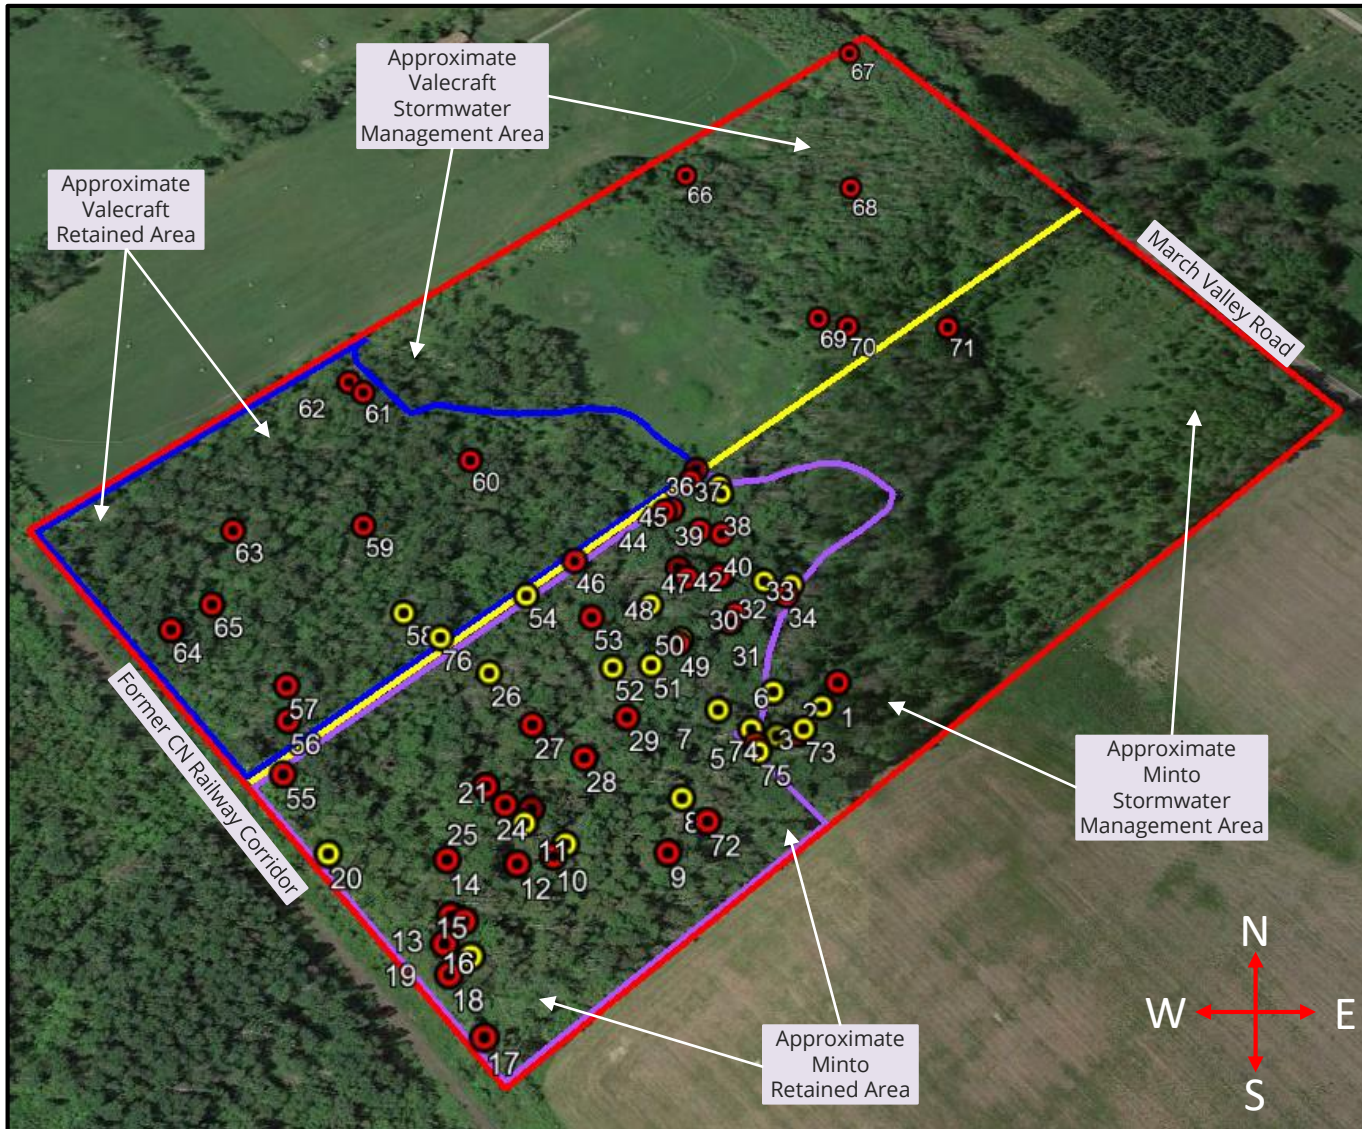
FIGURE 3: LARGE TREE LOCATIONS

The results of the Large Tree Inventory are summarized below in Table A. Photographs of the trees are included in Appendix A. Large tree locations are shown below in Figure 3. In total, seventy six (76) trees ≥ 50 cm dbh in size were documented within the Study Area. In total, eleven (11) tree species with specimens ≥ 50 cm dbh in size were recorded. This included Butternut (21%, 16 trees), White Ash (17%, 13 trees), Bur Oak (15%, 11 trees), Trembling Aspen (12%, 9 trees), White Pine (9%, 7 trees), Sugar Maple (9%, 7 trees), White Cedar (7%, 5 trees), Yellow Birch (4%, 3 trees), Crack Willow (2.5%, 2 trees), Basswood (2.5%, 2 trees), and American Elm (1%, 1 tree). Notably, approximately 32% of the large trees (24 trees) were identified as non-retainable. Non-retainable trees included those that were dead, in poor condition, or those trees identified as Category 1 (Non-retainable) Butternut Trees by Fleguel (2018a) and Fleguel (2018b). Potentially retainable trees included any trees that were found to be in good condition and living during the Large Tree Inventory. The relatively high proportion of non-retainable trees is due to the fact that the two (2) most common species with specimens ≥ 50 cm dbh in size were Butternut (21%, 16 trees) and White Ash (17%, 13 trees). Butternut Trees are an endangered species, and many Butternuts are in decline due to the effects of the Butternut Canker disease. White Ash trees throughout the Ottawa area are also frequently in decline due to the effects of the invasive Emerald Ash Borer. Extensive evidence of damage to Butternut Trees and White Ash by the Butternut Canker/Emerald Ash Borer was noted throughout the Study Area. Notably, virtually all of the mature White Ash trees within the Study Area showed signs of damage from the Emerald Ash Borer.

Please Note: This is not a legal land survey. All dimensions and locations are shown as approximate. Potentially retainable trees include those identified in Table A as being in good condition, Category 2 Butternut Trees, and Category 3 Butternut Trees. Non-retainable trees include those identified in Table A as dead, in poor condition, and Category 1 Butternut Trees.

Per the KNUEA EMP, it is recommended that all trees within the Study Area that occur outside of the limits of the future SWM pond should be preserved. In addition, wherever feasible, trees that occur along the edge of the retained area should also be preserved. Based on the estimated limits of the SWM pond shown above in Figures 1 to 3, the only potentially retainable trees (healthy) that currently occur along the edge of the SWM pond are Tree #34, which is a 51 cm diameter at breast height (dbh) Basswood, and Tree #74, which is a 74 cm dbh Butternut. If feasible and compatible with the requirements of the SWM pond, Tree #34 and Tree #74 should be preserved adjacent to the edge of the retained area during the construction of the SWM pond.

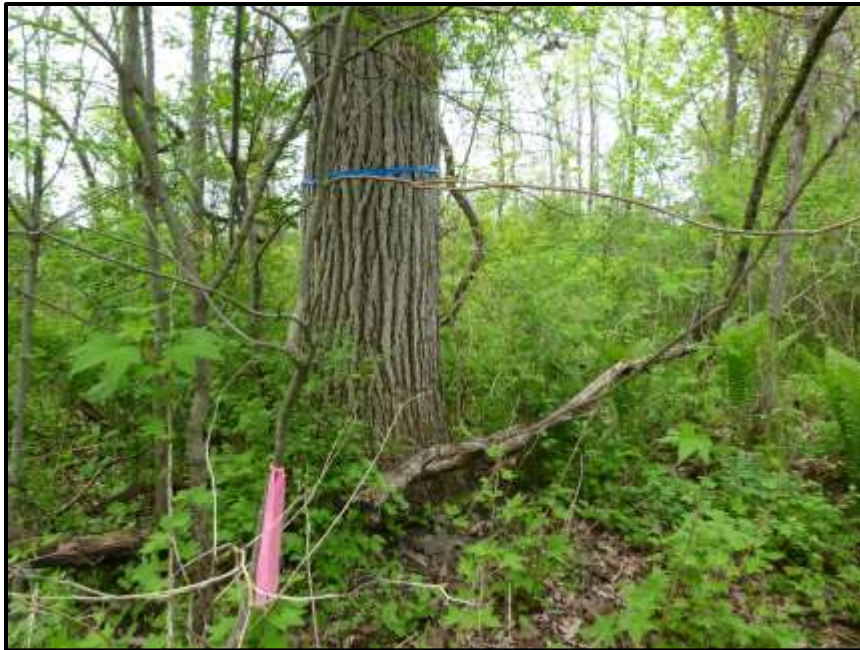
Photograph 1: Tree #1 – Bur Oak in good condition (May 27th, 2019).

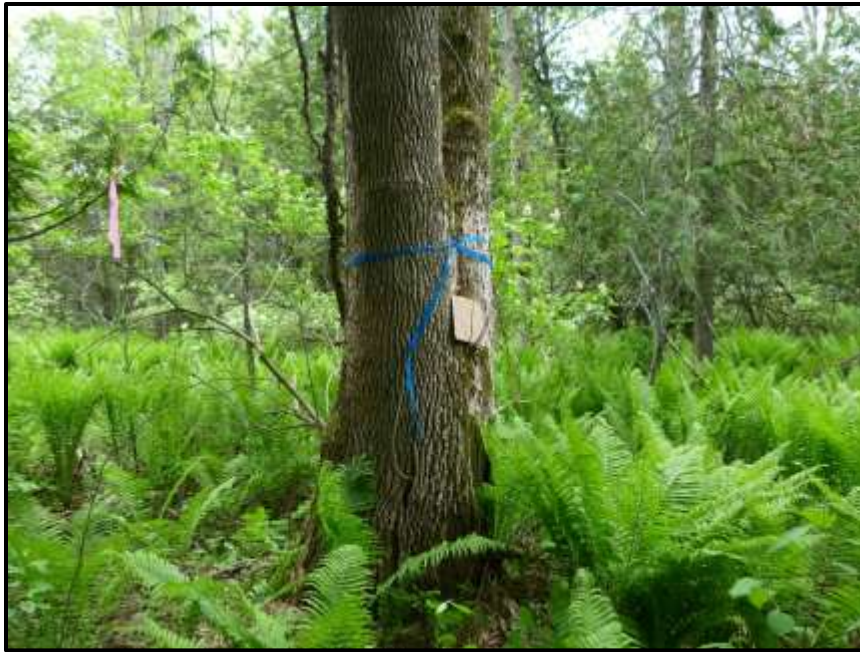
Photograph 7: Tree #8 – dead White Ash (May 27th, 2019).

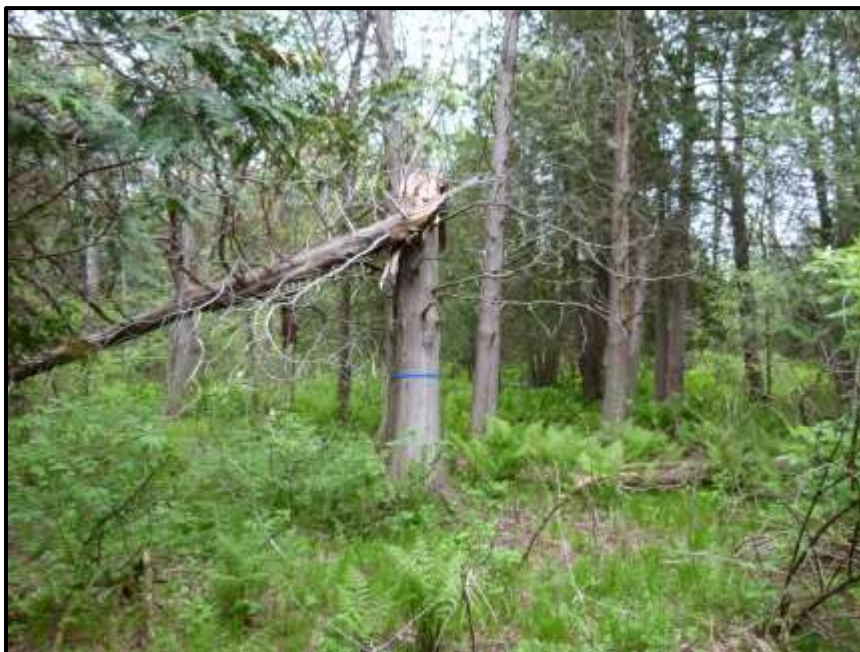
Photograph 10: Tree #11 – dead White Cedar (May 27th, 2019).

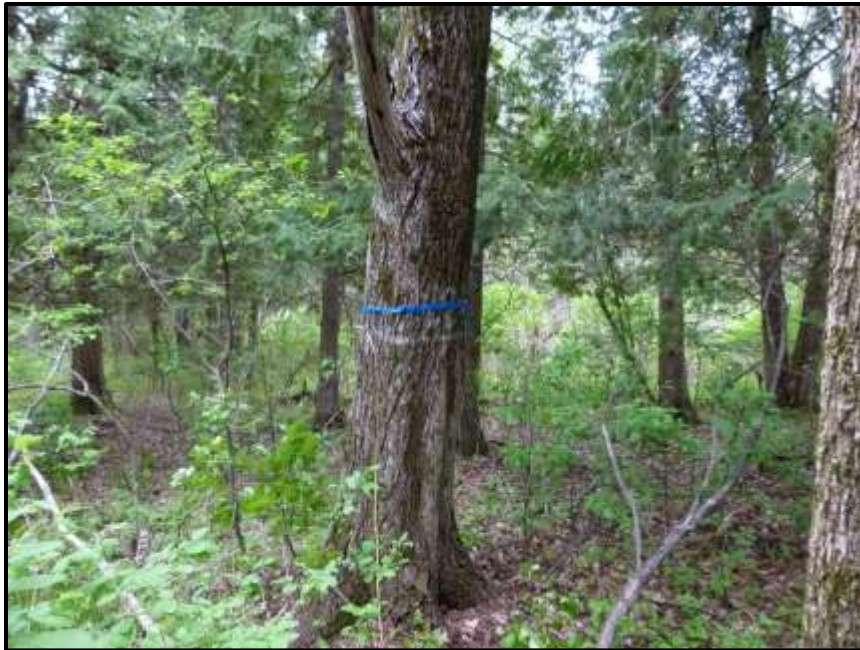
Photograph 15: Tree #16 - Category 1 Butternut (May 27th, 2019).

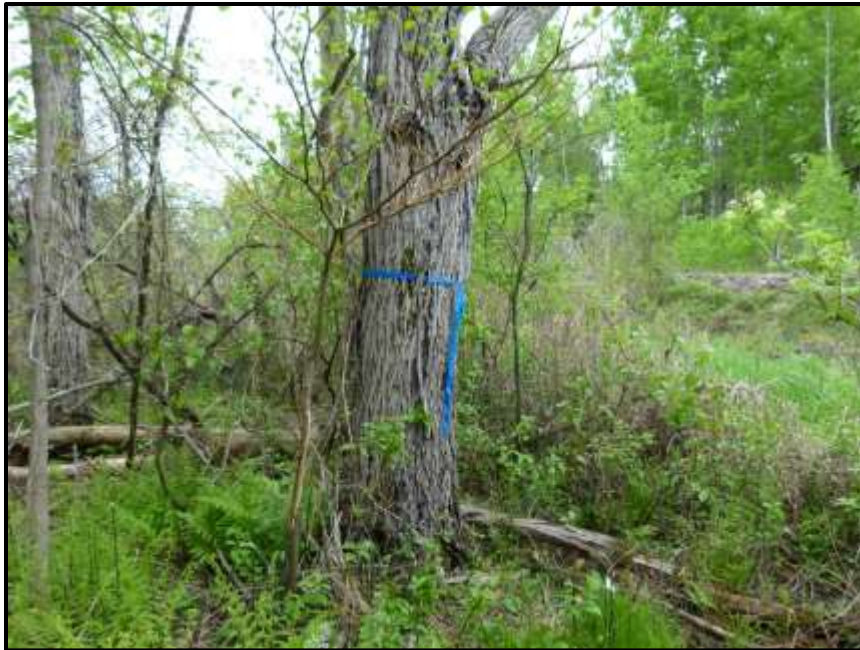
Photograph 19: Tree #20 – Category 1 Butternut (May 27th, 2019).

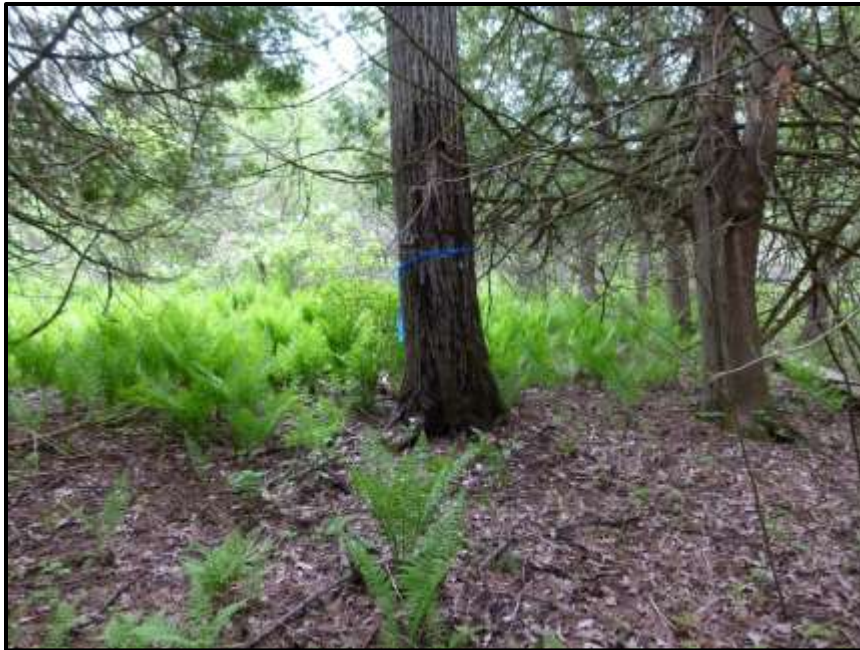
Photograph 23: Tree #24 – Category 1 Butternut Tree (May 27th, 2019).

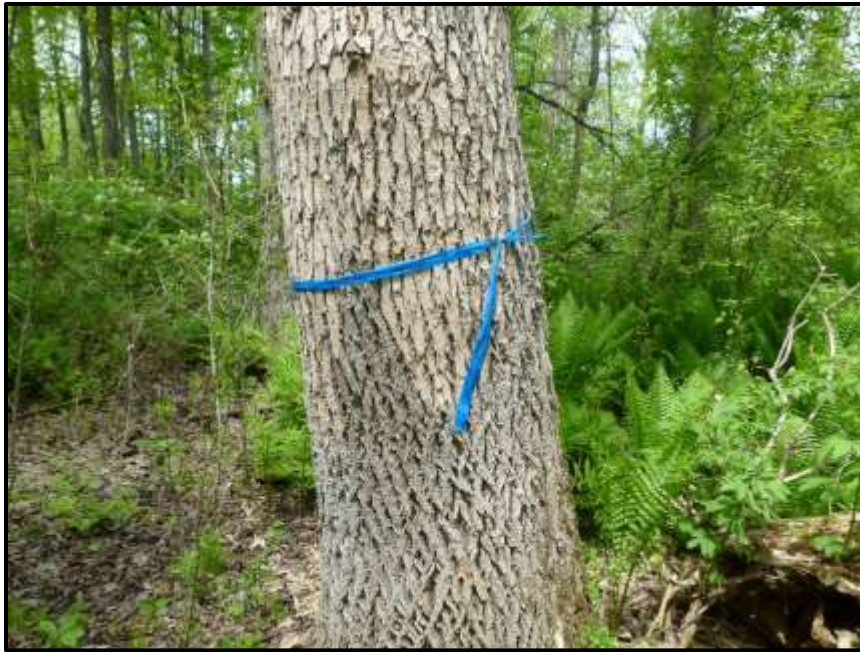
Photograph 31: Tree #32 – dead White Ash (May 27th, 2019).

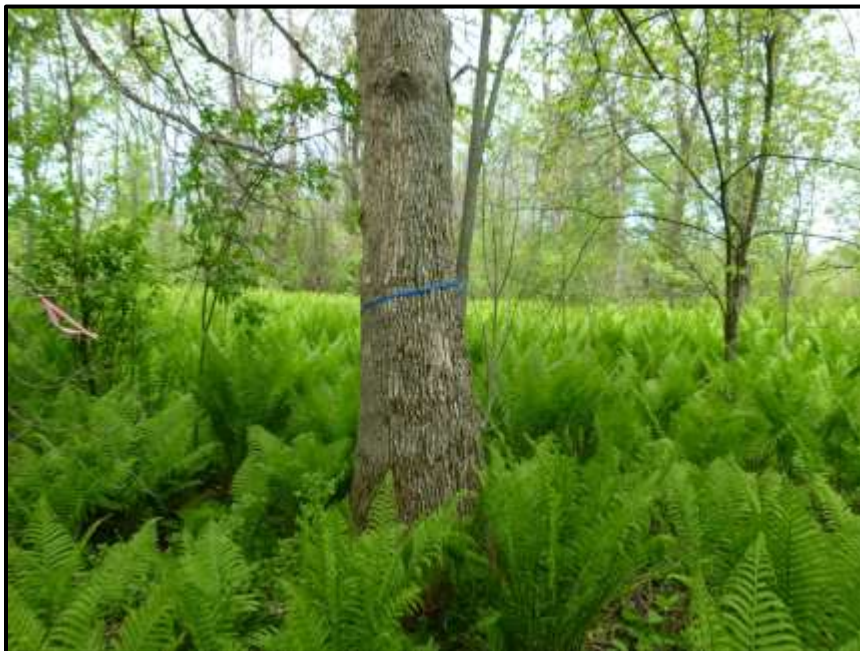
Photograph 32: Tree #33 – dead White Ash (May 27th, 2019).

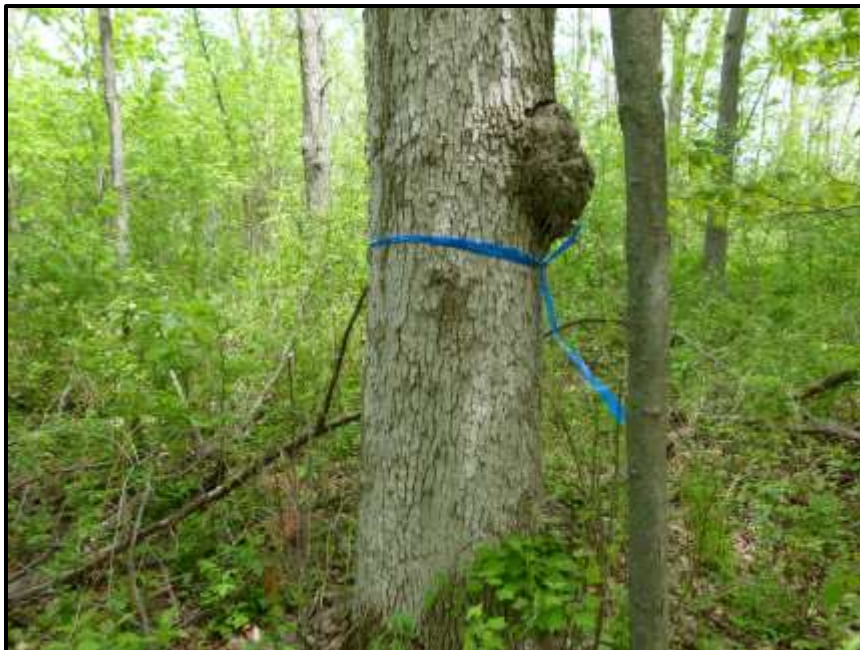
Photograph 36: Tree #37 – dead White Ash (May 27th, 2019).

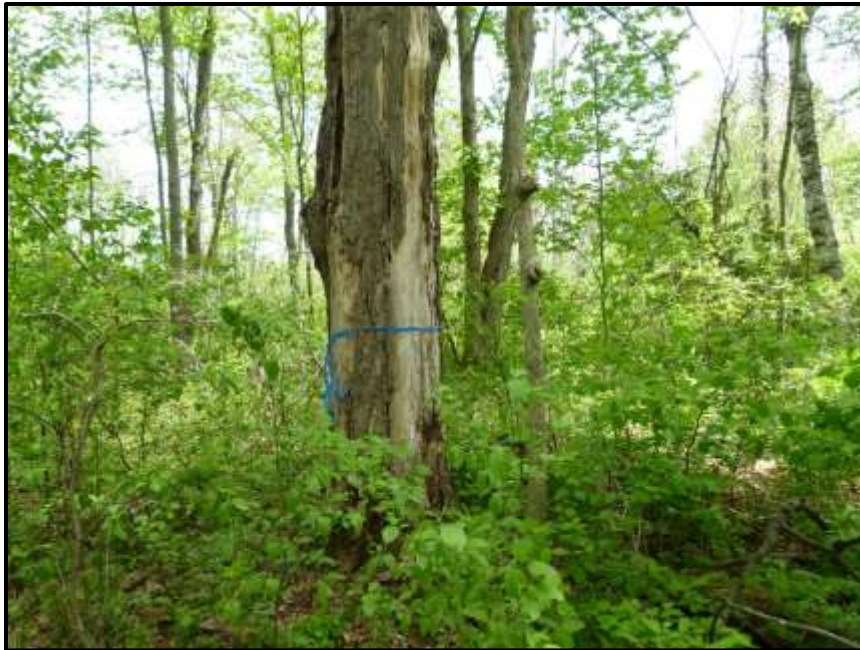
Photograph 37: Tree #38 – Sugar Maple in poor condition (May 27th, 2019).

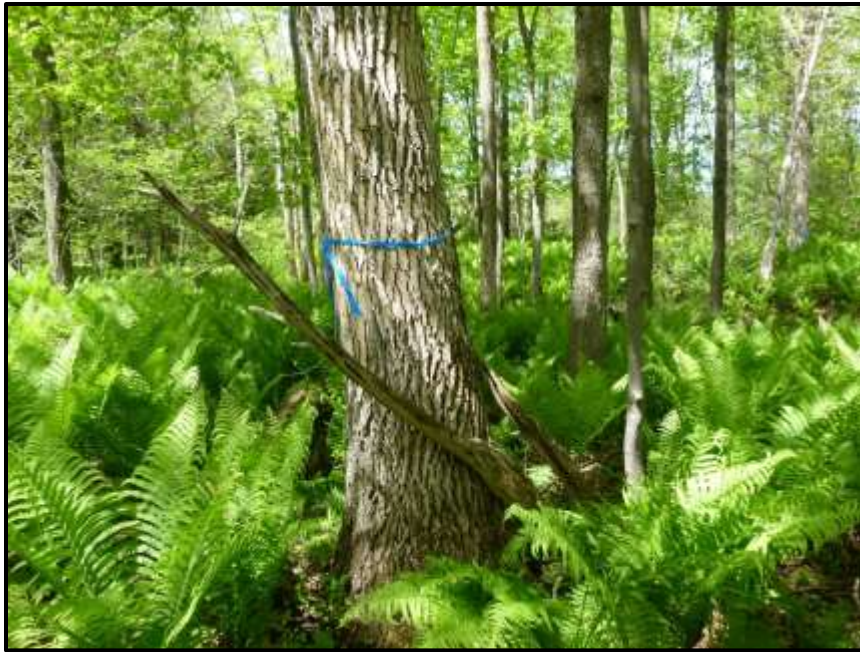
Photograph 47: Tree #48 – dead White Ash (May 27th, 2019).

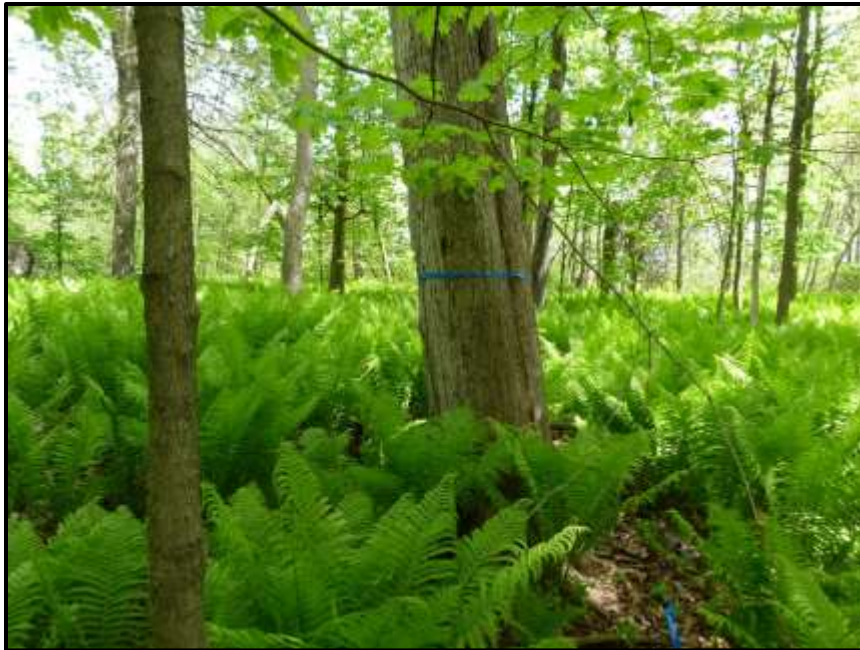
Photograph 49: Tree #50 – Basswood in poor condition (May 27th, 2019).

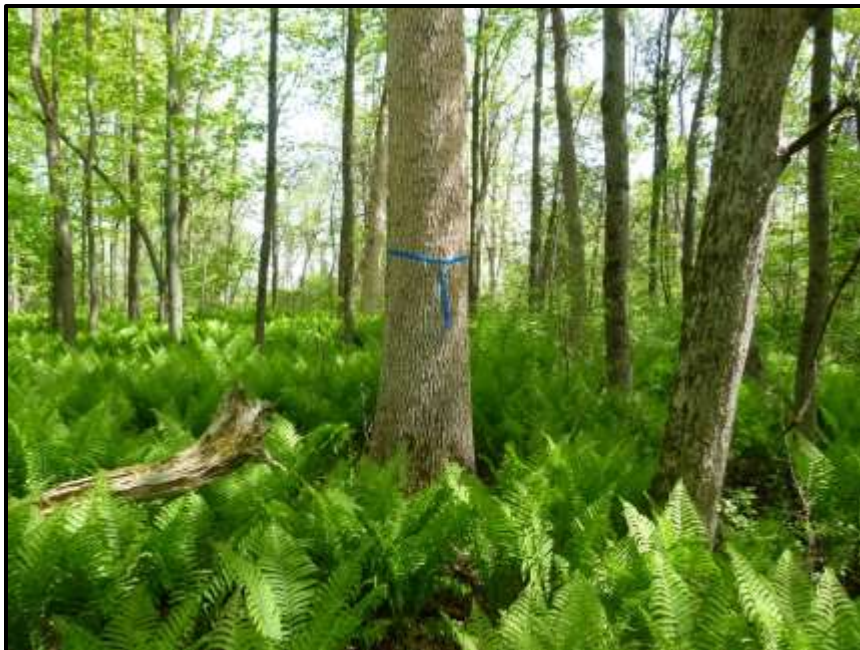
Photograph 50: Tree #51 – dead White Ash (May 27th, 2019).

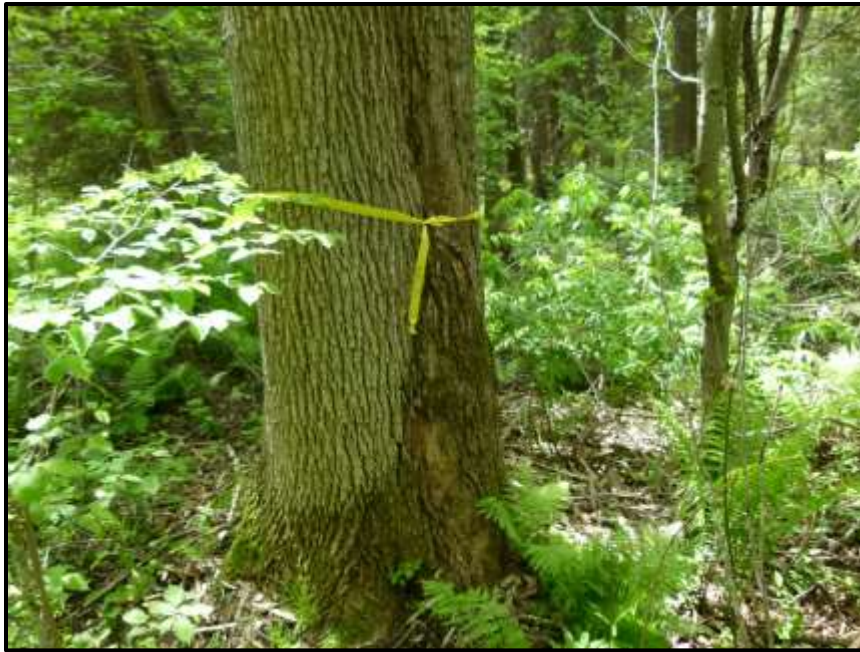
Photograph 51: Tree #52 – dead White Ash (May 27th, 2019).

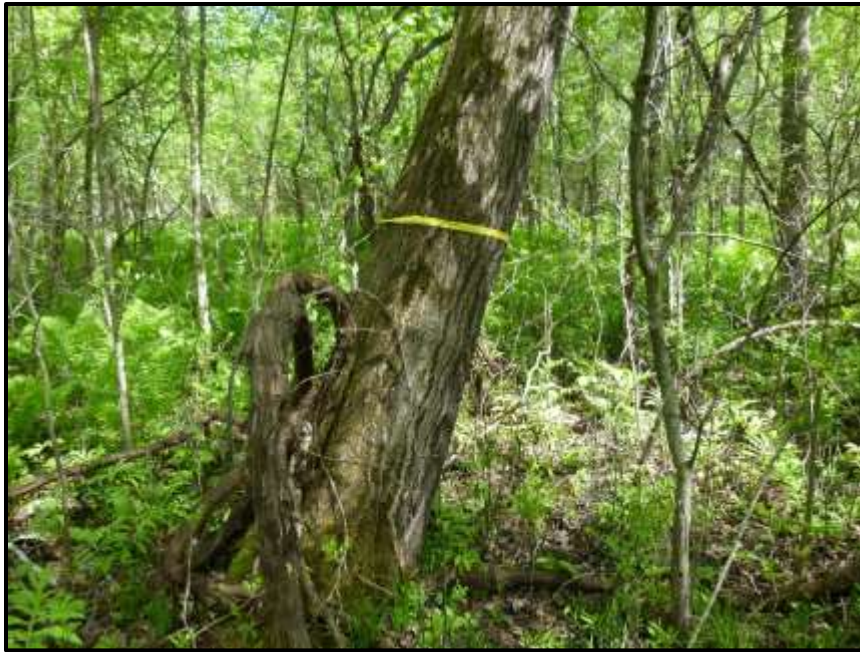
Photograph 57: Tree #58 – Trembling Aspen in poor condition (May 30th, 2019).
