TREE CONSERVATION REPORT V2.0

109-115 Dalhousie

Tree Conservation Report submitted as Partial
Requirements for a Site Plan Control Application,
February 16, 2022

Tree Conservation Report v2.0

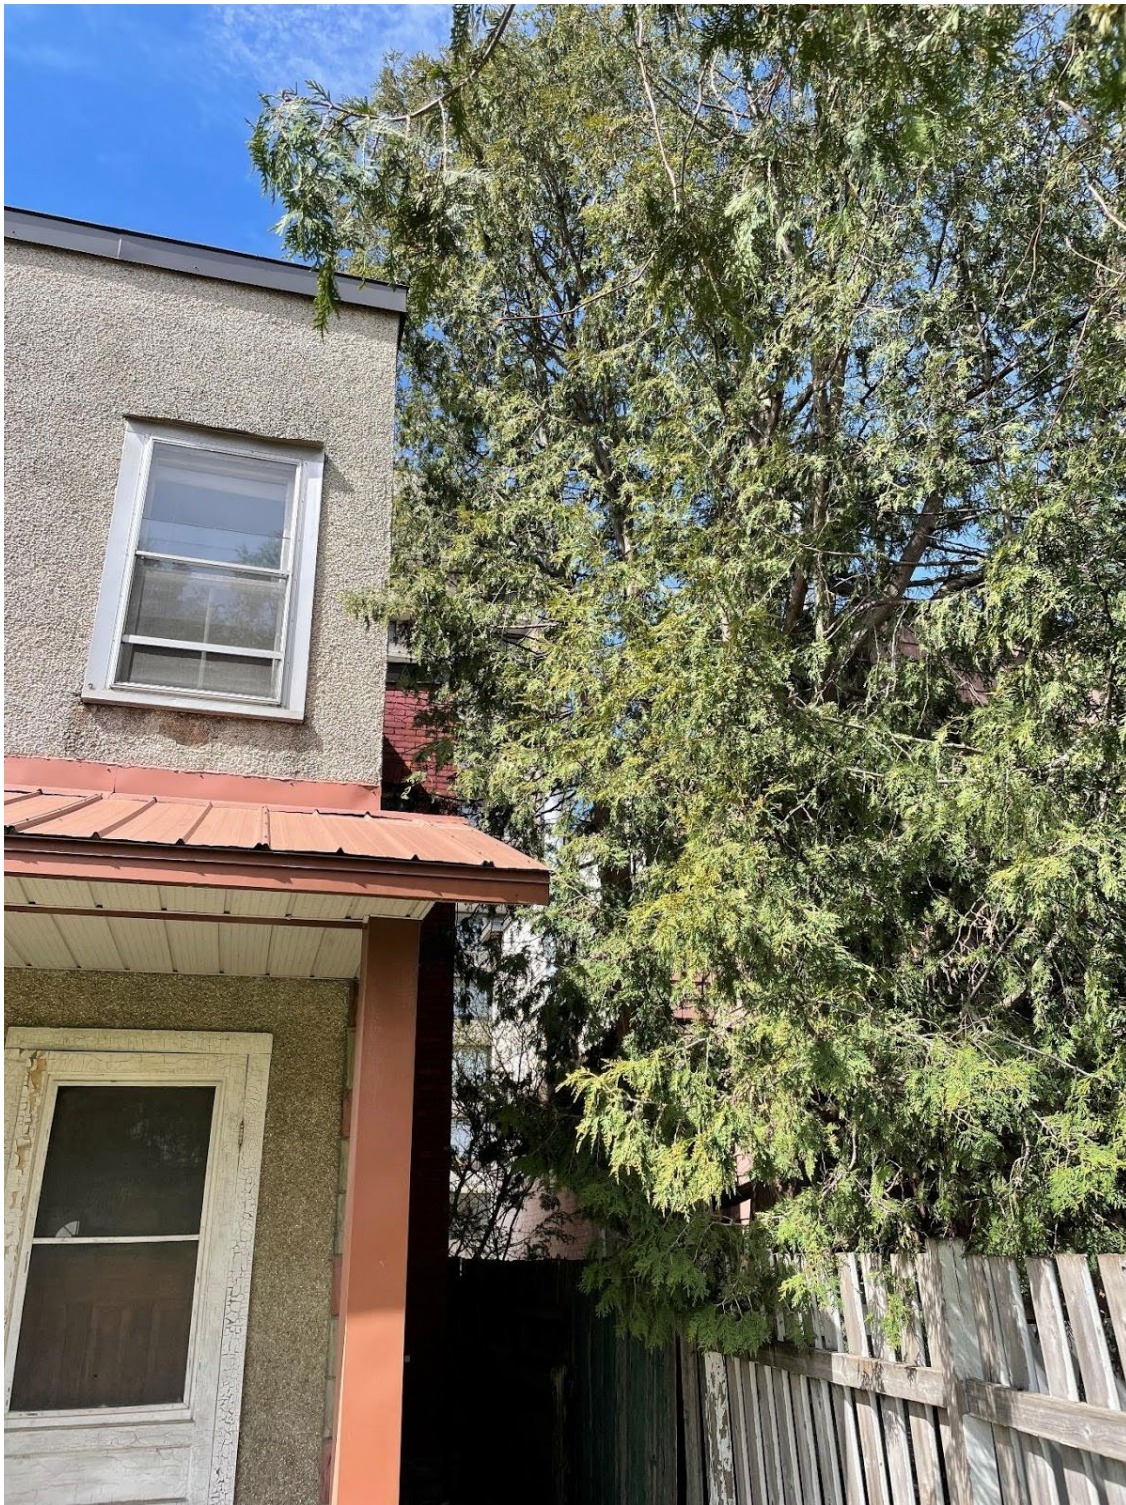
Tree 1, an eastern white cedar, located on adjacent property is in good health. However, the proposed development will involve severing some of the roots, possibly impacting the structural integrity of the tree. If the excavation in this area cannot be limited to at least 1 m from the edge of the tree, then removal is recommended. The two trunks are situated 25 and 40 cm from the current fence. If the tree is retained, an onsite inspection by an arborist to assess stability during excavation is recommended. Alternatively, the roots can be severed prior to excavation by an arborist using an airspade, at which time, an assessment on potential stability can be made. Pruning of the crown is also required to

Figure 1: Tree 1, eastern white cedar on adjacent property to be retained

accommodate the scaffolding while the new building is under construction. If excavation cannot be reduced to 1 m from the tree trunk, then removal is the recommended option. Since this tree is entirely on adjacent property, permission from the neighbour would be required for removal.

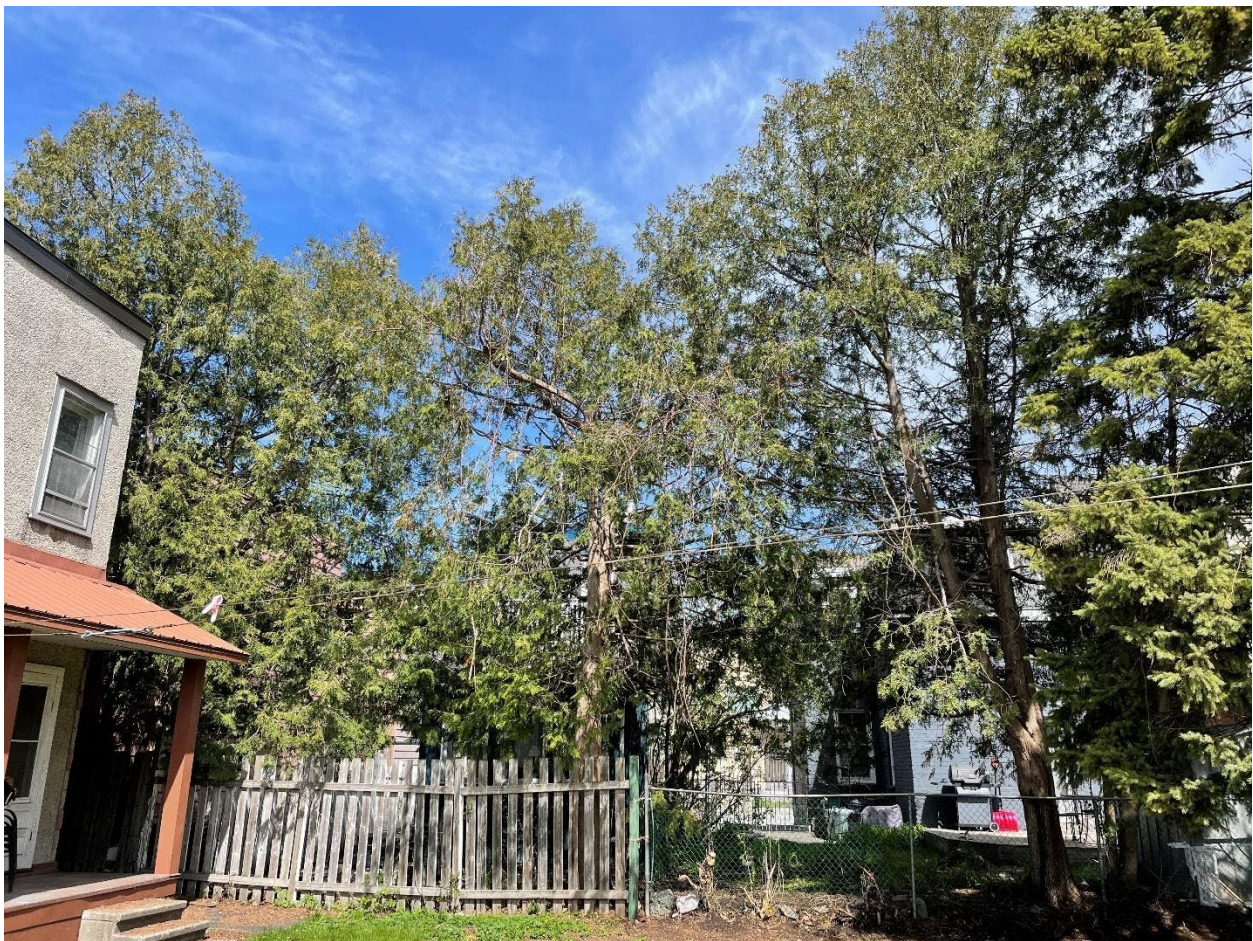
Tree 2 is in fair health due to the loss of its tops and will be within the area of excavation – removal is recommended. Although tree 3 is slightly further away, there will be some impact to the tree through severing of the roots from the excavation. The main stem of this tree has a large stem attached to the base of the trunk that is at risk of failure. The preferred option by the client is to retain this tree, but it should be monitored through construction for signs of failure. Some of the smaller stems close to this tree may be retained, but they are being suppressed by tree 4, and combined with the stress of the excavation, are not ideal candidates for retention.

Figure 2: Trees 1 (left), 2 (middle), 3 (right), all eastern white cedar

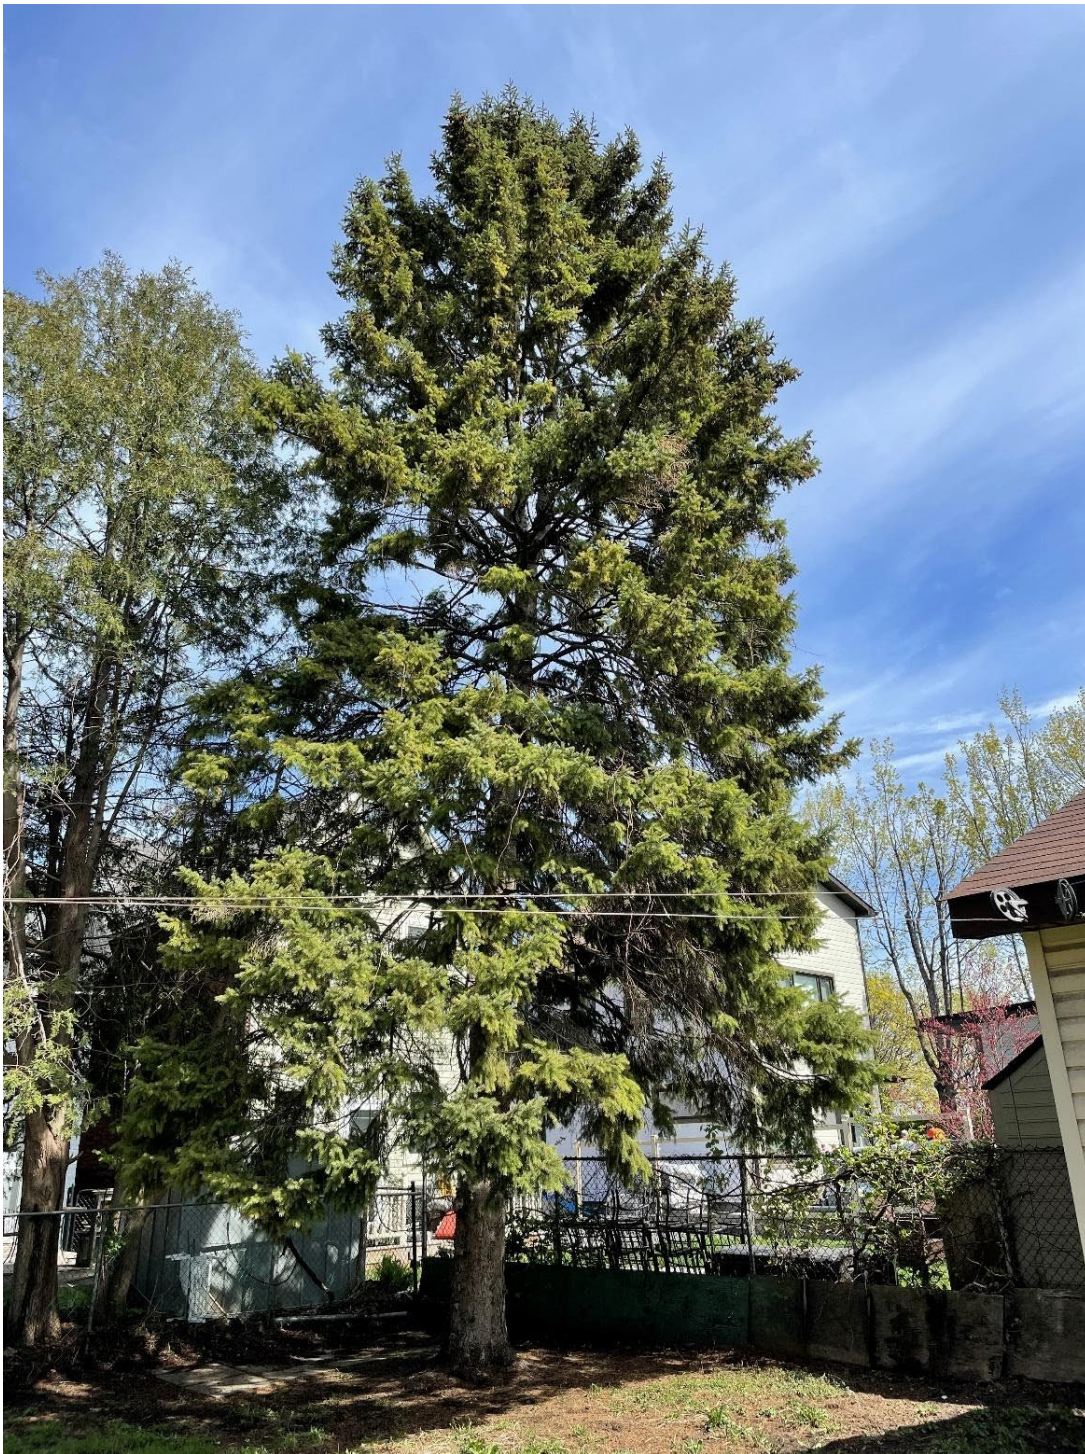
Figure 3: Tree 4, white spruce to be retained

Tree 4 is a healthy spruce that should be retainable if the area can be well protected throughout site works as per the tree protected specifications below. Tree 5 is on adjacent property and the roots will likely be impacted by the proposed excavation. This tree is set back far enough that stability should not be severely compromised by the excavation, however, root cutting/pruning by an arborist is recommended.

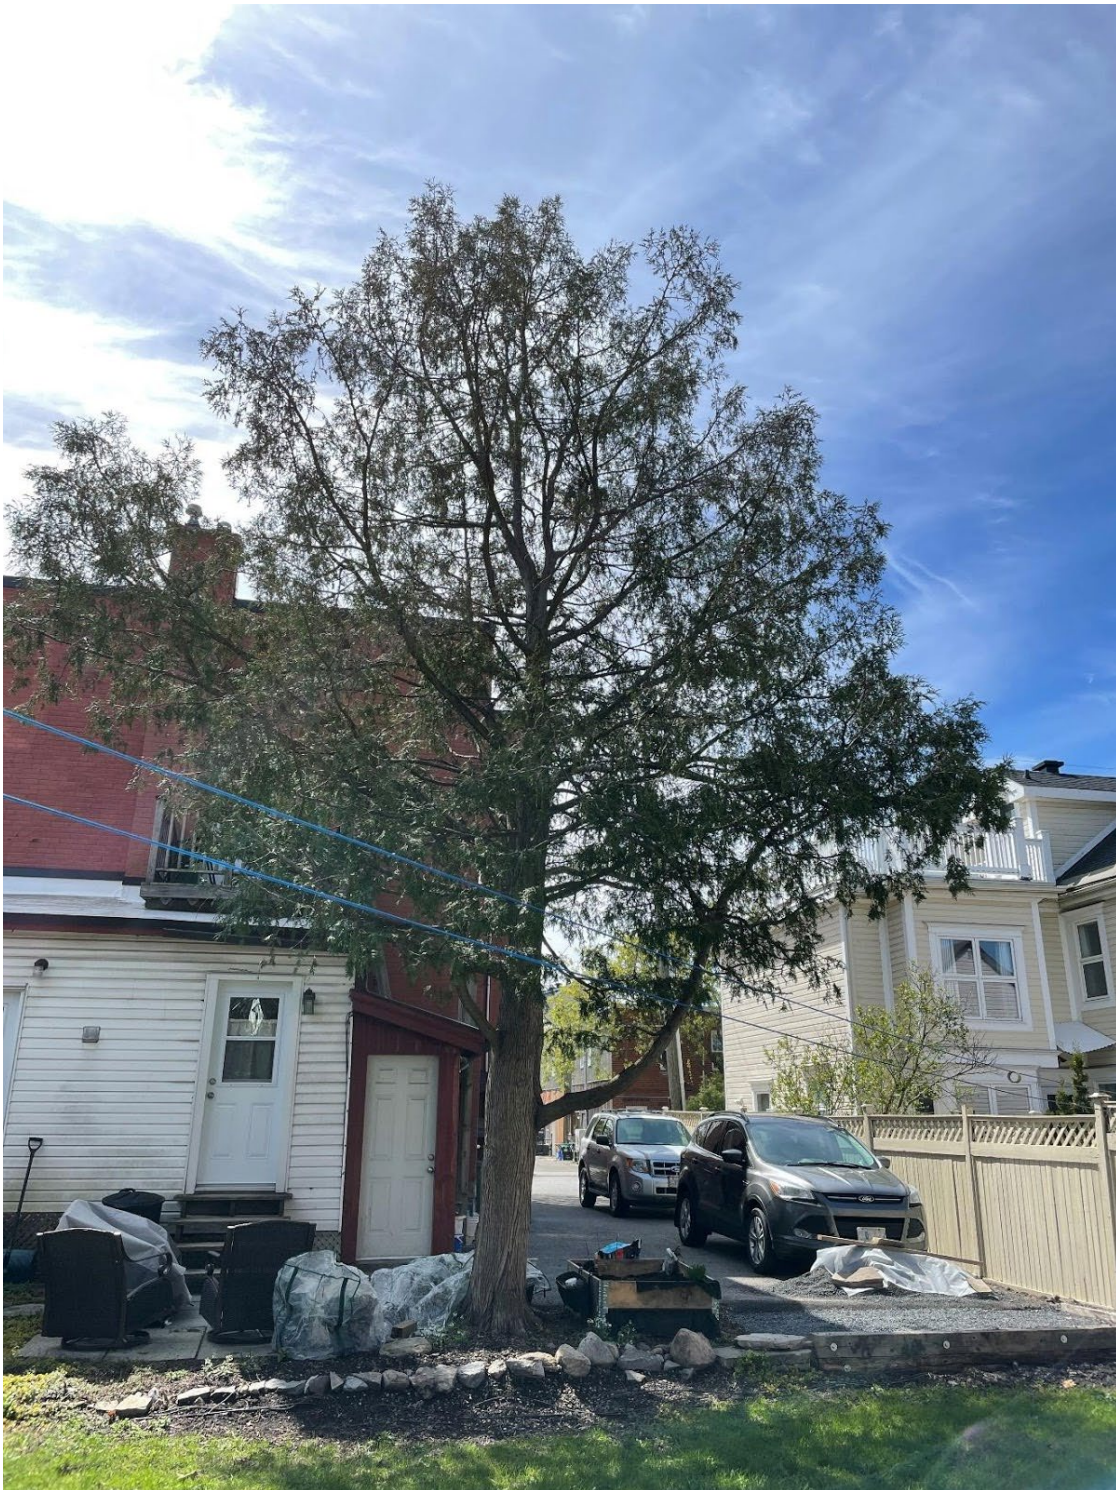
Figure 4: Tree 5, eastern white cedar on adjacent property to be retained
