TREE CONSERVATION REPORT

PROJECT NAME:	Scouts Canada
PROJECT NO.	22831-1
LOCATION	1345 Baseline Rd, Ottawa ON, K4B 1P6
DATE:	June 1 st 2022

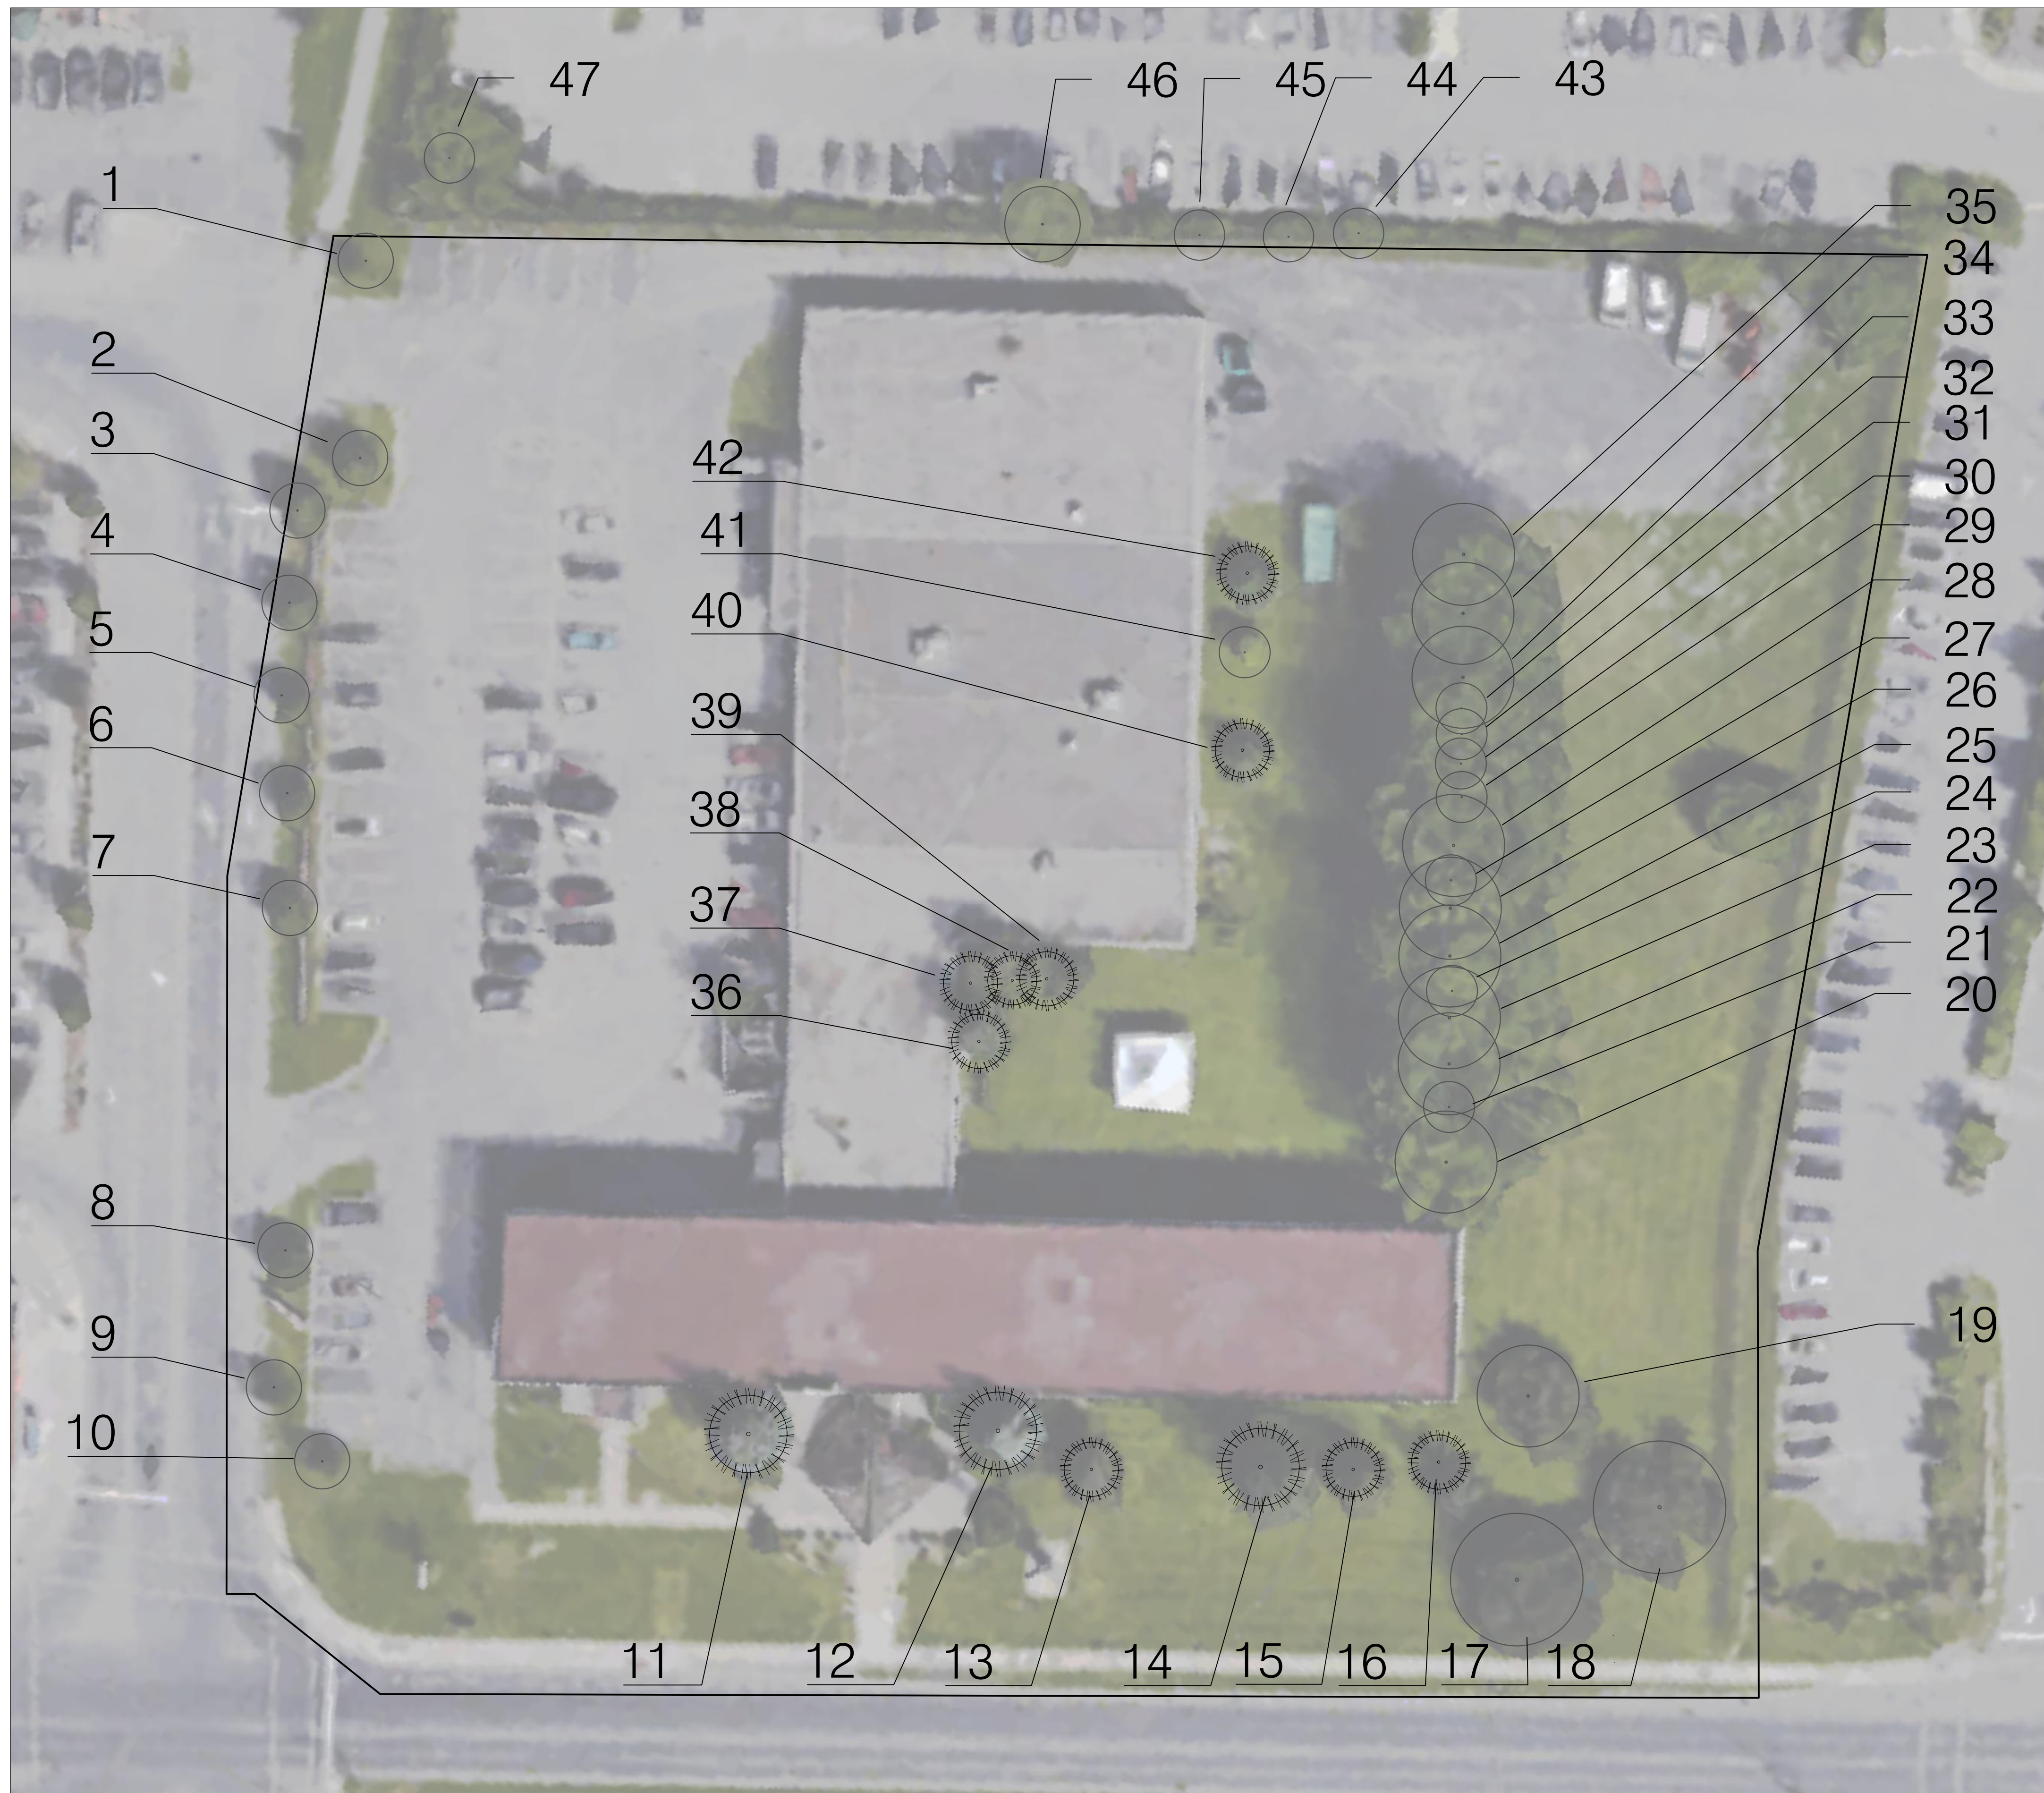
1 PRE DEVELOPMENT VEGETATION

SCOUTS CANADA SITE-EXISTING TREES

NO.	TREE SPECIES	DBH (cm)	CONDITION	COMMENTS
1	Little Leaf Linden/ <i>Tilia cordata</i>	9	Poor	Stressed
2	Little Leaf Linden/ <i>Tilia cordata</i>	17	Good	
3	Little Leaf Linden/ <i>Tilia cordata</i>	17	Good	
4	Little Leaf Linden/ <i>Tilia cordata</i>	15	Good	
5	Little Leaf Linden/ <i>Tilia cordata</i>	13	Poor	Wound in trunk, stressed
6	Little Leaf Linden/ <i>Tilia cordata</i>	14	Fair	Stressed, east lean
7	Little Leaf Linden/ <i>Tilia cordata</i>	15	Good	
8	Little Leaf Linden/ <i>Tilia cordata</i>	16	Good	
9	Little Leaf Linden/ <i>Tilia cordata</i>	14	Good	
10	Little Leaf Linden/ <i>Tilia cordata</i>	14	Good	
11	Colorado Blue Spruce/ <i>Picea pungens</i>	53	Good	
12	Colorado Blue Spruce/ <i>Picea pungens</i>	44	Good	
13	Black Spruce/ <i>Picea mariana</i>	18, 13	Poor	50% dead
14	White Spruce/ <i>Picea glauca</i>	35	Good	
15	White Spruce/ <i>Picea glauca</i>	26	Good	
16	White Spruce/ <i>Picea glauca</i>	16	Fair	Stressed

17	Crab Apple/ <i>Malus sylvestris</i>	51	Good	
18	Crab Apple/ <i>Malus sylvestris</i>	18,22,18,17,16	Good	
19	Crab Apple/ <i>Malus sylvestris</i>	23,28	Good	
20	Silver Maple/ <i>Acer saccharium</i>	27,30,25	Good	
21	Silver Maple/ <i>Acer saccharium</i>	16,17	Fair	Crowded out
22	Silver Maple/ <i>Acer saccharium</i>	30,29,40	Good	
23	Silver Maple/ <i>Acer saccharium</i>	22,18	Fair	Crowded out, weak stem
24	Silver Maple/ <i>Acer saccharium</i>	18,16	Dead	
25	Silver Maple/ <i>Acer saccharium</i>	18	Poor	50% dead
26	Silver Maple/ <i>Acer saccharium</i>	18,16,16,13	Poor	50% dead, dry stem
27	Silver Maple/ <i>Acer saccharium</i>	26,19	Fair	Dead limbs
28	Silver Maple/ <i>Acer saccharium</i>	25,27	Fair	Weak stem
29	Silver Maple/ <i>Acer saccharium</i>	20,6,10,13,13	Fair	Abnormal trunk joints
30	Silver Maple/ <i>Acer saccharium</i>	20,21	Good	
31	Silver Maple/ <i>Acer saccharium</i>	15,17	Poor	Dead limbs
32	Silver Maple/ <i>Acer saccharium</i>	27,26,29	Good

33	Silver Maple/ <i>Acer saccharium</i>	15,12,21,27	Fair	Weak base
34	Silver Maple/ <i>Acer saccharium</i>	12,15,27,31	Fair	Dead limbs
35	Silver Maple/ <i>Acer saccharium</i>	28,35,49	Good	
36	White Spruce/ <i>Picea glauca</i>	26	Good	
37	White Spruce/ <i>Picea glauca</i>	22	Good	
38	White Spruce/ <i>Picea glauca</i>	16,18	Good	
39	White Spruce/ <i>Picea glauca</i>	25	Good	
40	Colorado Blue Spruce/ <i>Picea pungens</i>	22	Good	
41	White Pine/ <i>Pinus strobus</i>	6,10	Good	
42	Colorado Blue Spruce/ <i>Picea pungens</i>	25	Good	
43	Balsam poplar/ <i>Populus balsamifera</i>	15,17,19	Good	
44	Hackberry/ <i>Celtis occidentalis</i>	12	Good	
45	Siberian Elm/ <i>Ulmus pumila</i>	16,17,17,20	Fair	Stressed, leaf loss
46	Red Maple/ <i>Acer rubrum</i>	10	Good	
47	Red Maple/ <i>Acer rubrum</i>	10	Good

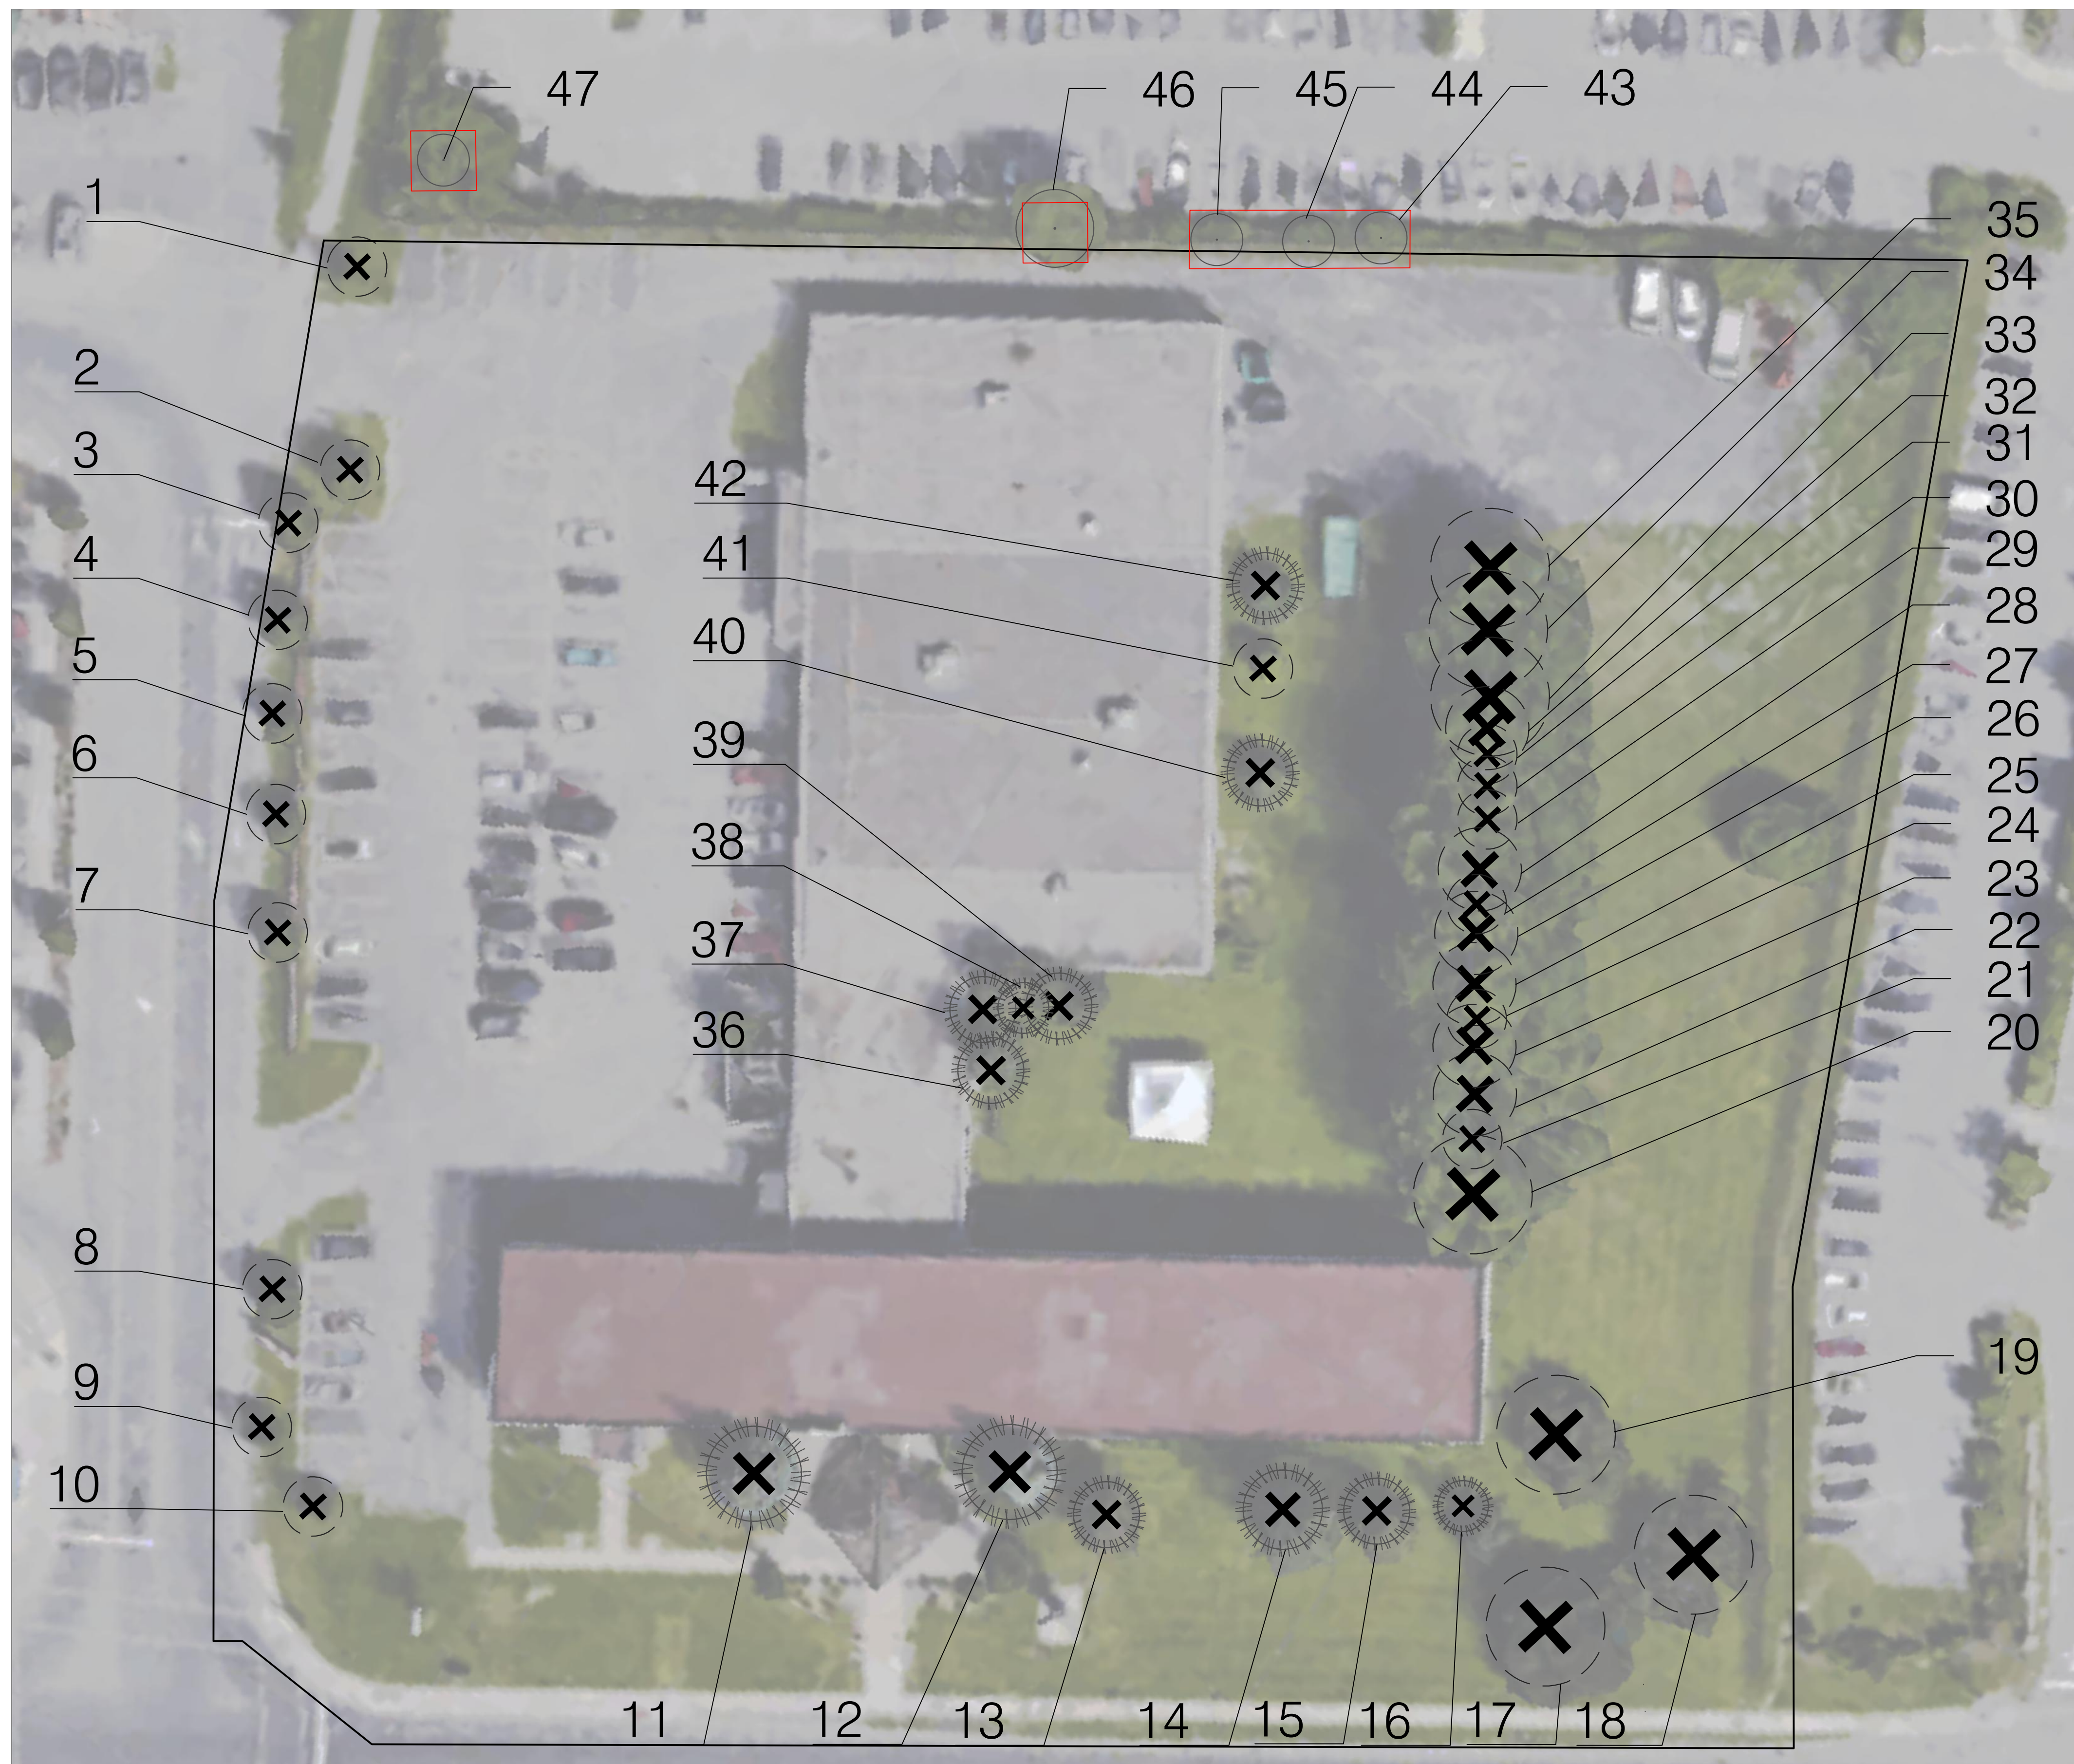
1 POST DEVELOPMENT VEGETATION
L-TP2

SCOUTS CANADA SITE- TREES TO BE RETAINED

NO.	TREE SPECIES	DBH (cm)	CONDITION	COMMENTS
43	Balsam poplar/ <i>Populus balsamifera</i>	15,17,19	Good	
44	Hackberry/ <i>Celtis occidentalis</i>	12	Good	
45	Siberian Elm/ <i>Ulmus pumila</i>	16,17,17,20	Fair	Stressed, leaf loss
46	Red Maple/ <i>Acer rubrum</i>	10	Good	
47	Red Maple/ <i>Acer rubrum</i>	10	Good

SCOUTS CANADA SITE- TREES TO BE REMOVED

NO.	TREE SPECIES	DBH (cm)	CONDITION	COMMENTS
1	Little Leaf Linden/ <i>Tilia cordata</i>	9	Poor	Stressed
2	Little Leaf Linden/ <i>Tilia cordata</i>	17	Good	
3	Little Leaf Linden/ <i>Tilia cordata</i>	17	Good	
4	Little Leaf Linden/ <i>Tilia cordata</i>	15	Good	
5	Little Leaf Linden/ <i>Tilia cordata</i>	13	Poor	Wound in trunk, stressed
6	Little Leaf Linden/ <i>Tilia cordata</i>	14	Fair	Stressed, east lean
7	Little Leaf Linden/ <i>Tilia cordata</i>	15	Good	
8	Little Leaf Linden/ <i>Tilia cordata</i>	16	Good	
9	Little Leaf Linden/ <i>Tilia cordata</i>	14	Good	
10	Little Leaf Linden/ <i>Tilia cordata</i>	14	Good	
11	Colorado Blue Spruce/ <i>Picea pungens</i>	53	Good	
12	Colorado Blue Spruce/ <i>Picea pungens</i>	44	Good	
13	Black Spruce/ <i>Picea mariana</i>	18, 13	Poor	50% dead
14	White Spruce/ <i>Picea glauca</i>	35	Good	
15	White Spruce/ <i>Picea glauca</i>	26	Good	
16	White Spruce/ <i>Picea glauca</i>	16	Fair	Stressed

17	Crab Apple/ <i>Malus sylvestris</i>	51	Good	
18	Crab Apple/ <i>Malus sylvestris</i>	18,22,18,17,16	Good	
19	Crab Apple/ <i>Malus sylvestris</i>	23,28	Good	
20	Silver Maple/ <i>Acer saccharium</i>	27,30,25	Good	
21	Silver Maple/ <i>Acer saccharium</i>	16,17	Fair	Crowded out
22	Silver Maple/ <i>Acer saccharium</i>	30,29,40	Good	
23	Silver Maple/ <i>Acer saccharium</i>	22,18	Fair	Crowded out, weak stem
24	Silver Maple/ <i>Acer saccharium</i>	18,16	Dead	
25	Silver Maple/ <i>Acer saccharium</i>	18	Poor	50% dead
26	Silver Maple/ <i>Acer saccharium</i>	18,16,16,13	Poor	50% dead, dead stem
27	Silver Maple/ <i>Acer saccharium</i>	26,19	Fair	Dead limbs
28	Silver Maple/ <i>Acer saccharium</i>	25,27	Fair	Weak stem
29	Silver Maple/ <i>Acer saccharium</i>	20,6,10,13,13	Fair	Abnormal trunk joints
30	Silver Maple/ <i>Acer saccharium</i>	20,21	Good	
31	Silver Maple/ <i>Acer saccharium</i>	15,17	Poor	Dead limbs
32	Silver Maple/ <i>Acer saccharium</i>	27,26,29	Good

33	Silver Maple/ <i>Acer saccharium</i>	15,12,21,27	Fair	Weak base
34	Silver Maple/ <i>Acer saccharium</i>	12,15,27,31	Fair	Dead limbs
35	Silver Maple/ <i>Acer saccharium</i>	28,35,49	Good	
36	White Spruce/ <i>Picea glauca</i>	26	Good	
37	White Spruce/ <i>Picea glauca</i>	22	Good	
38	White Spruce/ <i>Picea glauca</i>	16,18	Good	
39	White Spruce/ <i>Picea glauca</i>	25	Good	
40	Colorado Blue Spruce/ <i>Picea pungens</i>	22	Good	
41	White Pine/ <i>Pinus strobus</i>	6,10	Good	
42	Colorado Blue Spruce/ <i>Picea pungens</i>	25	Good
