2-15 unit 2 BR residences Located at 2345 - 2351 Mer Bleue, Ontario

> Prepared for: Ziad Zamat

Prepared by: Derrick R. Clark, P.Eng. EAU Structural & Environnemental Services Telephone (613) 869 0523 <u>derrick.r.clark@rogers.com</u> 27 Nov. 2021(1)

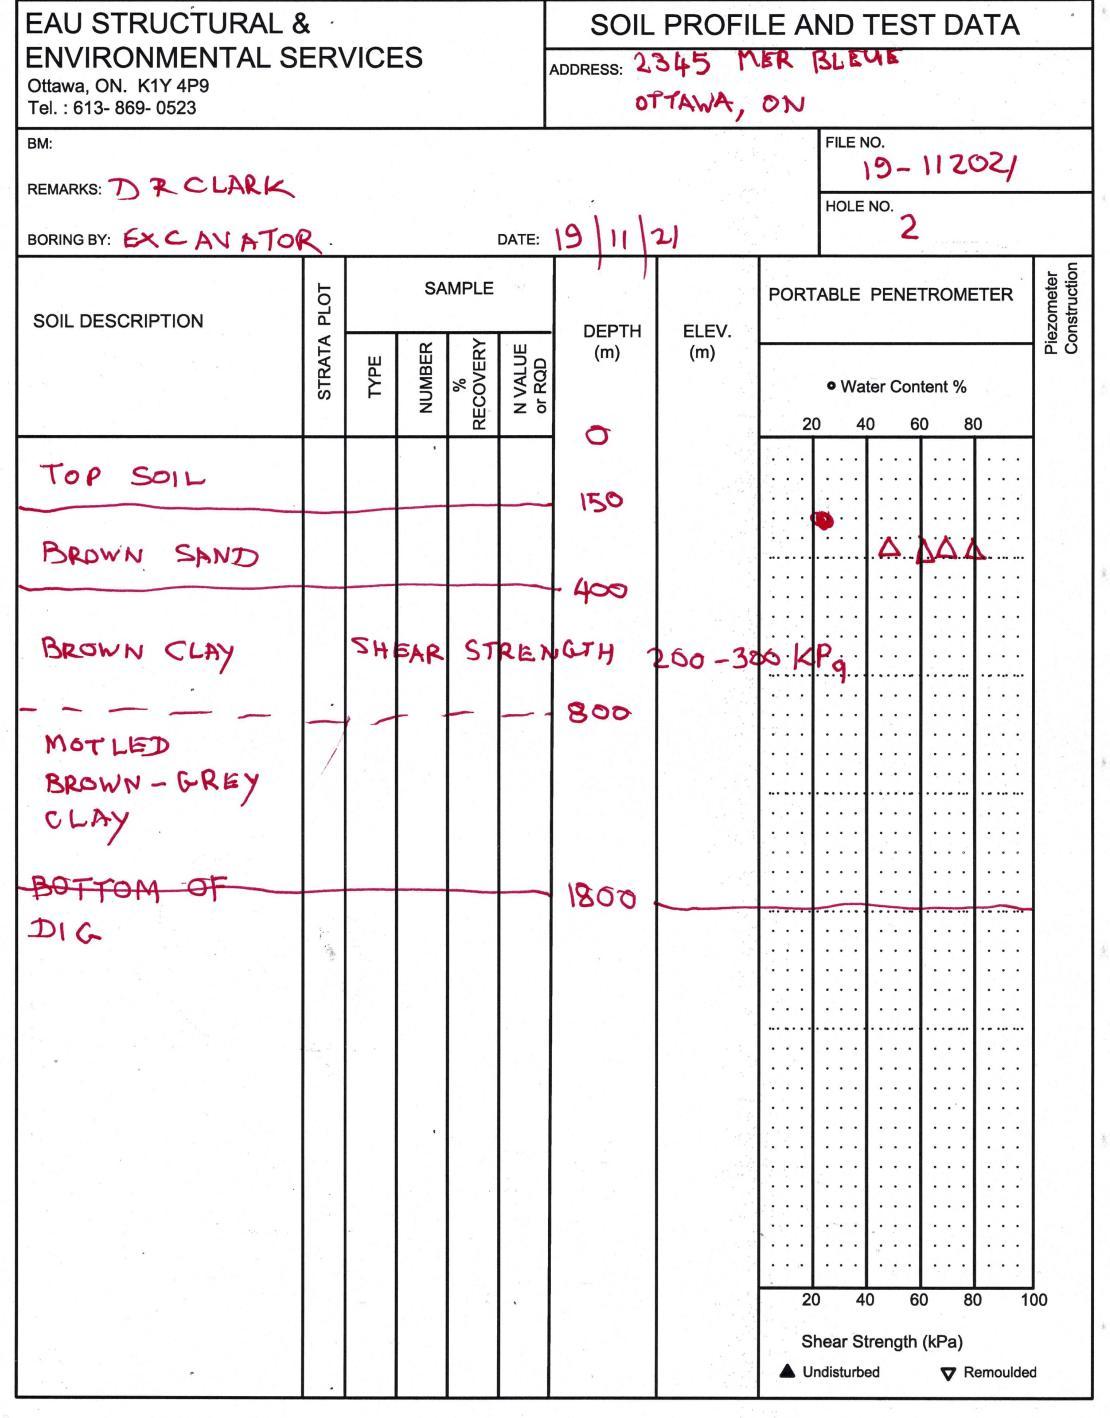
# **APPENDIX D – TP data**

Tel. : 613- 869- 0523						0	17 AWA,	ON						
BM:								FILE NO. 19 - 11 2021						
REMARKS: DRCLARK						19/11/21			HOLE NO.					
BORING BY EXCAVATOR	DATE:					<u>4</u> ן יין ט	<u></u>							
SOIL DESCRIPTION	SAMPLE					DEPTH	ELEV.	PORTABLE PENETROMETER					Piezomete Constructi	
	YPE YPE			ALUE	) (m)	(m)	• Water Content %							
N N S S S S S S S S S S S S S S S S S S				N N	5		20 40 60 80							
TOP SOIL						NEO.		•••	· · ·	· · · ·				
BROWN SAND						130		· · 9	• • • •	Δ۵	۵۵

-					500		· · ·		· · ·				
BROWN CLAY	S	HE.	AR	STR	EN	GTH	200-30	o k	Pg	· · · · · · ·	· · · · · · ·	· · · ·		
Marino	-	-		-		800		······ · · ·	· • • • •	· · · · ·	· · · · ·	· · · · ·		
BROWN - CREV								· · · · · · ·	· · · · · ·	 	· · · · · · ·	· · · · · · ·		
CLAY									· · · ·	· · · ·	· · · ·	· · · ·		
BOTTON DE			,			1000			· · · ·	: : : : : :	· · · · · ·	· · · ·		
שופ											· · ·	· · ·		
	1								· · · ·	· · · · · ·	· · · ·	· · · ·		
성 10월 13일 - 1912년 - 1913년 1913년 1월 13일 - 1913년 - 1913년 1913년 1913년 1월 13일 - 1913년 1913년 - 1913년 1913년 1913년 1913년 1913년 1913년 1913년 1913년 1913년								· · · · · · ·	· · · · · · ·	· · · · · · ·	· · · · · · ·	· · · · · · ·		
									· • · · ·	· · · ·	····- · · ·	·•••••• •••		
								••••	· · · · · · ·	· · · · · · ·		· · · · · ·		
								· · · ·	••••	· · · ·	· · · · · · ·	· · · · · · ·		
								· · · ·	· · · ·	· · ·				
								••••	•••		••••	•••		
								20	0 4	0 6	0 8	0 10	00
