TREE CONSERVATION REPORT V2.0

326-330 Wilbrod

Tree Conservation Report submitted as Partial
Requirements for a Site Plan Control Application,
June 28, 2022

Date: June 28, 2022

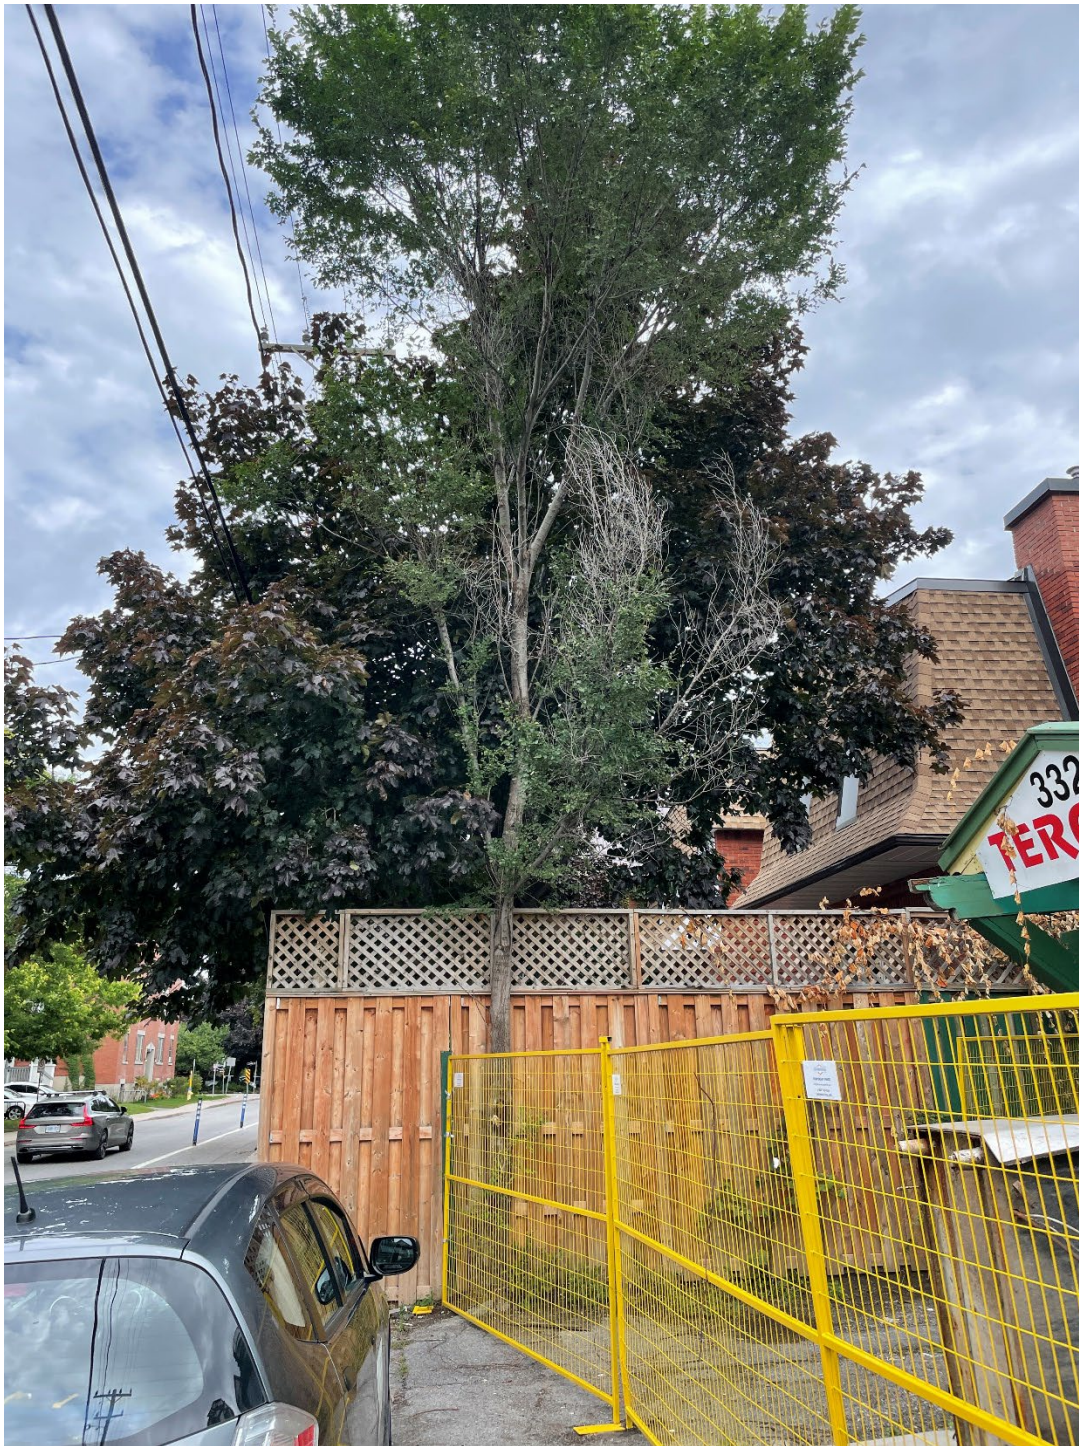
Figure 1: Tree 1, Siberian elm in the city right of way to be removed

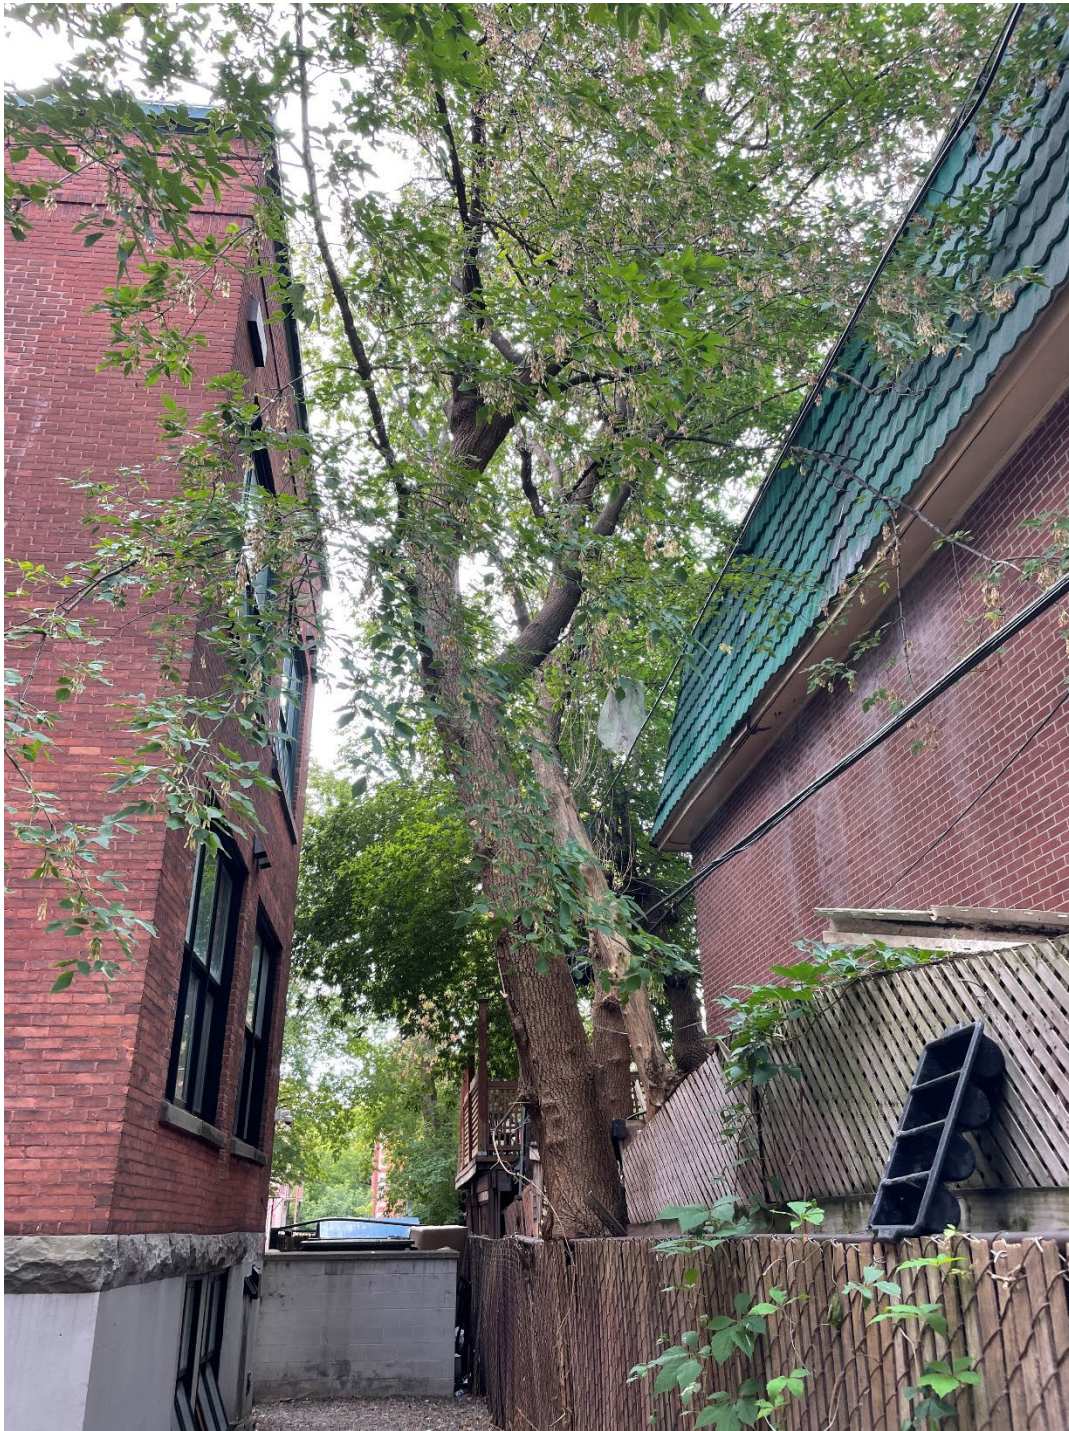
Figure 2: Tree 2, Manitoba maple, to be removed

Although trees 2 and 3 have been recommended for removal in this report, if the preference is to retain them, then it is highly recommended that a second health assessment be conducted once the site is more accessible and all the trees are fully visible. Manitoba maples are short-lived species and are more prone to failure than other species. Their viability for retention during construction taking into consideration their structural stability, should be re-assessed before any decision is made to retain them.

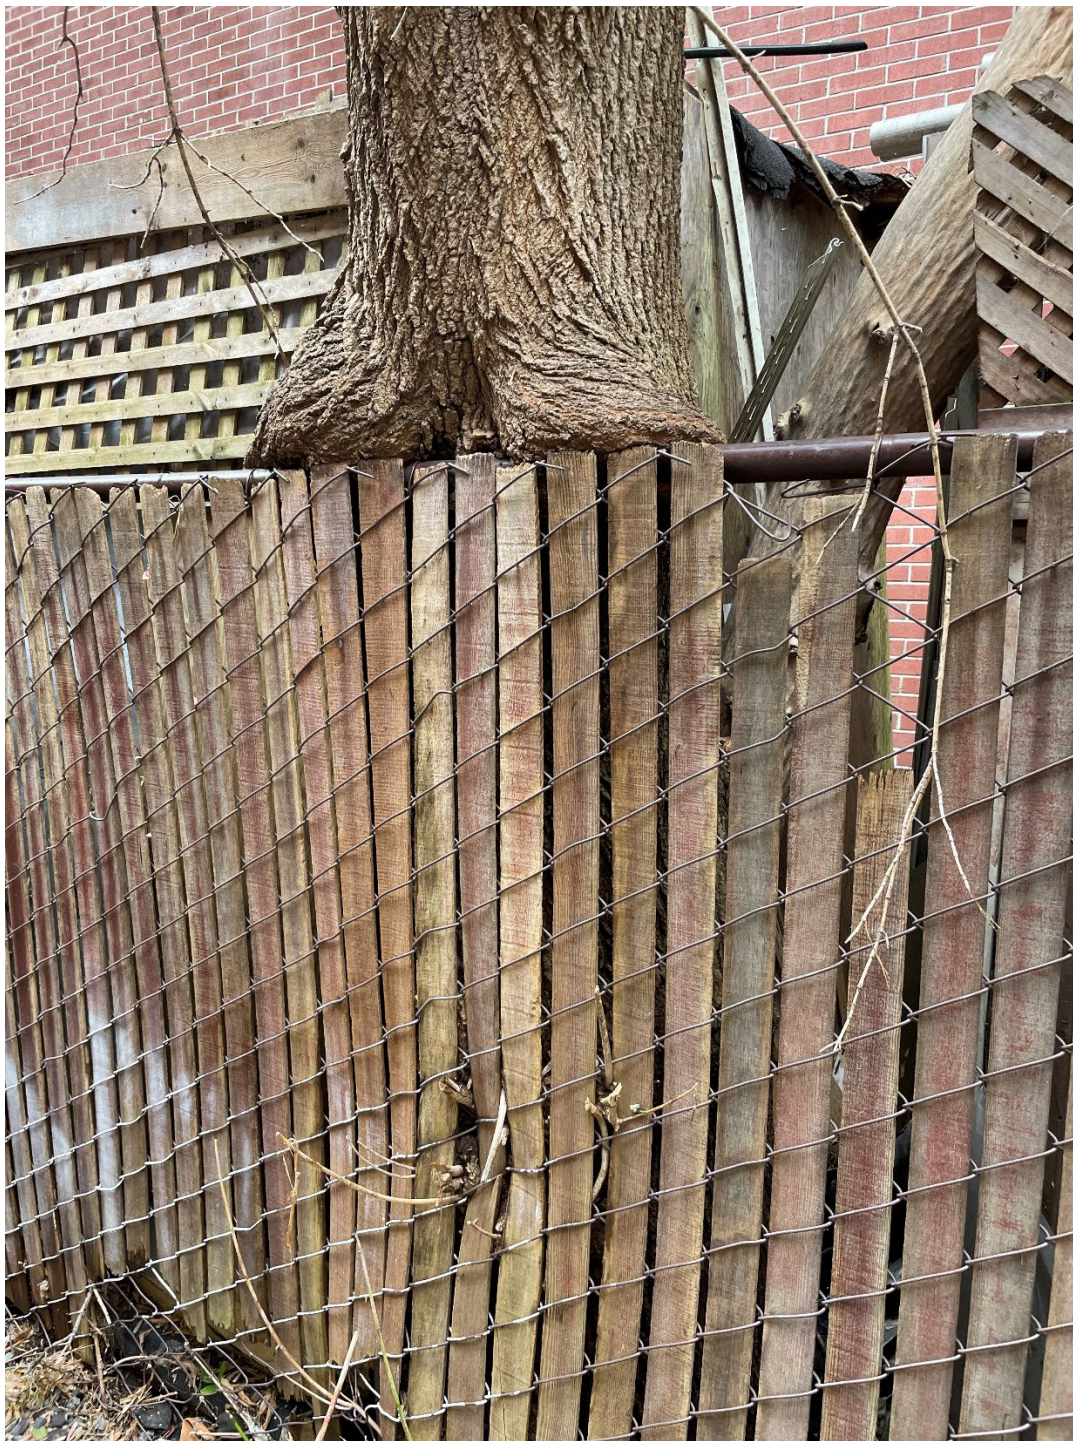
Figure 3: Tree 2, close-up of trunk growing into metal fence

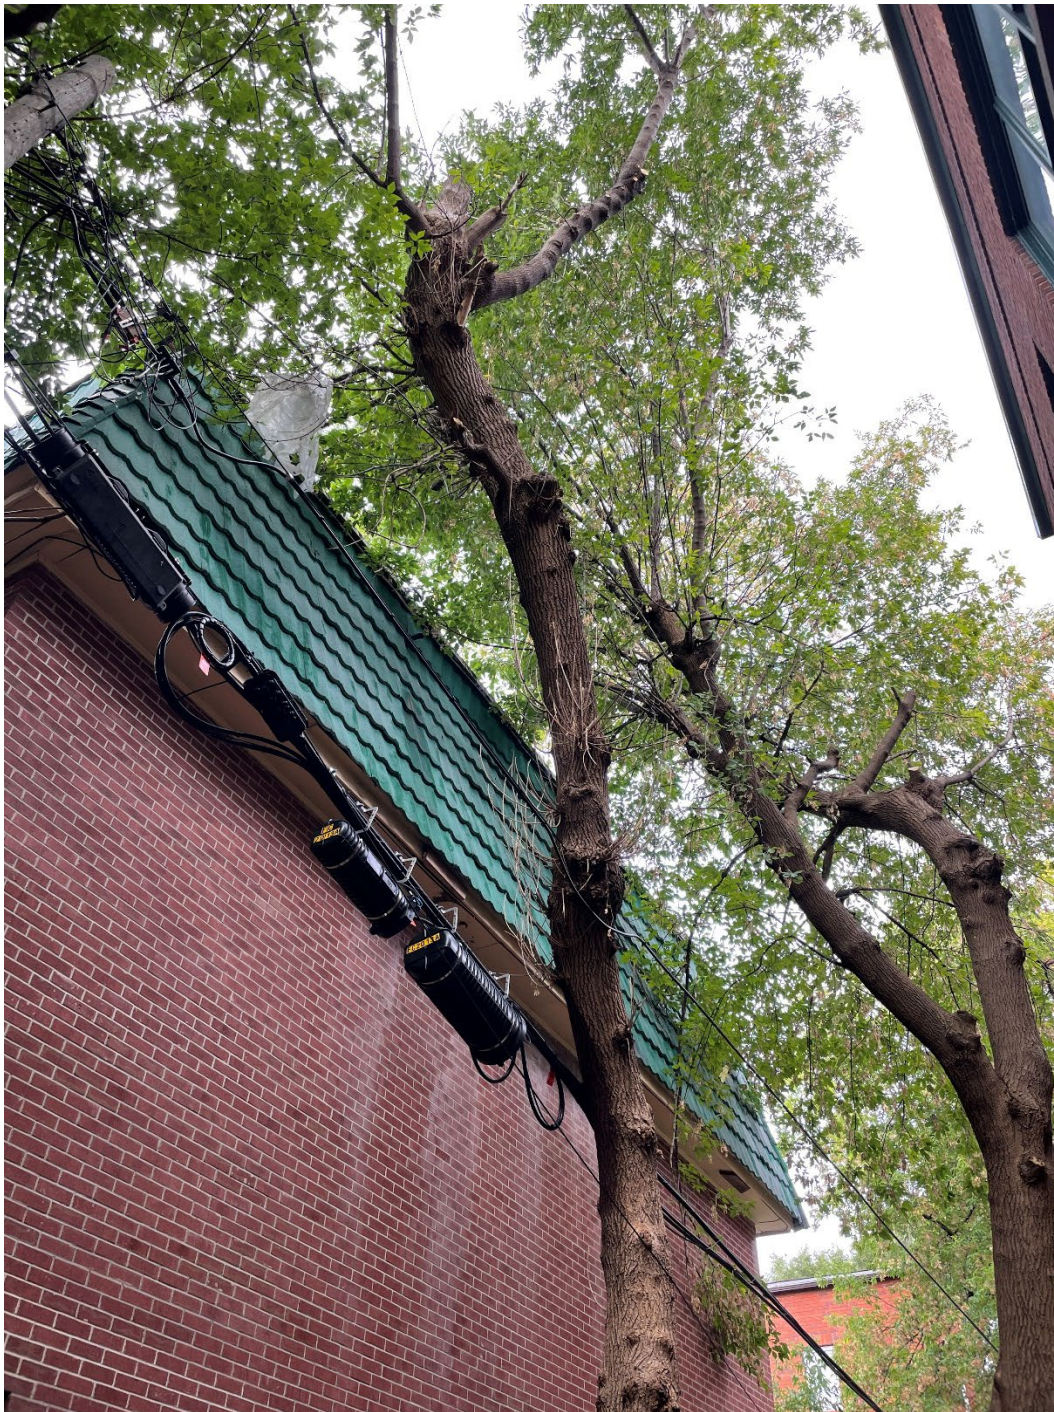
Figure 4: Tree 3 (left), Manitoba maple to be removed

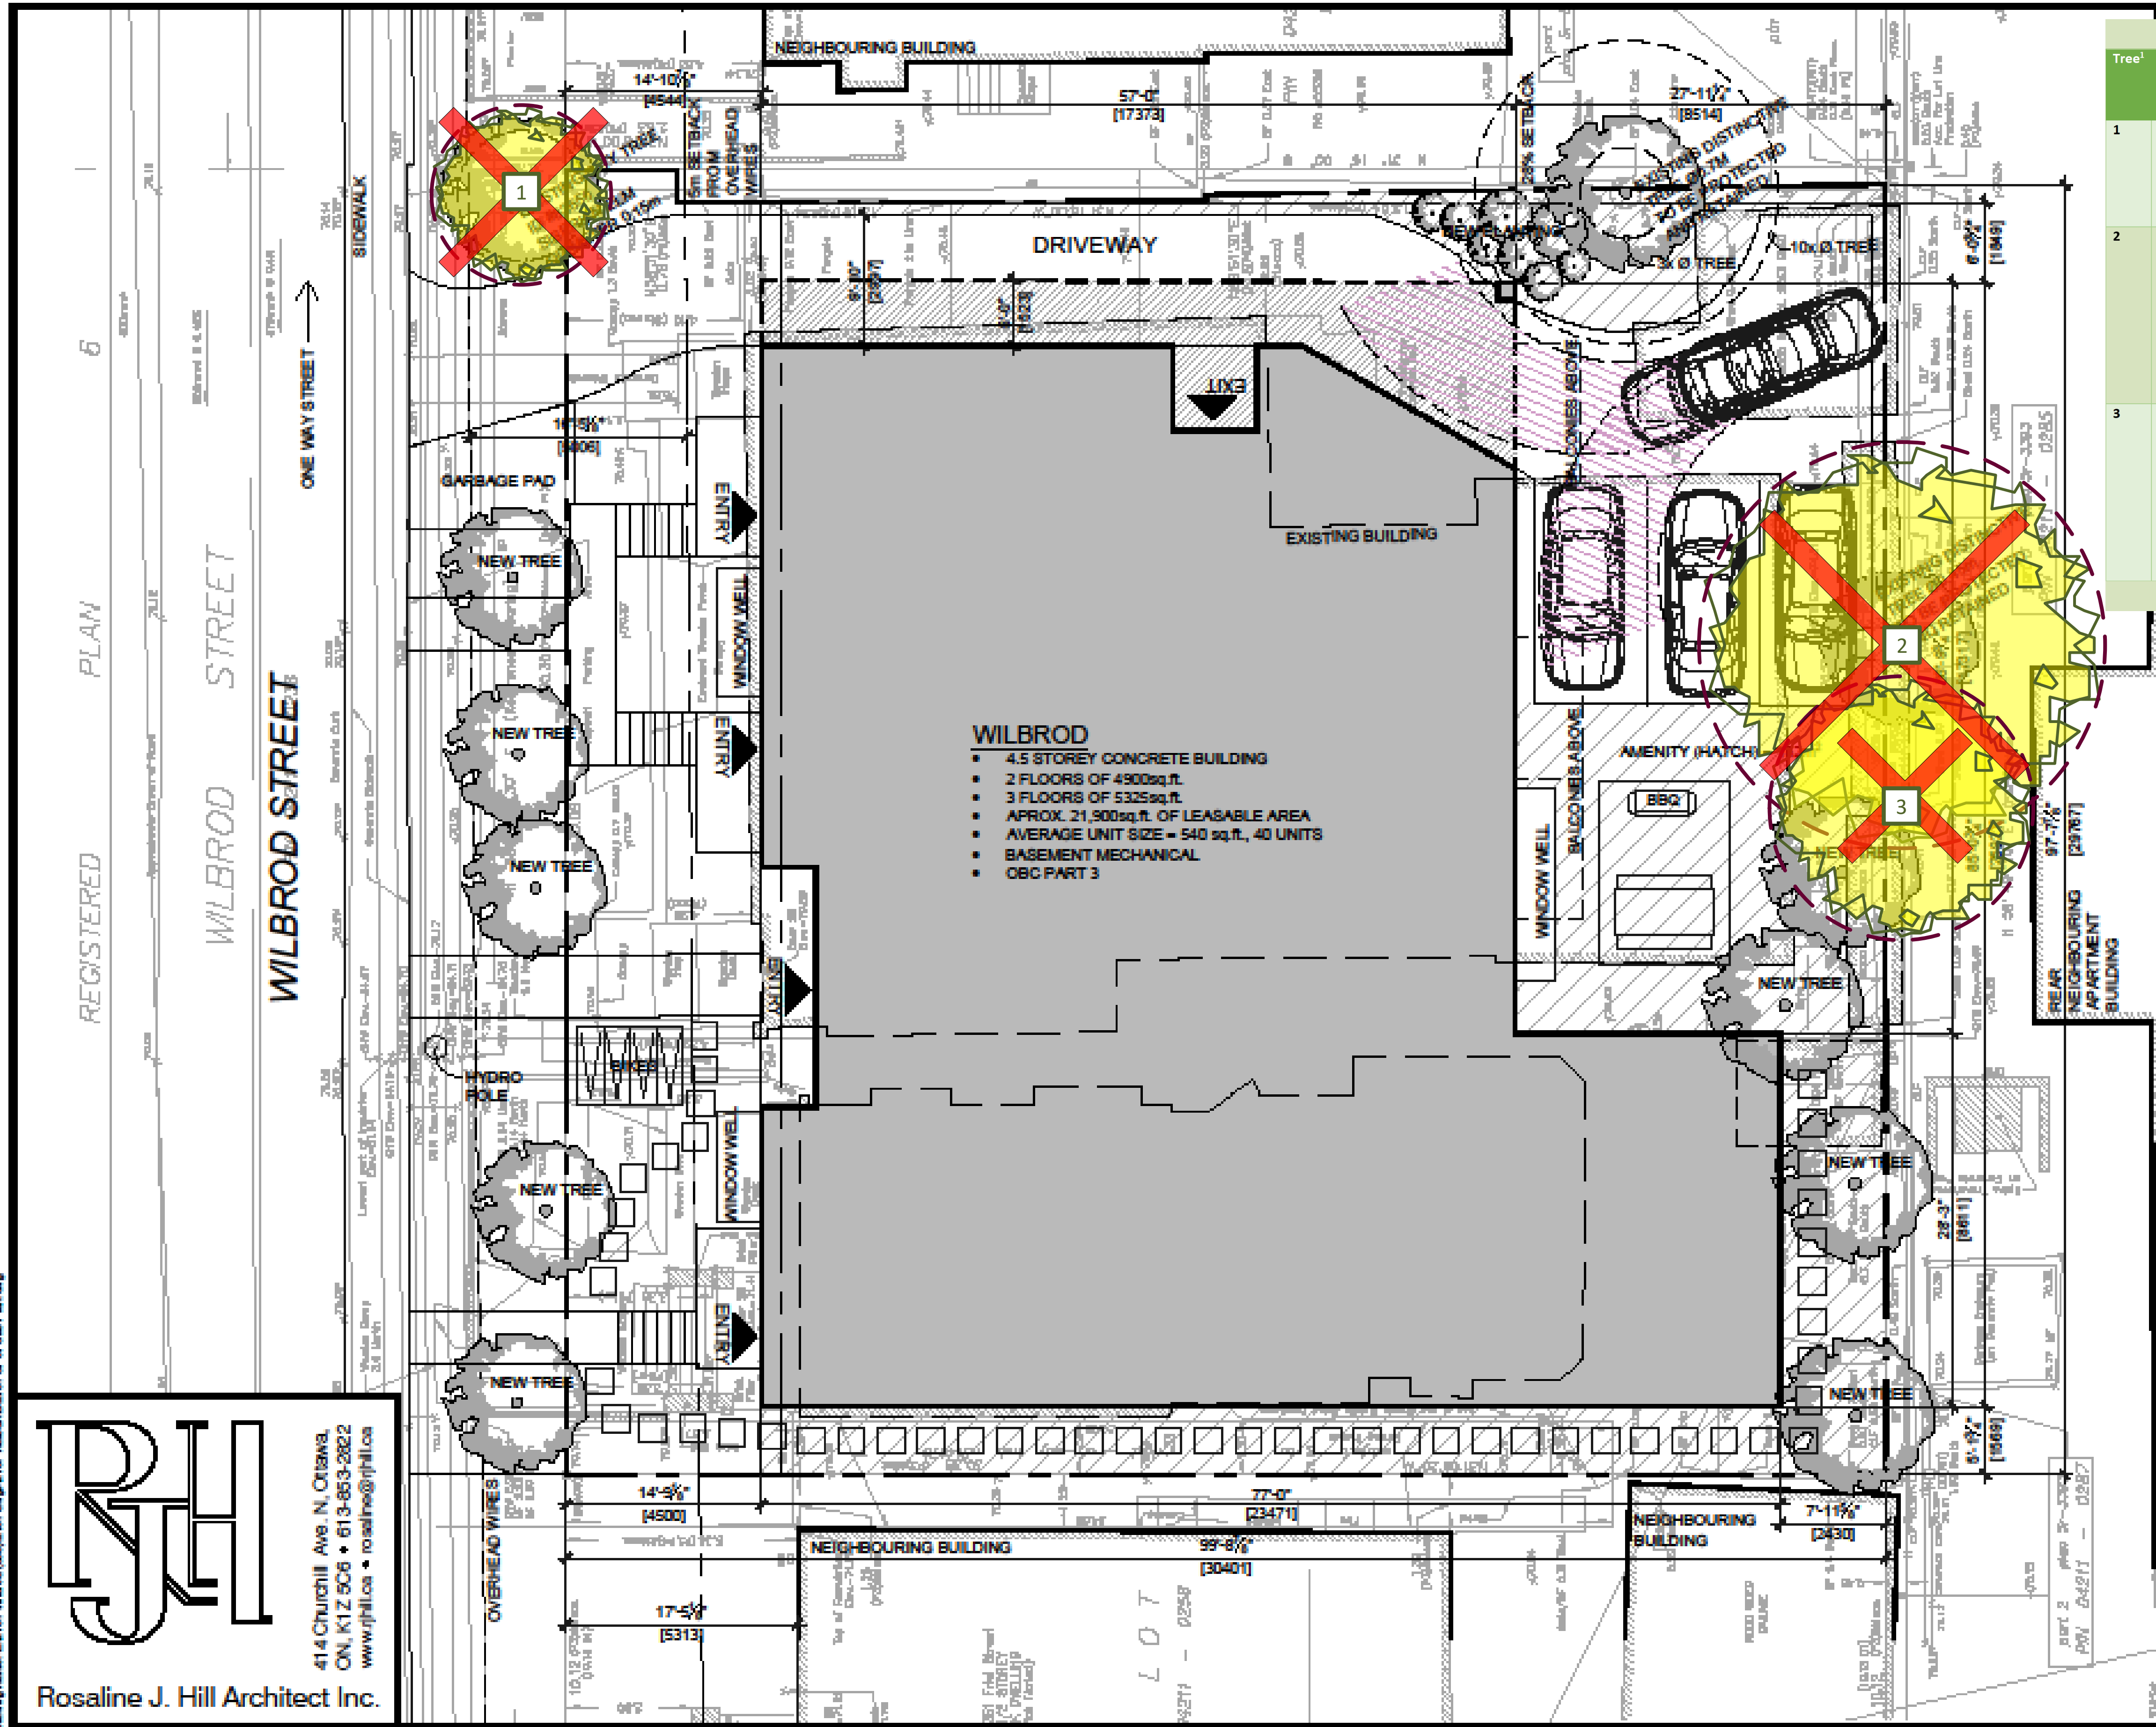
Tree Conservation Report – 326-330 Wilbrod
 Tree layer prepared by Dendron Forestry Services
 Version 2.0, June 28, 2022
 For more information, please contact info@dendronforestry.ca

Note: This report has been updated to show in the map that tree 4 has been removed from the site as part of the demolition of the existing buildings. Confirmation of the removal of this tree was provided by the client via email dated June 27, 2022 – an additional site visit was not completed.
